# National Transportation Safety Board

ERA22LA104

## EXAMINATION

Location: Edisto Island, South Carolina  
Date: January 11, 2022  
Time: 1247 Lcl  
1747 UTC  
Airplane: Piper PA-32-300 N475RT

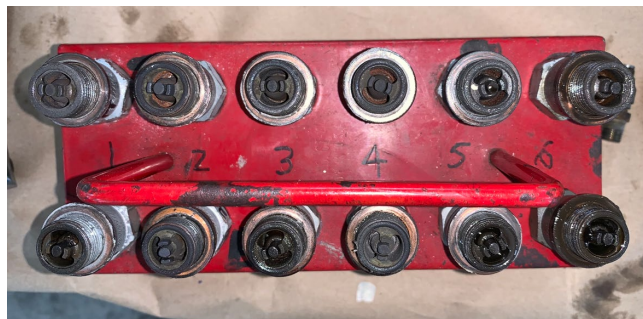
The spark plugs appeared slightly dark in color indicating some minor carbon buildup but otherwise the electrodes appeared normal per the Champion check a plug chart. (Figure 1)

Figure 1 Spark plug condition

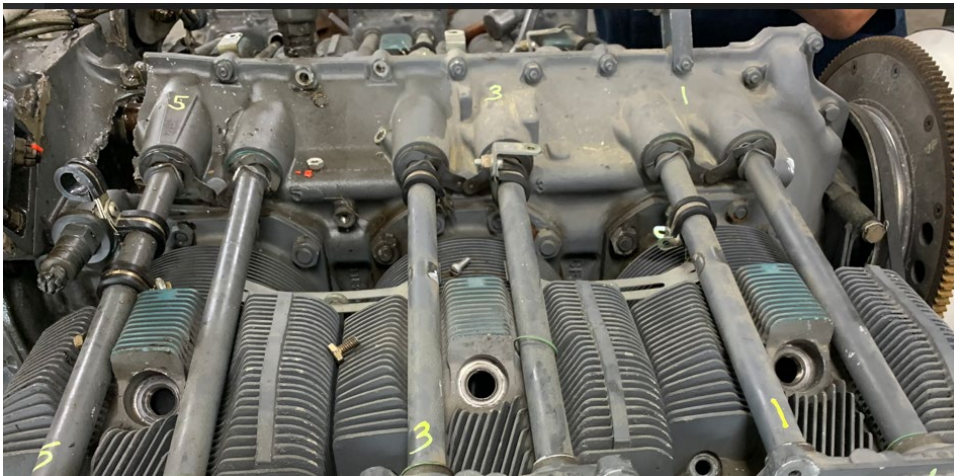
Two irregular shaped holes were found at the rear crown of the engine located above the nos. 5 and 6 connecting rods, exposing the camshaft. Crankshaft continuity could not be performed because of internal damage. The nos. 5 and 6 connecting rods were found broken at the connecting rod caps with no heat signatures present. (Figure 2)

**Figure 2 Overall view of top of engine showing hole over No. 5**

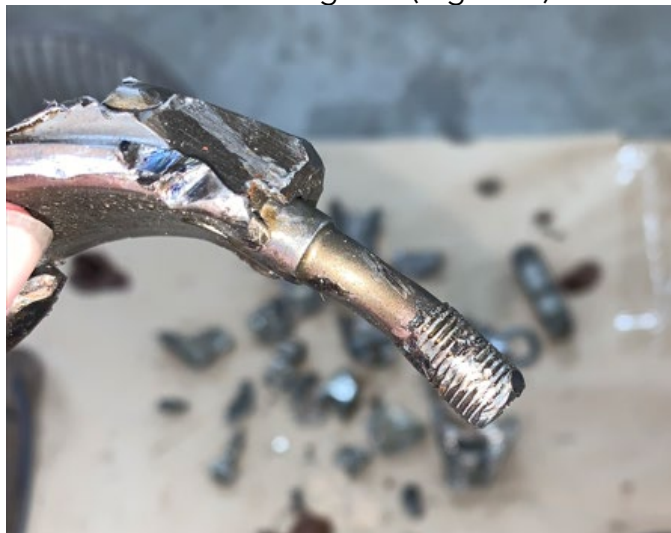
One connecting rod cap bolt remained intact although it was bent showing exposed and damaged threads and a missing nut. (Figure 3)

**Figure 3 Connecting rod with damaged threads and missing nut.**

Both connecting rod caps were broken into pieces. Minor scoring was noted on the adjacent bearings and surfaces.

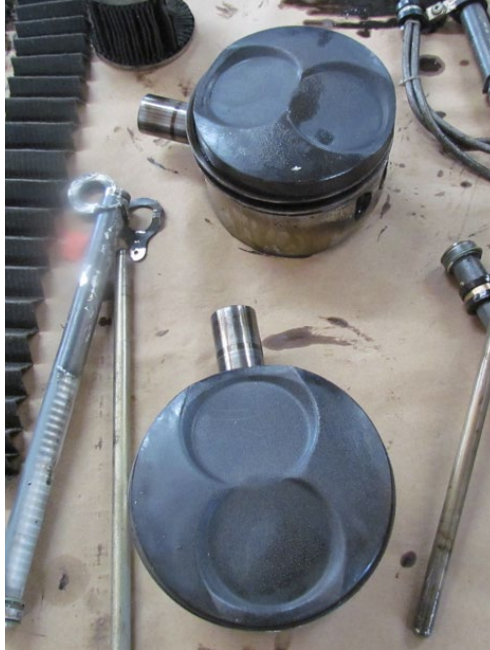
The nos. 5 and 6 piston crowns and cylinder head domes exhibited features consistent with detonation; the piston crowns had the appearance of a "sandblast;" smooth and clean with the compression and oil rings compressed into the ring walls. (Figure 4)

**Figure 4 Piston crowns with features consistent with detonation.**

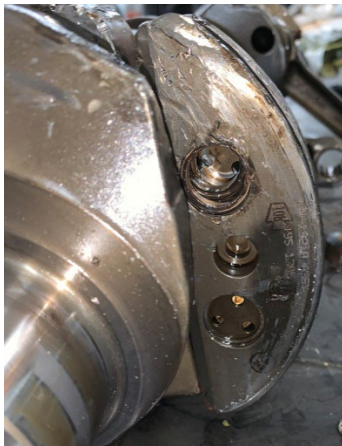
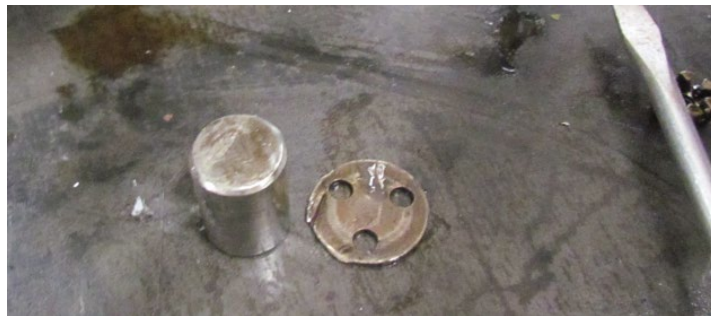
The internal retaining ring (circlip), washer, and roller were found separated from one of the counterweights. And all the internal retaining rings exhibited anomalous damage; their eyelets were broken off. (Figure 5)

**Figure 5 Counterweight missing roller, washer, and circlip. On the right, a free roller and washer found in the crankcase.**

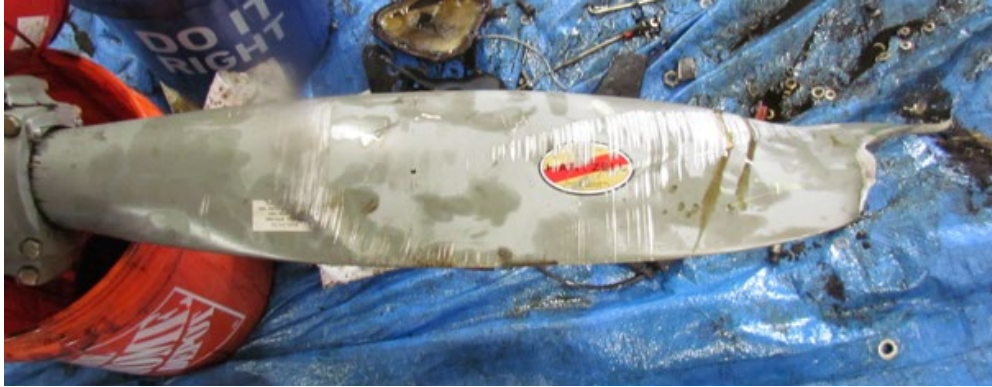
One propeller blade was twisted, and it contained some chordwise scraping and polishing. The opposing blade contained some scraping and was missing about 3 inches from the tip. (Figure 6)

**Figure 6 Blade condition**
