# National Transportation Safety Board

ERA22LA148

## AIRCRAFT PERFORMANCE STUDY

Location: Middle River, Maryland  
Date: March 7, 2022  
Time: 1045 Eastern Standard Time (EST)  
1545 Coordinated Universal Time (UTC)  
Airplane: Cessna Citation 525B CJ3, N22AU, 525B-0304

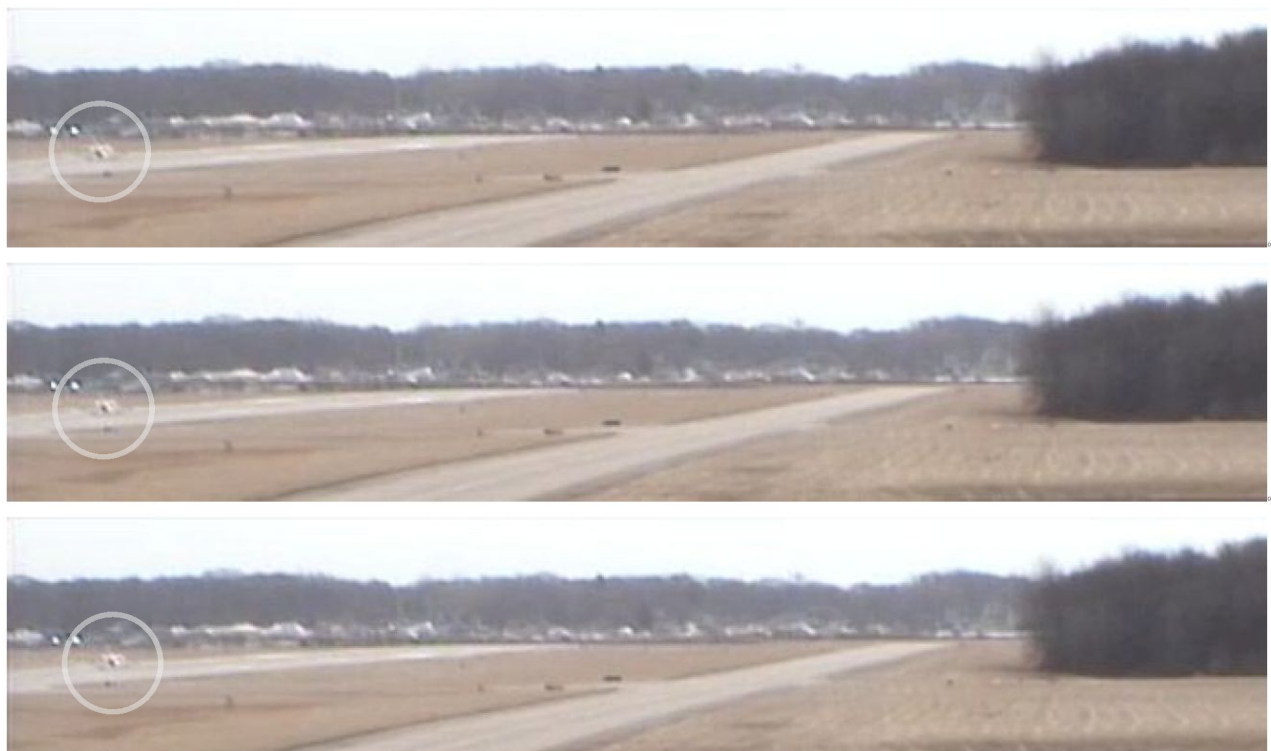
**"Airport" Camera (N22AU landing ground rollout segment), Attachment 4**

Figure 2: Cropped and enlarged image sequence extracted from "Airport" surveillance camera recording. N22AU moving left to right during ground rollout toward departure end of runway 15.

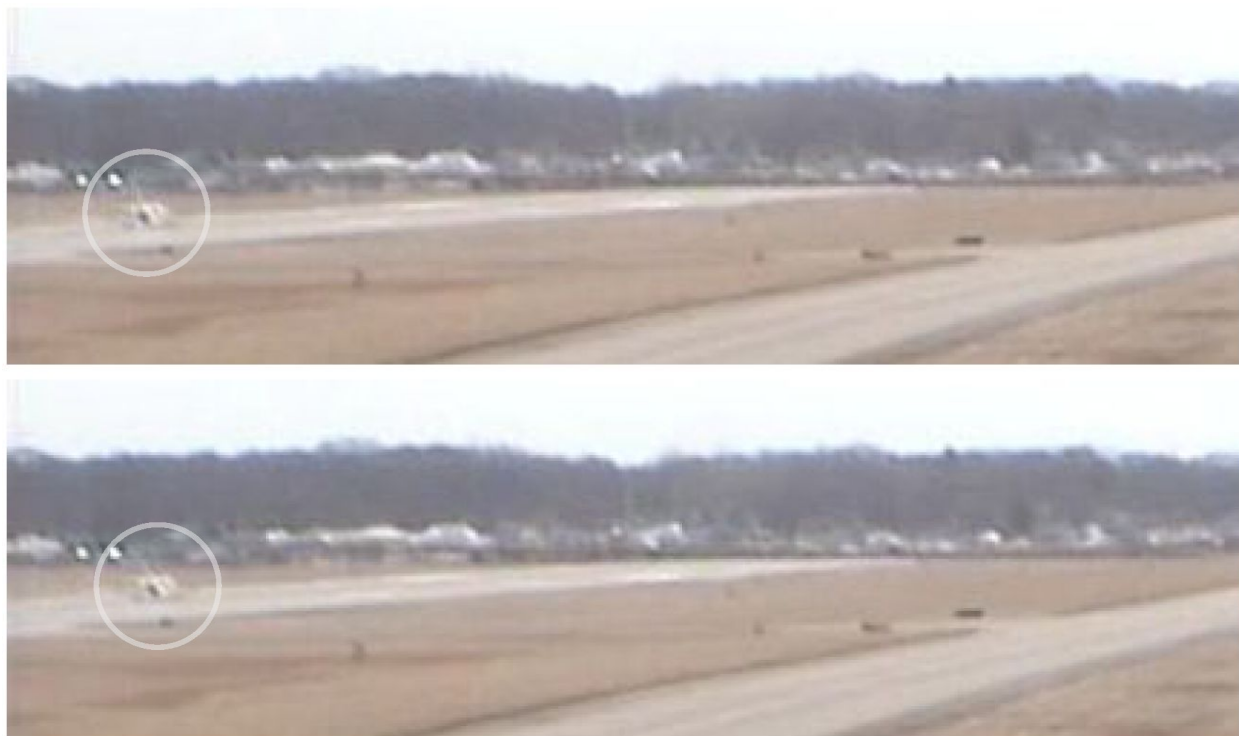
## **“Airport” Camera (N22AU landing ground rollout segment, digital zoom), Attachment 5**

Figure 3: Cropped, further enlarged image sequence extracted from “Airport” surveillance camera recording. N22AU moving left to right during ground rollout toward departure end of runway 15.

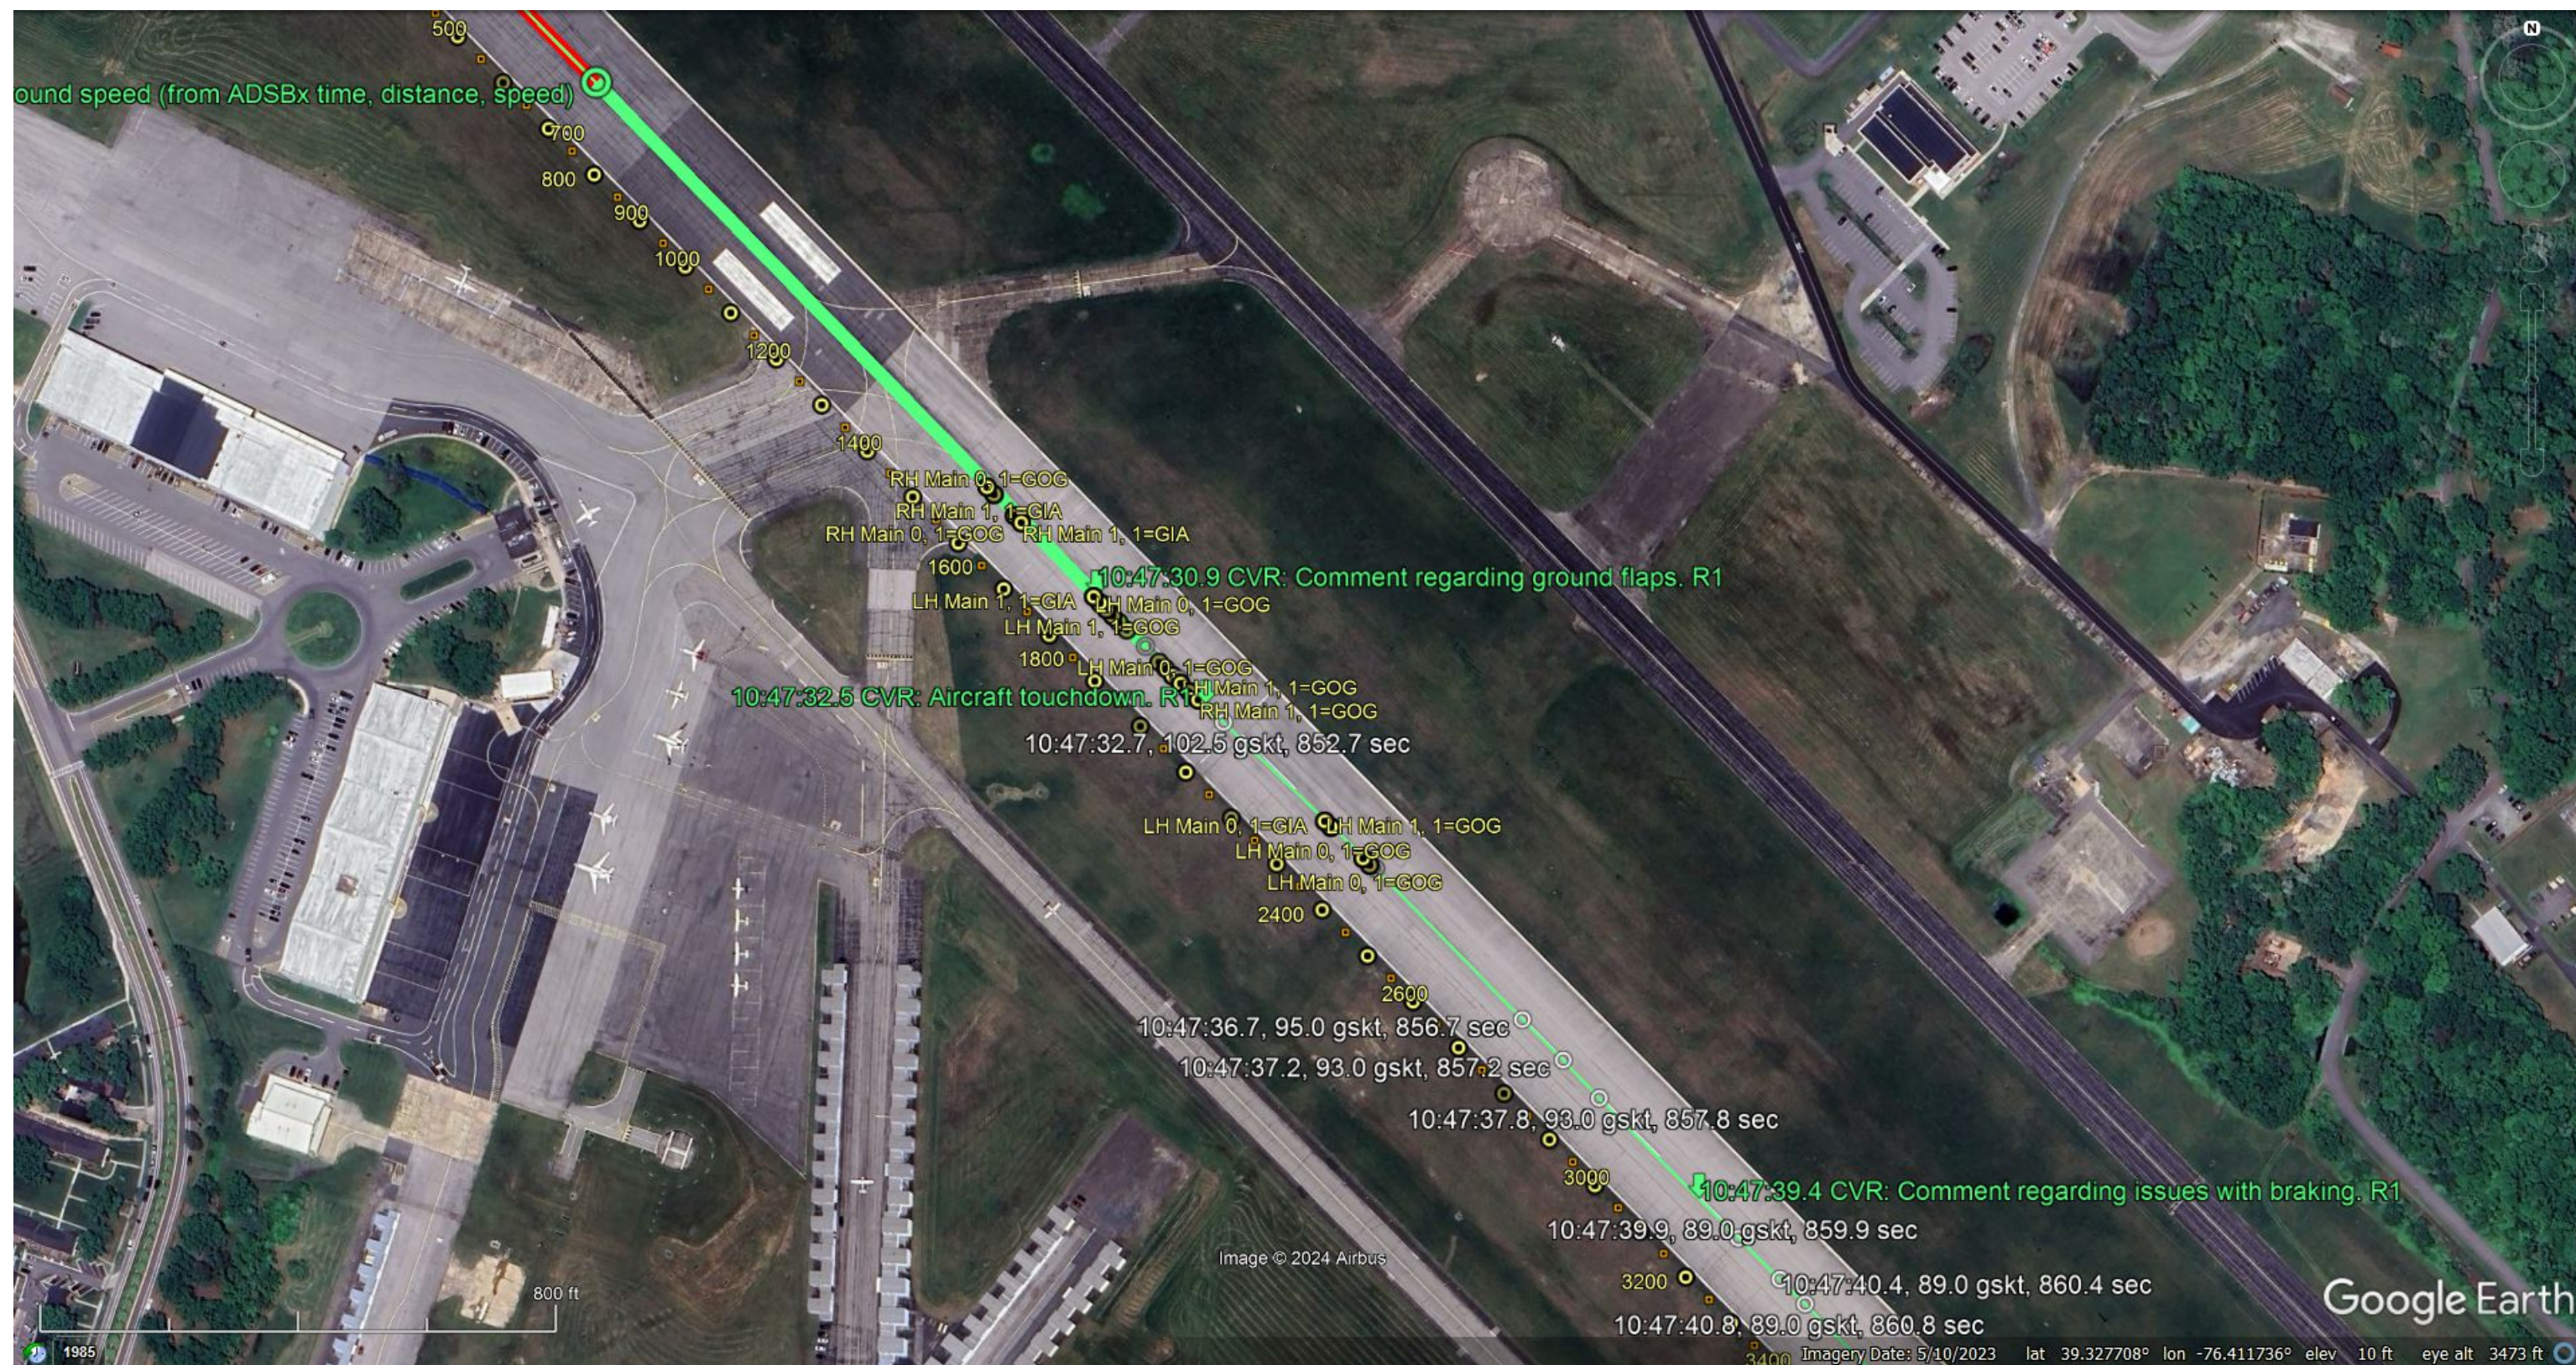
The time aligned paraphrased CVR events, ADS-B data, and AReS data were positioned on the N22AU event ground track reconstruction to yield the exemplar runway 15 overview plot shown in Figure 7. The sequence of plots in Attachment 11 illustrate the reconstructed N22AU ground track from short final approach to the airplane final rest position.

Figure 7: Example of N22AU accident flight reconstruction showing main gear touchdown and deceleration device configuration segment (between 800 and 3,400 feet along MTN runway 15). Ground track is based on ADS-B, Cessna AReS, paraphrased CVR, video, and runway witness mark evidence. Aircraft direction of travel is upper left to lower right. Due north is toward the top of the page. This image is a duplicate of Attachment 11, Figure A11.6.

The ADS-B groundspeed and AReS altitude, airspeed, engine throttle lever angle, main landing gear GOG, main landing gear GIA, and speed brake parameters were incorporated in the ground track model. Factual evidence downrange of the runway 15 departure end, such as witness marks associated with landing gear rutting were not used to position N22AU in time or space.
