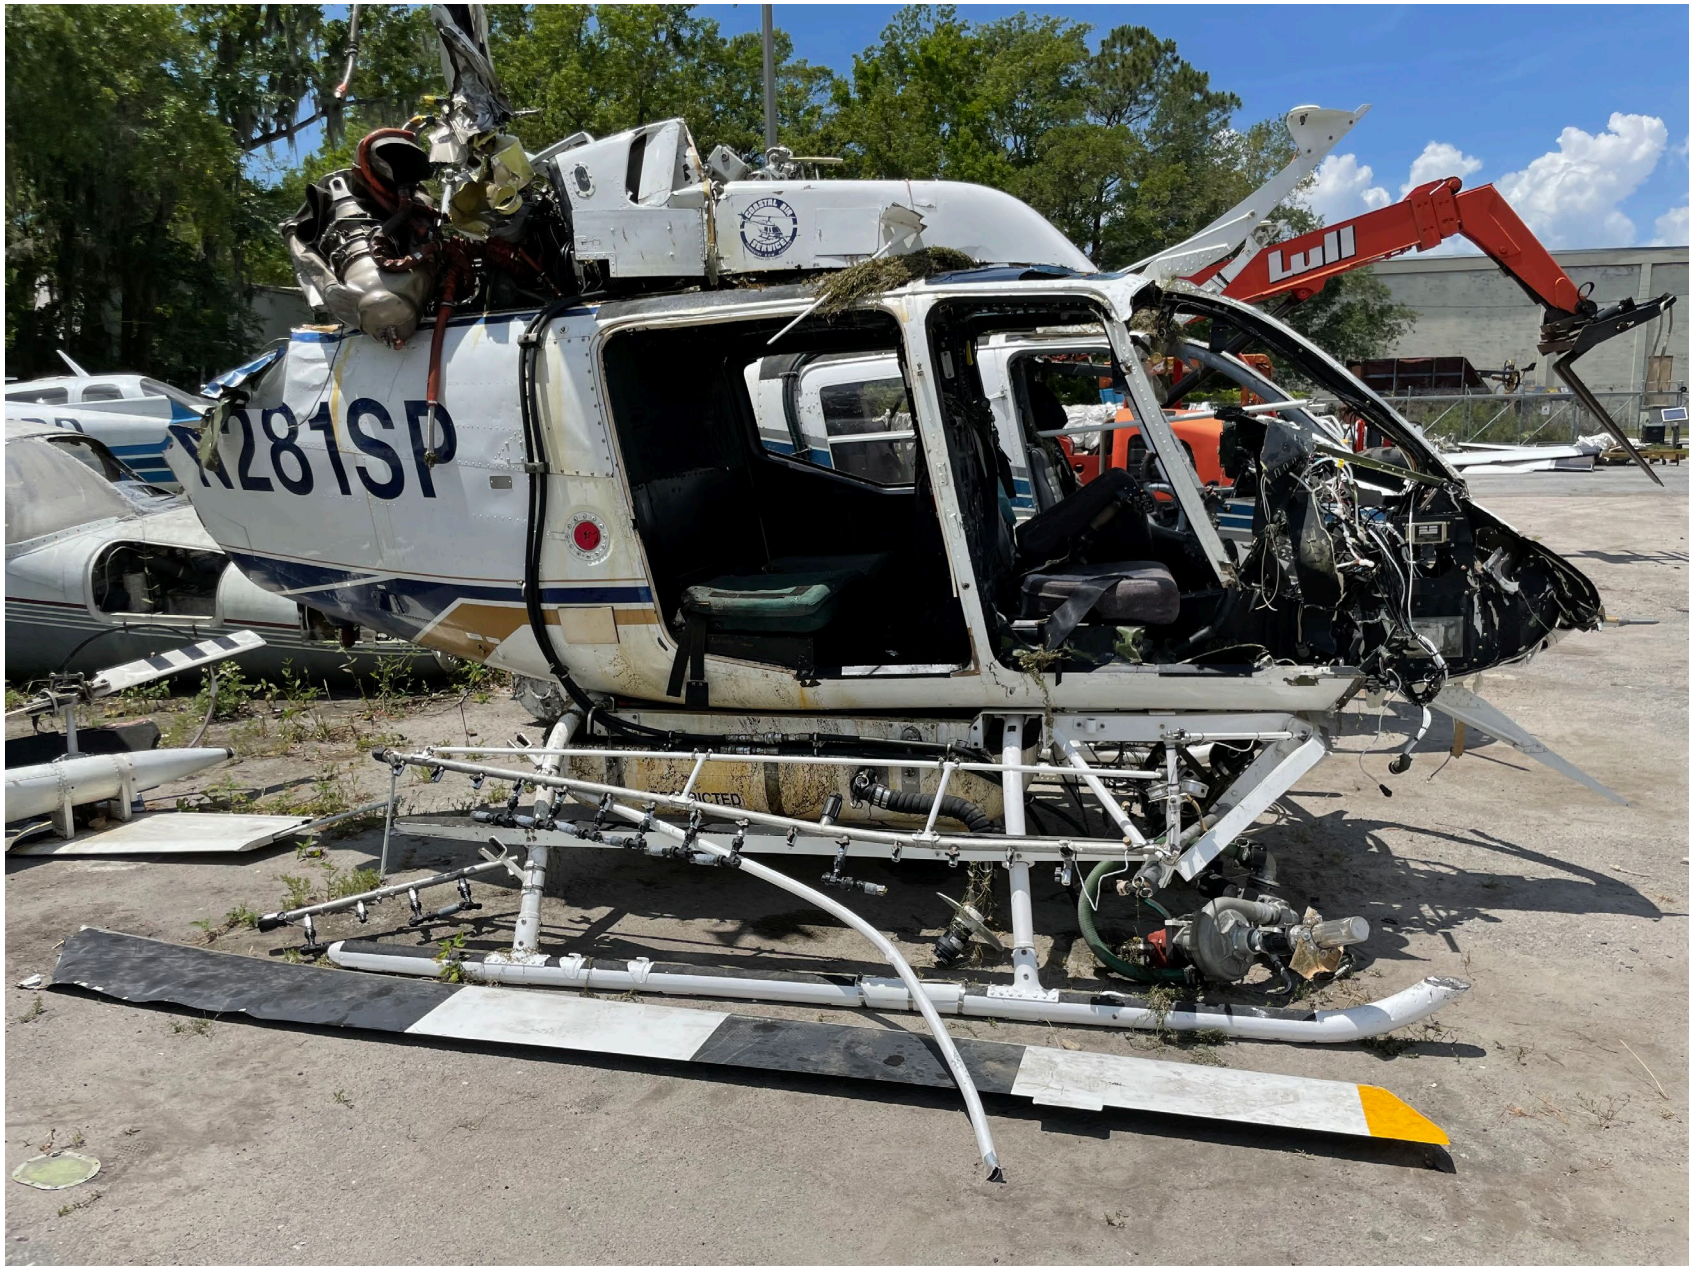
**Photo 1 – Digital Photograph From Recovery Company. Right Side View of the Helicopter Following Recovery. Note the Separated Tailboom and Displaced Engine.**

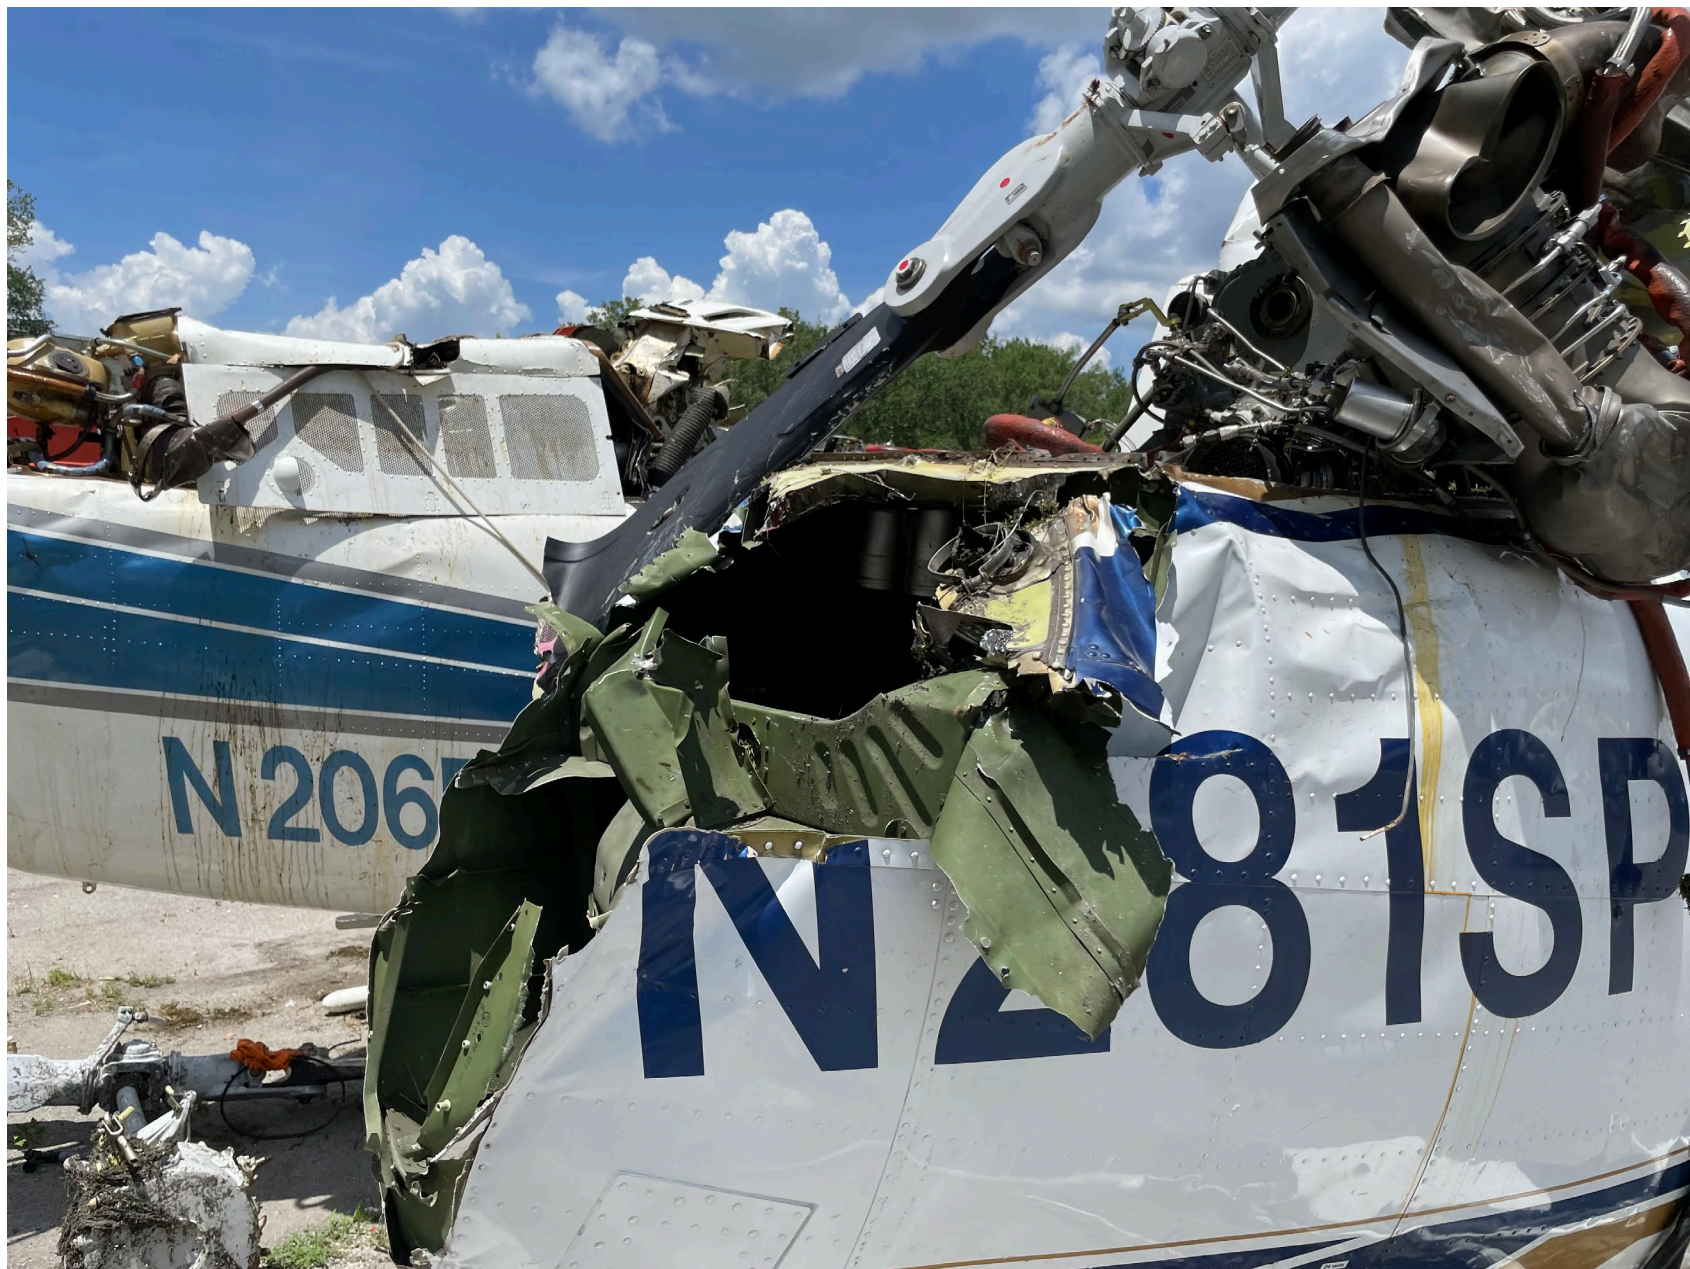
**Photo 2 - Digital Photograph From Recovery Company. Right Side View of the Helicopter Following Recovery. Note the Structural Damage, Separated Tailboom, and Displaced Main Rotor Assembly.**

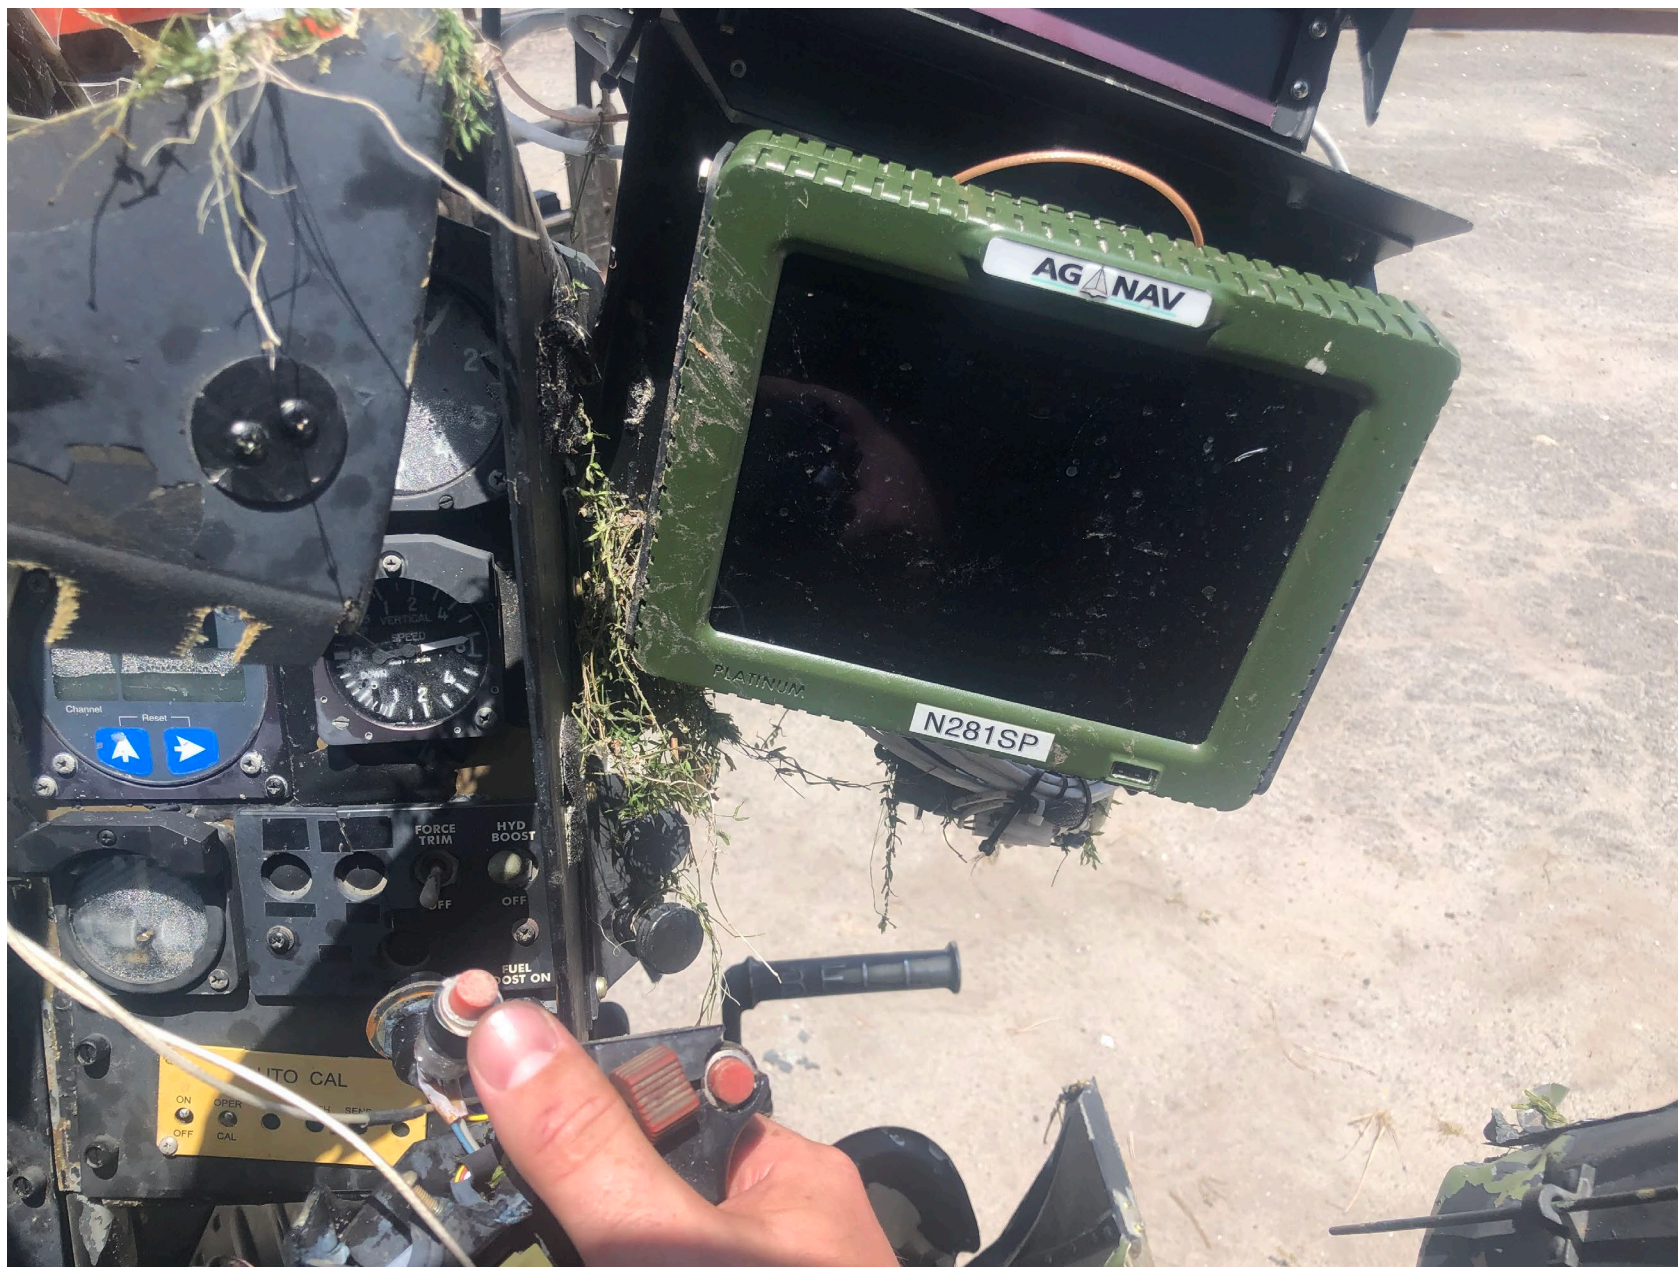
**Photo 3 - Digital Photograph From Recovery Company. Image Taken From Pilot's Seat Showing Location of GPS.**
