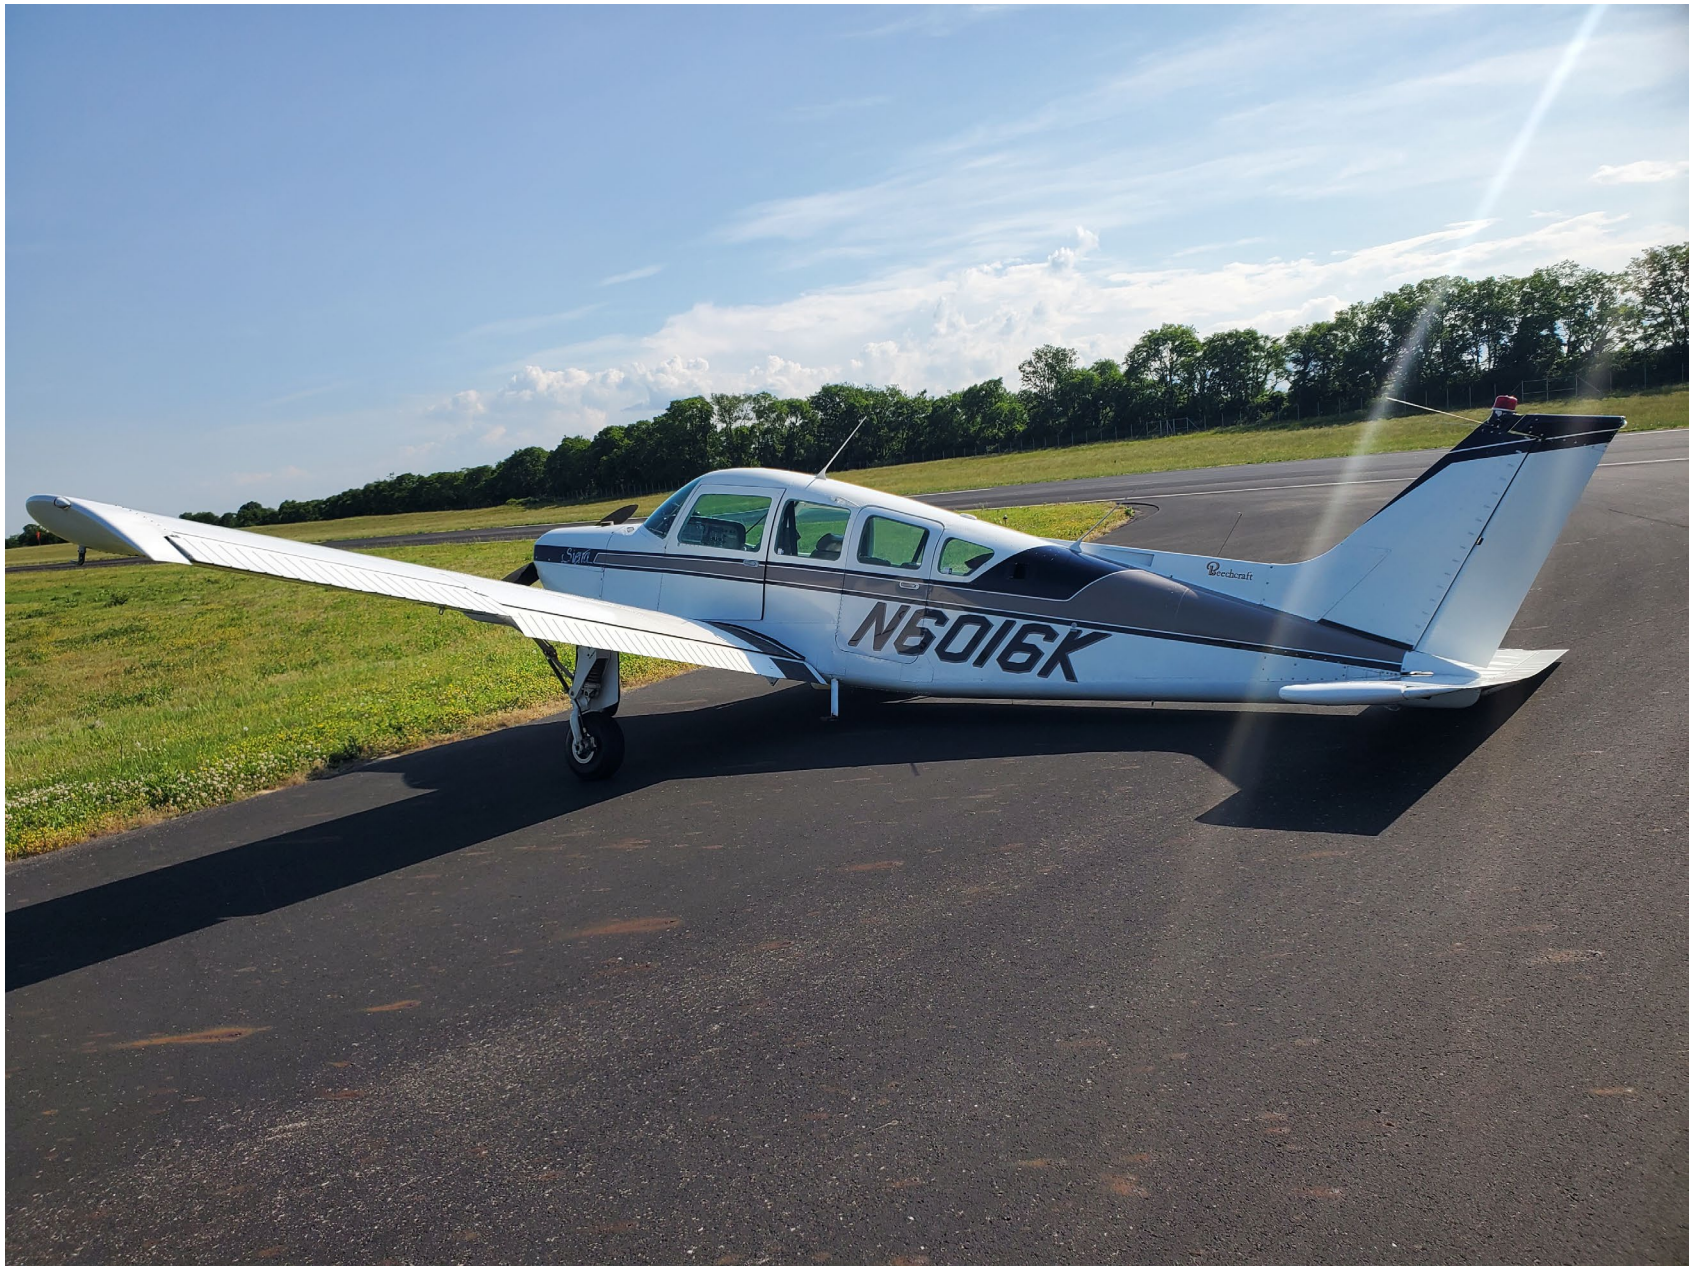
**Photo 1 – Digital Photograph From Pilot. Left Side View of the Airplane Where it Came to Rest. Note the Collapsed Right Main Landing Gear.**

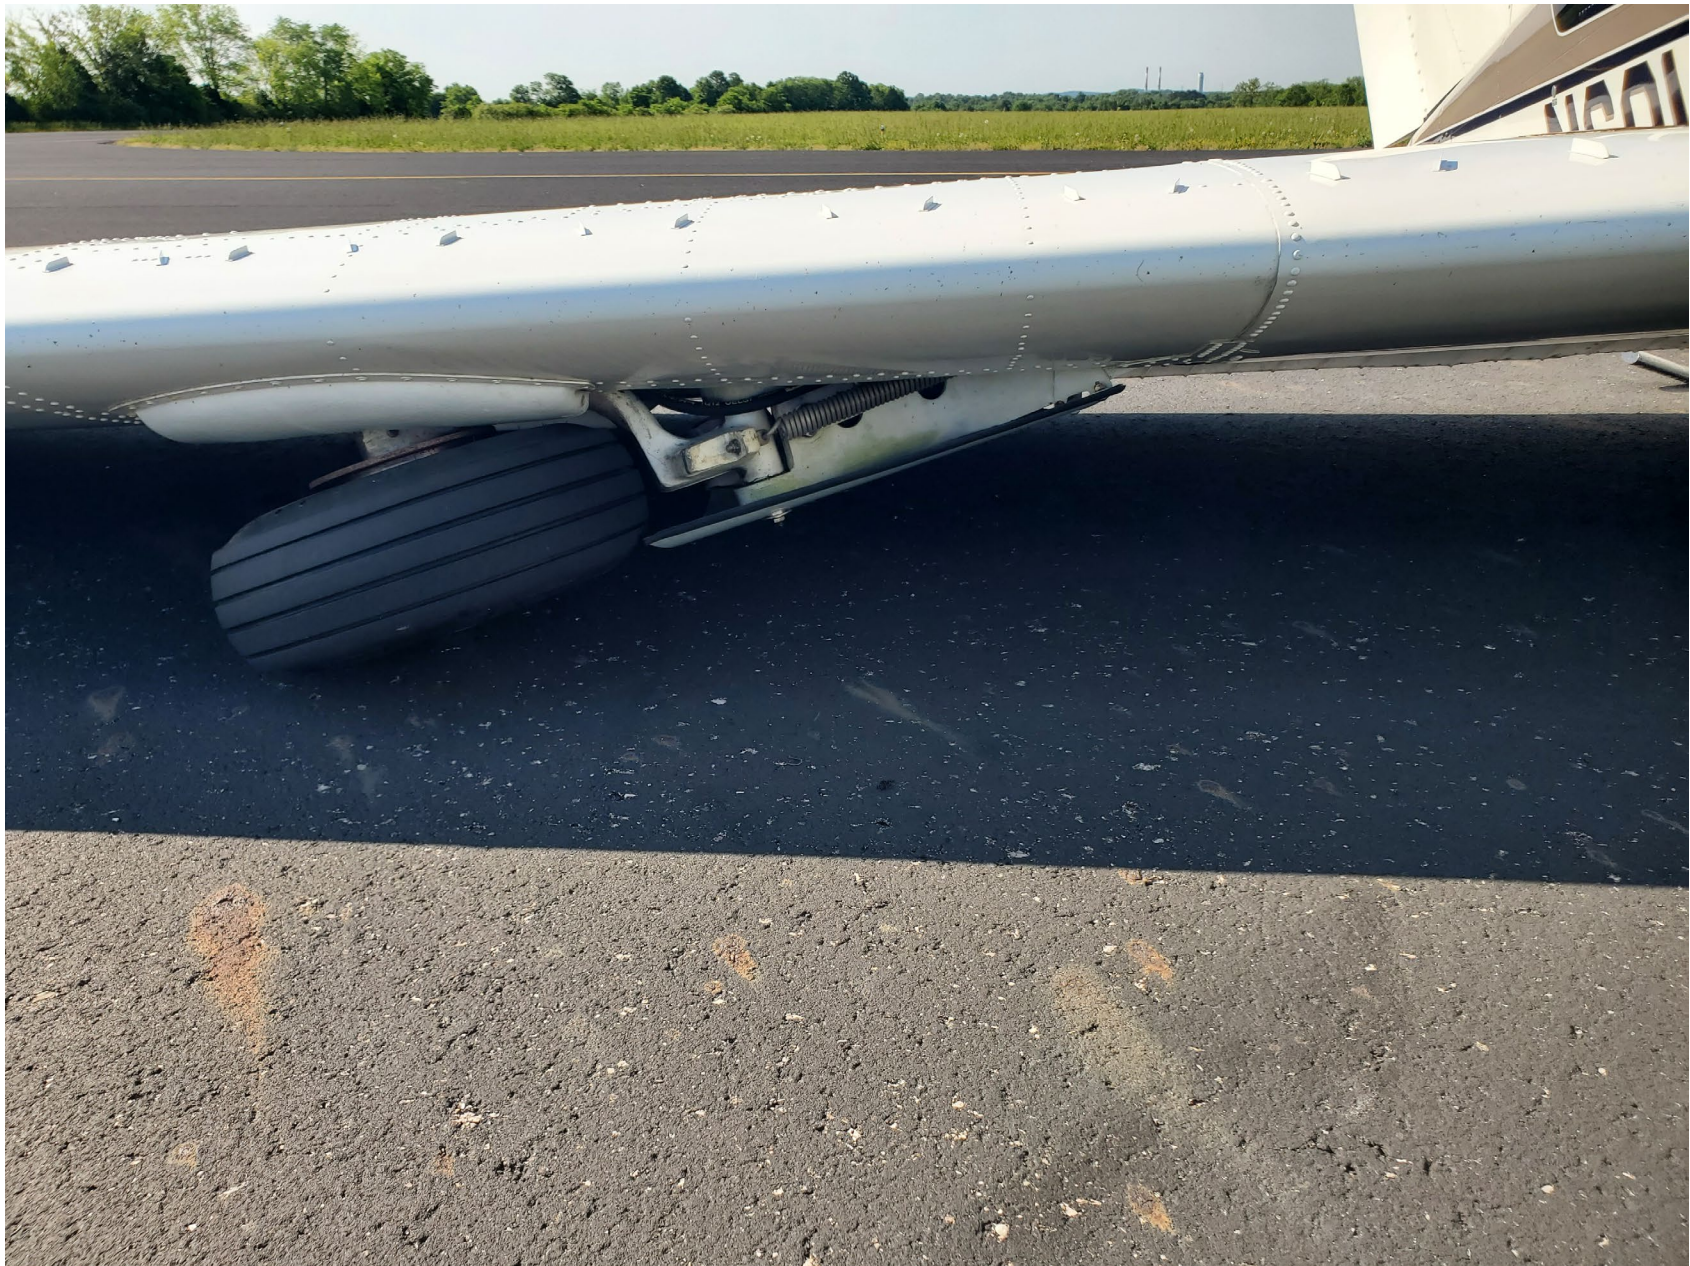
**Photo 2 - Digital Photograph From Pilot. View of the Collapsed Right Main Landing Gear.**

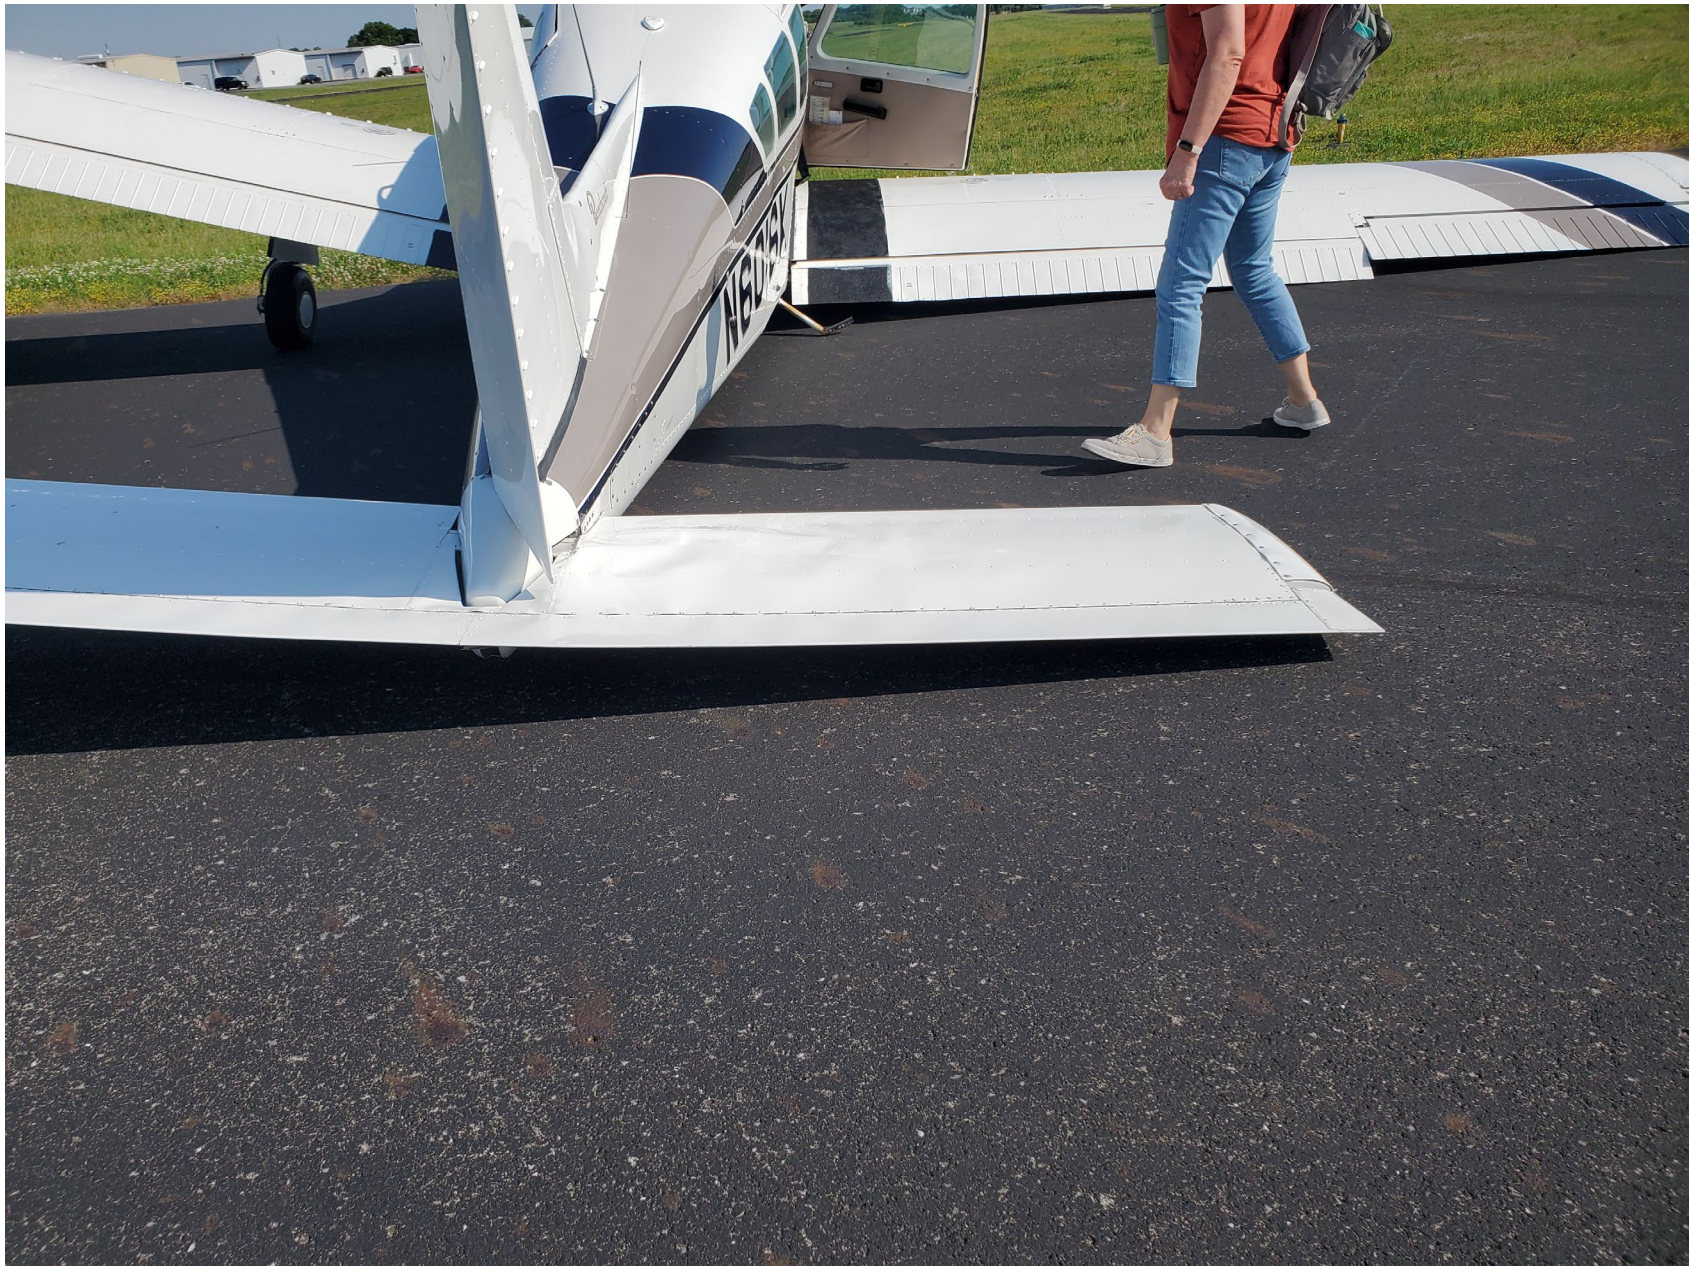
**Photo 3 - Digital Photograph From Pilot. Aft View of the Airplane Where it Came to Rest. Note the Compression Wrinkle on the Upper Skin of the Right Side of the Stabilator.**

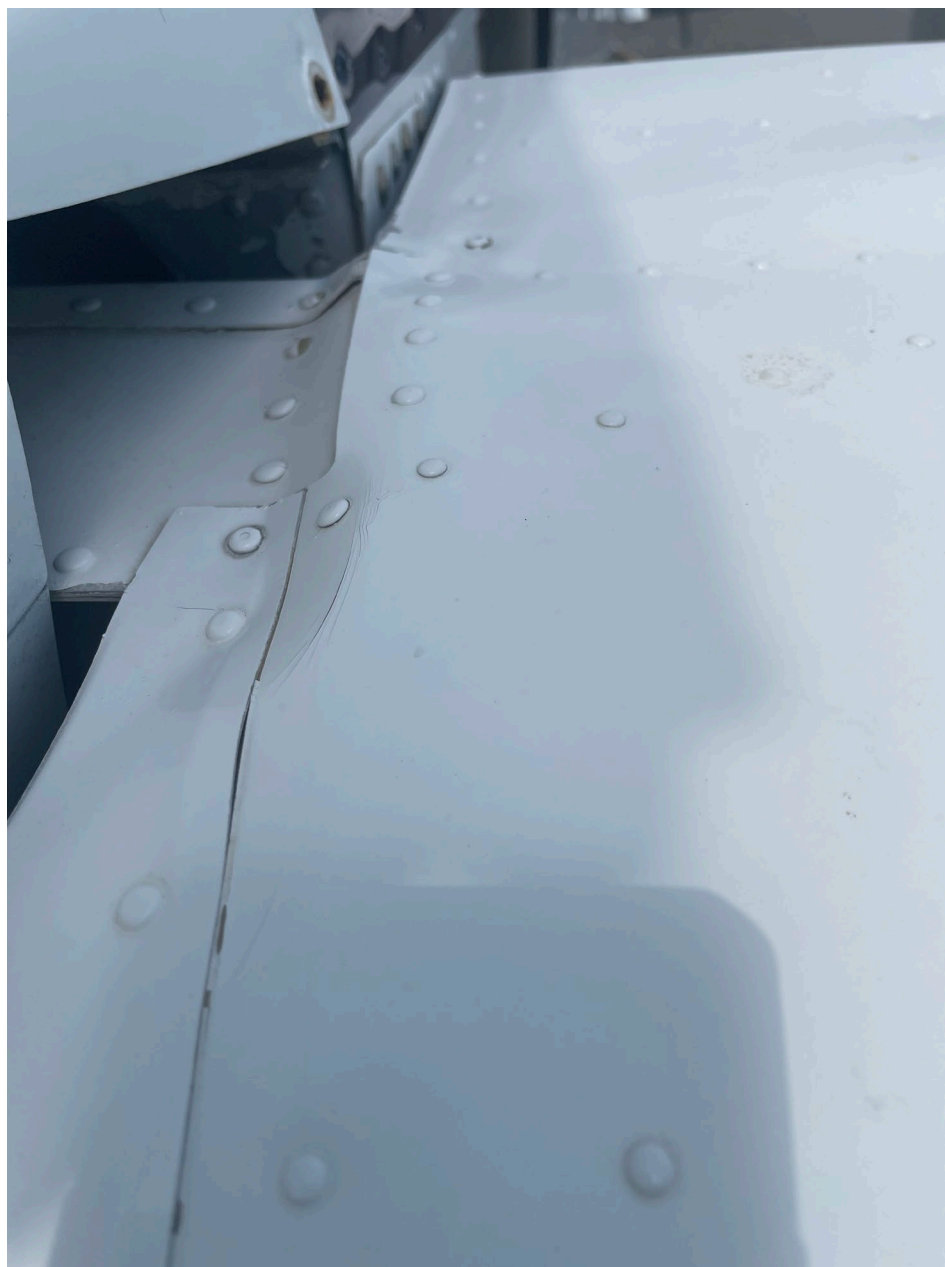
**Photo 4 – FAA Digital Photograph. View Showing the Structural Damage to the Right Side of the Stabilator.**

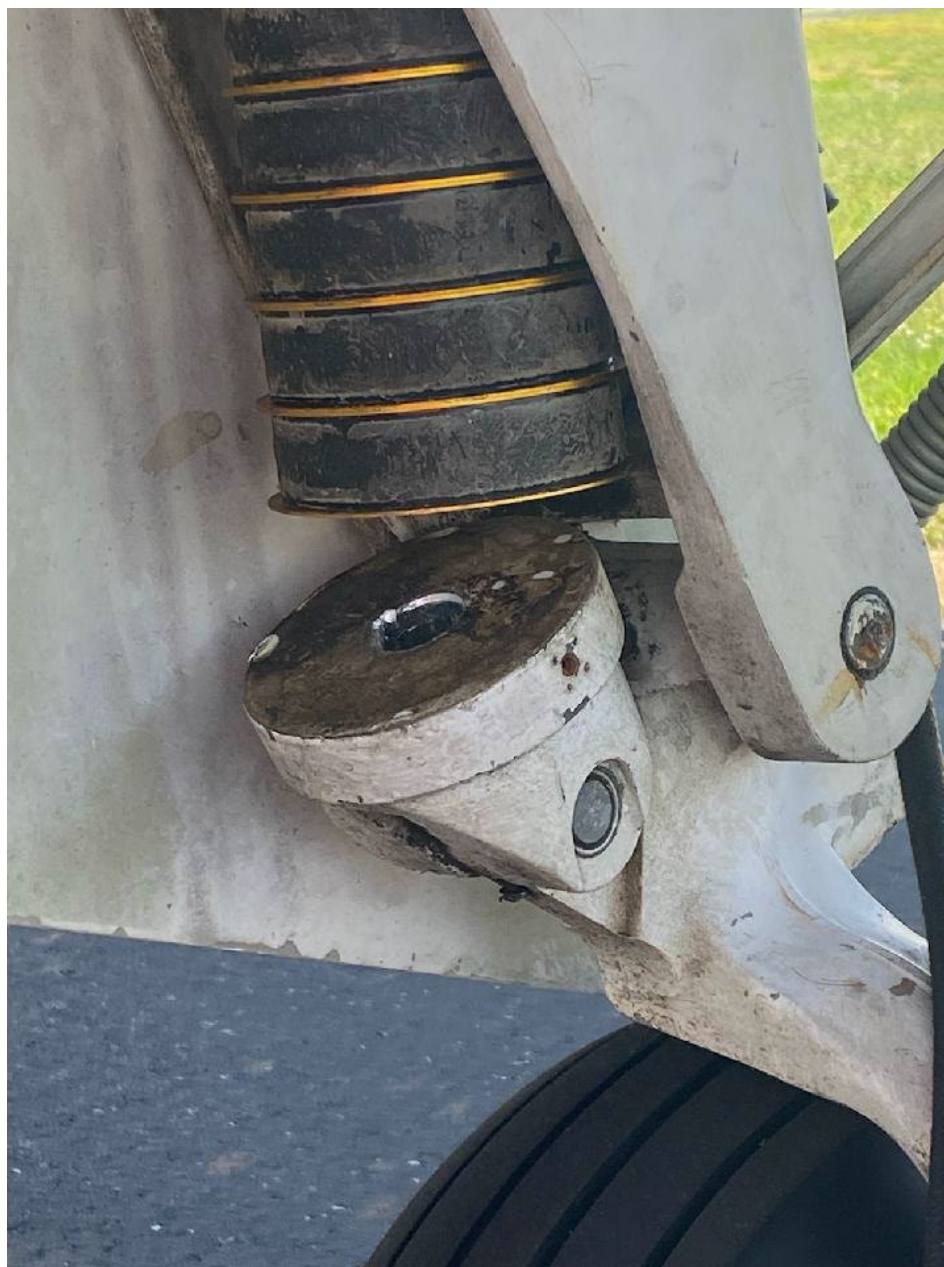
**Photo 5 - Digital Photograph From Pilot. View Showing the Separation of the Right Main Landing Gear Shock Absorber Rod From the Compressor Fitting.**
