# National Transportation Safety Board

ERA22LA312

## ONBOARD VIDEO RECORDER

Specialist's Factual Report

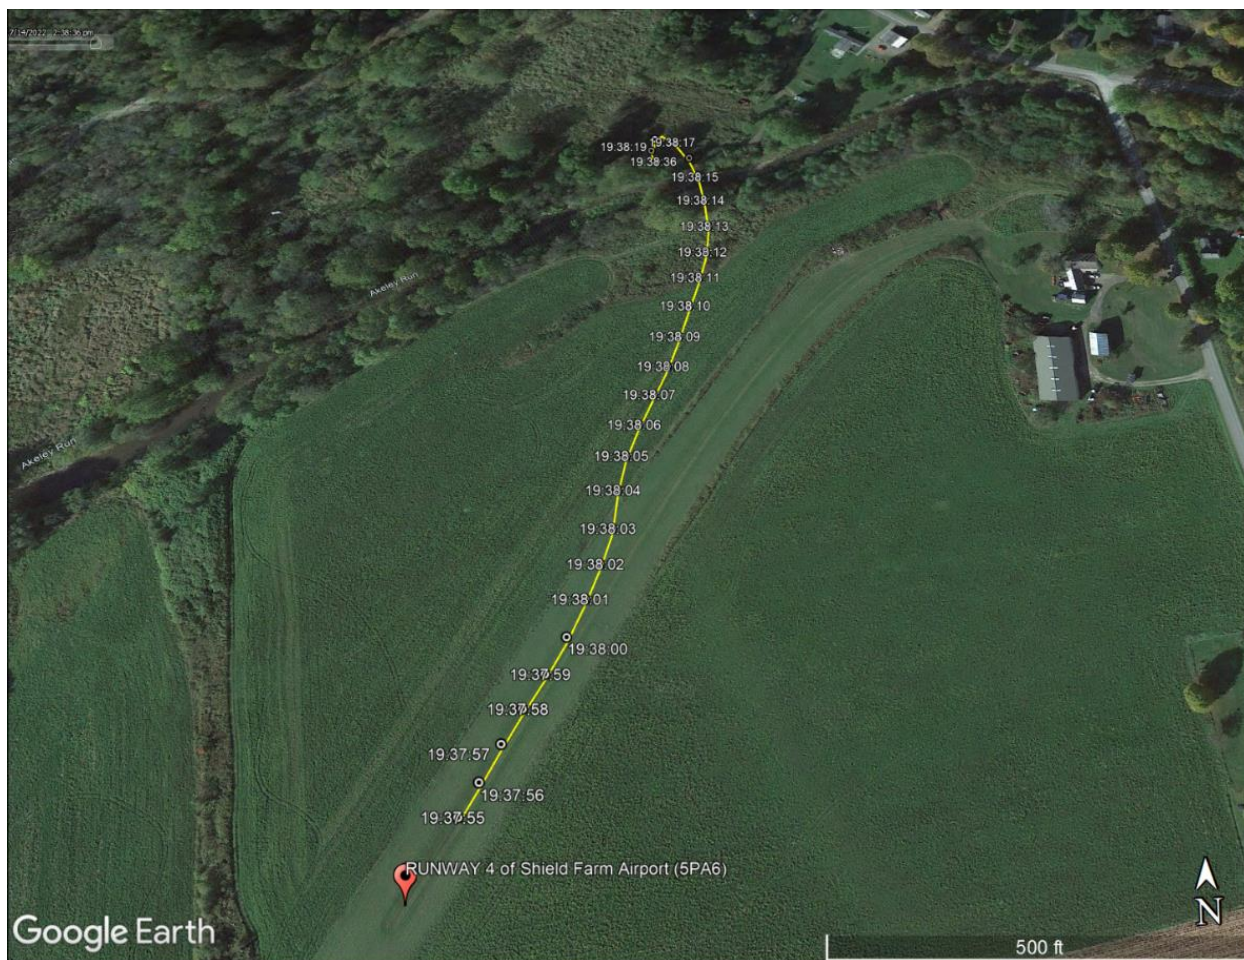
File #3 - 20220714-1938.kml contained GPS location data recorded from 19:37:55 to 19:38:36 EDT, on July 14, 2022, with sampling rate of 1 Hz, including geometric latitude and longitude, and altitude. However, the altitude data which were all below the local elevation were determined to be invalid. Figure 1 shows the Google Earth overlay of the event flight based on the GPS location data. The kml (Keyhole Markup Language) file was converted into comma-separated value (CSV) format and is provided as attachment 1 to this report. Note that the duration of the GPS location data recording was longer than the image and audio recordings.

**Figure 1.** Google Earth overlay of the event flight based on the GPS location data.

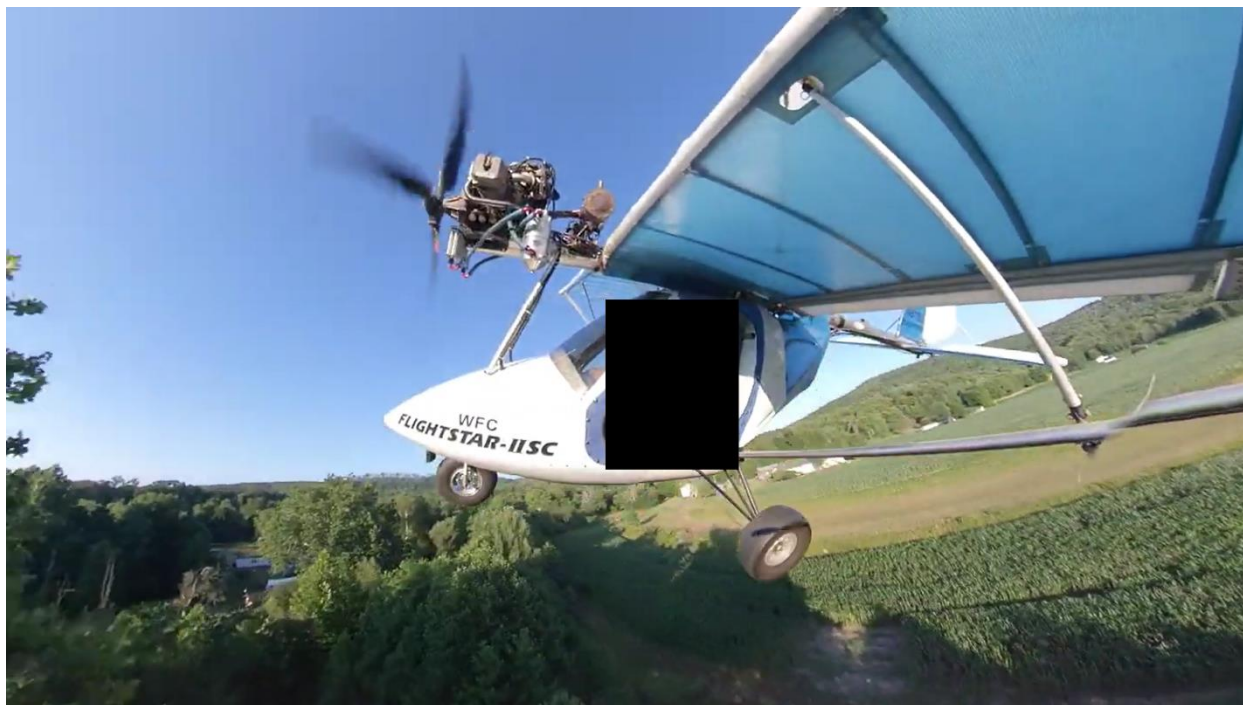
The image file showed the accident aircraft from takeoff to a point before the impact with trees. The image file began with the aircraft stationary on the grassy runway, with engine running. There were two people on board; the pilot who was sitting on the left seat, was closer to the camera, and the passenger was sitting on the right seat. At 00:08, the pilot released the brake, and the aircraft started moving forward and accelerating. At 00:21, the aircraft became airborne. The pilot was maneuvering the control stick as the aircraft ascended. At 00:36, the image file ended with some tree branches right in front of the accident aircraft; figure 2 shows a screenshot at this moment with the pilot and passenger redacted.

**Figure 2.** A screenshot of the image file right before the image file ended.
