# NTSB MEMORANDUM OF RECORD

**NTSB Accident Number: ERA22LA348**  
**Subject: CASA 212 Measurements and Photo**  
**Date: 10/14/2022**

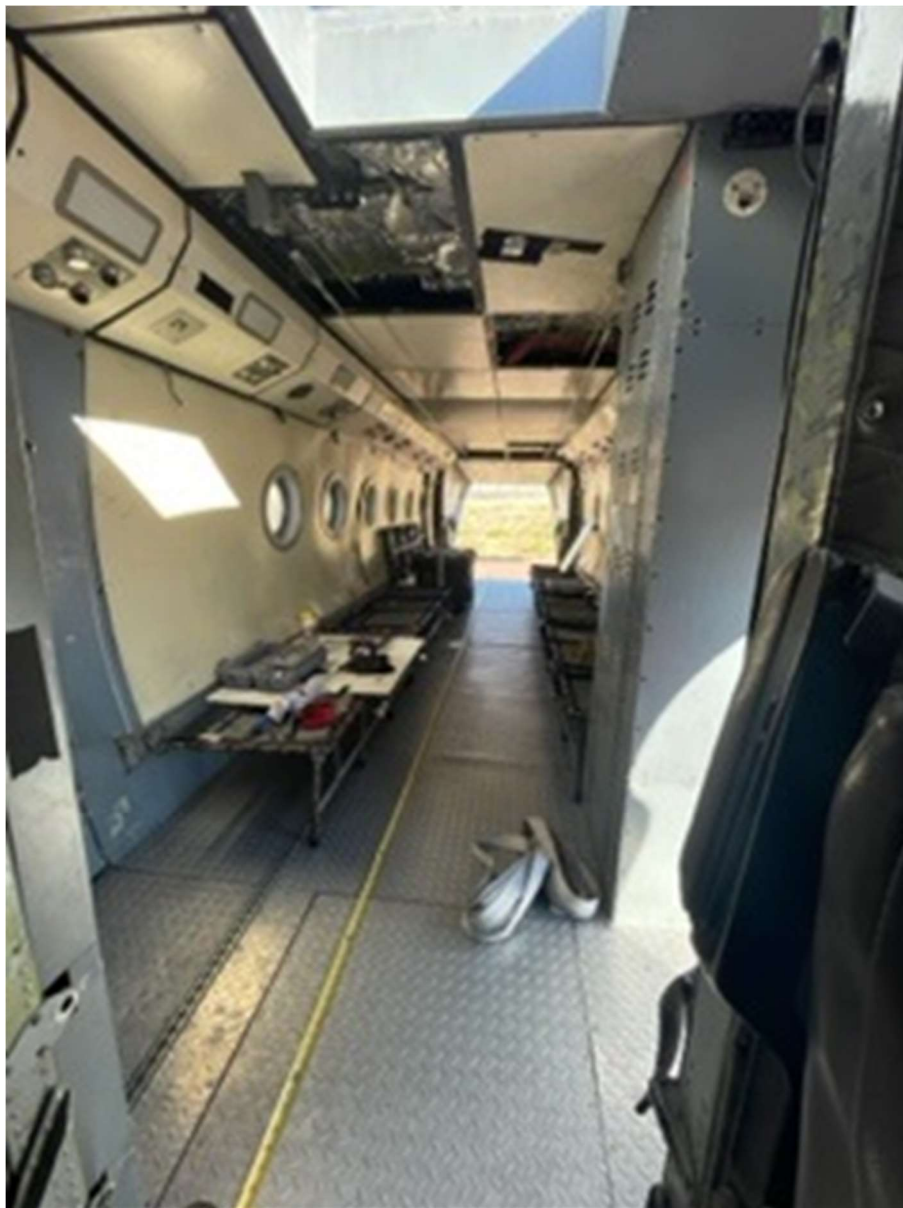
*Photo 1- Photo looking from cockpit aft to rear of airplane with ramp open (Photo courtesy of Rampart Aviation)*

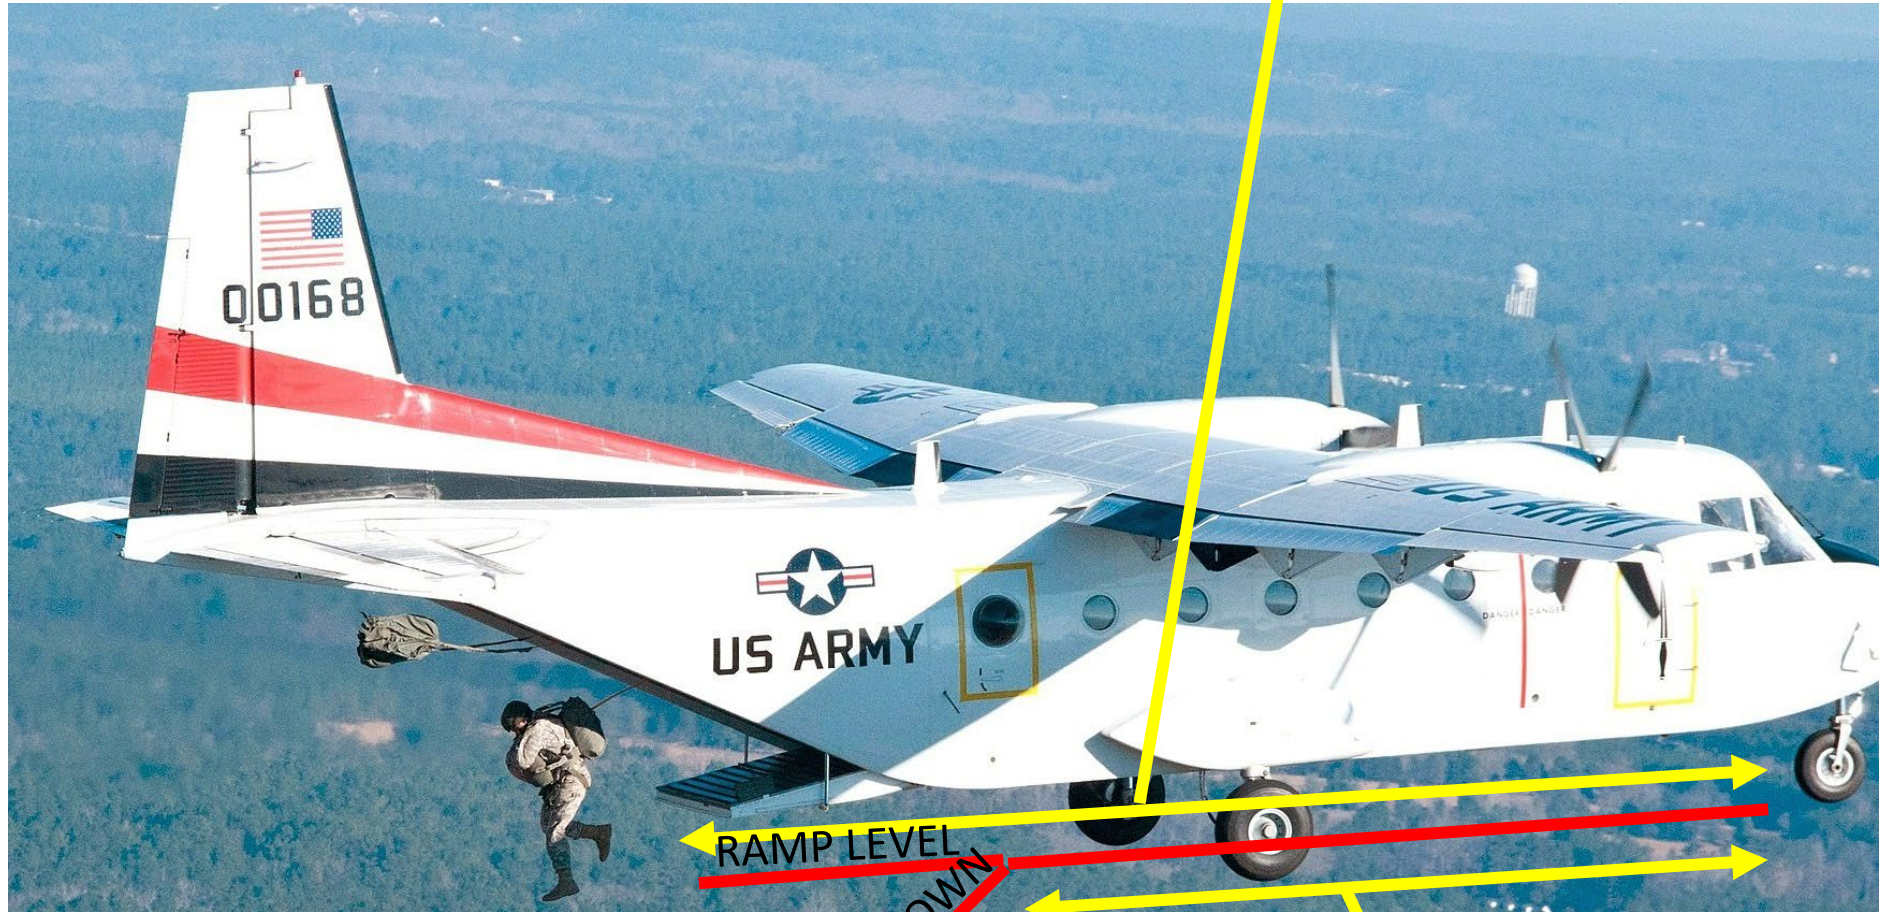
Measurement 1: cockpit to ramp end when ramp is level

Measurement 2: cockpit to ramp forward edge when fully down

- Distance from cockpit bulkhead to end of ramp door: 25' 10"
- Distance from cockpit bulkhead to the pivot point of ramp door: 21' 5 3/4"
