## SERVICE BULLETINS

# VIKING 110 SERVICE BULLETINS

# VIKING 130 SERVICE BULLETINS

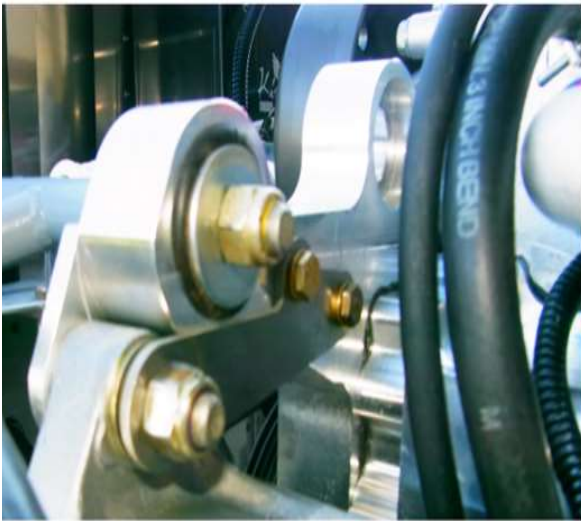
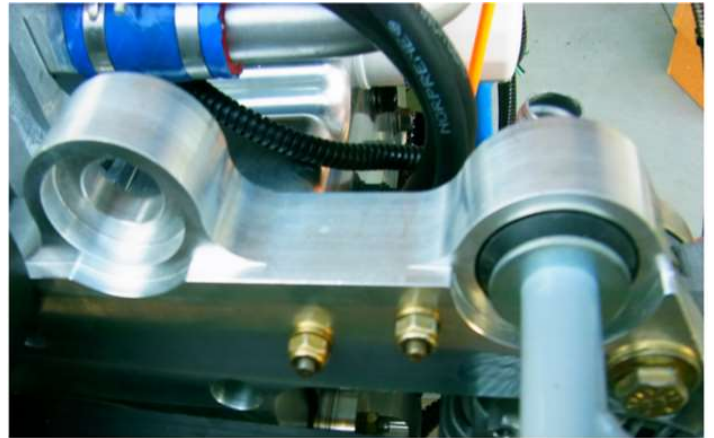
#### **VIKING 110 SINGLE EAR ALTERNATOR ATTACH UPGRADE**

There is an additional alternator support add-on bracket for Viking 110 engines equipped with a single top attach point. The additional bracket is available from Viking. Just bolt it to the original alternator top mount, center it on the machined housing, drill 2 holes and install AN-3 bolts of the correct length.

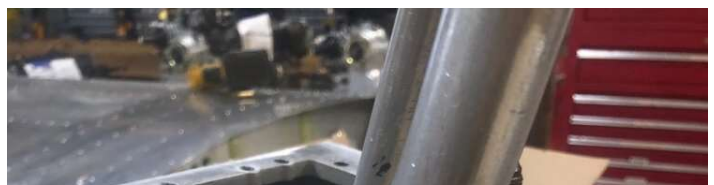
#### **VIKING 110 OIL PICKUP HOSE**

There has been an instance of the top mounted oil pickup tube fracturing and falling into the oil tank. Naturally, when this happens oil pressure is lost. Because all tanks were made

the same way, and there has already been an update prior, to move the oil pickup to the bottom of the tank in order to increase suction, this now becomes a mandatory change. No Viking 110 Engines should fly with a top mounted oil pickup hose after 06/05/2018.

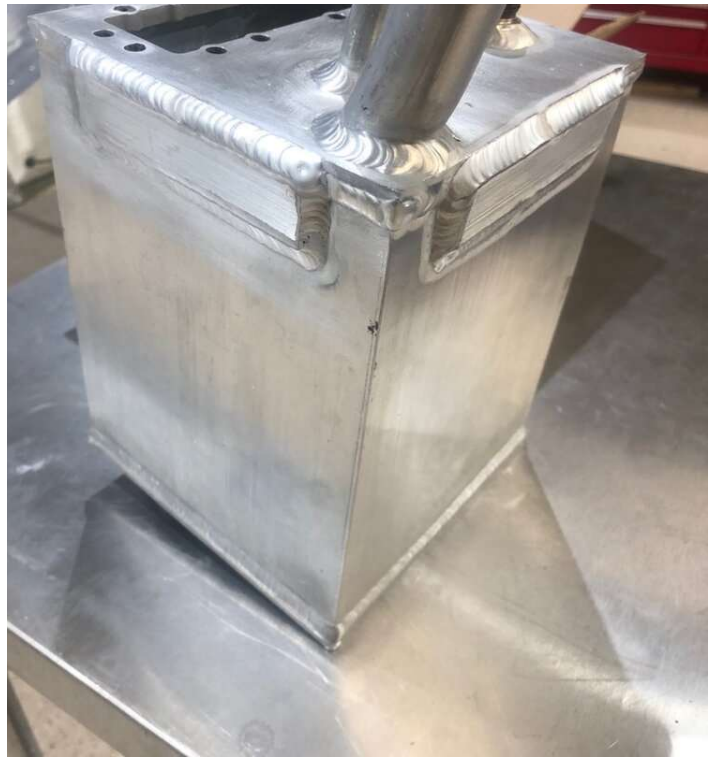
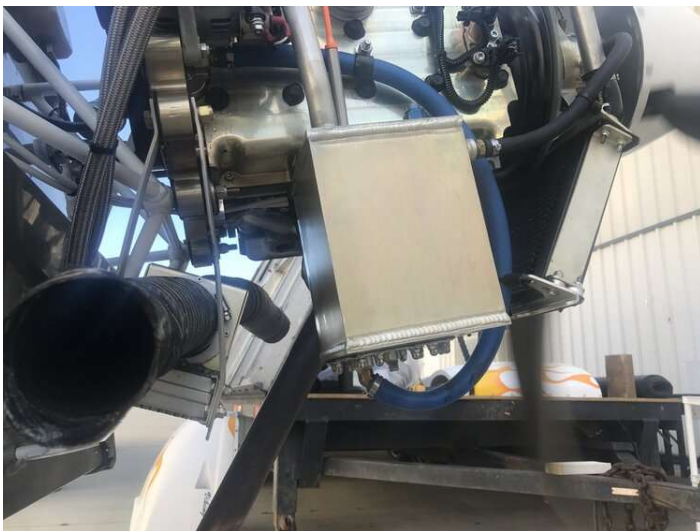
This picture shows the best oil pickup system for the Viking 110 engine. Some engines already have this but might use 1/2" hose, rather than a 5/8 hose and fittings. This particular engine can maintain 55-70 psi of oil pressure.

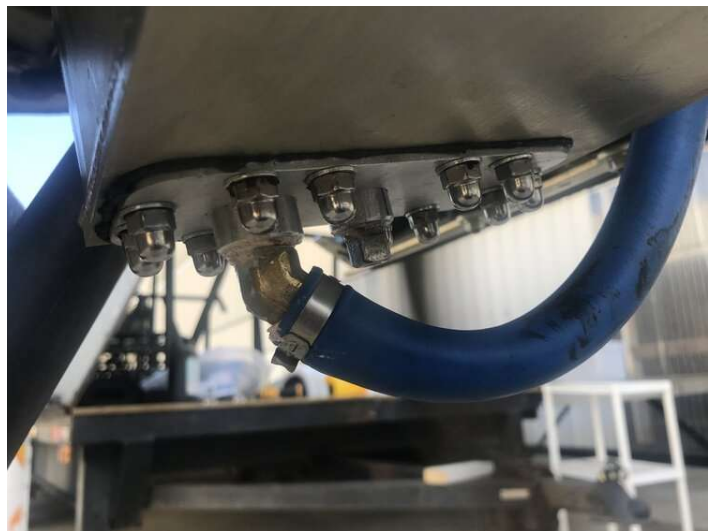
No 90 degree fittings if possible. 3/8 NPT threads. 5/8 hose barb. 5/8 hose rated for oil and suction.

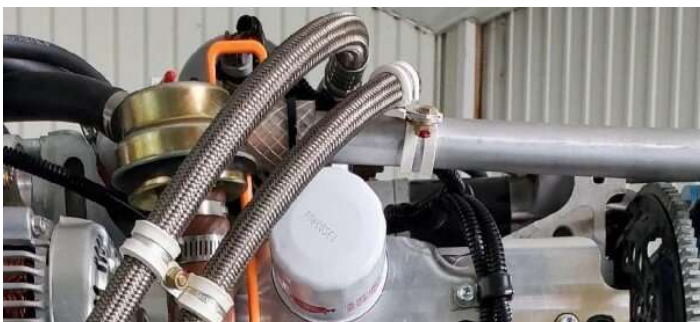
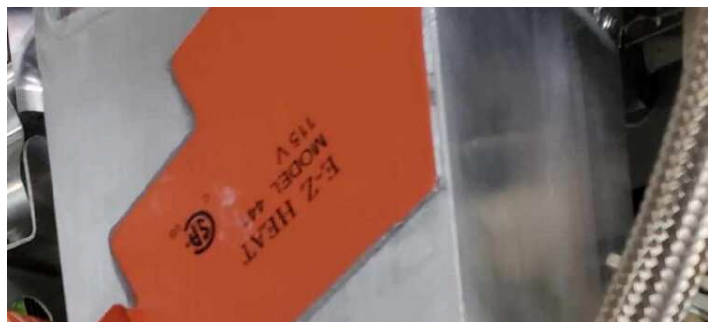
Example of the best oil tank system: The oil pickup tube should be of the ridged teflon type so it can take the heat and not collapse under suction.

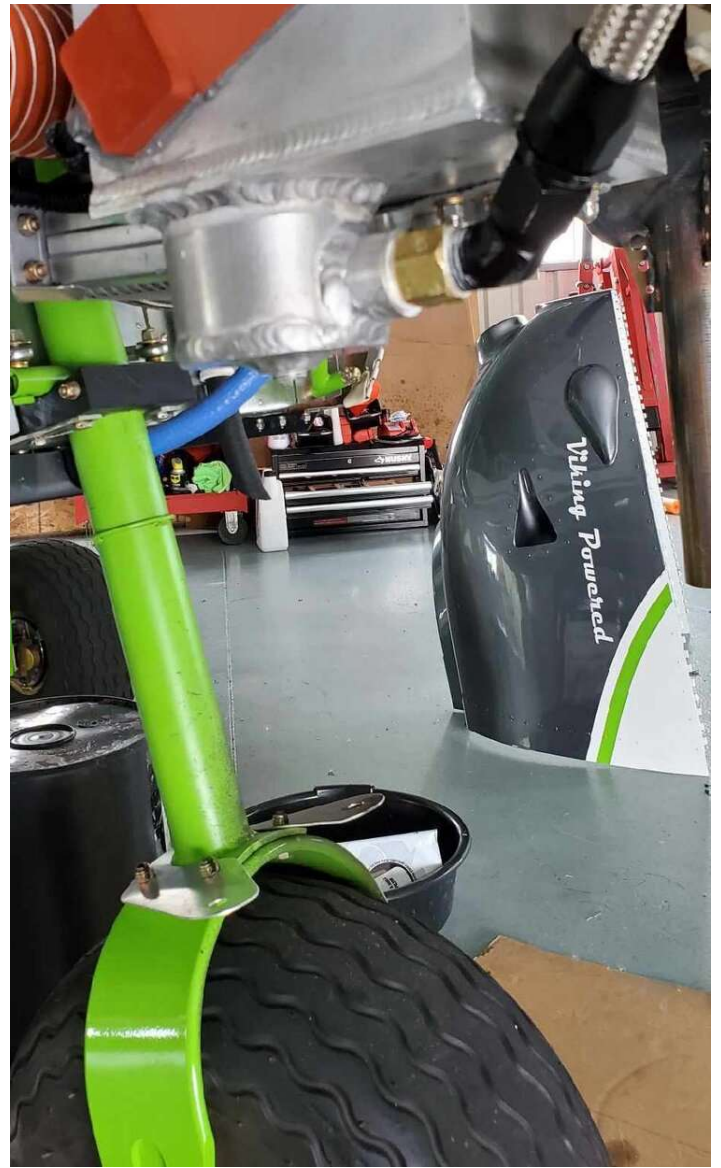
## VIKING 110 WIRING UPGRADE

Change wiring to match the current wiring diagram for the Viking 130.

The reason for this change is several instances of intermittent operation between ECU 1 and ECU 2 with zero failures of either one.

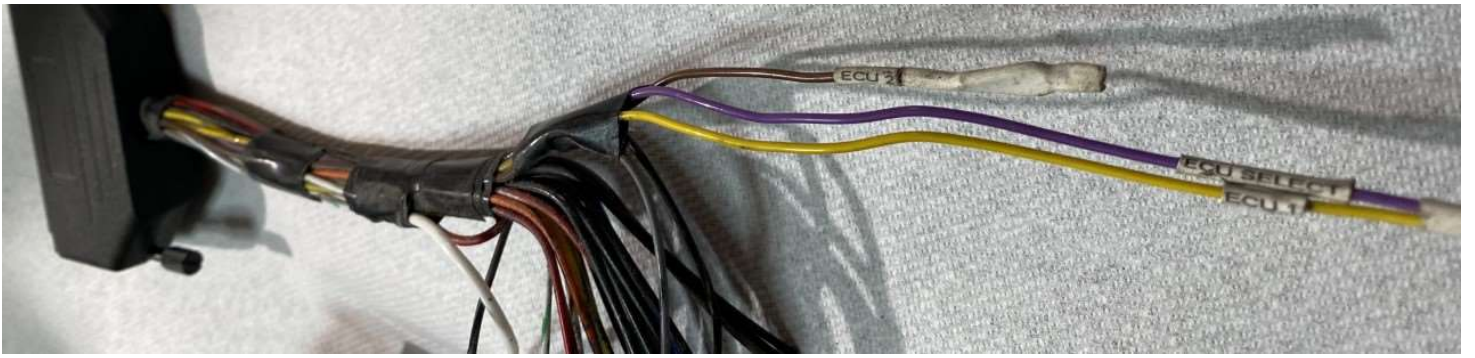
Locate these wires

Remove ECU select switch in order to operate on a single computer only. Do this by locating the select switch on the panel, remove the three wires labeled; ECU 1, ECU 2 and SELECT. Disregard and tape the ECU 2 wire. Solder ECU 1 and SELECT together and protect with shrink tubing. If done correctly, the engine will start and run normally and the TAC (RPM) will be working.

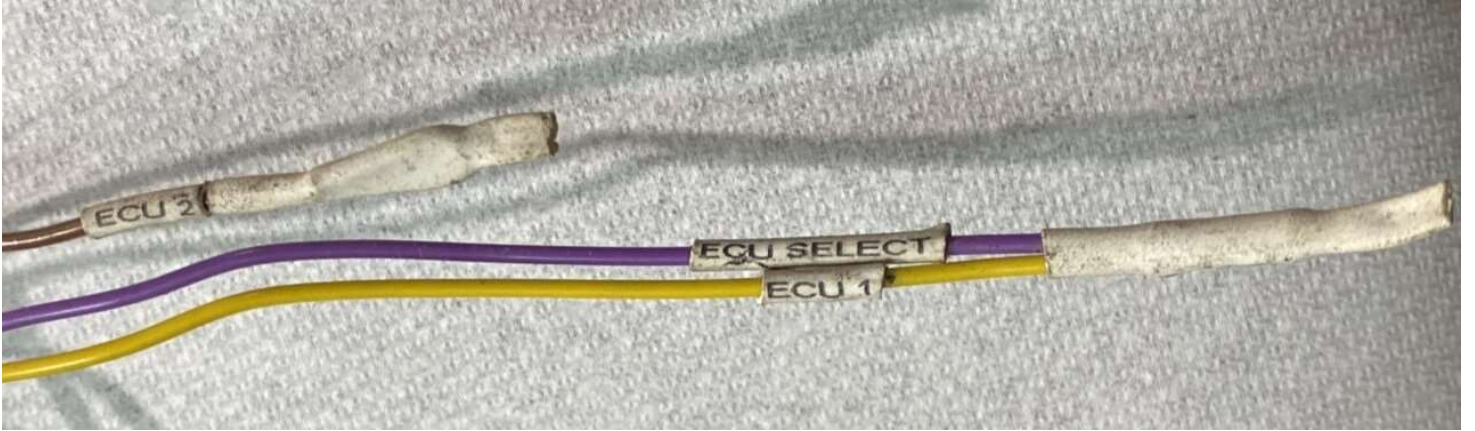
Cap and solder as shown.

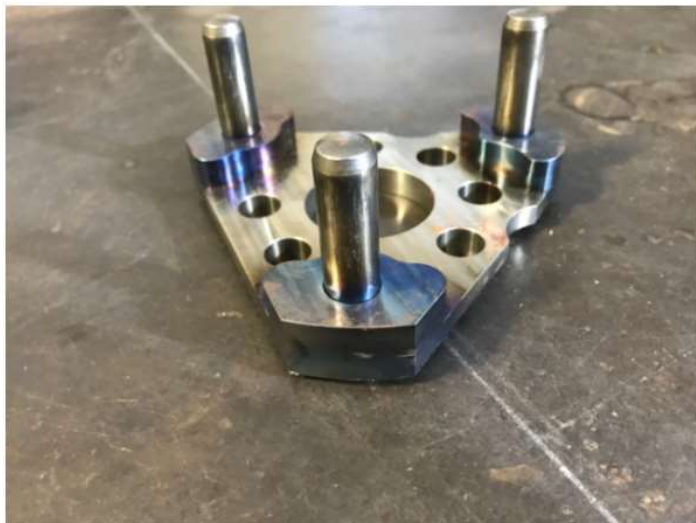
OLD RECALLED FLYWHEEL COUPLING

The batch of parts distributed are recalled and replaced by a heavier duty part. Even though there has never been a failure, we do not take any chances. The part is already in use on the 180 hp turbo engine and has considerable testing already completed.

It will fit the 110 and 130 engines directly. Anyone that has a part like this picture it should be replaced. No engines should be flying after 7/17/2017 unless the flywheel drive disk looks like the one in the picture above.

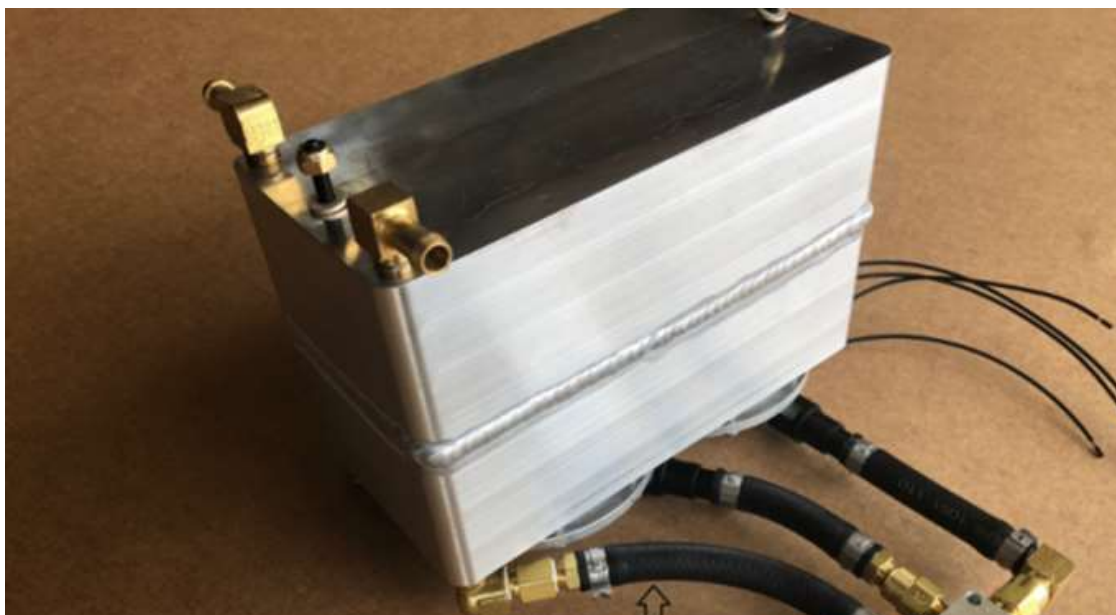
A 0.010 ORIFICE INSTALLED TO BLEED POSSIBLE EXCESS FUEL PRESSURE FROM FUEL LINES WHILE AIRCRAFT IS PARKED. THIS CAN HAPPEN IF PRESSURE LEAKS BY THE REGULATOR NEEDLE OF THE HIGH PRESSURE ENGINE DRIVEN PUMP AND INTO THE AIRCRAFT FUEL SYSTEM. PRESSURE COULD BUILD TO OVER 100+ PSI SINCE THE RAIL PRESSURE IS 2,200 PSI IN THE STAINLESS STEEL INJECTOR RAIL. THIS IS A MANDATORY UPDATE

A 0.010 orifice install to bleed possible excess fuel pressure from fuel lines while aircraft is parked. This can happen if pressure leaks by the regulator needle of the high pressure engine driven pump and into the aircraft fuel system. Pressure could build to over 100+ psi since the rail pressure is 2200 psi in the stainless steel injector rail. Please call if more information is needed.

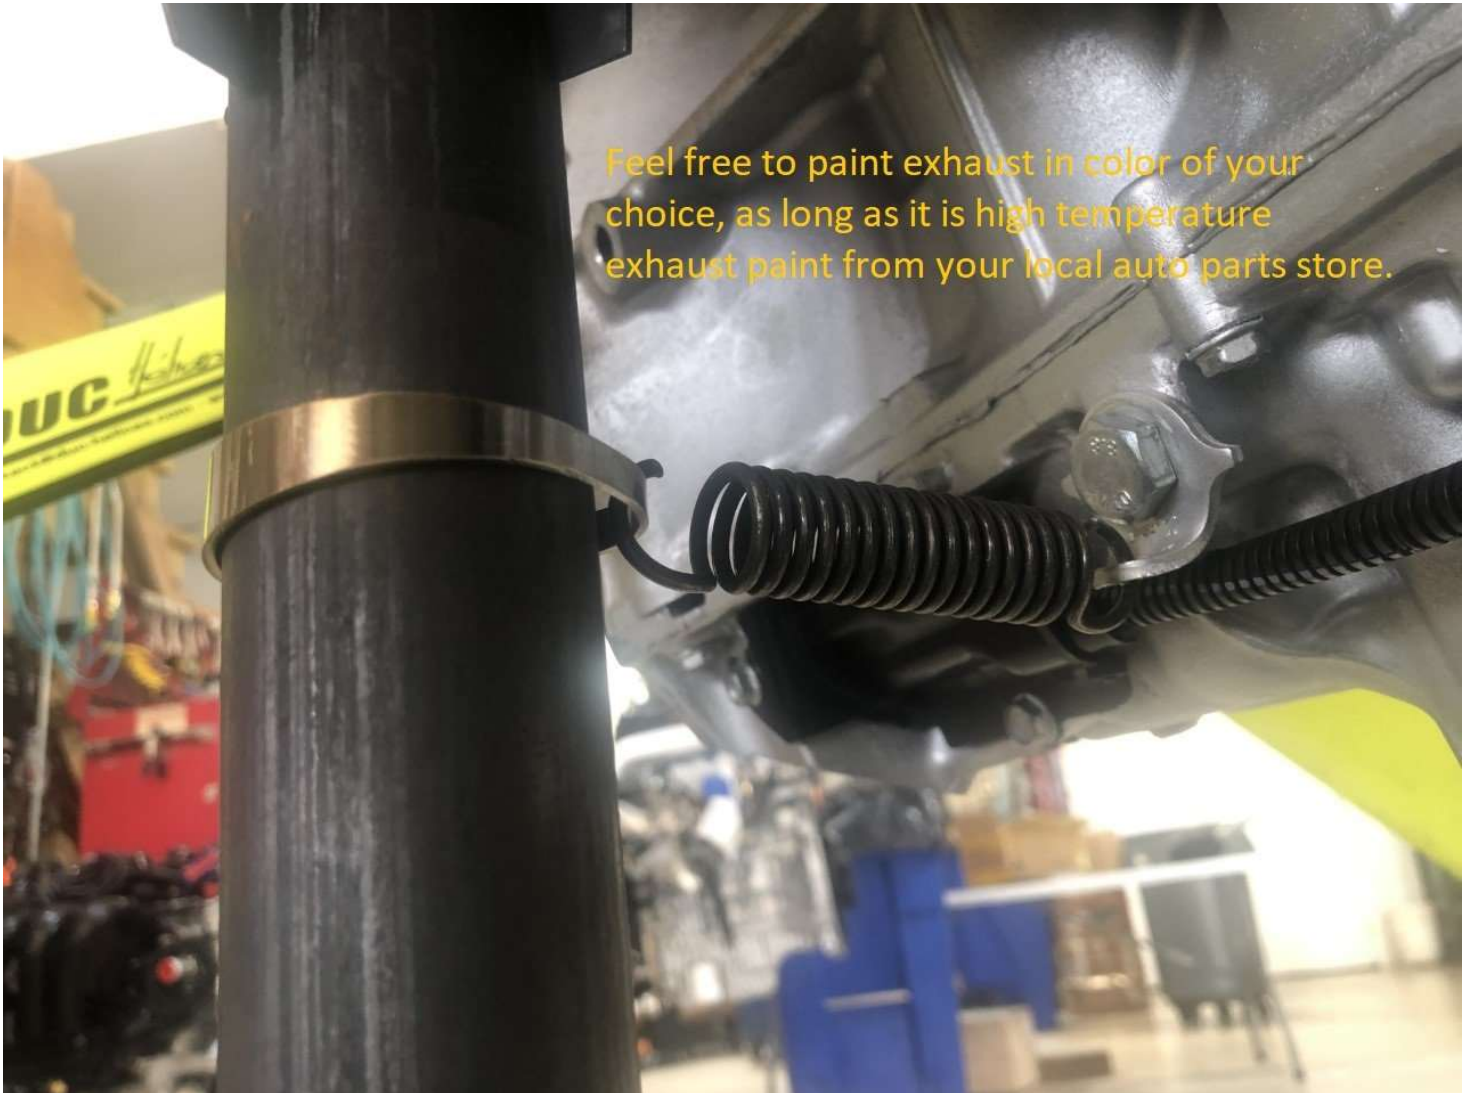
## EXHAUST BRACE WITH SPRING

The exhausts should have a spring attachment as shown below to help with any cracking issues.

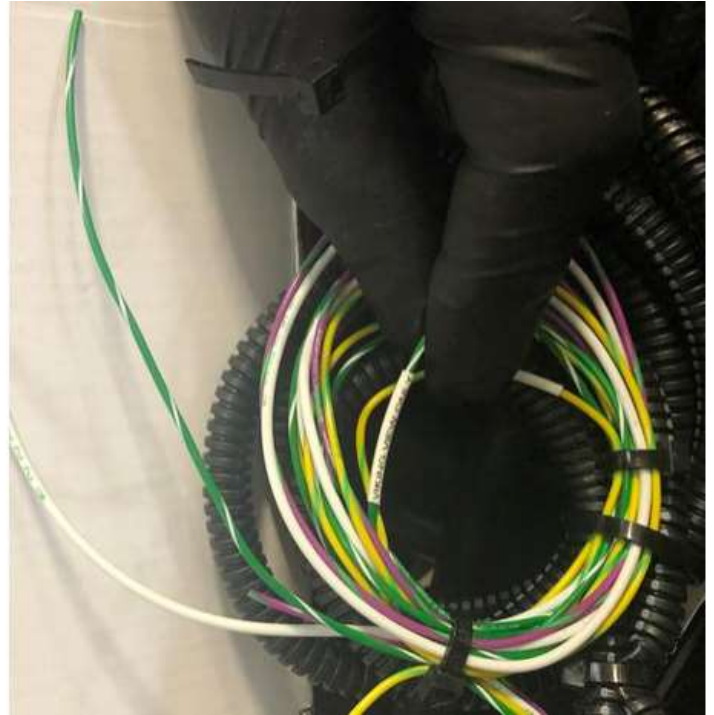
### **VIKING VIEW WIRE**

Some have mistaken the Viking View (Green/White) wire as a negative ground. If this wire is grounded you will disrupt the proper operation of the ECU. If you DO NOT have a Viking View instrument, this wire must be capped off and not used. If you DO have a Viking View, simply use for the Viking View ground as instructed with instrument. That means, connect to Viking View ground wire. It does not mean to connect the wire to any ground, it IS teh ground for the Viking View.
