**Subject:** ERA23FA048  
METEOROLOGICAL INFORMATION

**Summary:** The following memorandum details airport information and routine hourly weather observations at the accident airport, Tucker-Guthrie Memorial Airport (I35) Harlan, Kentucky, and surrounding airports on the day of the accident.

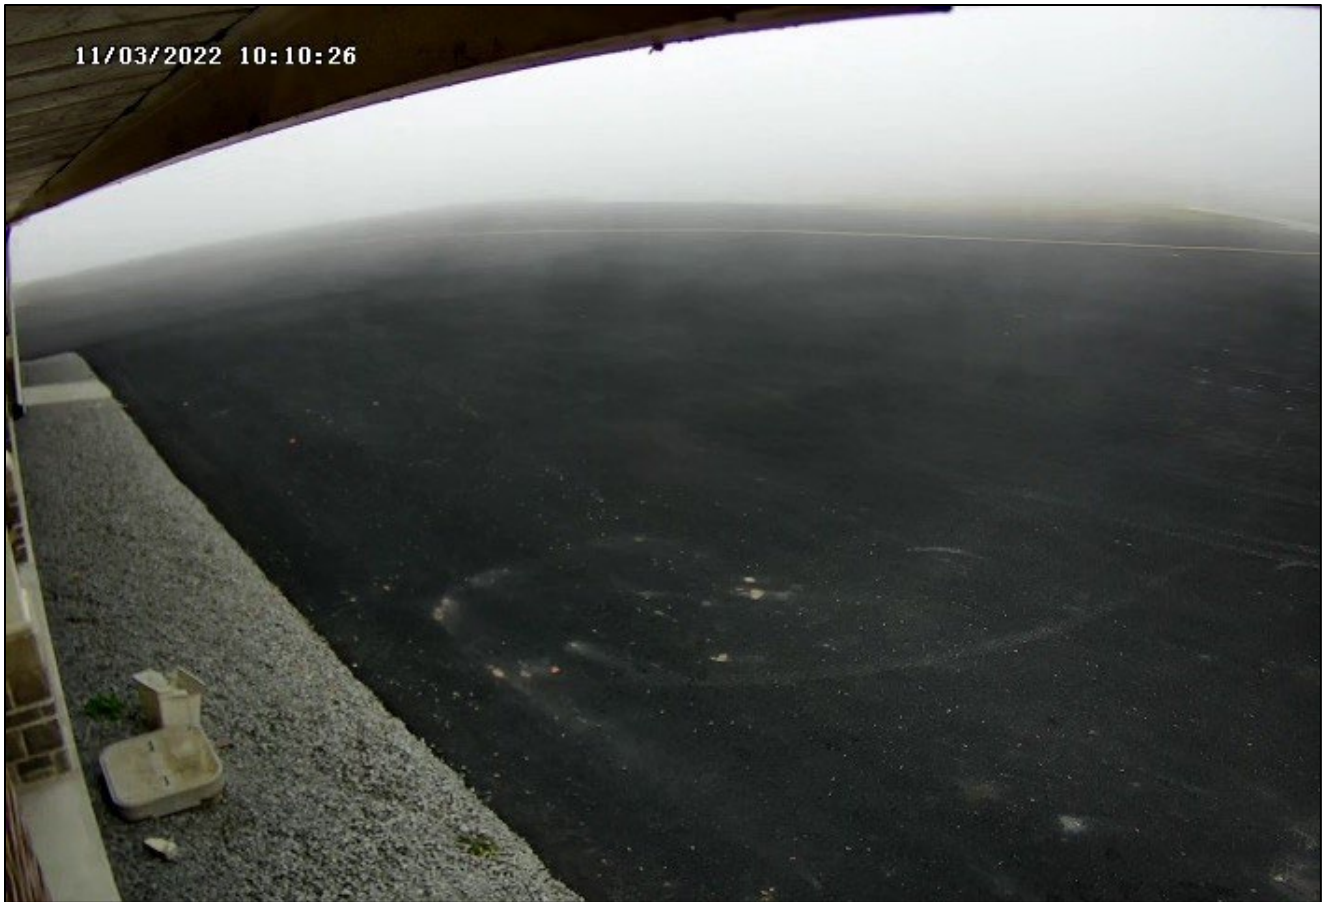
*Figure 1: Surveillance video screenshot at the time of the accident, as viewed from the airport terminal.*

Surveillance video screenshots were provided by the I35 airport at the time of the accident, as viewed in Figure 1. The security camera system did not record audio. The camera was located on the northeast corner of the terminal building facing the landing runway. As measured by Google Earth, the visibility was limited to about .03 nautical mile (175 ft) due to fog and low clouds. An additional image was provided as viewed in Figure 2, displaying improved visibility about an hour and a half after the accident.

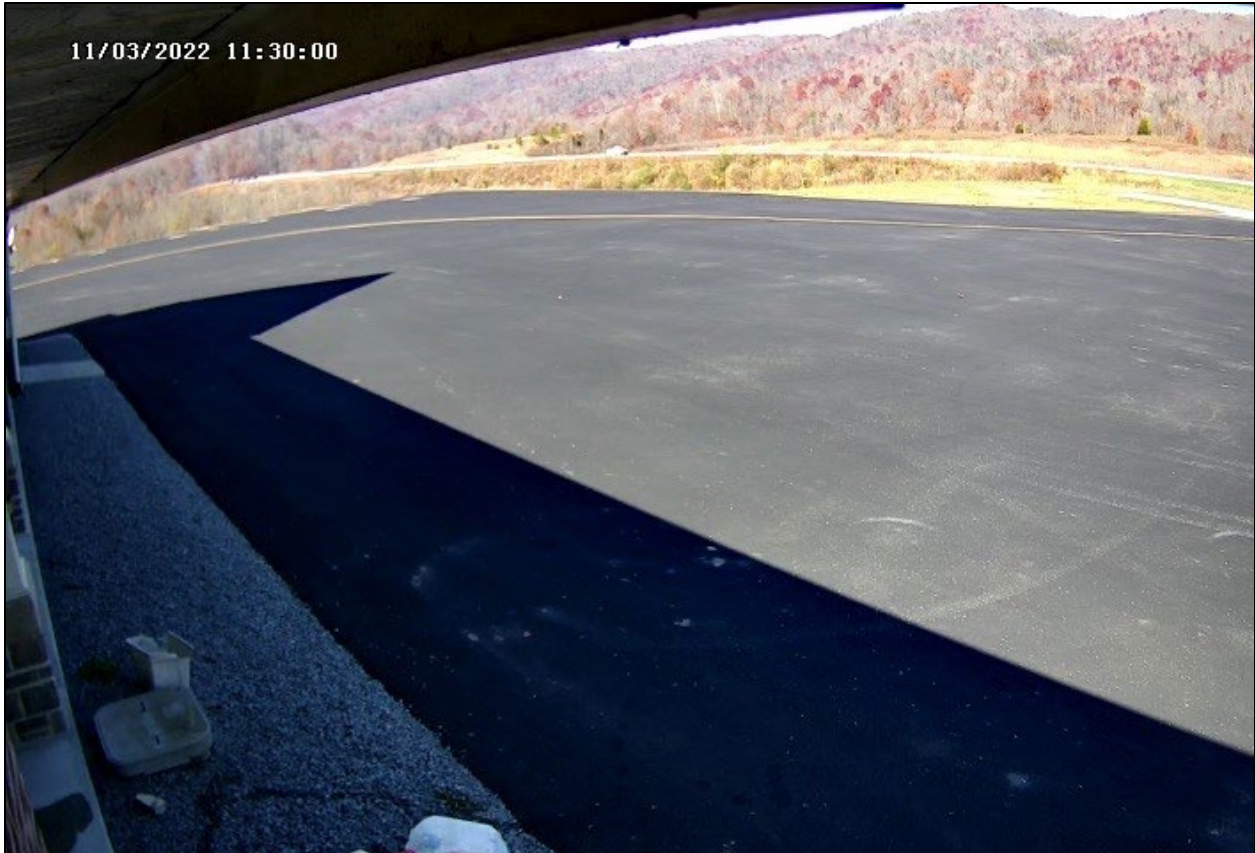
Figure 2: Surveillance video screenshot taken at 1130 the day of the accident, showing that the fog had burnt off and visibility had improved, as viewed from the airport terminal.
