# National Transportation Safety Board

ERA23FA078

## **COCKPIT DISPLAY - RECORDED FLIGHT DATA**

Location: Beverly, Massachusetts  
Date: December 4, 2022  
Time: 1135 eastern standard time (EST)  
Airplane: Rotorsport UK LTD Cavalon, N401GR

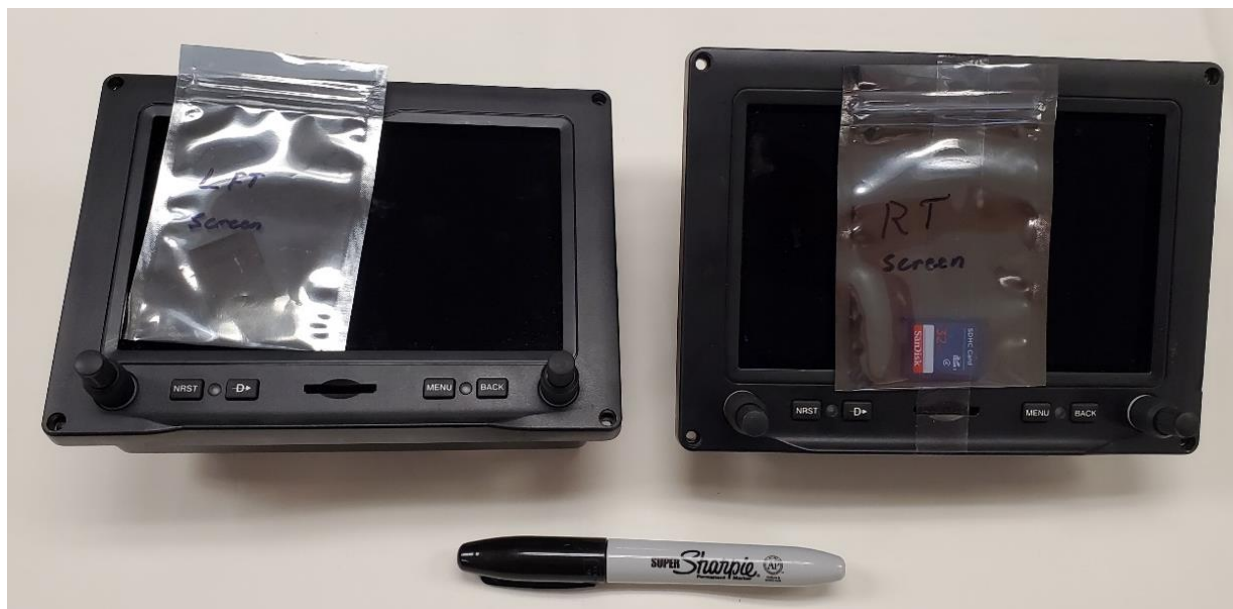
The two Garmin GDU 450 cockpit displays arrived in good condition, as shown in figure 1. The two displays were labeled left and right screen respectively. The SD card from the right screen contained recorded data logs.

**Figure 1.** The two Garmin GDU 450 cockpit displays as received.

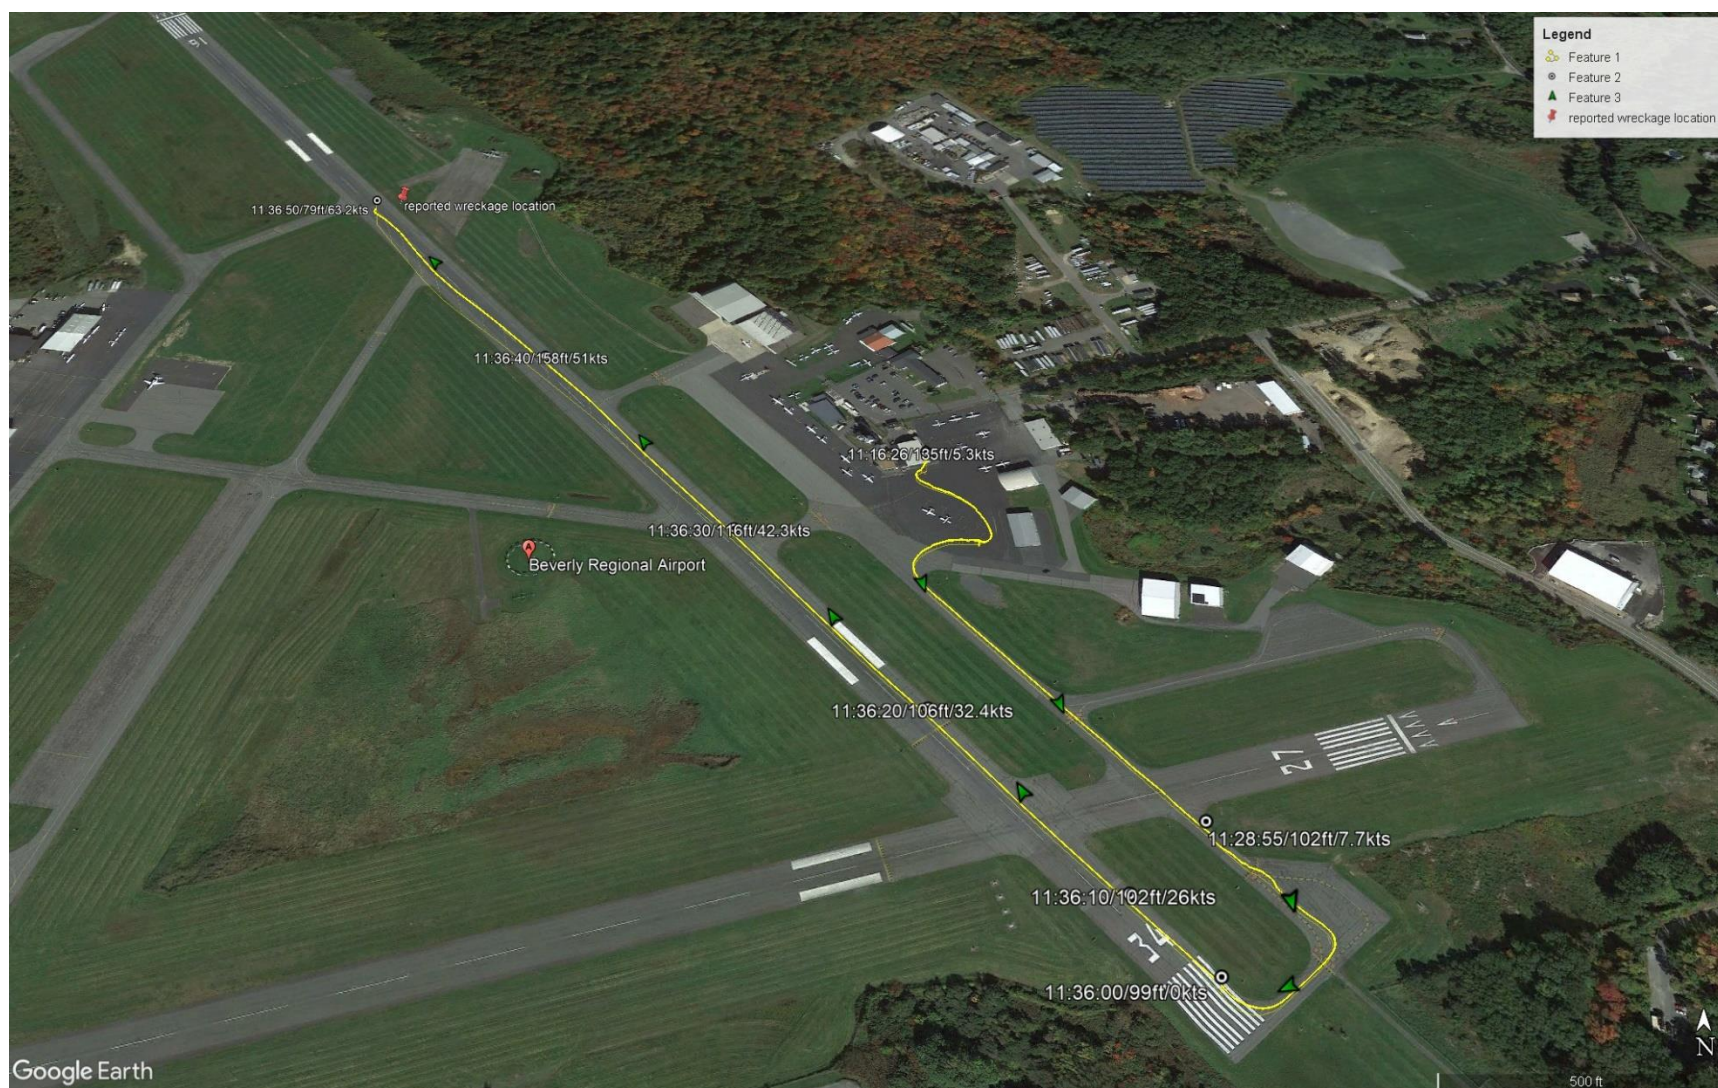
**Figure 7.** Google Earth overlay of the entire accident flight track.

Figures 7 and 8 show Google Earth overlays of the accident flight track. Figure 8 shows the takeoff with reference to the centerline of the runway. The reported wreckage location is shown with a red pin. Note that the weather and lighting conditions in Google Earth are not necessarily the weather and lighting conditions present at the time of the recording.

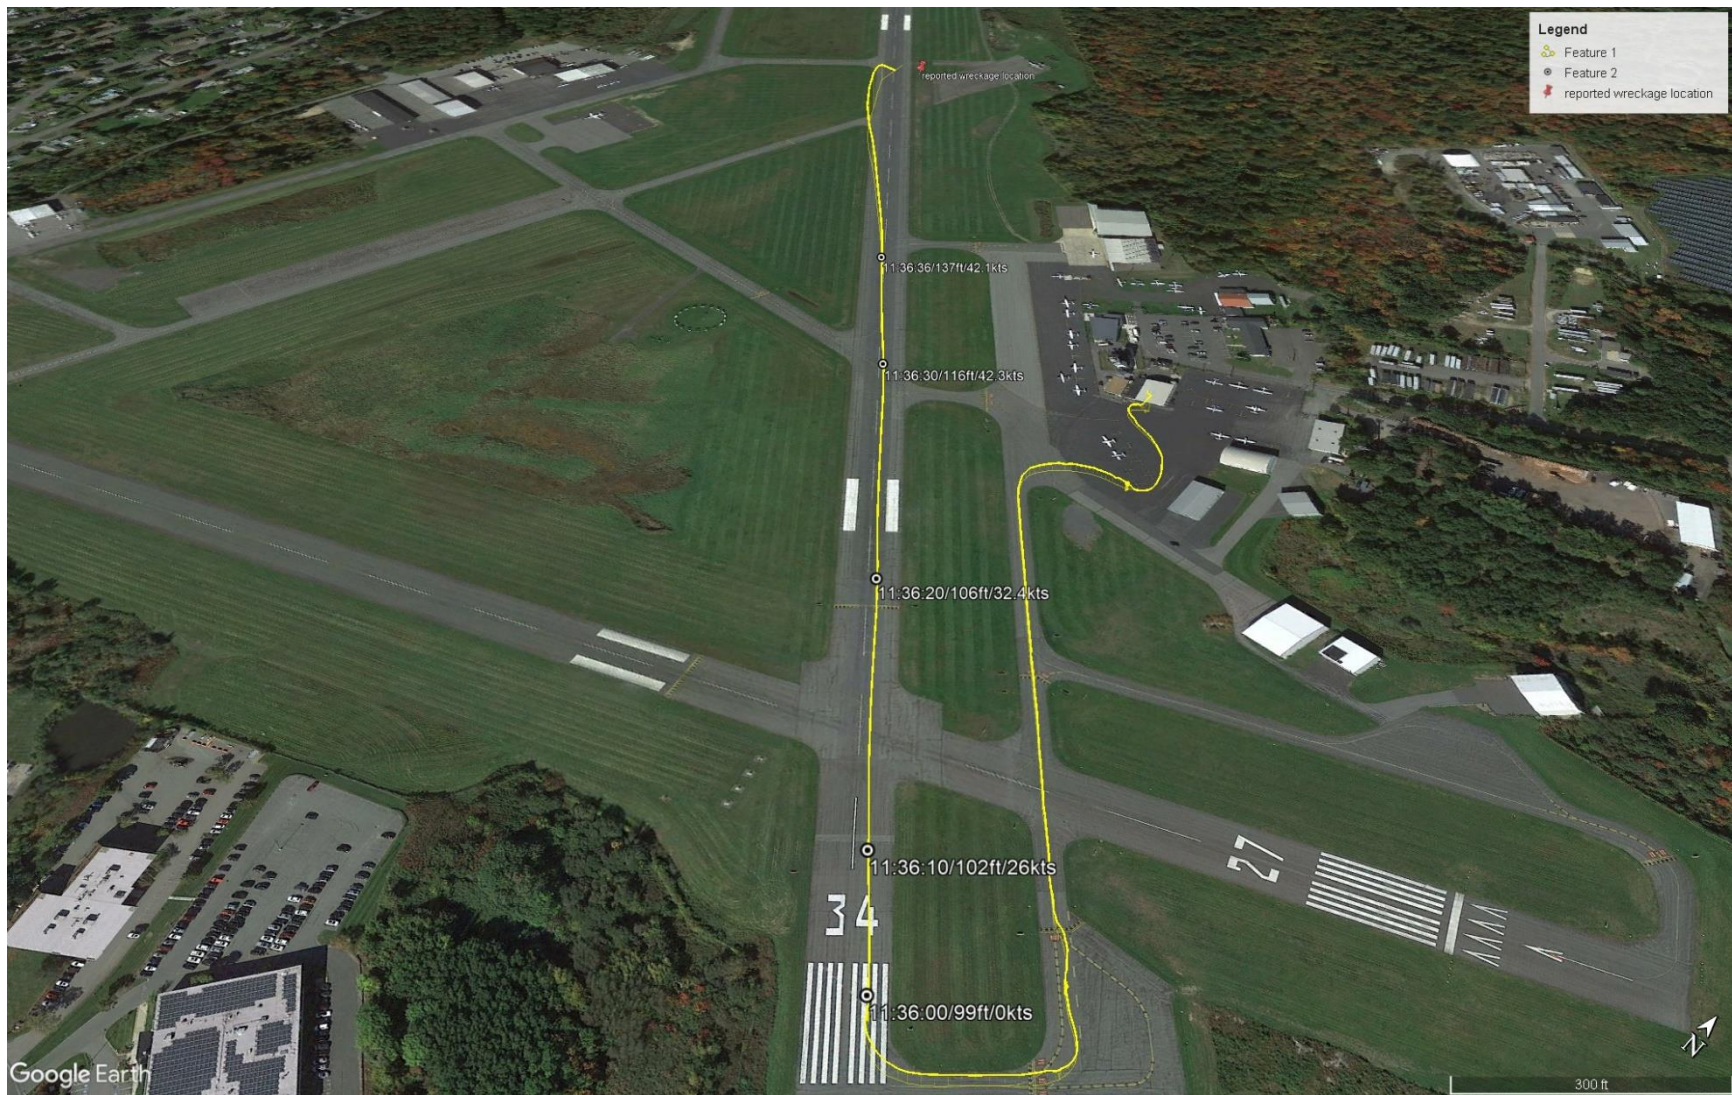
**Figure 8.** Google Earth overlay showing the takeoff with reference to the centerline of Runway 34.
