# National Transportation Safety Board

ERA23FA108

## **ELECTRONIC DEVICES**

Location: Dayton, Virginia  
Date: January 11, 2023  
Time: 1809 eastern standard time (EST)  
Airplane: Piper PA-32R-301, N43156

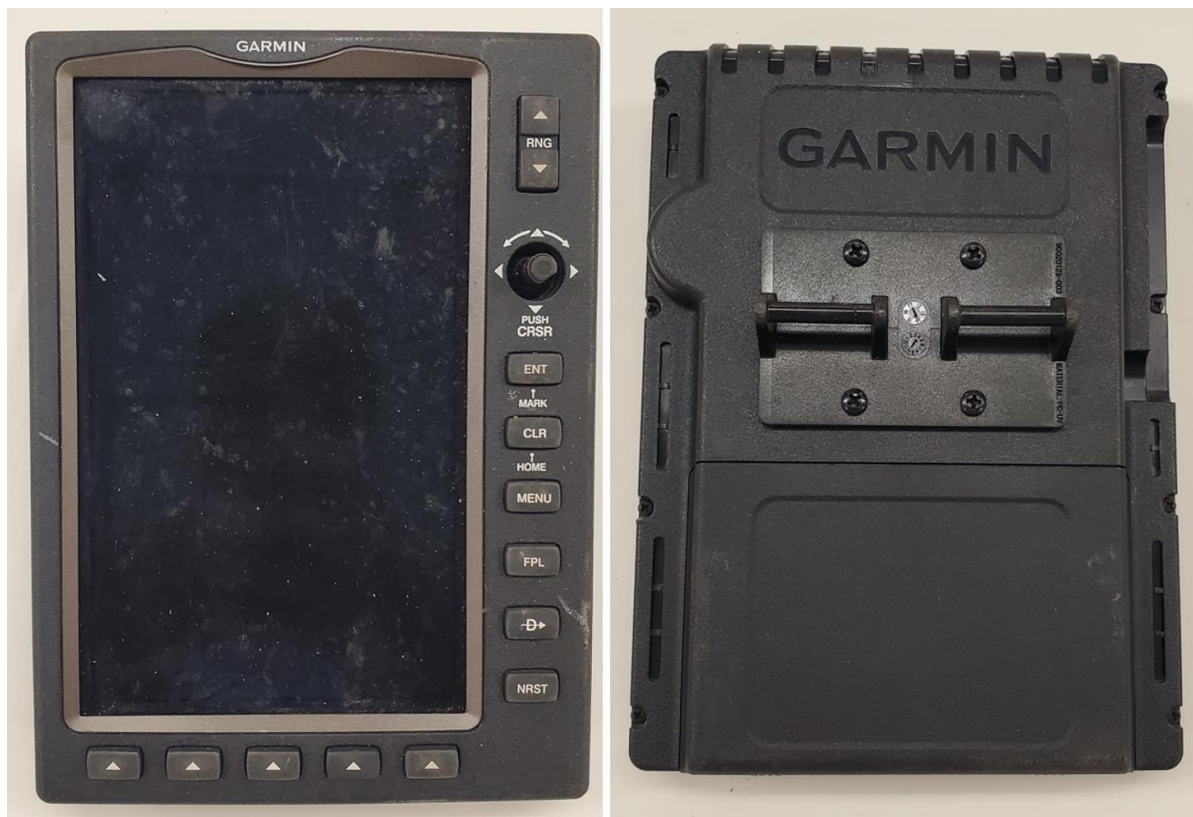
The Garmin GPS MAP 696 was in good condition upon arrival at the Vehicle Recorder Division, as shown in figure 3. The device powered on normally. Figure 4 shows a numerous flight logs recorded on the device; however, those flight logs were recorded between December 25, 2002, to May 28, 2003. There were no data pertinent to the accident recovered from this device.

**Figure 3.** Front and back of the Garmin GPS MAP 696 as received.

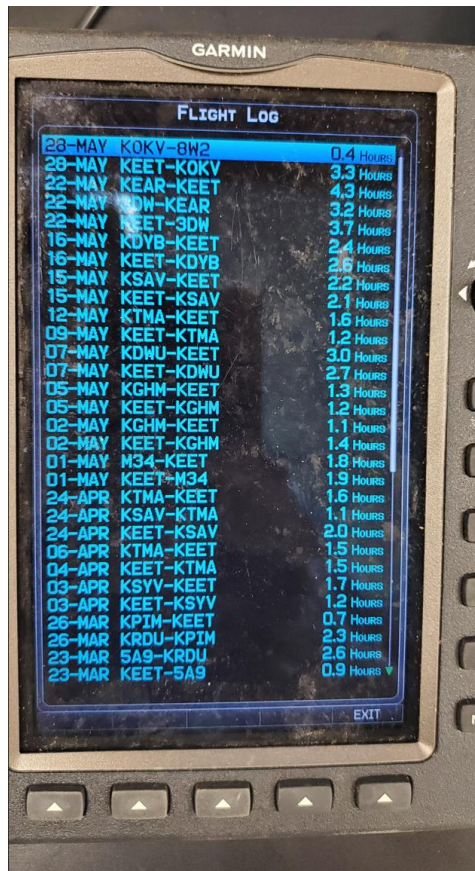
**Figure 4.** Flight Log of the Garmin GPS MAP 696.

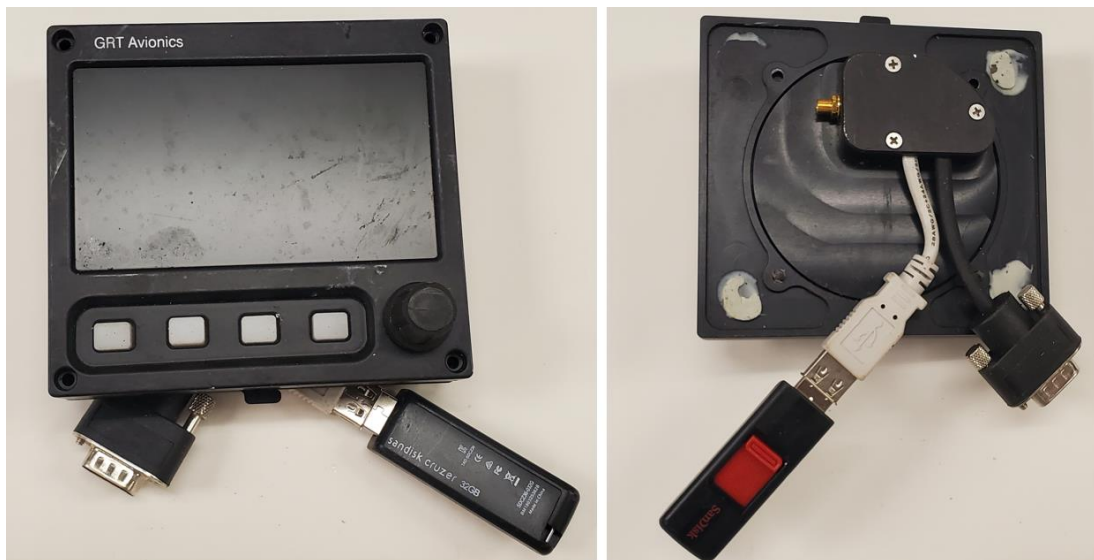
Upon arrival at the Vehicle Recorder Division, the GRT Avionics Mini EFIS did not show signs of damage under visual inspection, as shown in figure 5. Attached to the unit, there was a USB drive, which did not contain any flight data. This is pictured in figure 6. The unit's screen was damaged and would not display information (figure 7). A 4GB microSD card was recovered from the main circuit board of the device, shown in figure 8. This microSD card could not be mounted under a Windows

**Figure 5.** Front and back of the GRT Avionics Mini EFIS as received.

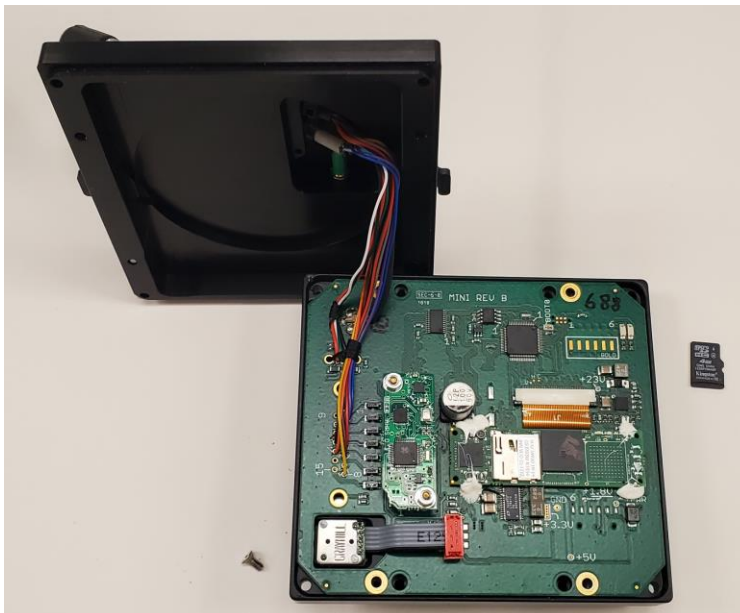
operating system. The manufacturer explained that the microSD card only contained map databases and did not contain any flight data. The manufacturer further explained that the device cannot record data internally and can only be configured to record flight data on a USB drive attached to it. Since the USB drive attached to the unit did not contain any flight data, there were no data pertinent to the accident recovered.

**Figure 8.** A microSD card was recovered from the inside of the GRT Avionics Mini EFIS. The microSD card is pictured to the right of the unit, after it had been removed.
