Eric Alleyne  
Air Safety Investigator  
AS-Eastern Region Aviation

**Subject:** ERA23FA136, photo review

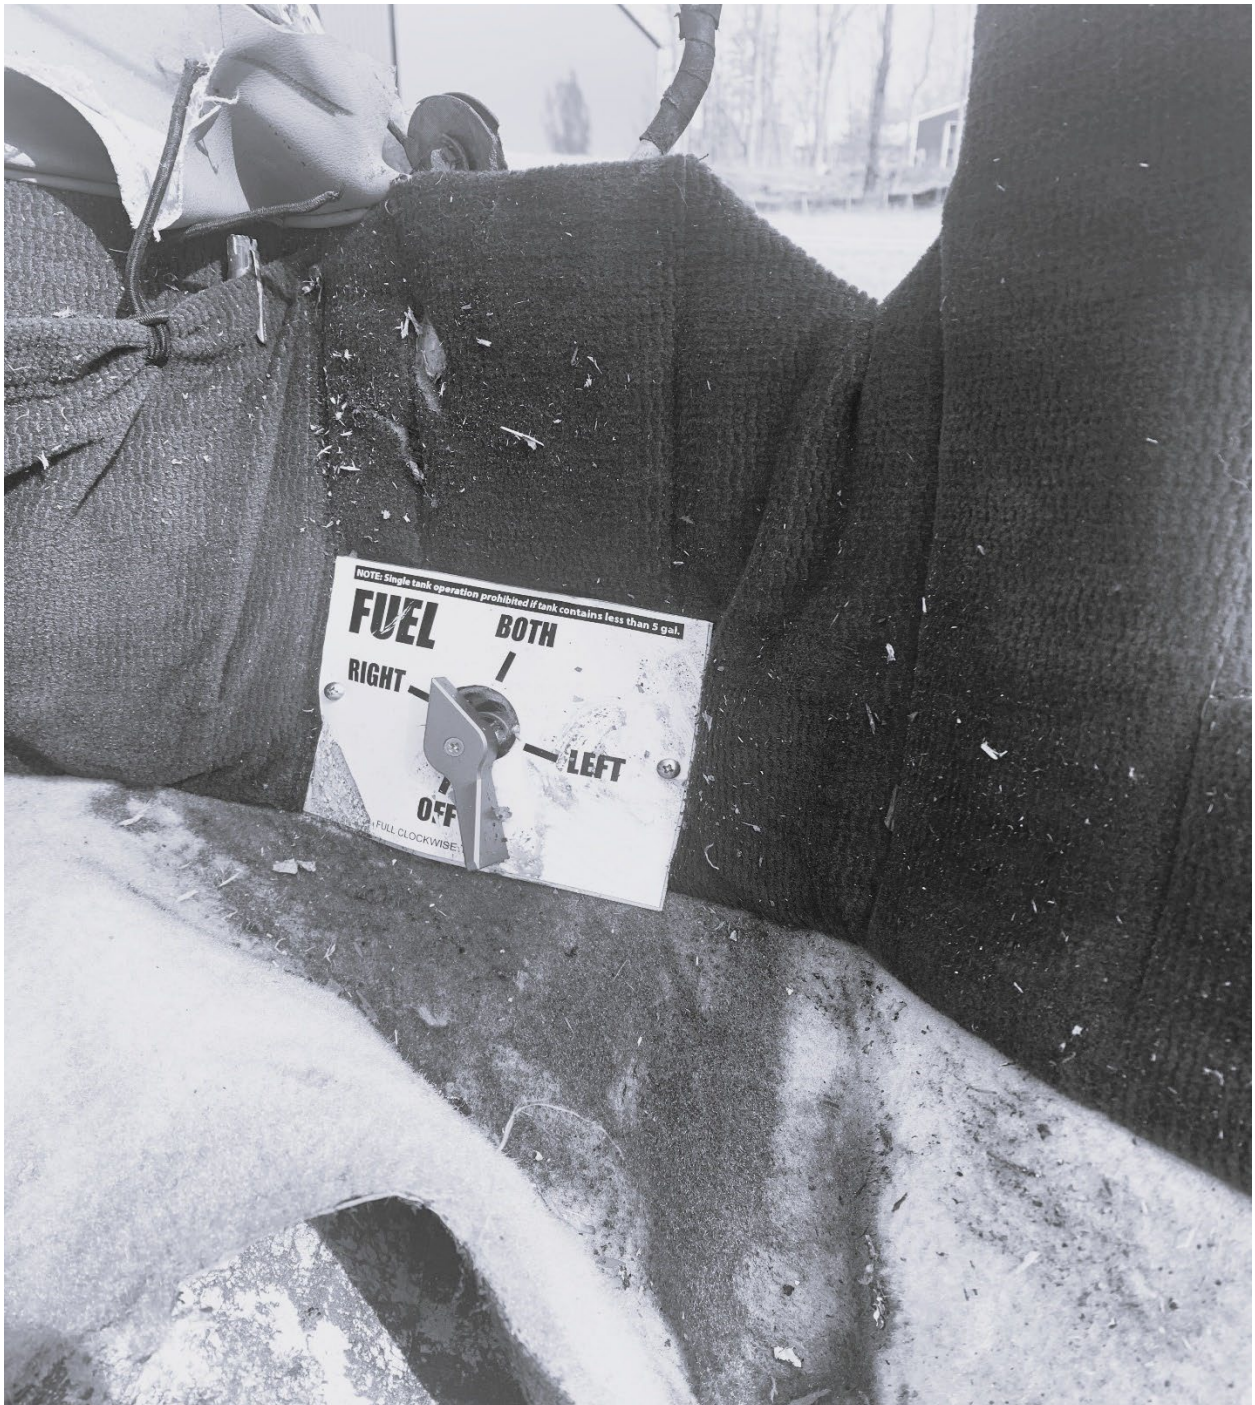
Photo of fuel Selector

This photograph was obtained from the Fannin County Sheriff's Office before the removal of the pilot. It clearly shows the fuel selector handle was positioned between the both and right fuel tank. During the on-scene investigation, the position of the selector was confirmed. Subsequently, the selector was carefully removed for a detailed examination. The inspection revealed no irregularities or issues, confirming that the selector was functioning properly and would not have hindered normal operation.
