# National Transportation Safety Board

ERA23FA182

## **METEOROLOGY**

Specialist's Factual Report

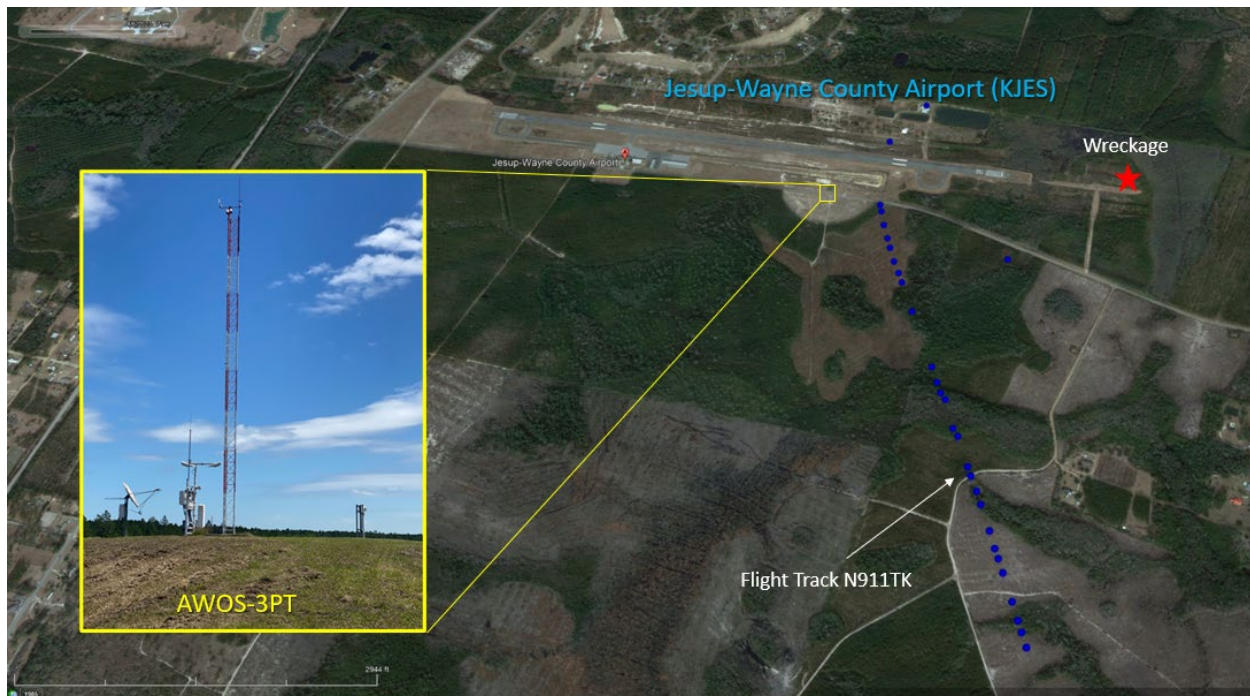
observations long-line<sup>7</sup> every 20-minutes. The AWOS system was located about 1,780 ft from the threshold of runway 29 and 500 ft south of the runway at an elevation of about 86 ft. A Google Earth view of the airport and the location and photo of the AWOS system is included as figure 3 with the wreckage location marked by the red star and flight track points (blue)<sup>8</sup>.

**Figure 3 - Location of the AWOS sensor array at KJES and wreckage location.**

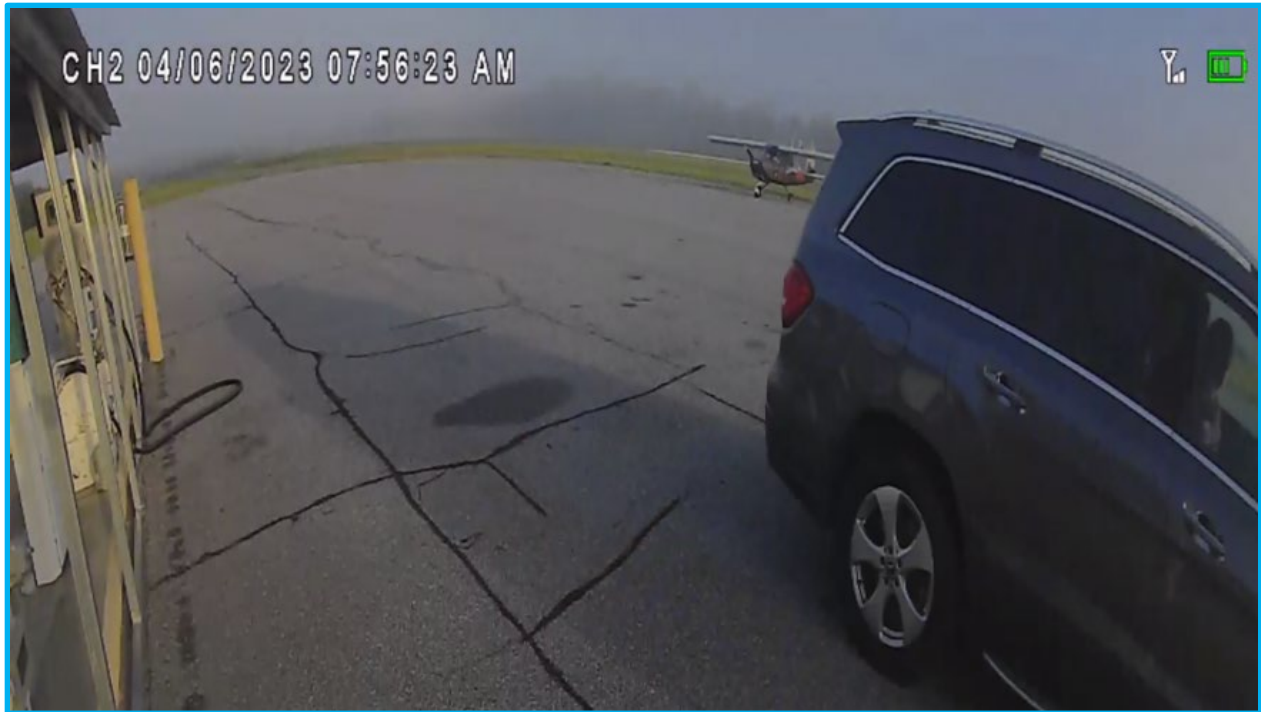
An airport worker arriving at KJES took a picture of the conditions at 0756 EDT from the ramp near the fuel pump, looking northwest. It is included as figure 13. The image showed the fog with the tree line still mostly obscured by the fog.

**Figure 13 - Photograph from the ramp at KJES at 0756 EDT.**
