# National Transportation Safety Board

ERA23FA219

## **MULTIPLE ELECTRONIC DEVICES**

Specialist's Factual Report

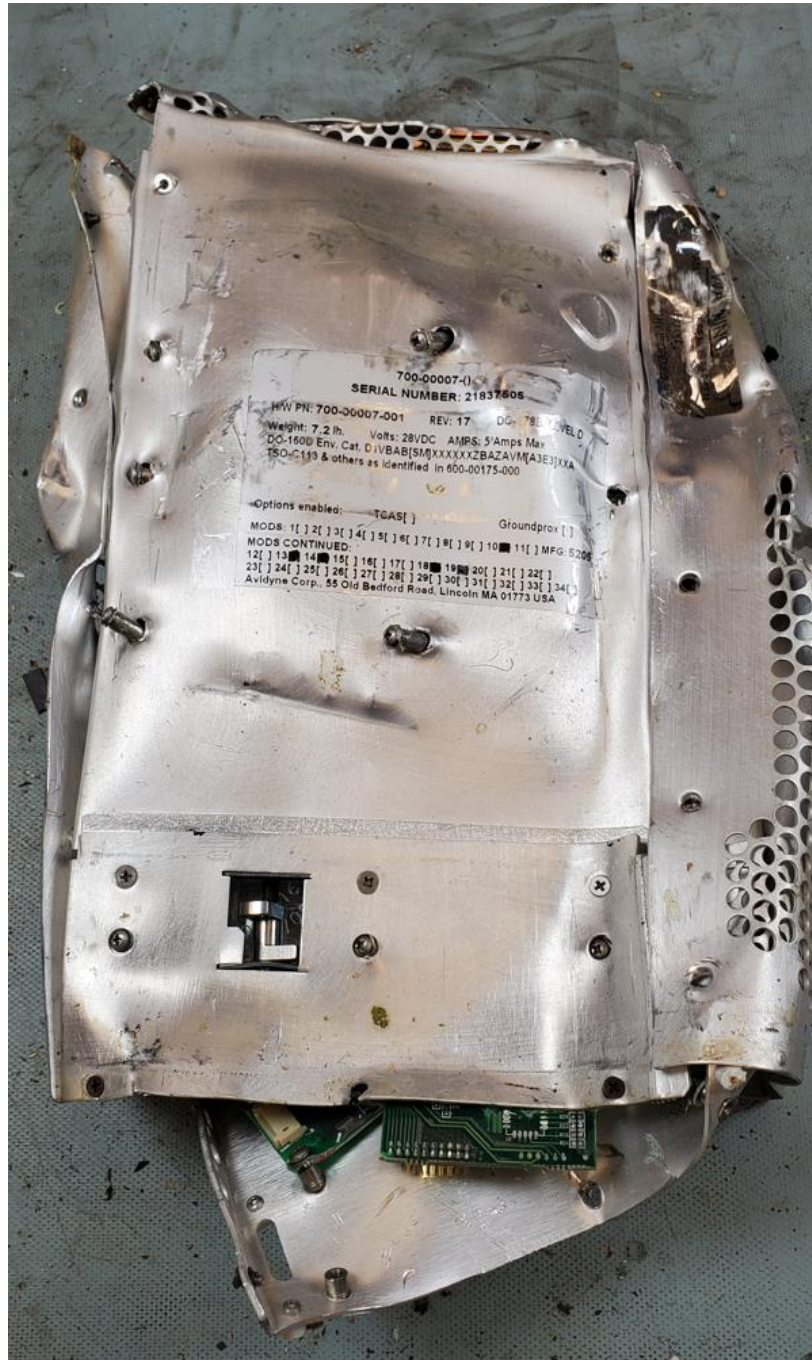
Figure 1 shows the Avidyne as received by the NTSB Vehicle Recorders Laboratory. The device showed signs of severe impact damage. A CF card was recovered from the device, and its raw data were read out and sent to the manufacturer for decoding. The manufacturer sent back converted data and

**Figure 1.** Avidyne EX500 as received by NTSB Vehicle Recorder Laboratory.

explained that the data indicated the weather receiver of the device was functional during the accident flight. Other than that, the data did not contain other pertinent information to this investigation. The converted data associated with the accident flight is provided in electronic comma-separated value (CSV) format as attachment 1 to this report.

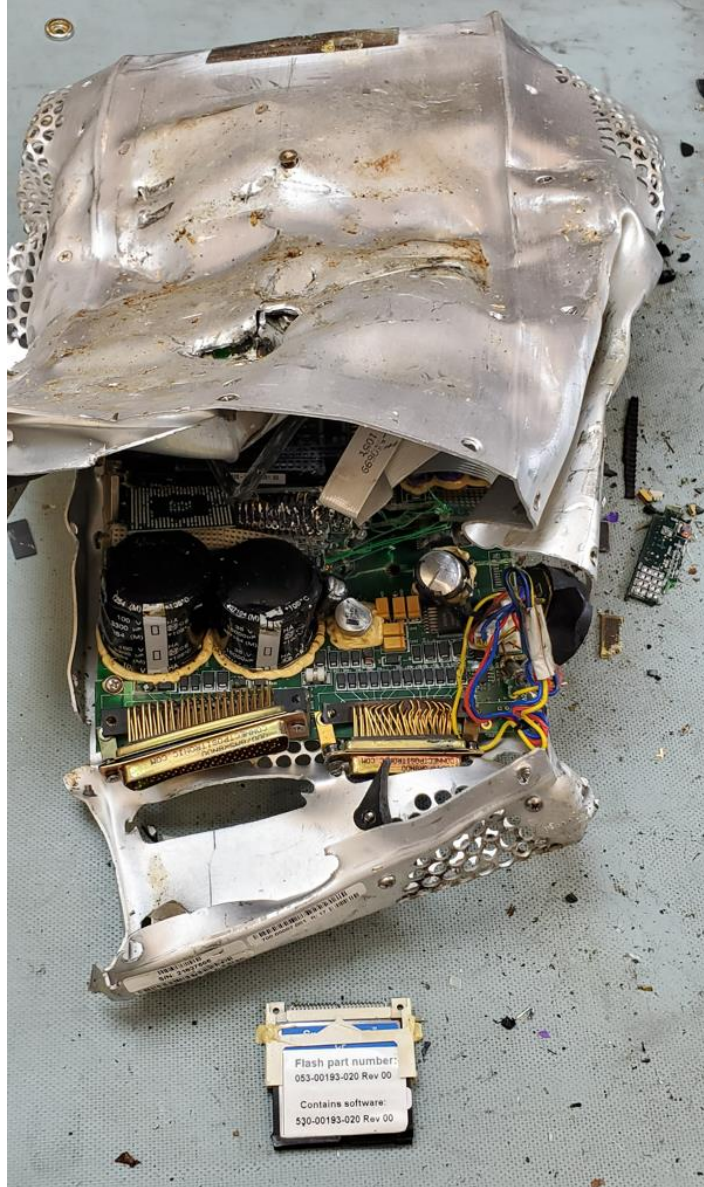
**Figure 2.** CF card recovered from the Avidyne EX500.

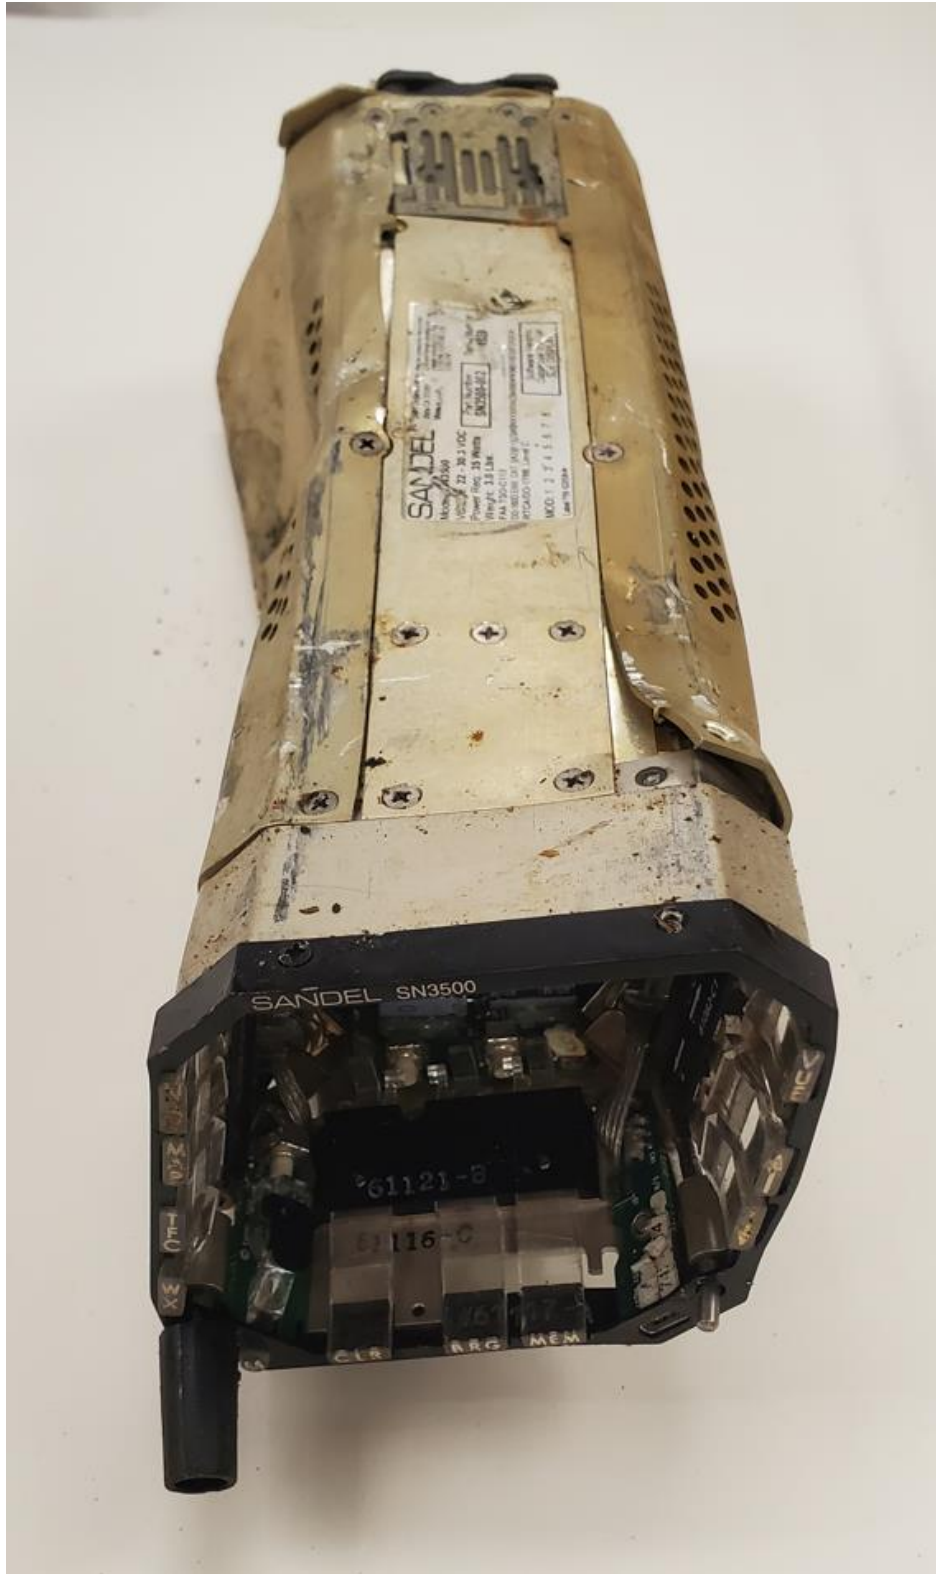
Figure 3 shows the Sandel SN3500 EHSI as received by the NTSB Vehicle Recorders Laboratory. Figure 4 shows the condition of the device internal circuit board with four non-volatile memory (NVM<sup>2</sup>) chips denoted. Those four NVMs which stored the flight data were removed from the damaged circuit board with a computer-aided precision desoldering rework machine and carefully examined. Figure 5 shows the removed and labeled NVMs. Each NVM was read out and imaged successfully. The Vehicle Recorders Laboratory performed reballing for each of the four NVMs in preparation for any further procedure. Figure 6 shows a comparison of a reballed NVM next to one before being reballed.

**Figure 3.** Sandel SN3500 EHSI as received by NTSB Vehicle Recorder Laboratory.

A formal data recovery support request was sent to the manufacturer. In summary Nighthawk Flight System reported that a custom hardware solution would need to be developed specifically for the SN3500, and that the custom hardware solution could not be used across its product line for future accident recoveries. Furthermore, Nighthawk could not guarantee that this hardware solution would work as surrogate to extract data from the accident device. The NTSB elected not to pursue the creation of the hardware solution due to the uncertainty of the project's success and the limitations that the device could not be used for future recoveries involving other Nighthawk/Sandel products. No data was recovered from the accident device.

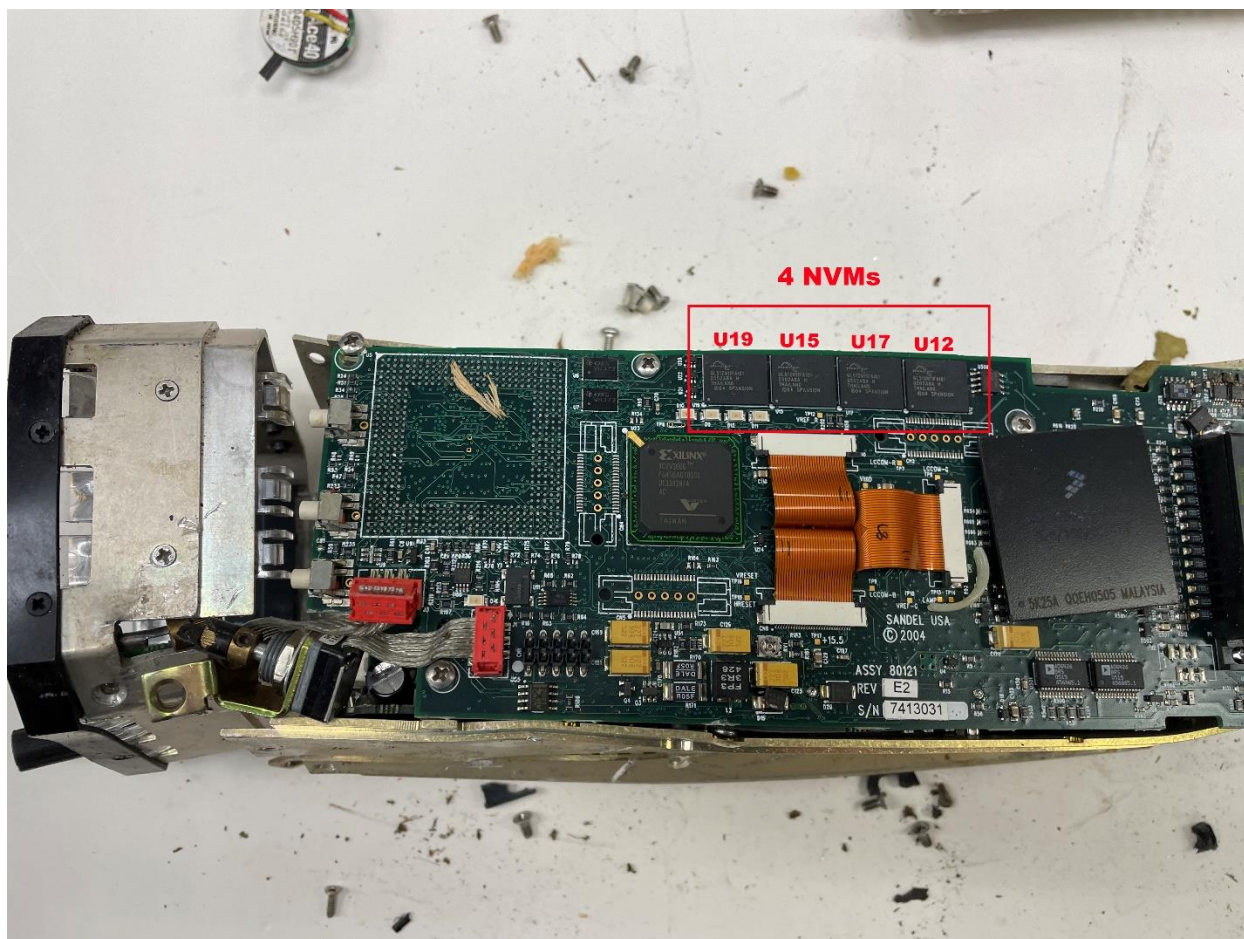
**Figure 4.** Sandel SN3500 internal circuit board.

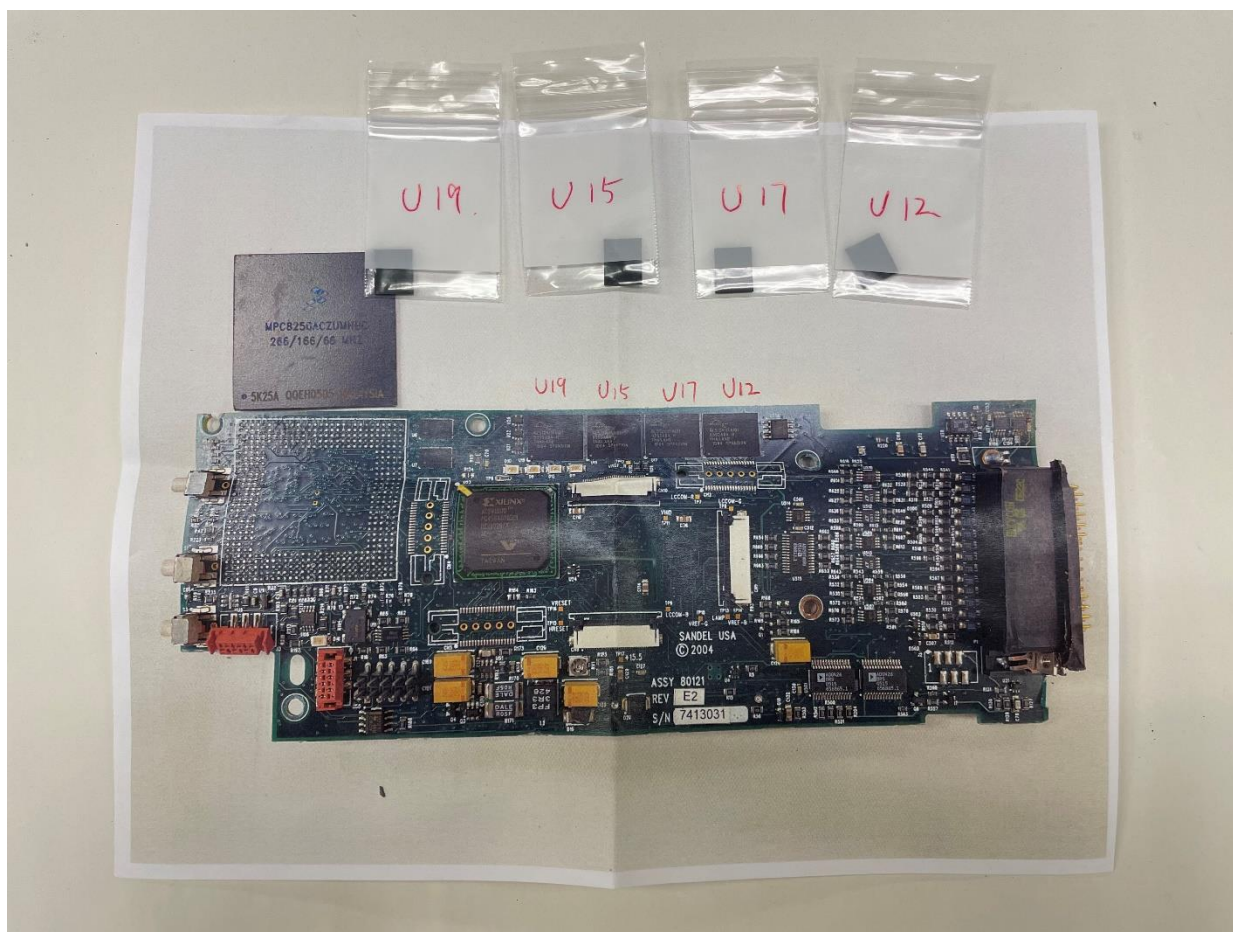
**Figure 5.** Four memory chips were removed from the circuit board and labeled accordingly.

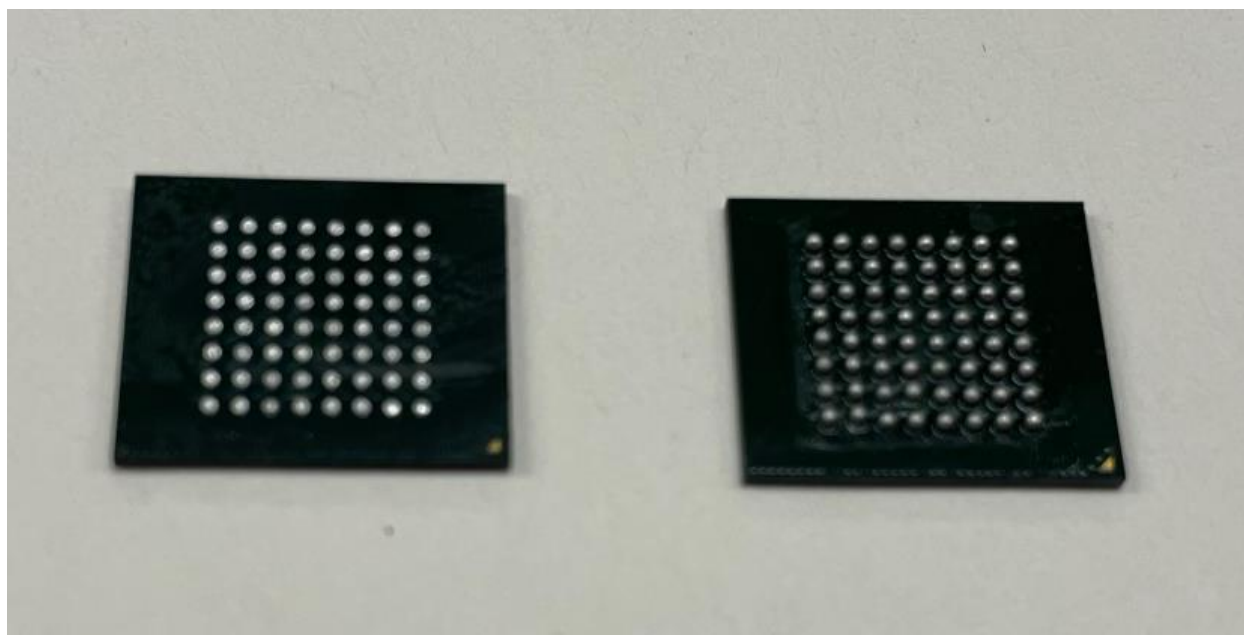
**Figure 6.** Each of the four memory chips was read-out and re-balled. The chip on the right was re-balled.
