# National Transportation Safety Board

ERA23FA235

## COMPUTED TOMOGRAPHY

Specialist's Factual Report

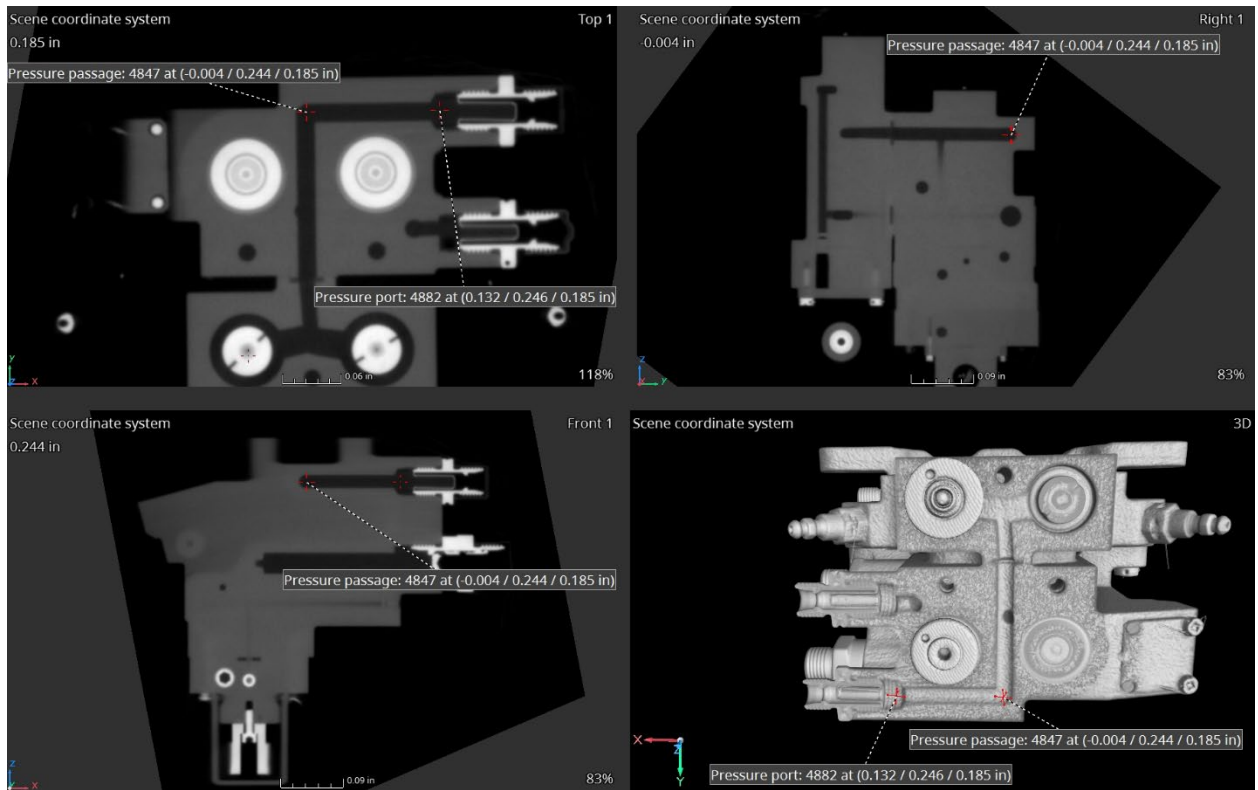
**Figure 12.** Power brake and antiskid valve assembly - pressure passages.

- 1) Figures 3 through 9 show the exterior of the valve assembly, the ports and the nomenclature of the ports.
- 2) Figures 10 through 13 show the pressure port and pressure passages.
- 3) Figures 14 through 16 show the servo valve and its filter screen.
- 4) Figures 17 through 22 show the left and right brake control valves.
- 5) Figures 22 through 35 show the left and right master cylinder metering valves and components. There were some indications of low-density material near the left master cylinder (MC) metering valve (see Figure 23)
- 6) Figures 36 through 39 show the exterior of the valve assembly, the ports and the nomenclature of the ports.
- 7) Figures 40 through 46 show the exterior of the valve assembly, the ports and the nomenclature of the ports.
- 8) Figure 47 shows the return port.
- 9) Figure 48 shows the servo valve electrical connector.

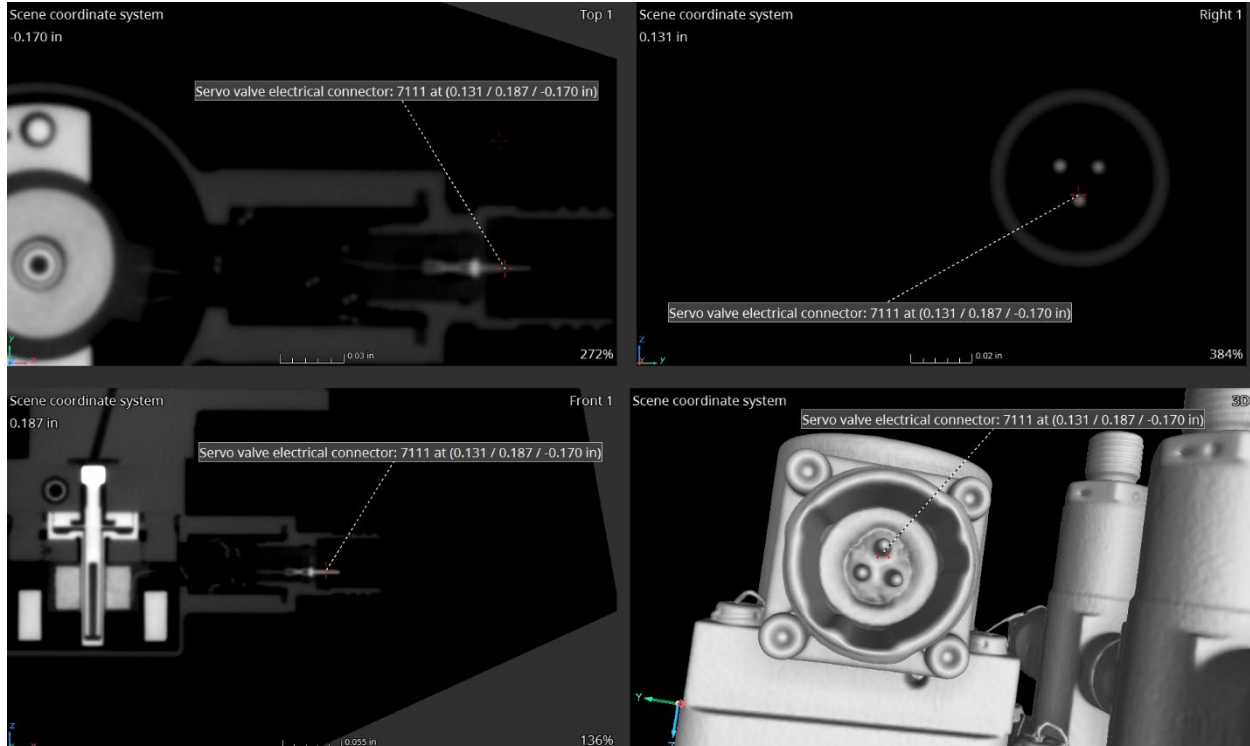
**Figure 48.** Power brake and antiskid valve assembly – servo valve electrical connector.
