**MEMORANDUM FOR RECORD**

**Subject:** ERA23FA249

**Contact:** Dipstick Information and Dipstick Conversion Chart

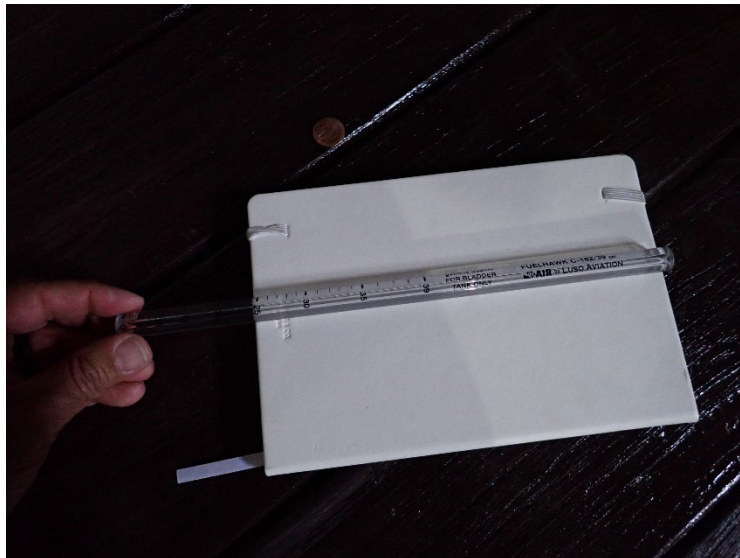
As part of the investigation, the pilot's personal effects at the operator's facility were inspected, which revealed a fuel dipstick that was identical to the dipstick located in the accident airplane<sup>1</sup> (Figure 1). There was no conversion chart located in his personal effects to correlate the readings on the dipstick with actual fuel load in each tank.

*Figure 1 View of Dipstick Found in Pilot's Personal Effects At Operator's Facility*
