# National Transportation Safety Board

ERA23FA258

## RECOVERABLE DATA MODULE

Specialist's Factual Report

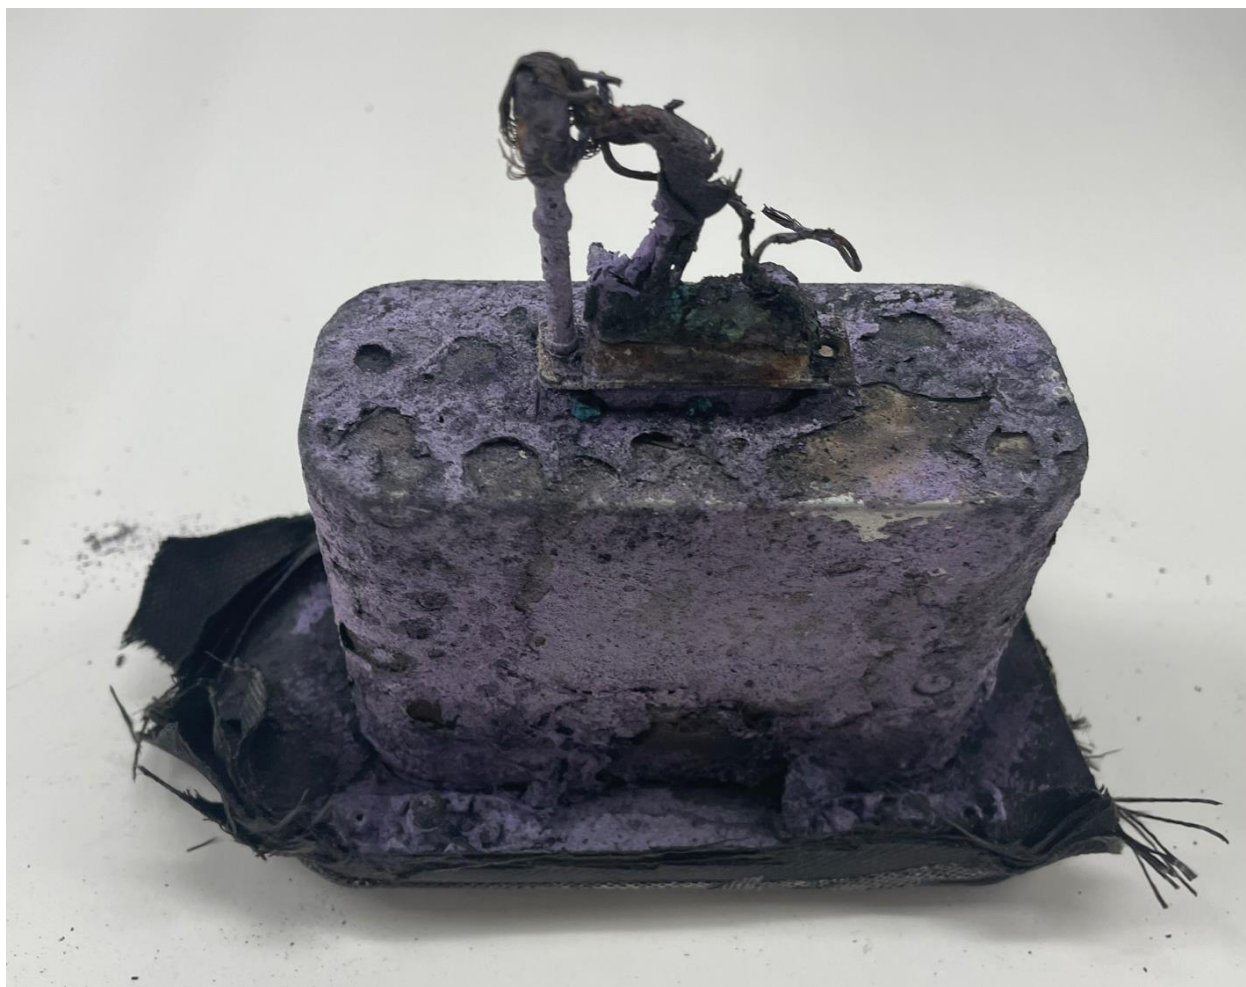
The Appareo RDM-300 had sustained severe fire damage, as shown in Figure 1. Figure 2 shows an inside view of the device and its circuit board. Although the connector exhibited fire damage, the circuit board was in good condition. The manufacturer sent in a connector replacement as well as downloading tools. After the connector was replaced, the last two hours of raw data were downloaded normally using the manufacturer's procedure. The downloaded raw data were then decoded and converted into engineering unit data by a Cirrus Aircraft representative at NTSB headquarters.

**Figure 1.** Appareo RDM-300 as received.

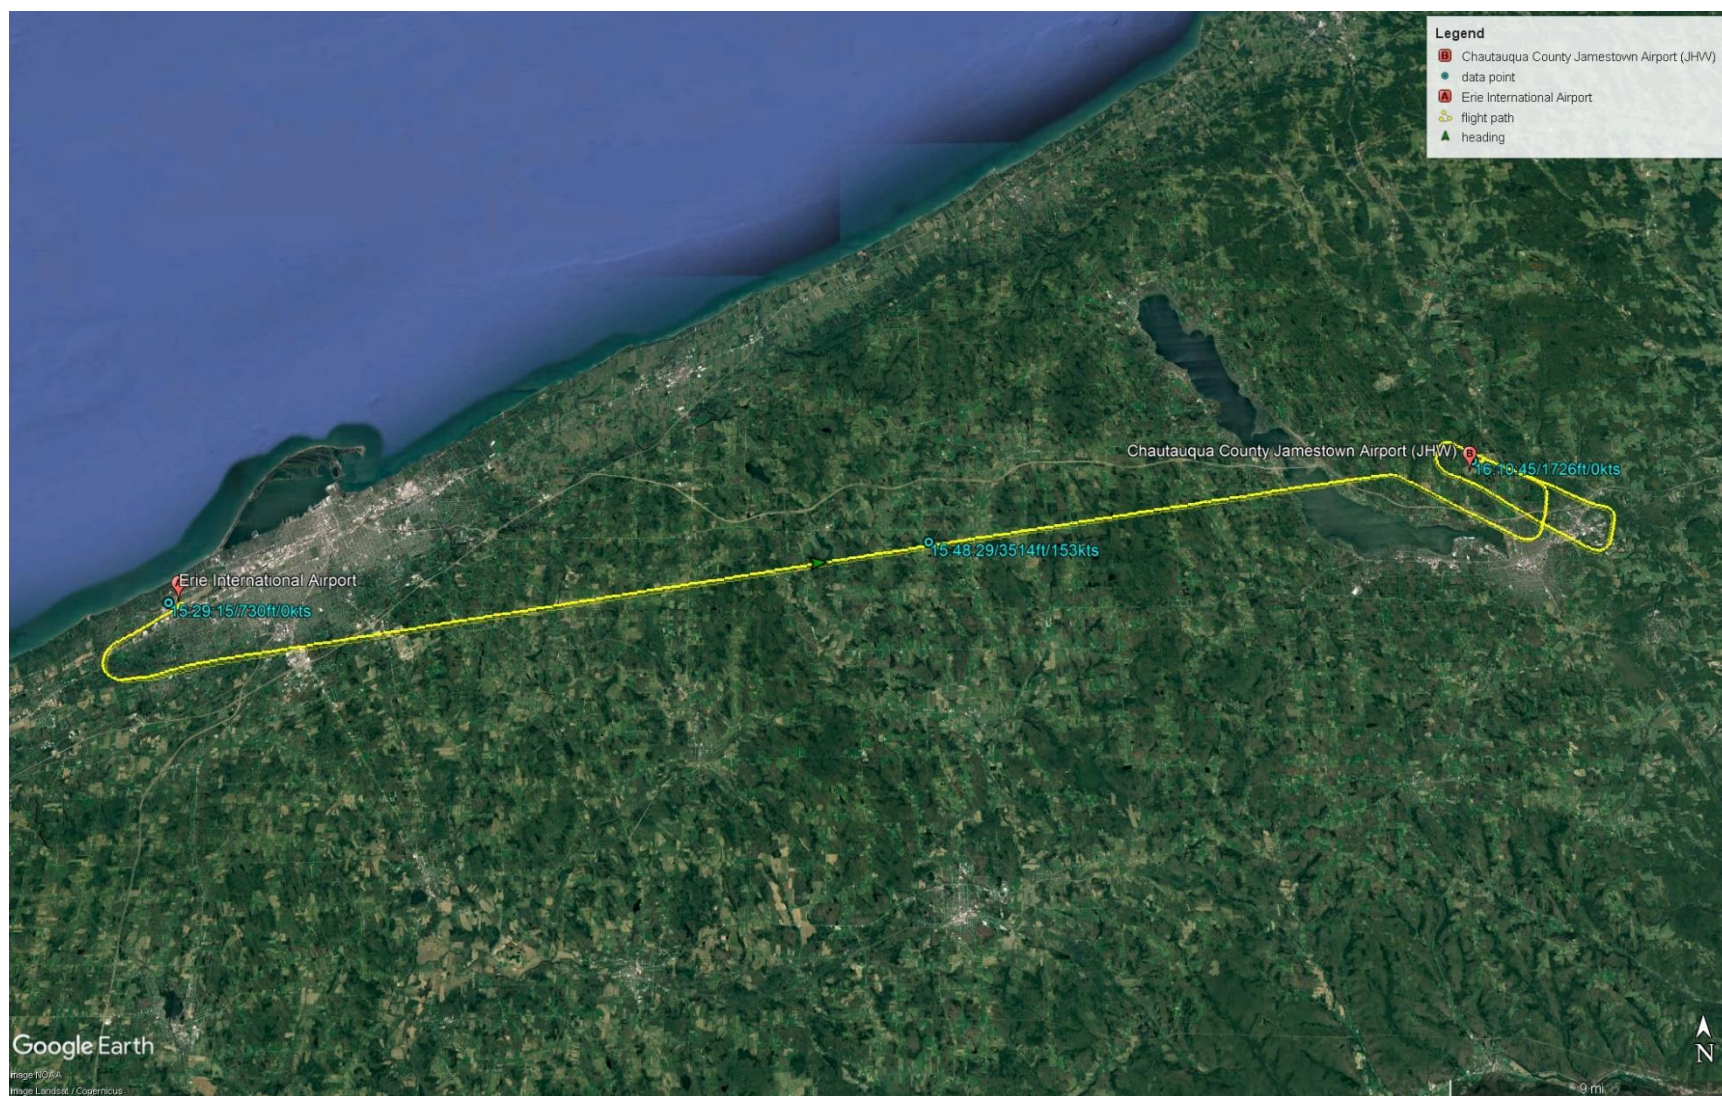
Figure 17 is a Google Earth overlay of this previous flight. The weather and lighting conditions in Google Earth are not necessarily the weather and lighting conditions present at the time of the recording.

**Figure 17.** Google Earth overlay of the previous flight recorded on the same day.
