# National Transportation Safety Board

ERA23FA317

## **GLOBAL POSITIONING SYSTEM DEVICE**

Specialist's Factual Report

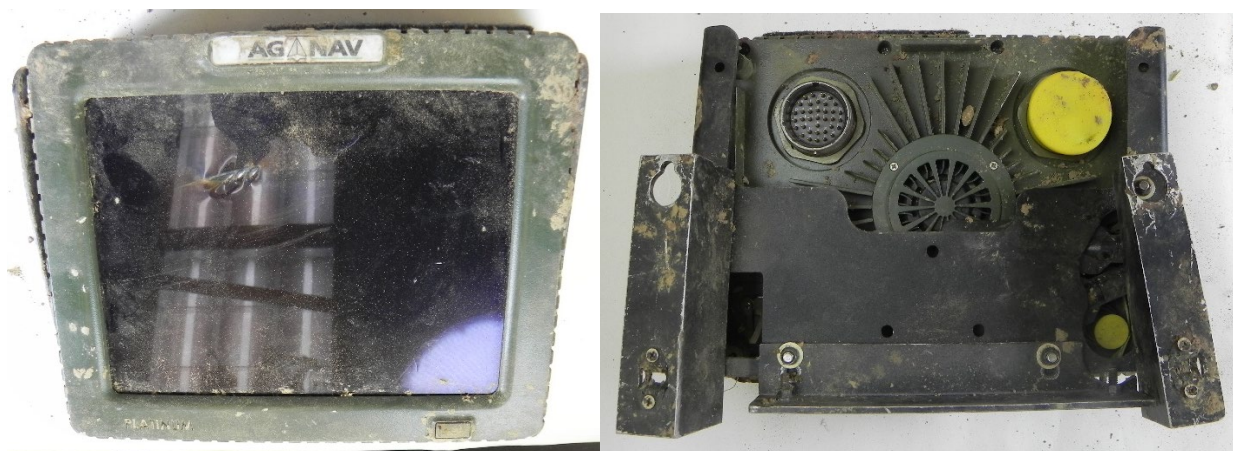
The device sustained damage to its display, as shown in figure 1. The device was otherwise in good condition and powered on normally, however, the touch screen was non-functional. Data from the hard drive were recovered utilizing procedures outlined by the manufacturer.

**Figure 1.** Front and back of the device as received.

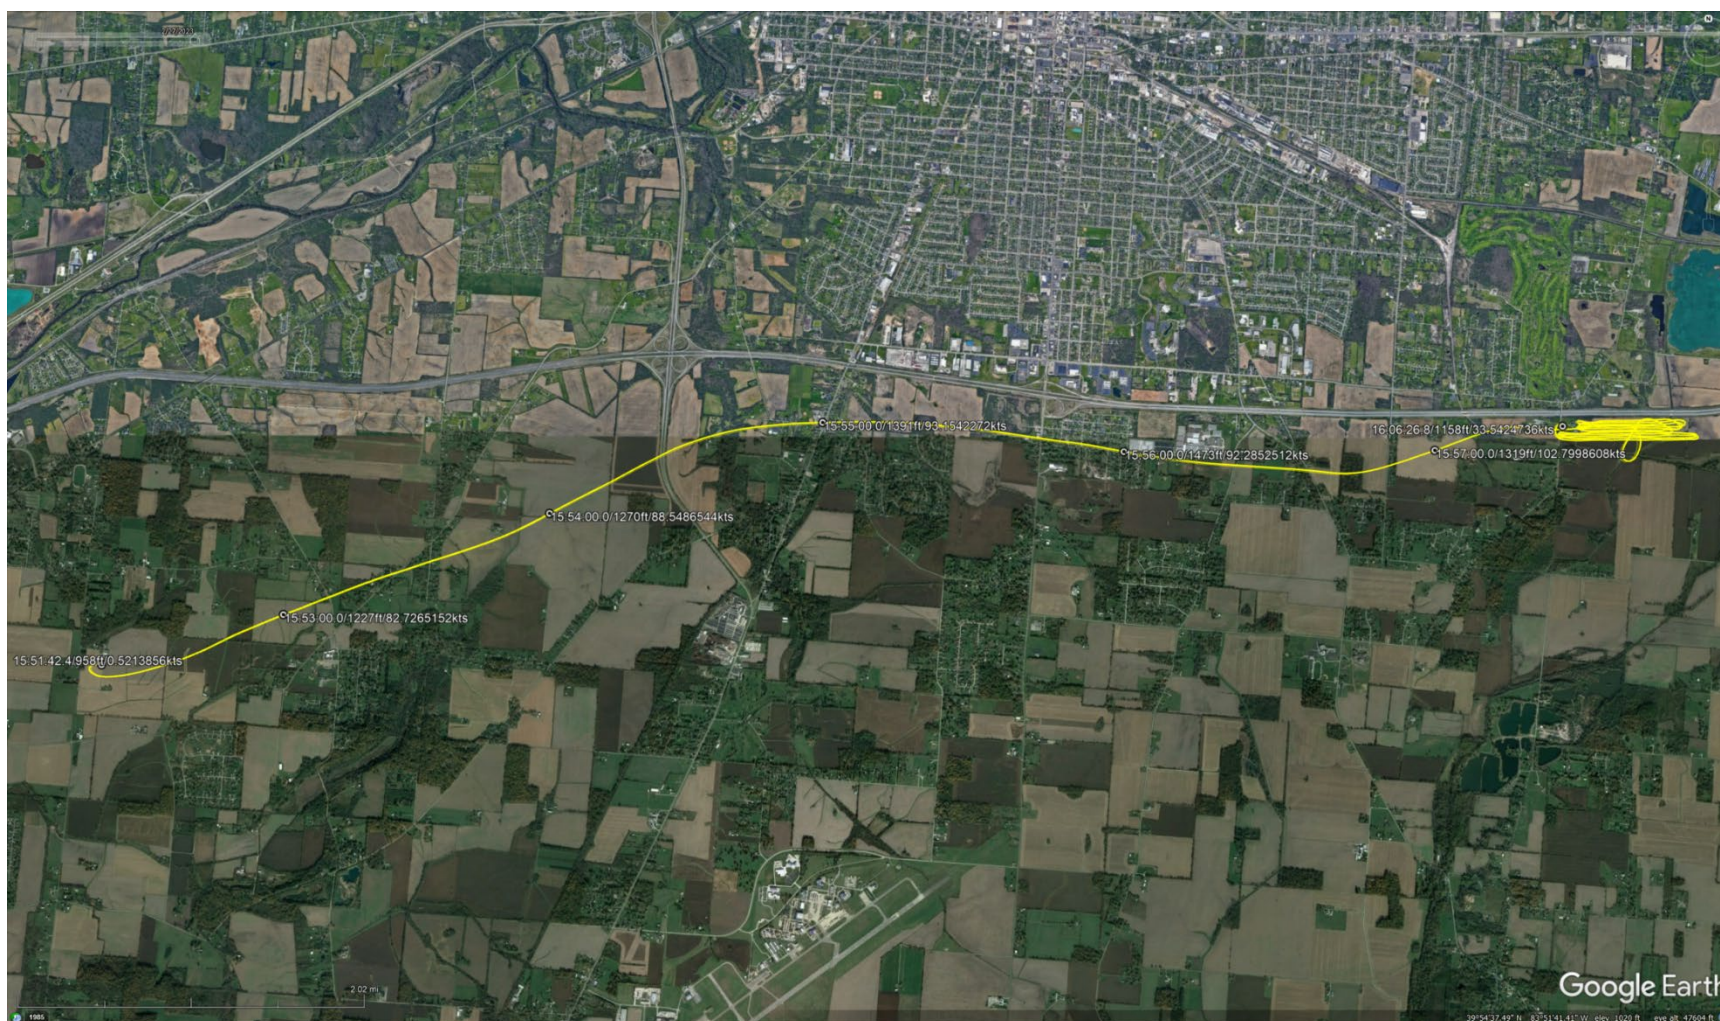
Figure 2 is an overview of the entire accident flight from 15:51:42.4 UTC and ended at 16:06:26.8 UTC.

**Figure 2.** Google Earth overlay of the entire accident flight.

The accident flight started at 15:51:42.4 UTC and ended at 16:06:26.8 UTC on July 29, 2023. The final recorded data point was approximately 0.4 nautical miles west of the reported wreckage location. The accident event may not have been captured due to data buffering on the device.

Figures 2 through 4 are graphical overlays generated using Google Earth showing the accident flight. Weather and lighting conditions in Google Earth are not necessarily the weather and lighting conditions present at the time of the recording.

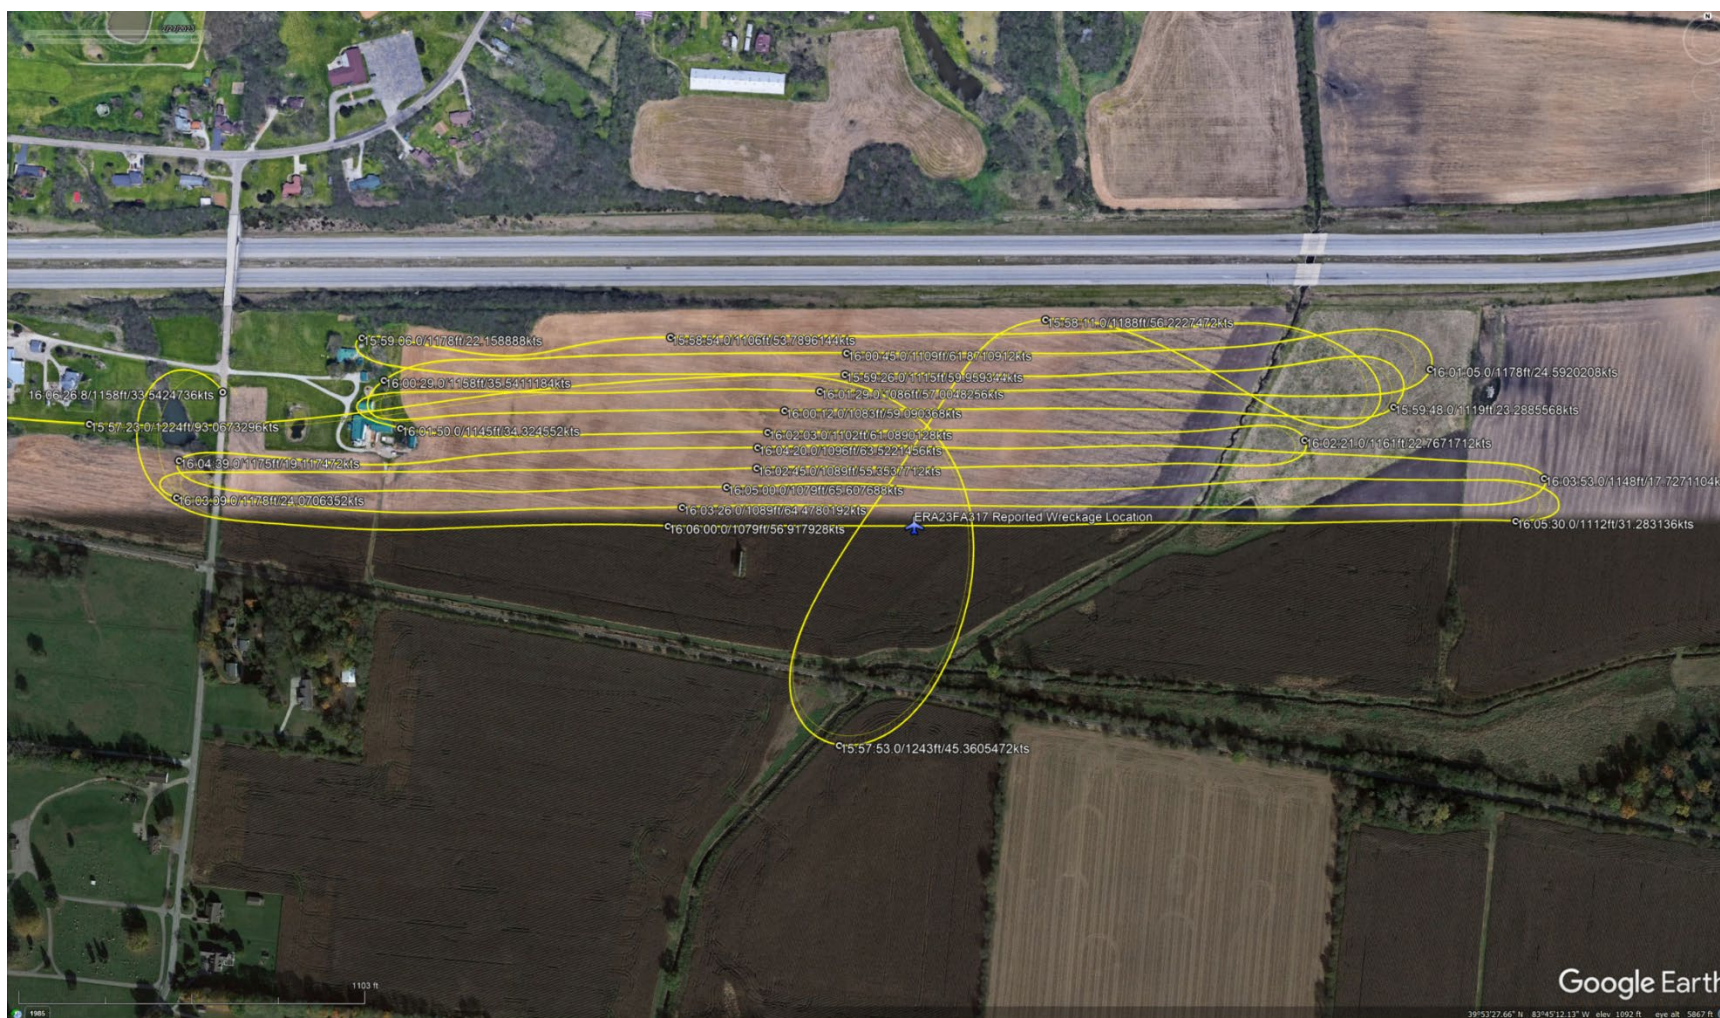
Figure 3 is an overview of the spray area and the reported wreckage location.

**Figure 3.** Google Earth overlay showing the spray area and the reported wreckage location.
