# National Transportation Safety Board

ERA23FA330

## **GLOBAL POSITIONING SYSTEM (GPS) DEVICE**

Location: Junction City, Georgia  
Date: August 10, 2023  
Time: 1005 eastern daylight time (EDT)  
Airplane: Cessna P210N, ToddAir Inc, N210JT

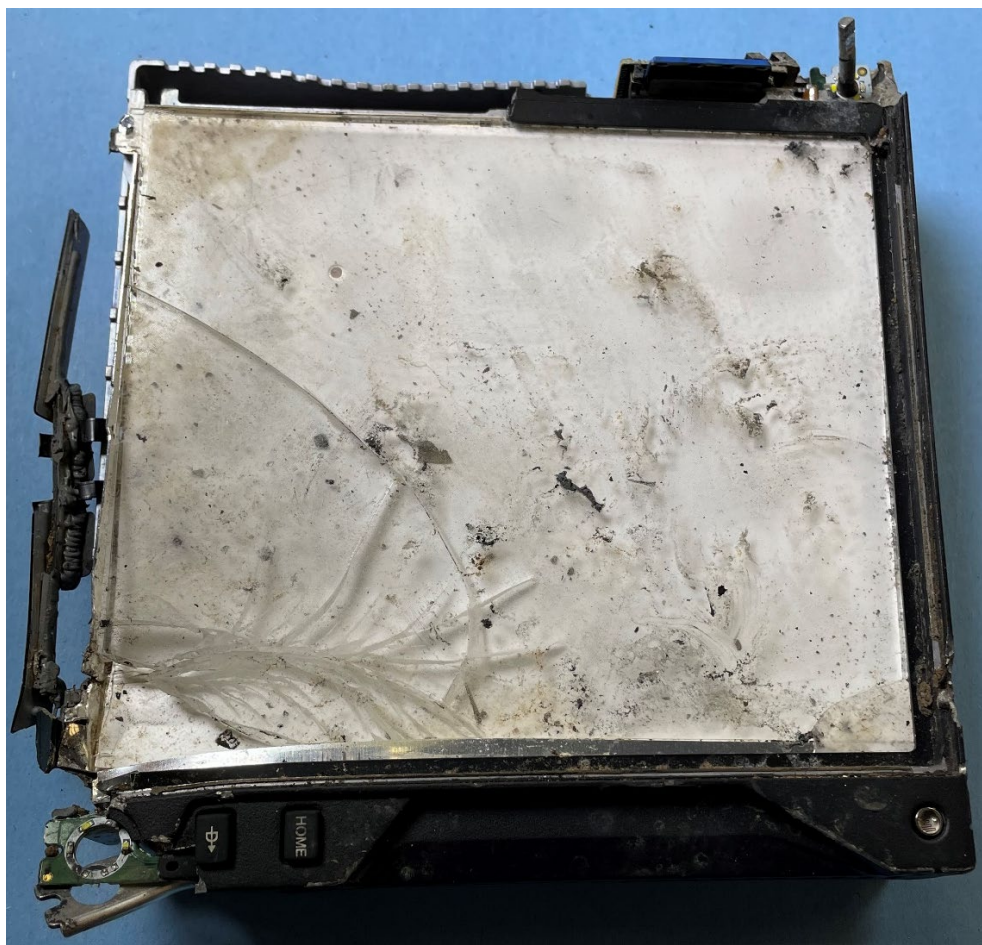
**Figure 1.** Garmin GTN 750Xi display screen as received at the NTSB Vehicle Recorder Laboratory.

The NTSB Vehicle Recorder Laboratory received a damaged display screen from the Garmin GTN 750Xi, as shown in figure 1. The Garmin GTN 750Xi display contained an SD card in good condition, as shown in figure 2. Data were downloaded using the manufacturer's procedure and it was determined to contain only chart information and no data pertinent to the accident were recorded. The accident aircraft was substantially damaged, and the remaining portion of the Garmin GTN 750Xi avionics box containing the flight data was unable to be located in the wreckage, as shown in figure 3.

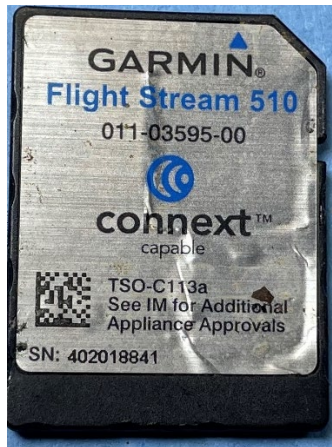
**Figure 2.** Undamaged Garmin Flight Stream 510 SD card containing no flight data.

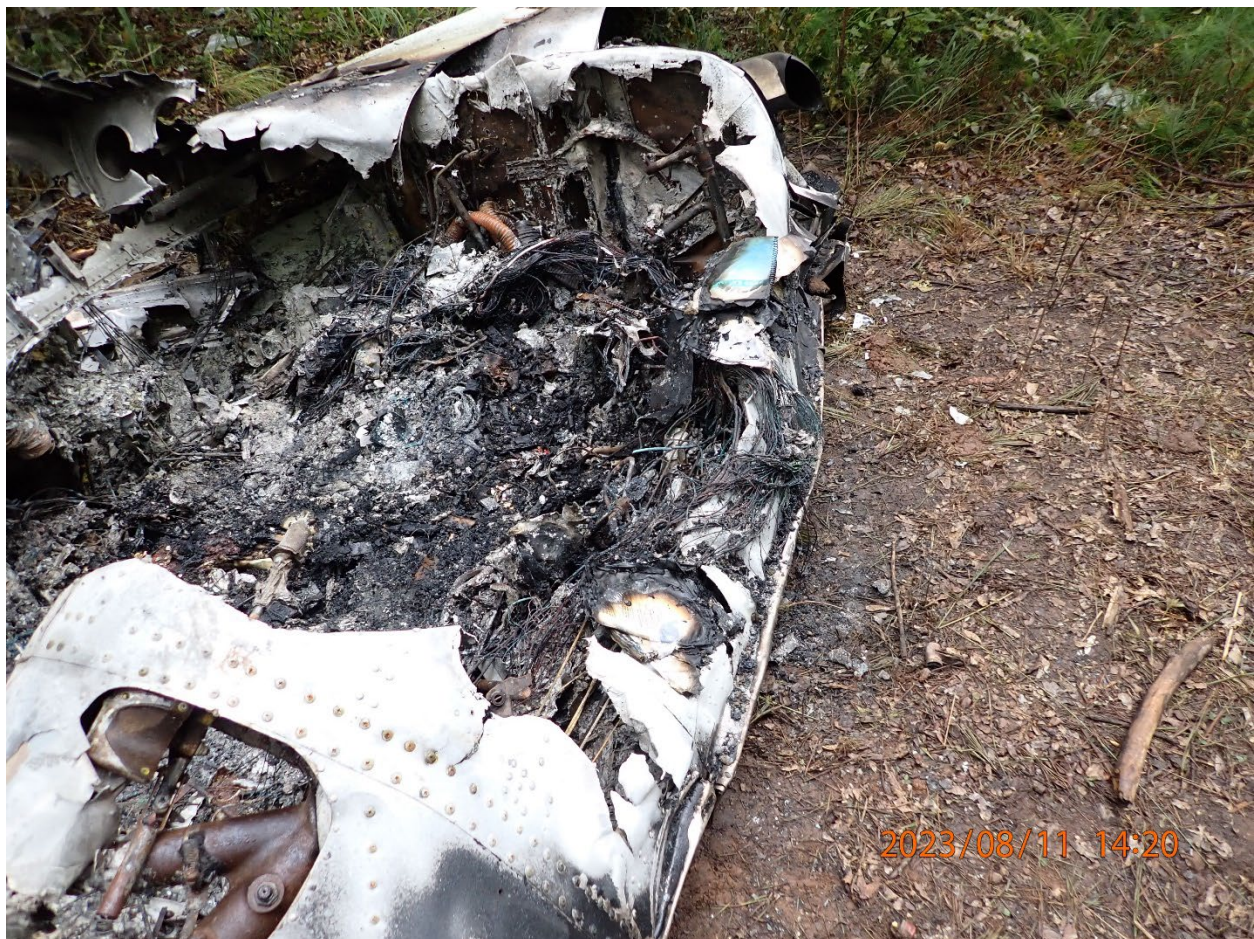
**Figure 3.** Photo taken from the accident showing the damaged cockpit where the Garmin GTN 750Xi avionics box is housed.
