# National Transportation Safety Board

ERA23FA330

## **AIR TRAFFIC CONTROL**

Group Chairman's Factual Report

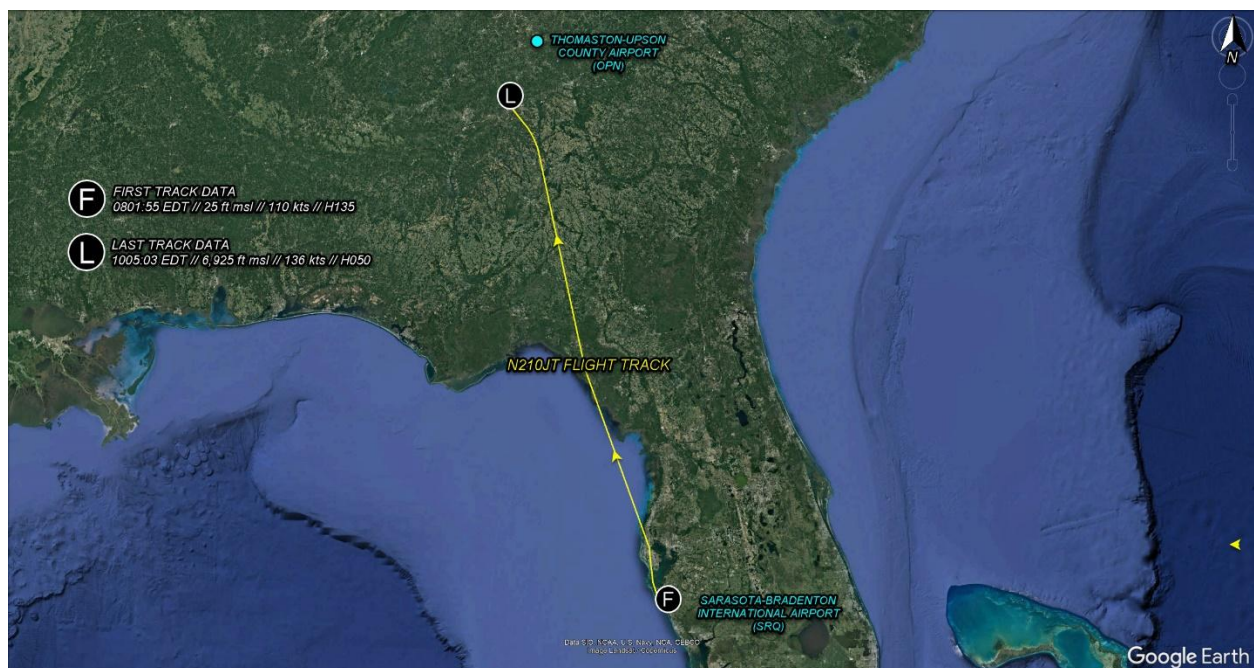
**Figure 1.** Overhead view of the accident aircraft's entire flight track overlaid onto satellite imagery.

Figures 1-3 below illustrate various views of the accident flight track with pertinent information included for reference.

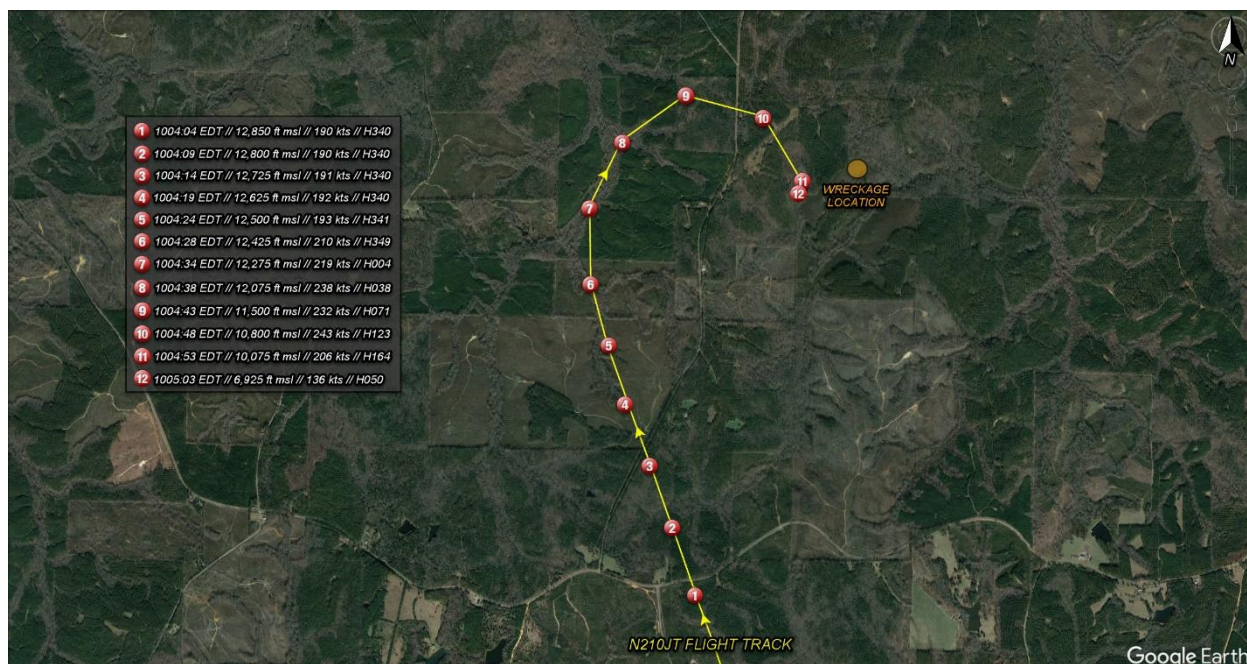
**Figure 2.** Overhead view of the final segment of the accident aircraft's flight track with time, altitude, ground speed, and heading information and overlaid onto satellite imagery.

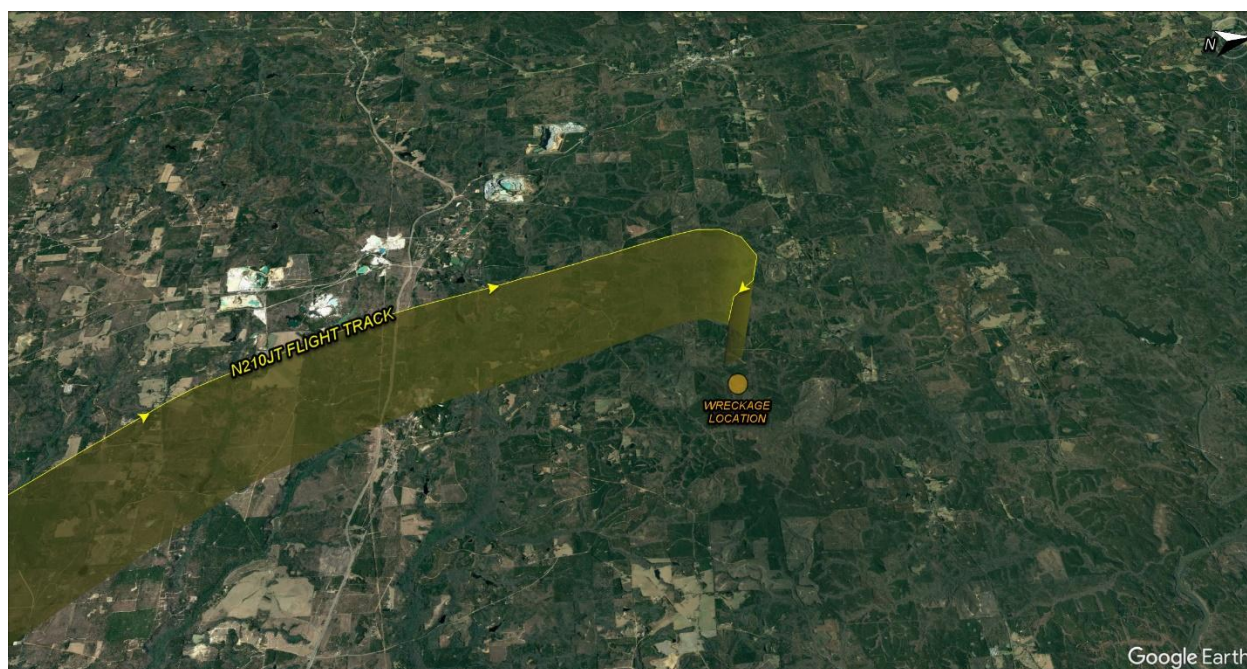
**Figure 3.** Profile view of the final segment of the accident aircraft's flight track.

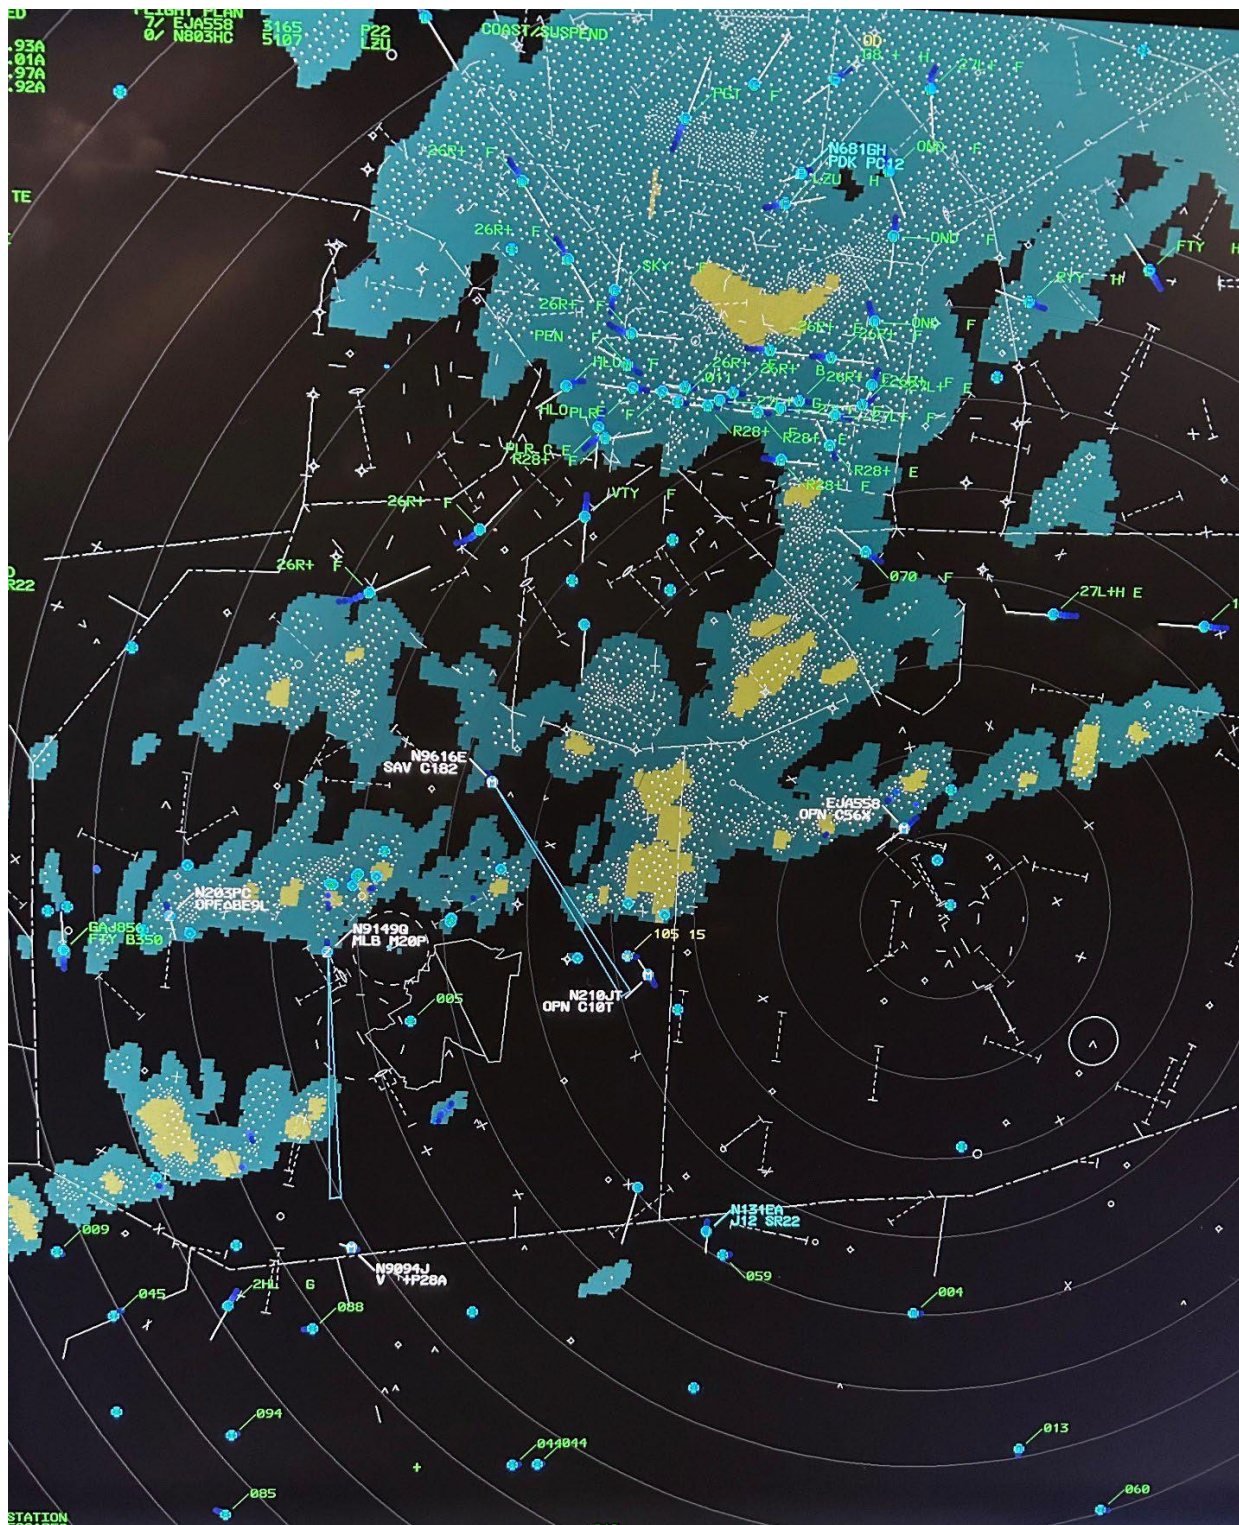
**Figure 4.** A80 STARS weather depiction from 1001. The accident aircraft is identified by 'N210JT' located slightly below the center of the photo.

Screenshots of the Standard Terminal Automation Replacement System (STARS<sup>10</sup>) display from the A80 TRACON during times surrounding the accident time are presented in Figures 4-8. The images, and the times associated with the images, were provided by A80 TRACON management. Figure 9 describes how different radar precipitation levels are presented in the STARS display while presenting a slightly different color shading (a green shading rather than a blue shading) than in Figures 4-8; however, the solid color/dots are consistent between the versions.

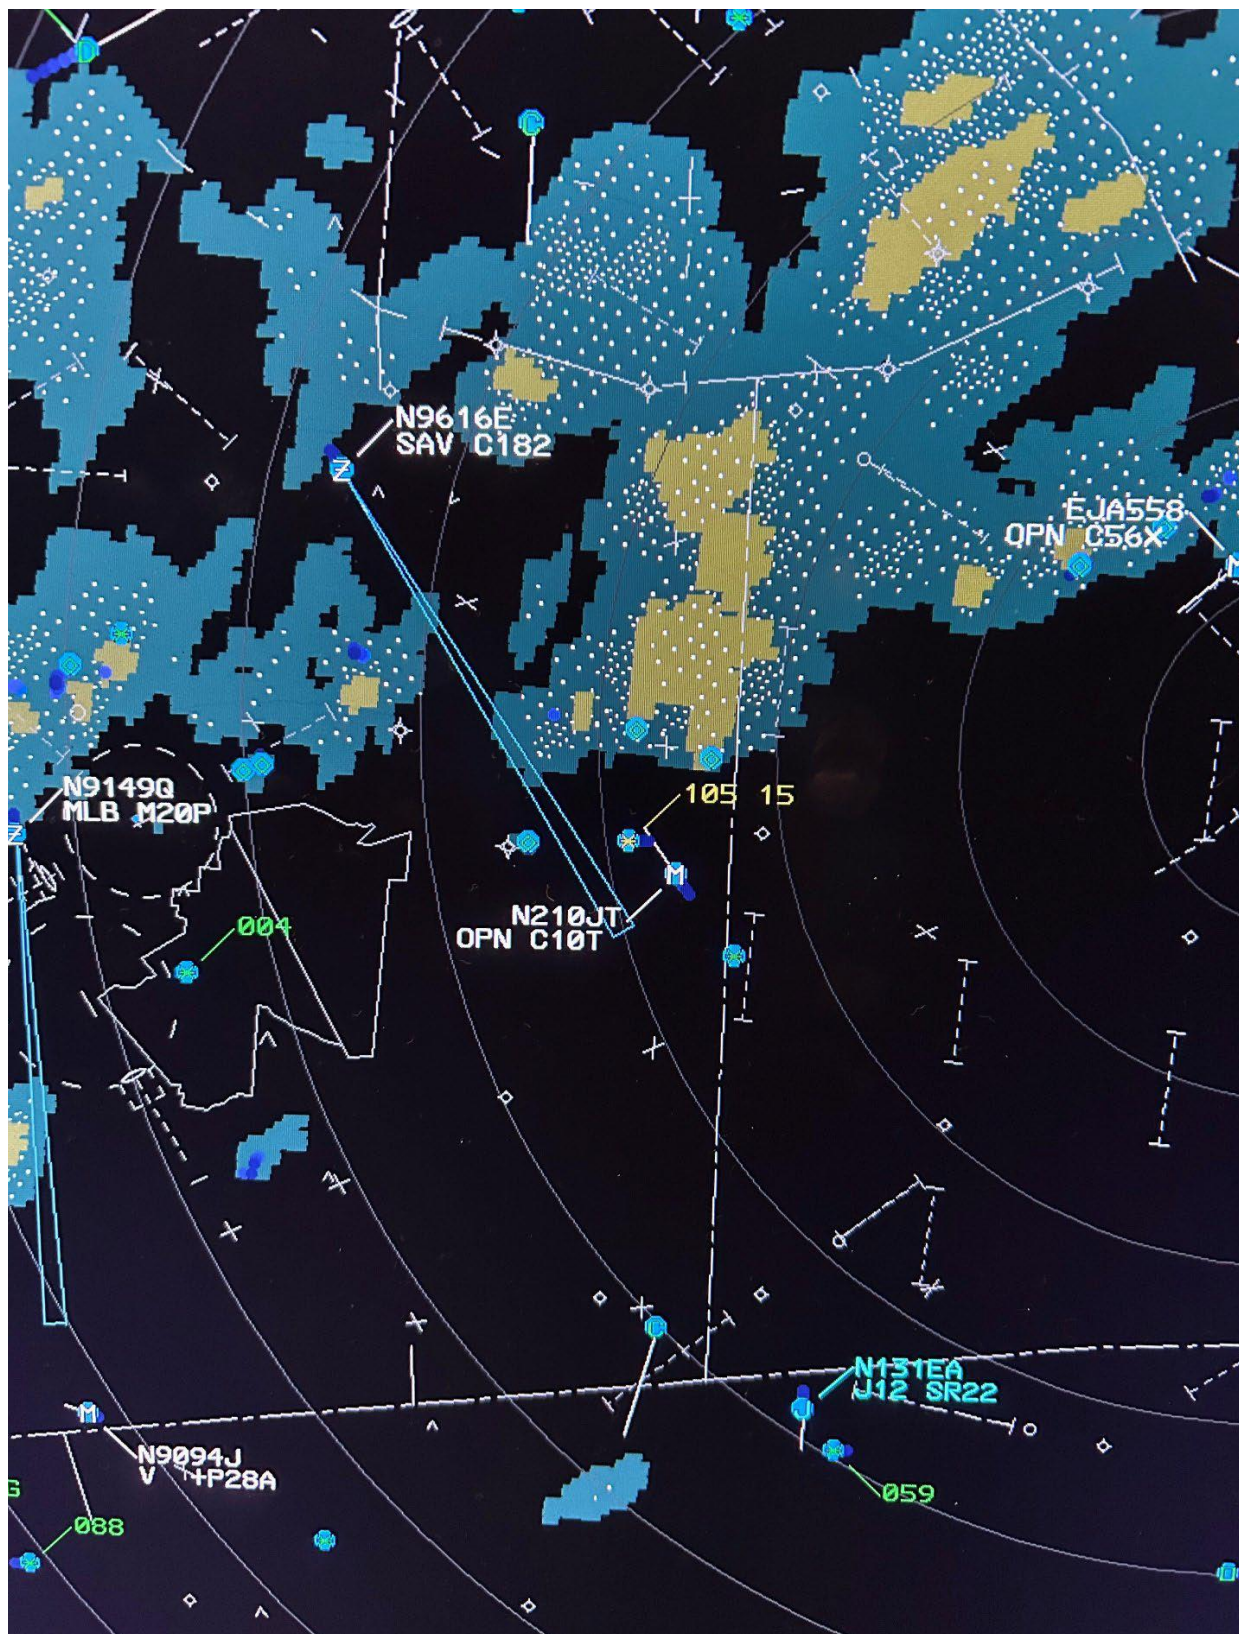
**Figure 5.** A80 STARS weather depiction from 1002. The accident aircraft is identified by 'N210JT' located slightly below the center of the photo.

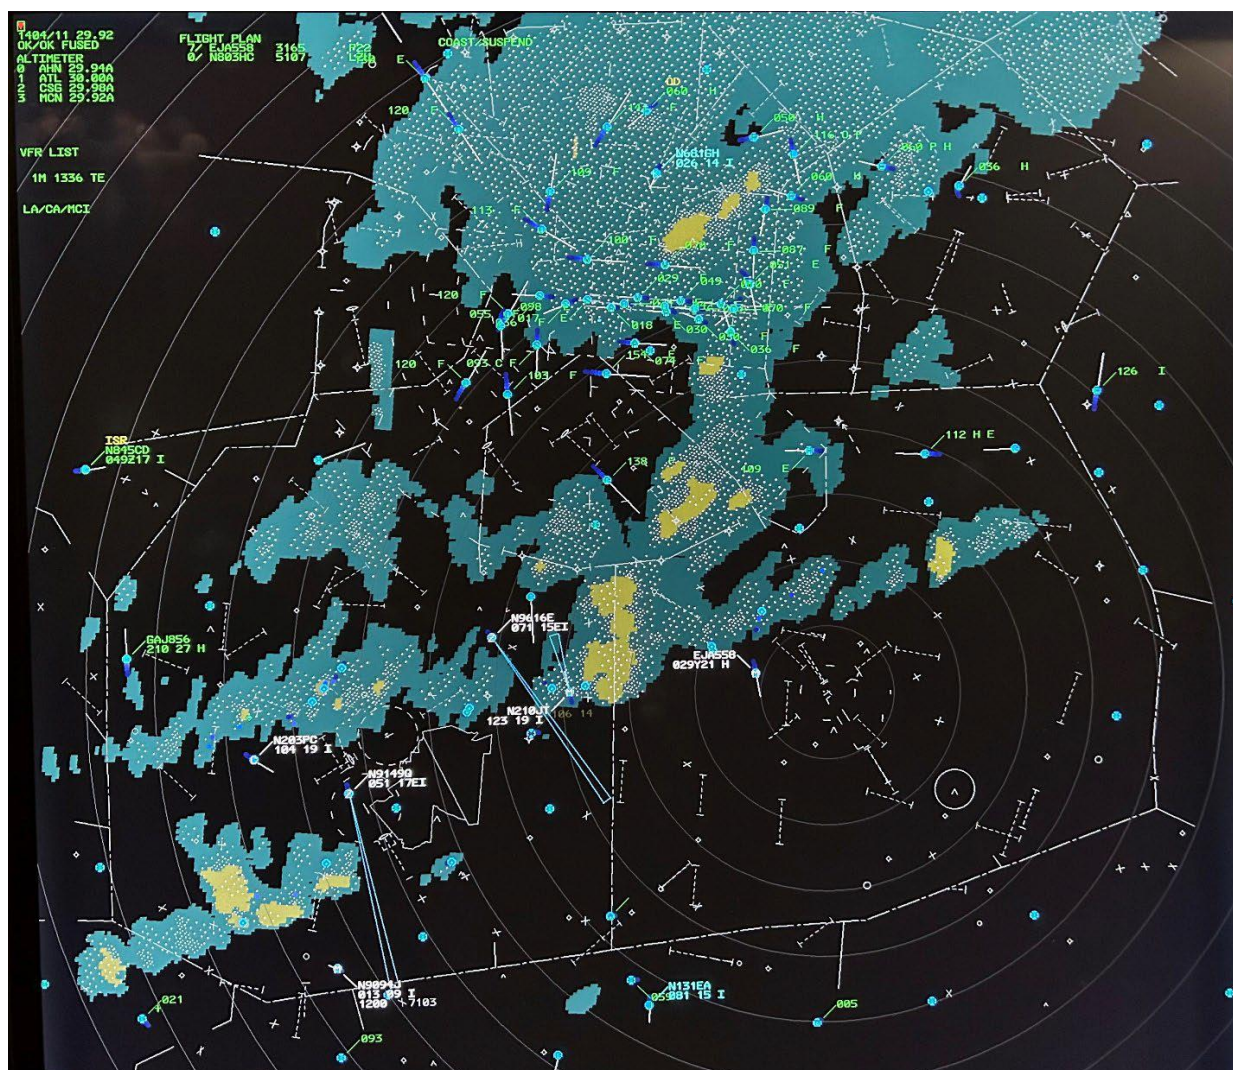
**Figure 7.** A80 STARS weather depiction from 1004. The accident aircraft is identified by "N210JT" located slightly below the center of the photo.

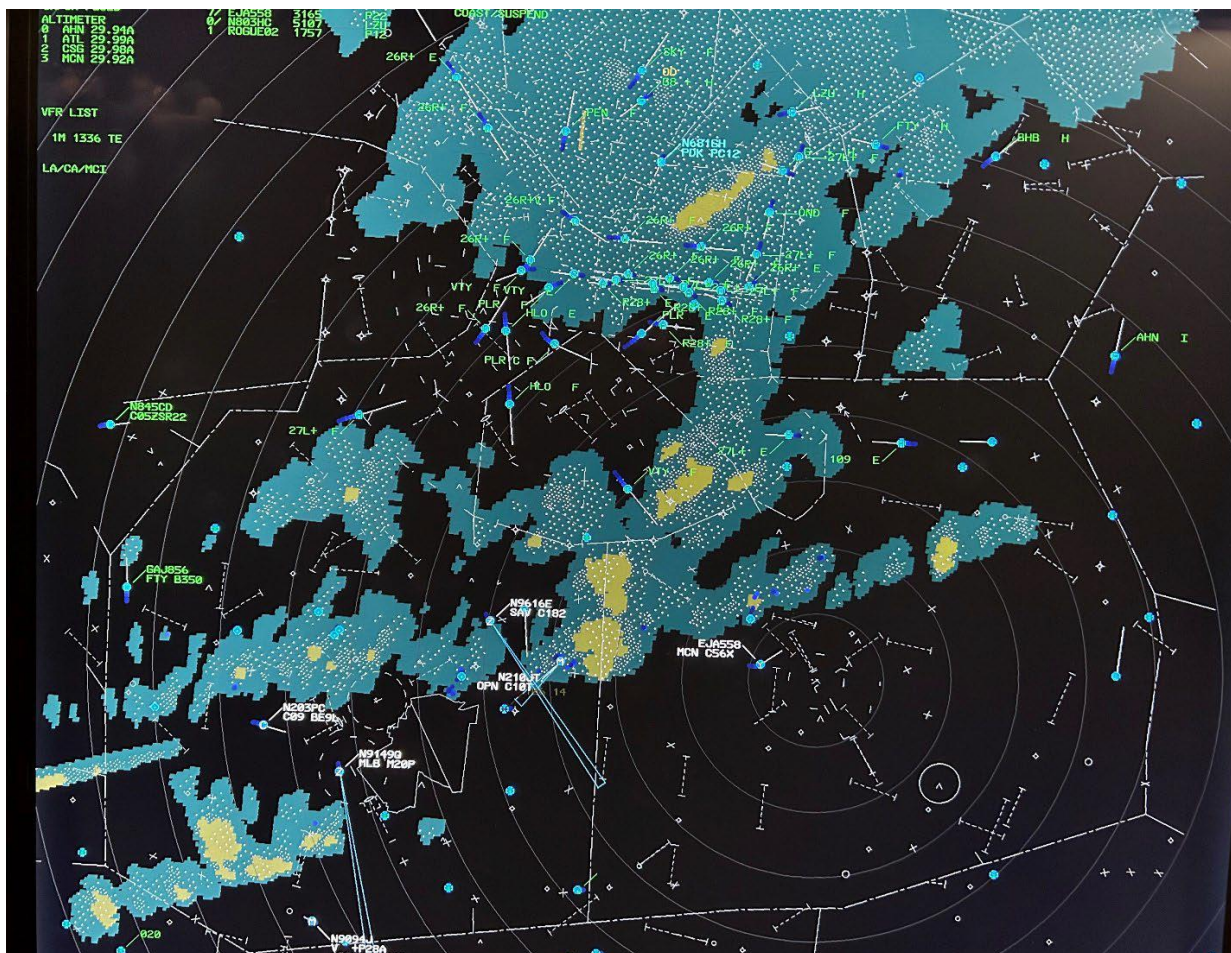
**Figure 8.** A80 STARS weather depiction from 1005. The accident aircraft is identified by "N210JT" located slightly below the center of the photo.

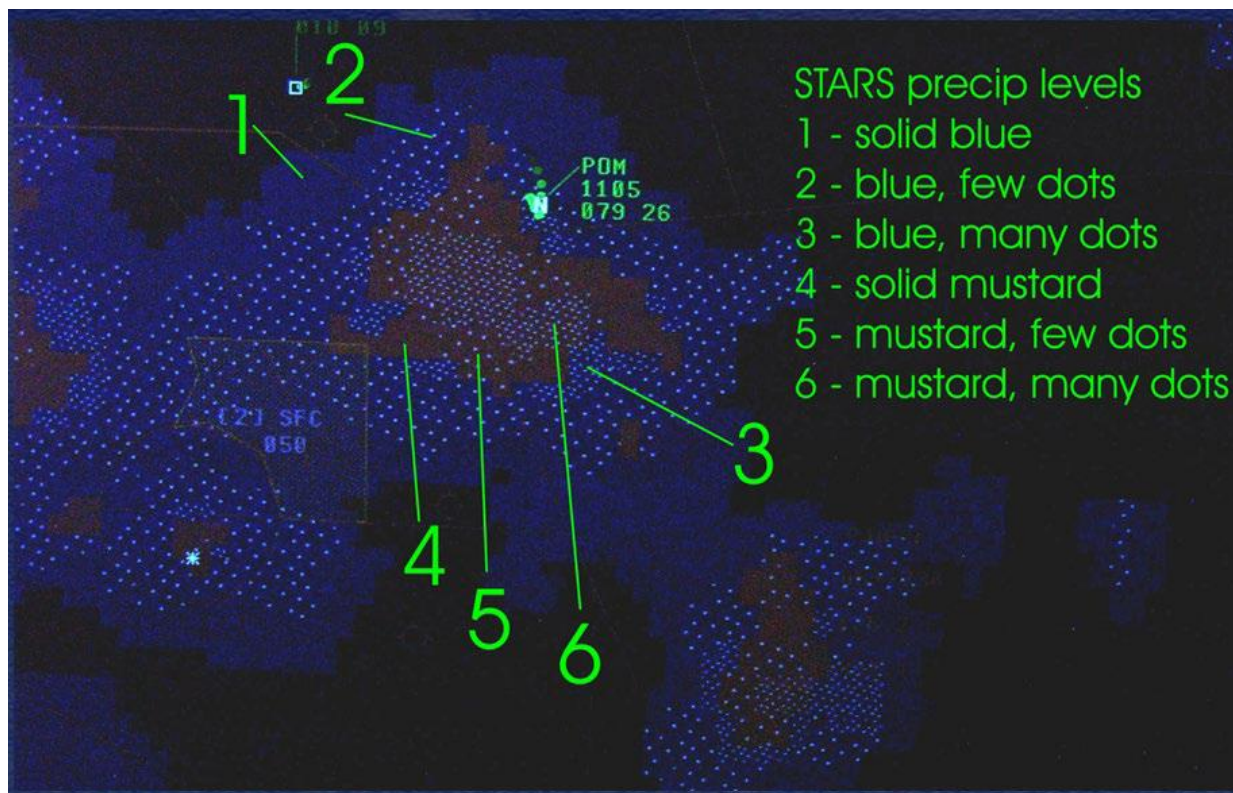
**Figure 9.** Example of the weather radar presentation in STARS.

The dBZ thresholds for the color scale (levels) presented in the STARS display are as follows (approximately):

- Level 1: 18 < 30 dBZ
- Level 2: 30 < 41 dBZ
- Level 3: 41 < 46 dBZ
- Level 4: 46 < 50 dBZ
- Level 5: 50 < 57 dBZ
- Level 6: 57+ dBZ
