# National Transportation Safety Board

ERA23FA352

## COMPUTED TOMOGRAPHY

Specialist's Factual Report

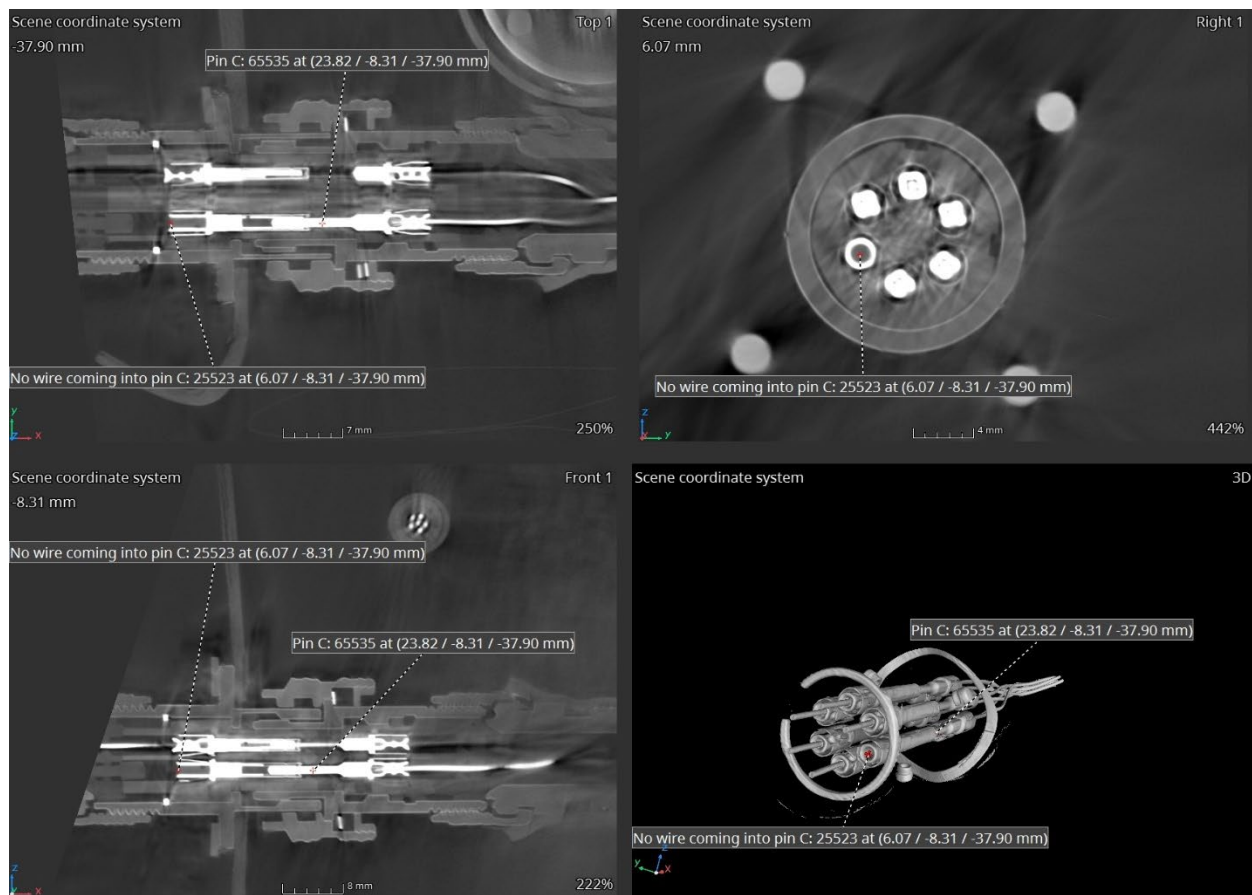
2. The pins of the electrical connector were seated properly. (Figures 10 - 18)
3. The helicopter wire for pin C was not present, as designed. (Figures 5 and 15)
4. The wires from the electrical connector to their terminations in the valve were intact and matched the electrical schematic. (Figures 19, 22, 23, 25, 26, 27, and 29).
5. Microswitch 1 was in the open position (contact between contacts "C" and "NC". Microswitch 2 was in the "closed" position (contact between contacts "C" and "NO". (Figure 21)
6. The drivetrain was intact with no anomalies observed (Figures 32 - 38)

**Figure 15.** Fuel shut-off valve – electrical connector – pin C. (225 kV)

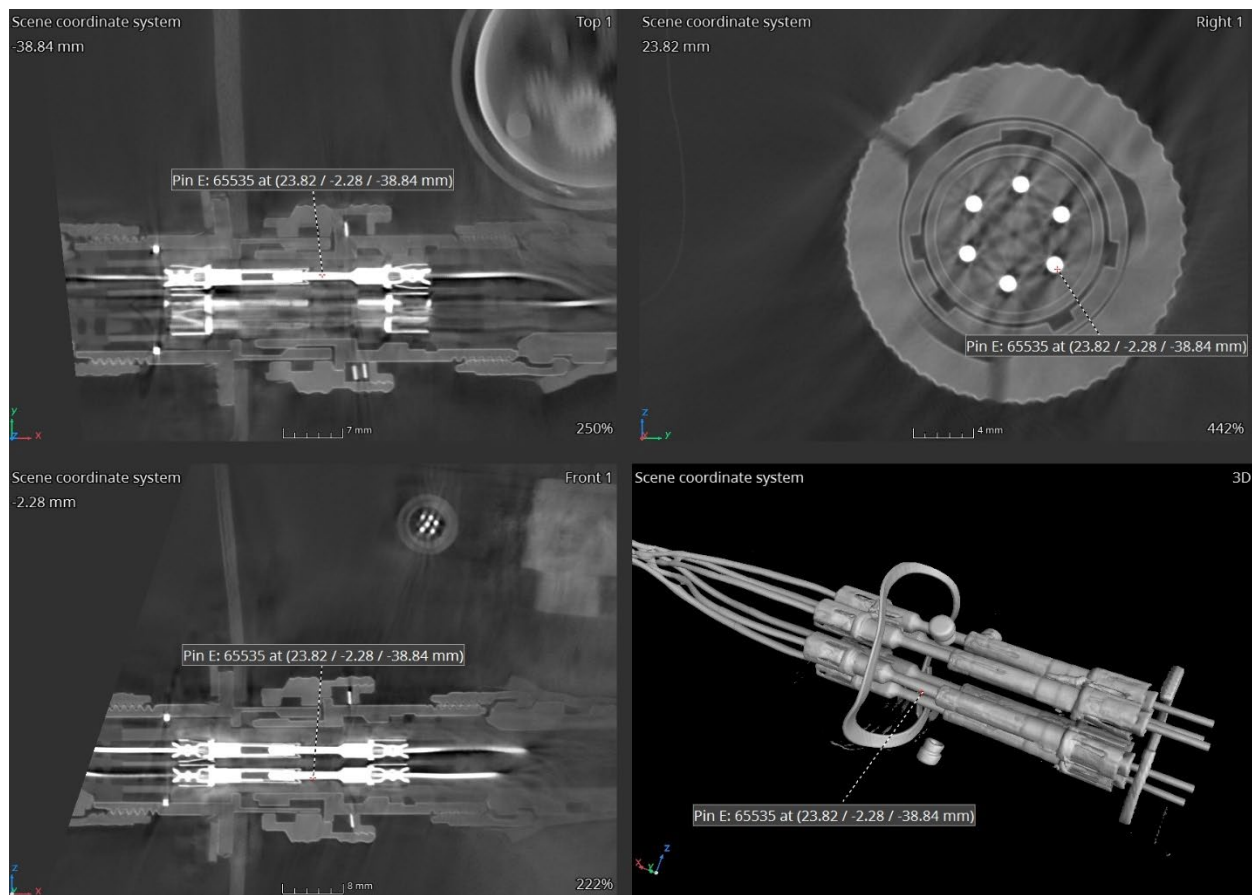
**Figure 17.** Fuel shut-off valve - electrical connector - pin E. (225 kV)

**Figure 18.** Fuel shut-off valve – electrical connector – pin F. (225 kV)
