# National Transportation Safety Board

ERA23FA358

## **ELECTRONIC DEVICES**

Location: Toms River, New Jersey  
Date: September 2, 2023  
Time: 22:18 eastern daylight time (EDT)  
Airplane: Cirrus SR-20, N420PB, Private

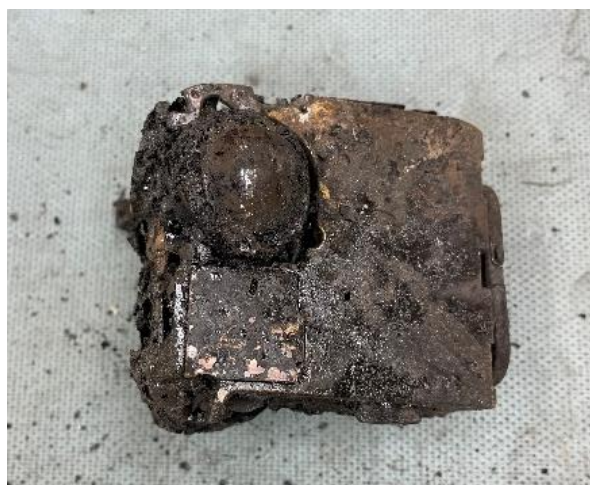
The GoPro Hero (Device 1) sustained extreme fire and impact damage; it is shown in Figure 1. The area in which the memory card was mounted was identified. The memory card was located, shown in Figure 2 (circled in red). The remnants of the memory card were fused to the battery, the entire structure was ashen and brittle. The remnants of the memory card could not be isolated and removed due to the brittle nature of the structure. In this condition, the card likely had extreme damage to its internal silicon structure. This structure needs to be undamaged, or data recovery is impossible. No data was recovered from the device.

**Figure 1.** The GoPro Hero (Device 1), as received from the wreckage site. No data was recovered from the device.

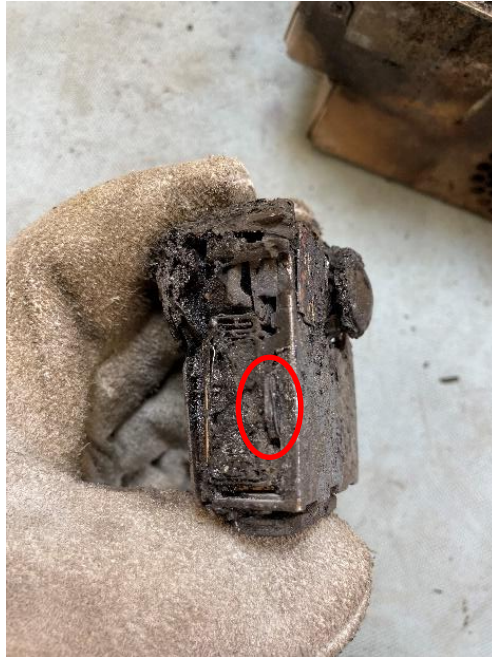
**Figure 2.** Device's internal memory unit (red box).

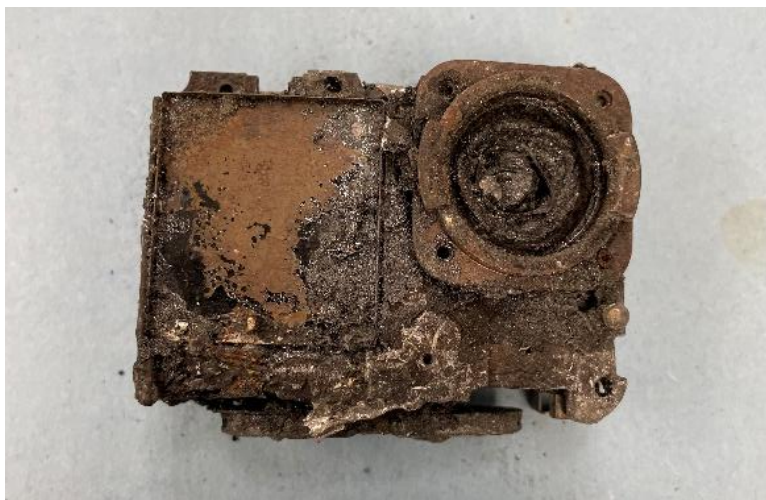
The GoPro-Like Hero (Device 2) sustained extreme fire and impact damage, as shown in Figure 3. The area in which the memory card was mounted was identified. The memory card was located, shown in Figure 4 (circled in red). The remnants of the memory card were fused to the battery, the entire structure was ashen and brittle. The remnants of the memory card could not be isolated and removed due to the brittle nature of the structure. In this condition, the card likely had extreme damage to its internal silicon structure. This structure needs to be undamaged, or data recovery is not possible. No data was recovered from the device.

**Figure 3.** The GoPro Hero (Device 2), as received from the wreckage site.

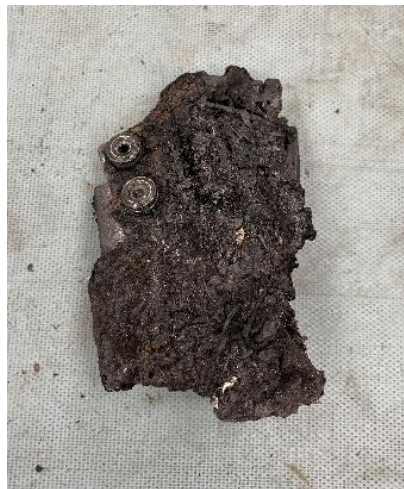
The Android phone sustained extreme fire and impact damage as result of the accident and post-crash fire. The extent of the damage is shown in figure 5. No data was recovered from the device.

**Figure 5.** The Android phone, as received from the wreckage site.

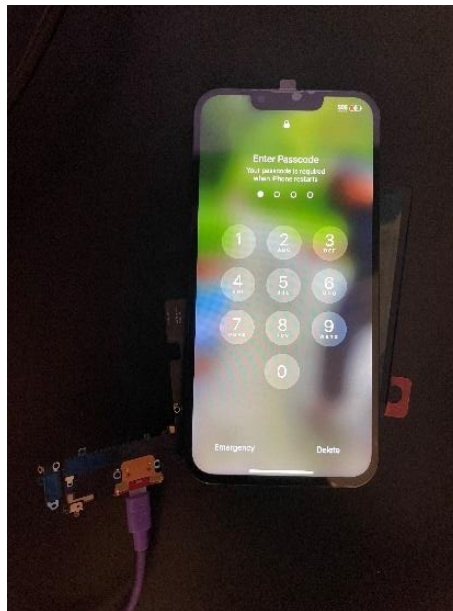
family member provided a number of potential passcodes, but none of the supplied passcodes unlocked the phone. No data was recovered from the iPhone.

**Figure 7.** The Apple iPhone in a functional state after repair. The passcode was unable to be obtained and no data was recovered.

The Apple iPhone sustained significant fire and impact damage. The extent of the damage is shown in Figure 6. The iPhone was repaired by swapping the main board to the surrogate device. The iPhone was powered successfully but was locked with a 4 digit passcode. The phone is shown in an operational state in Figure 7. A

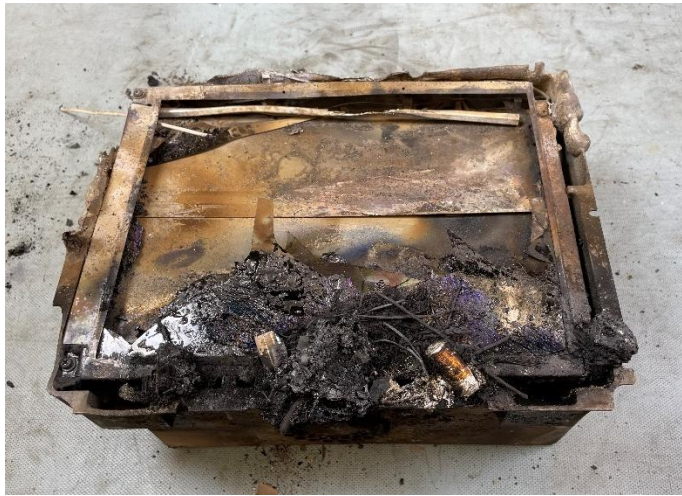
This aircraft was equipped with an Avidyne MFD, but not an accompanying Avidyne PFD. This type of equipment was standard in early model Cirrus aircraft. The Avidyne MFD sustained extreme fire and impact damage as result of the accident and post-crash fire. The Avidyne MFD is shown in Figure 8, as received from the wreckage site. The area of the unit that contained the CF card is circled in red in Figure 9. The CF card was destroyed. No data was recovered from the device.

**Figure 8.** The Avidyne MFD, as received from the wreckage site.

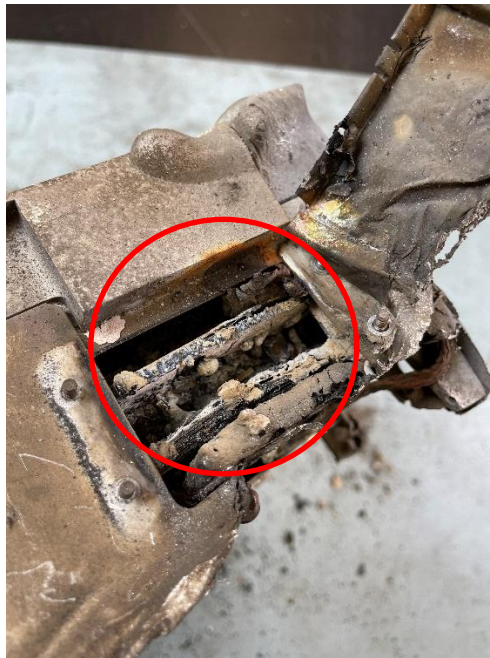
**Figure 9.** The Avidyne MFD CF card location. The CF card is circled in red. The CF card was destroyed.
