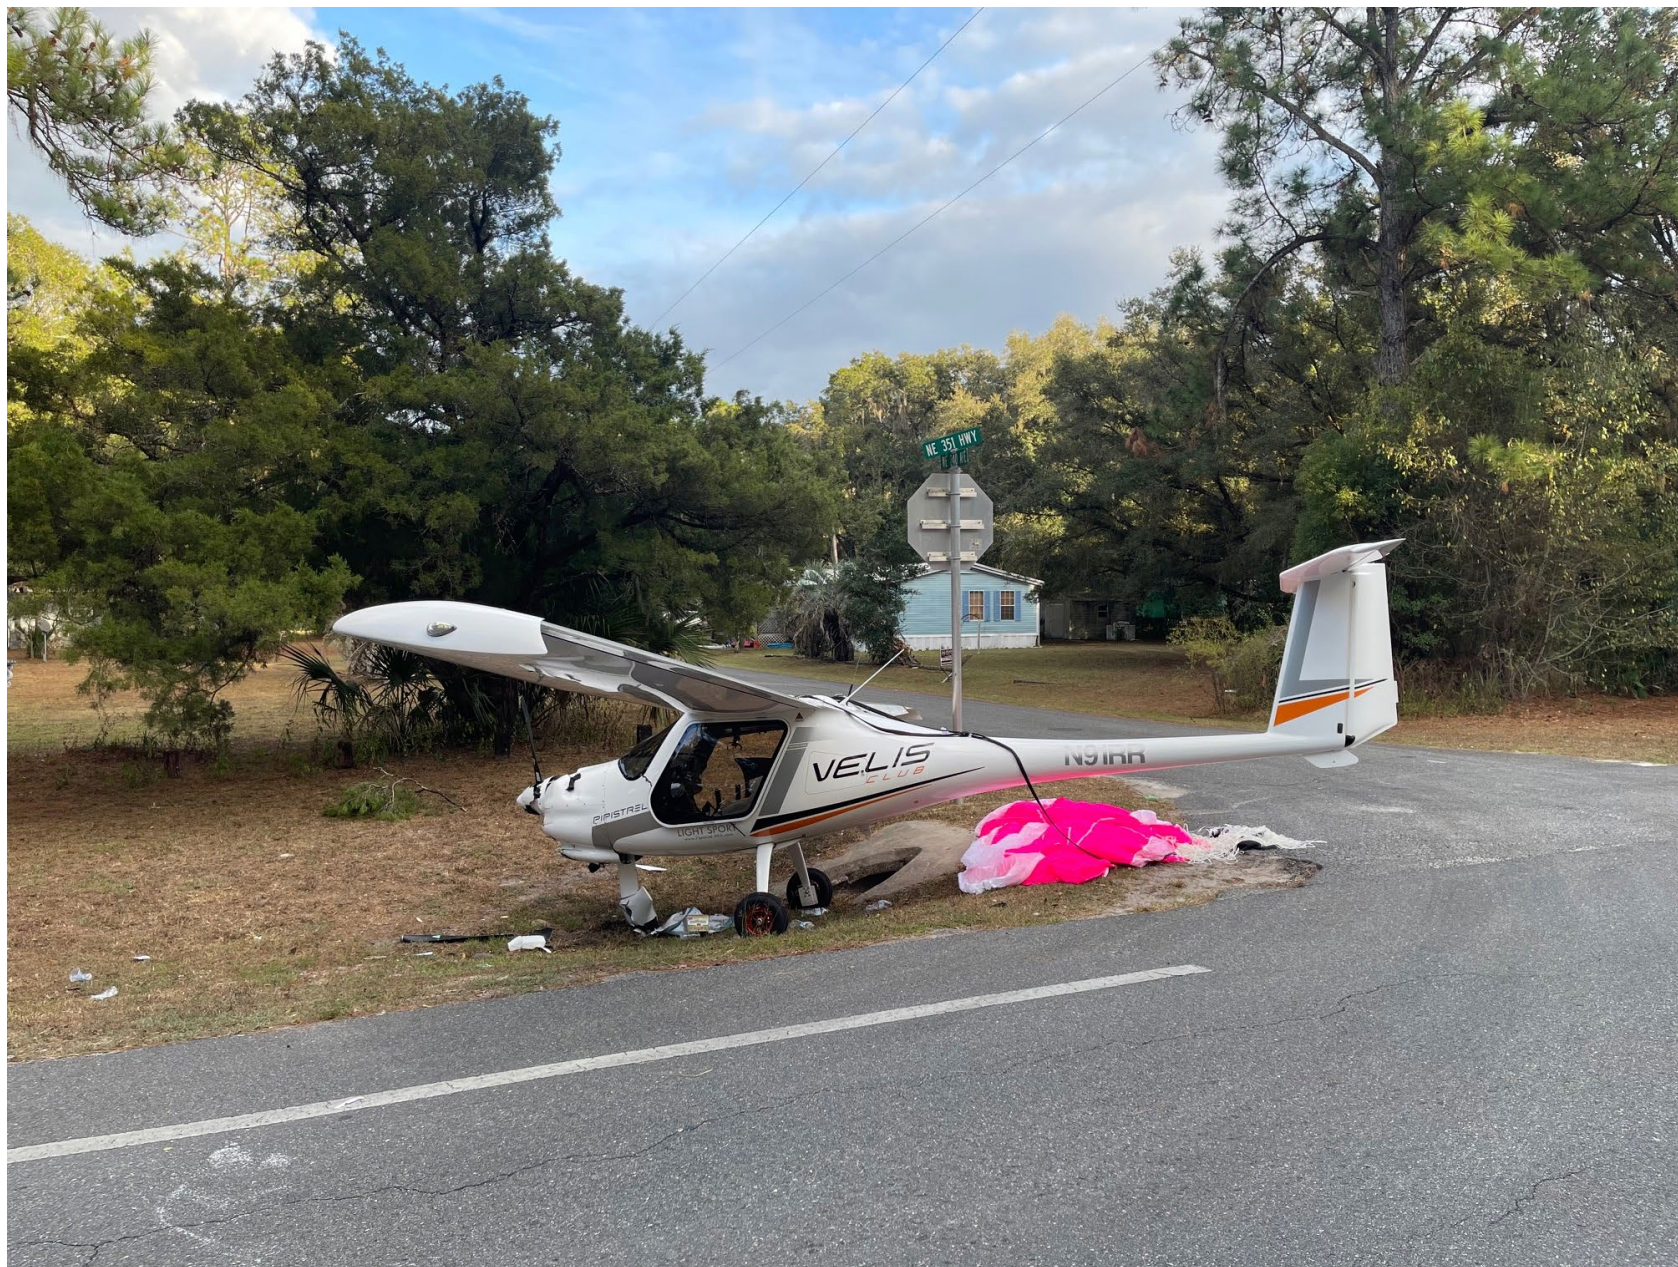
**Photo 1 – Accident Site (FAA Photo)**

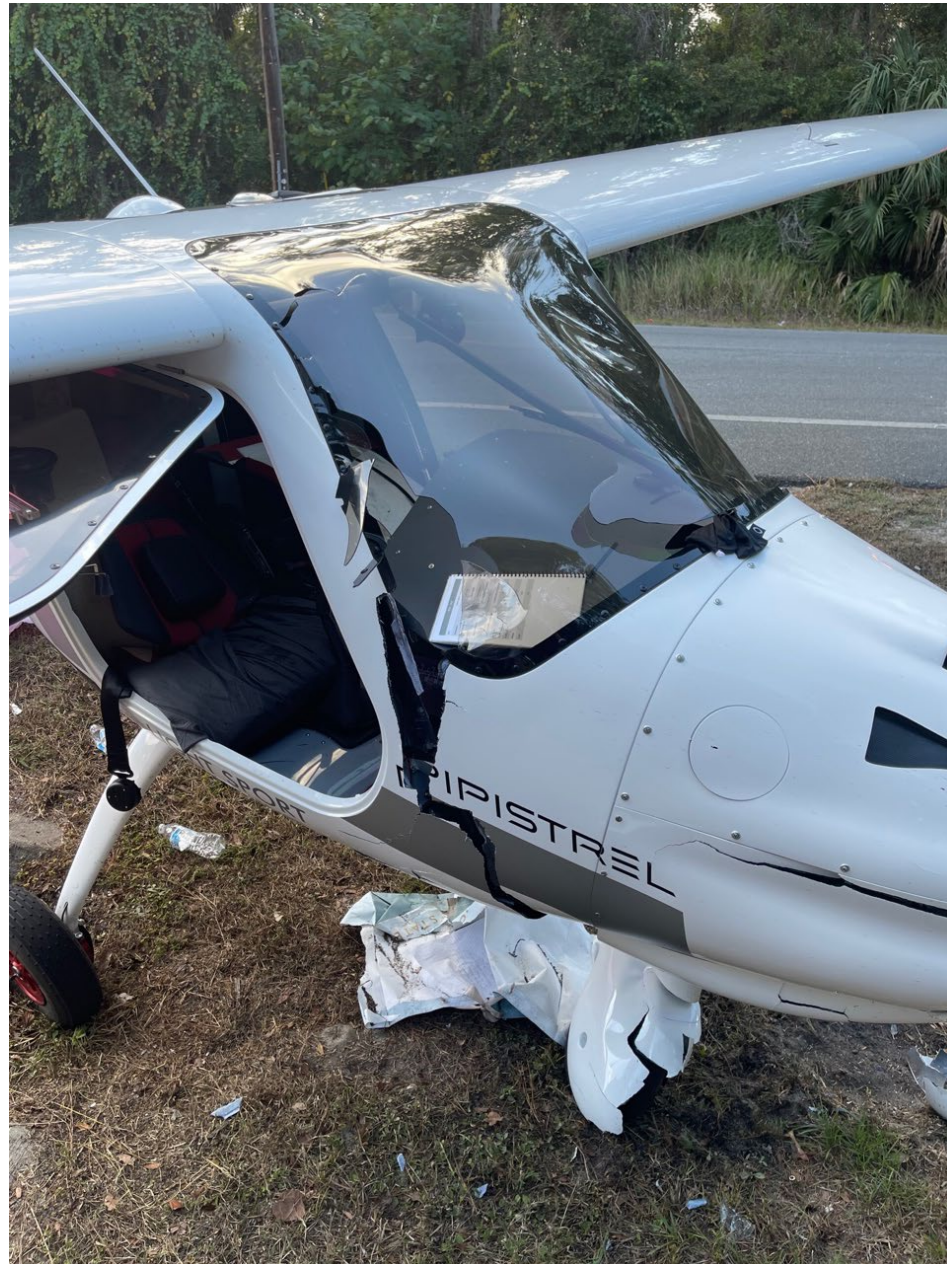
**Photo 2 - Fuselage Damage (FAA Photo)**

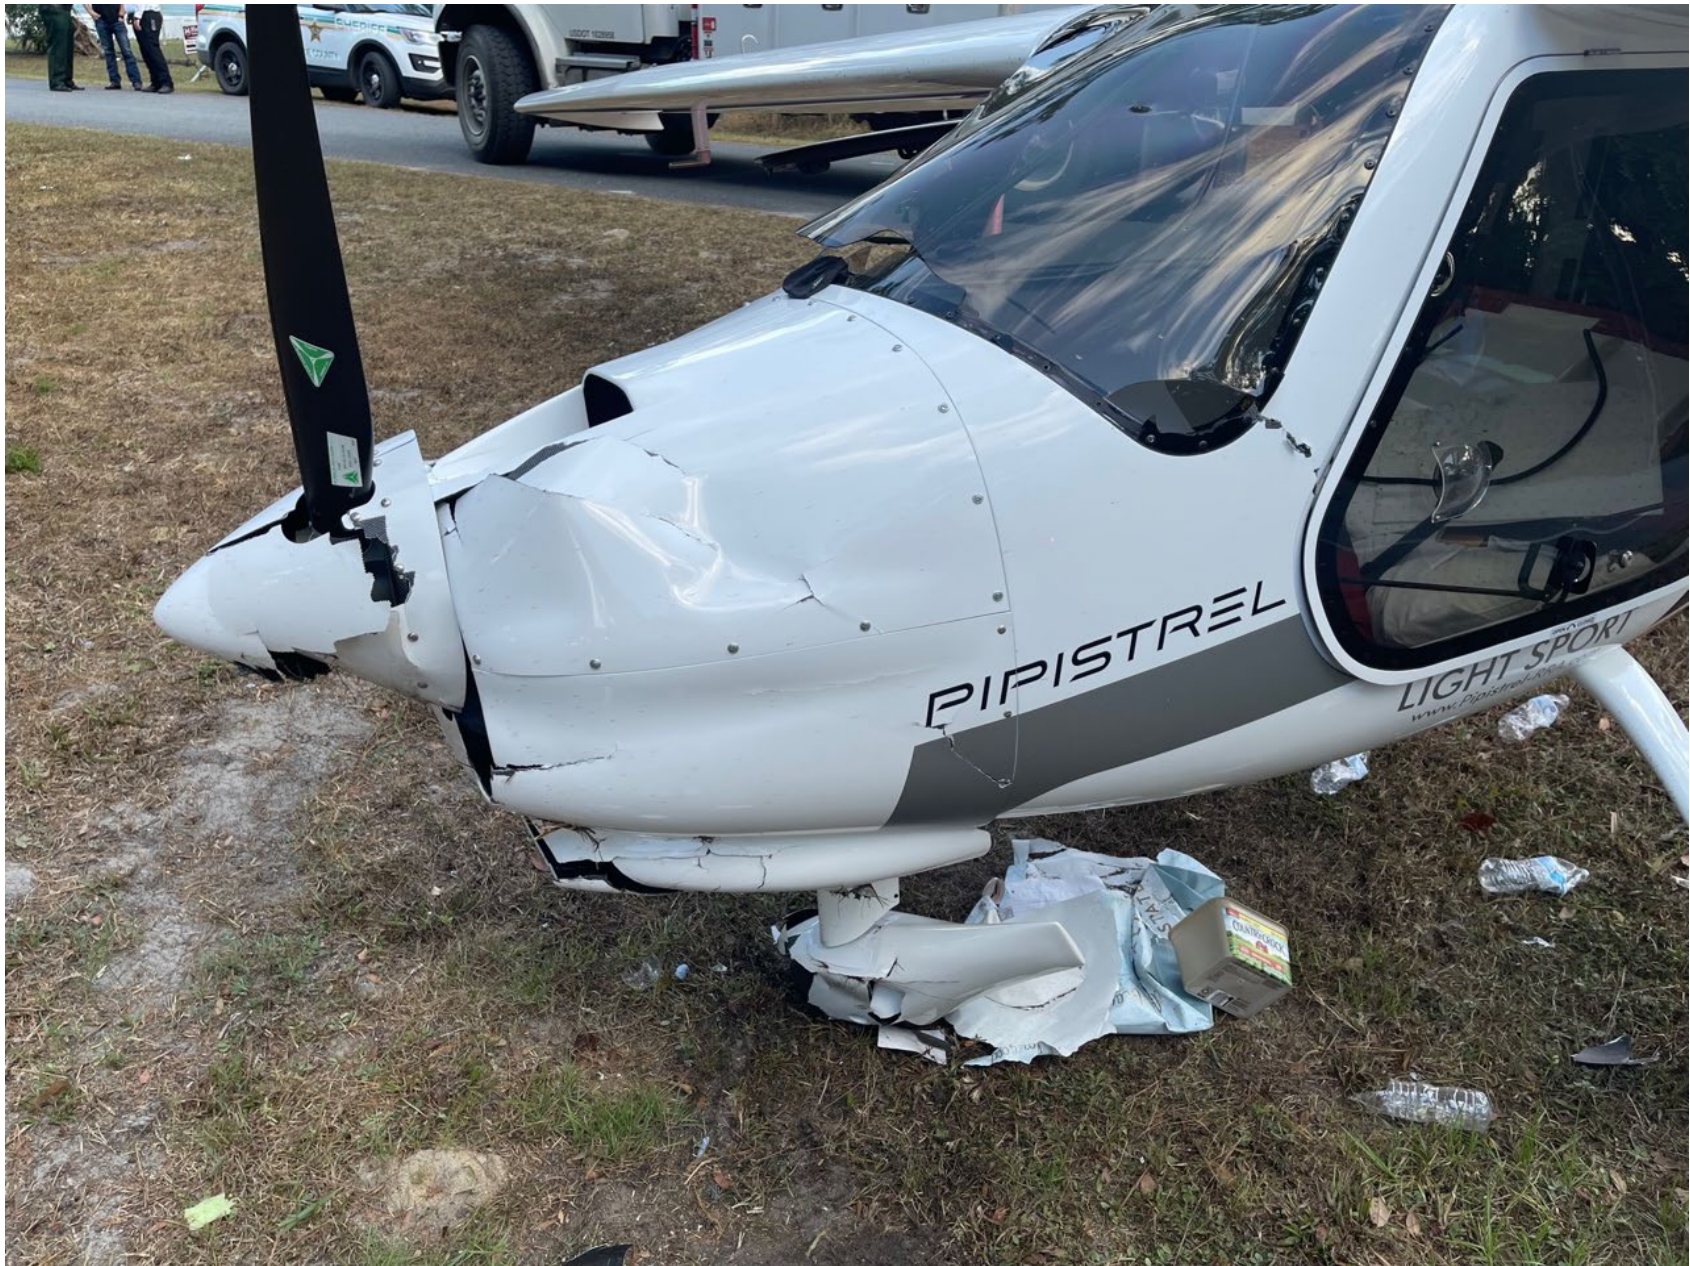
**Photo 3 – Fuselage Damage (FAA Photo)**

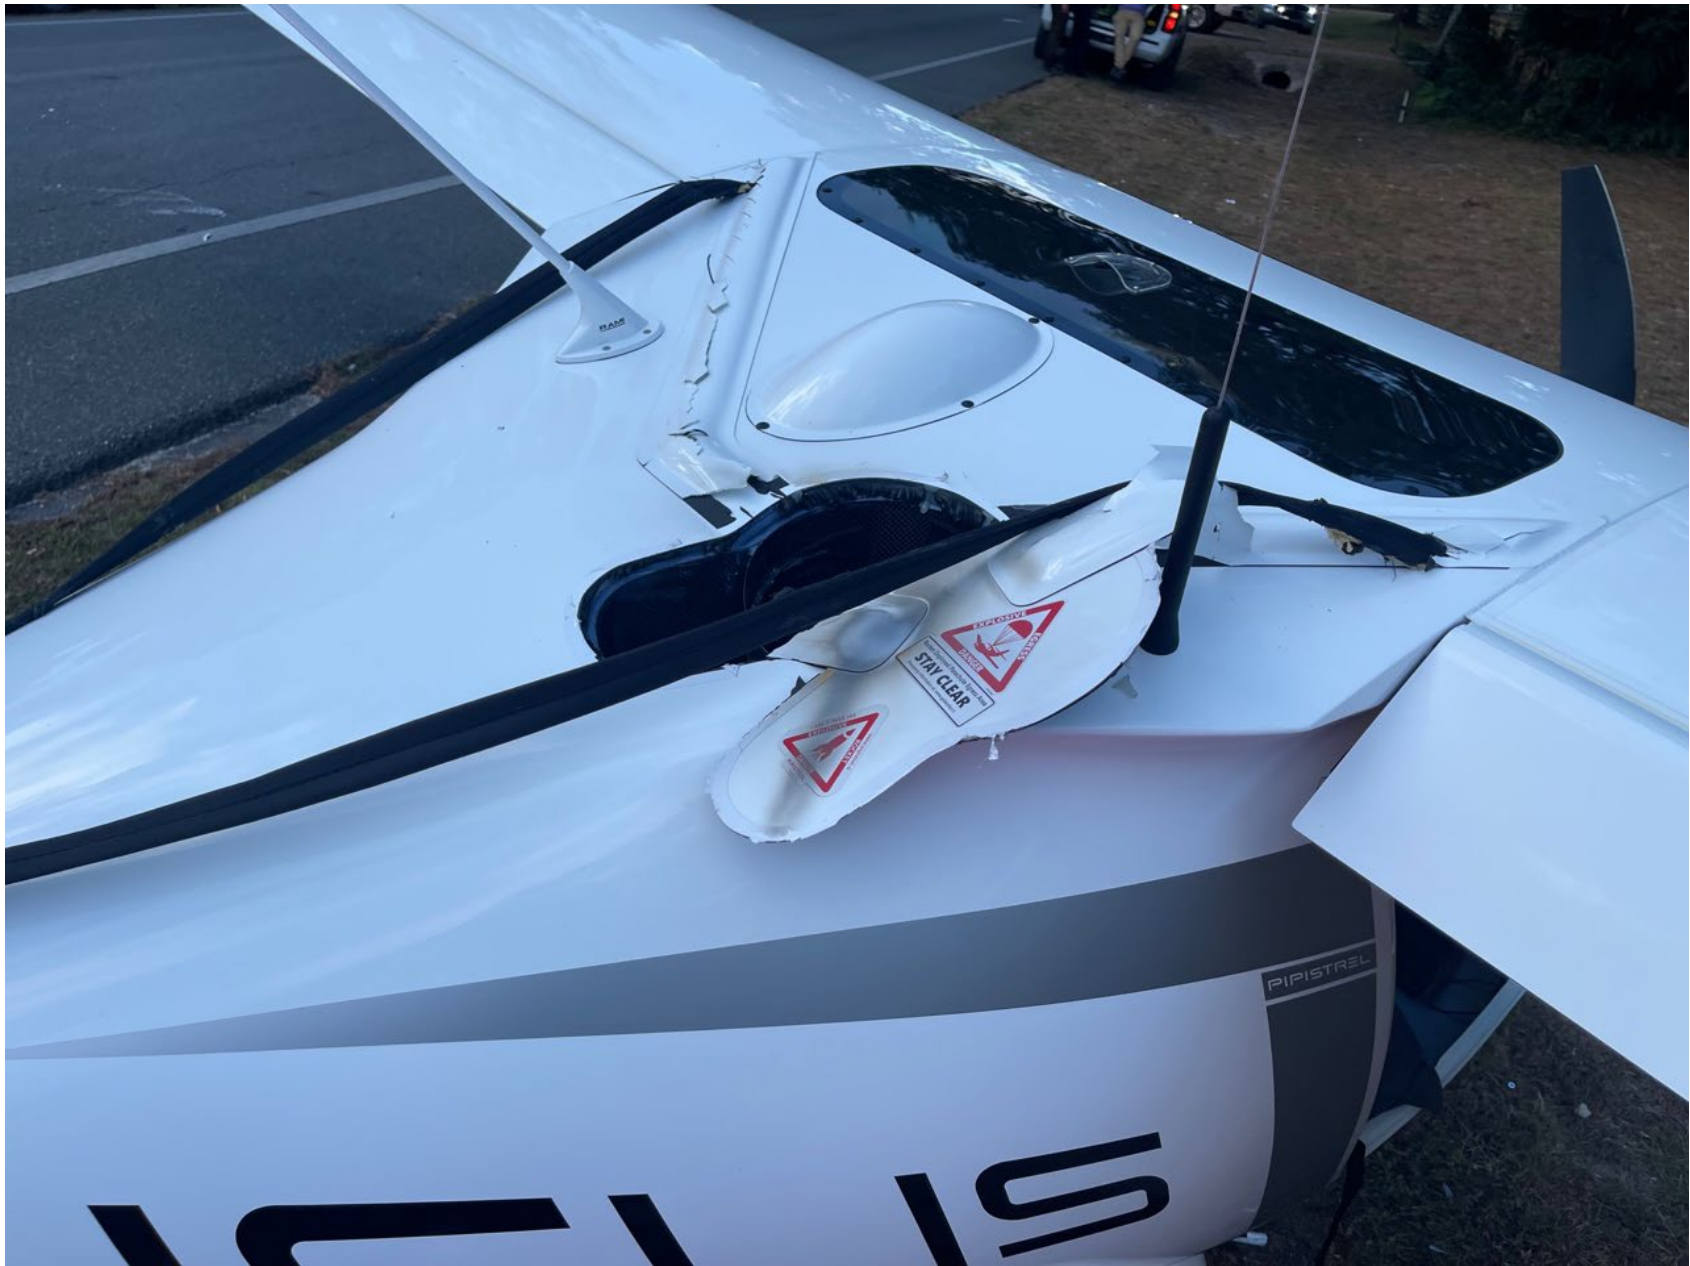
**Photo 4 - Airframe Parachute Compartment and Mount (FAA Photo)**

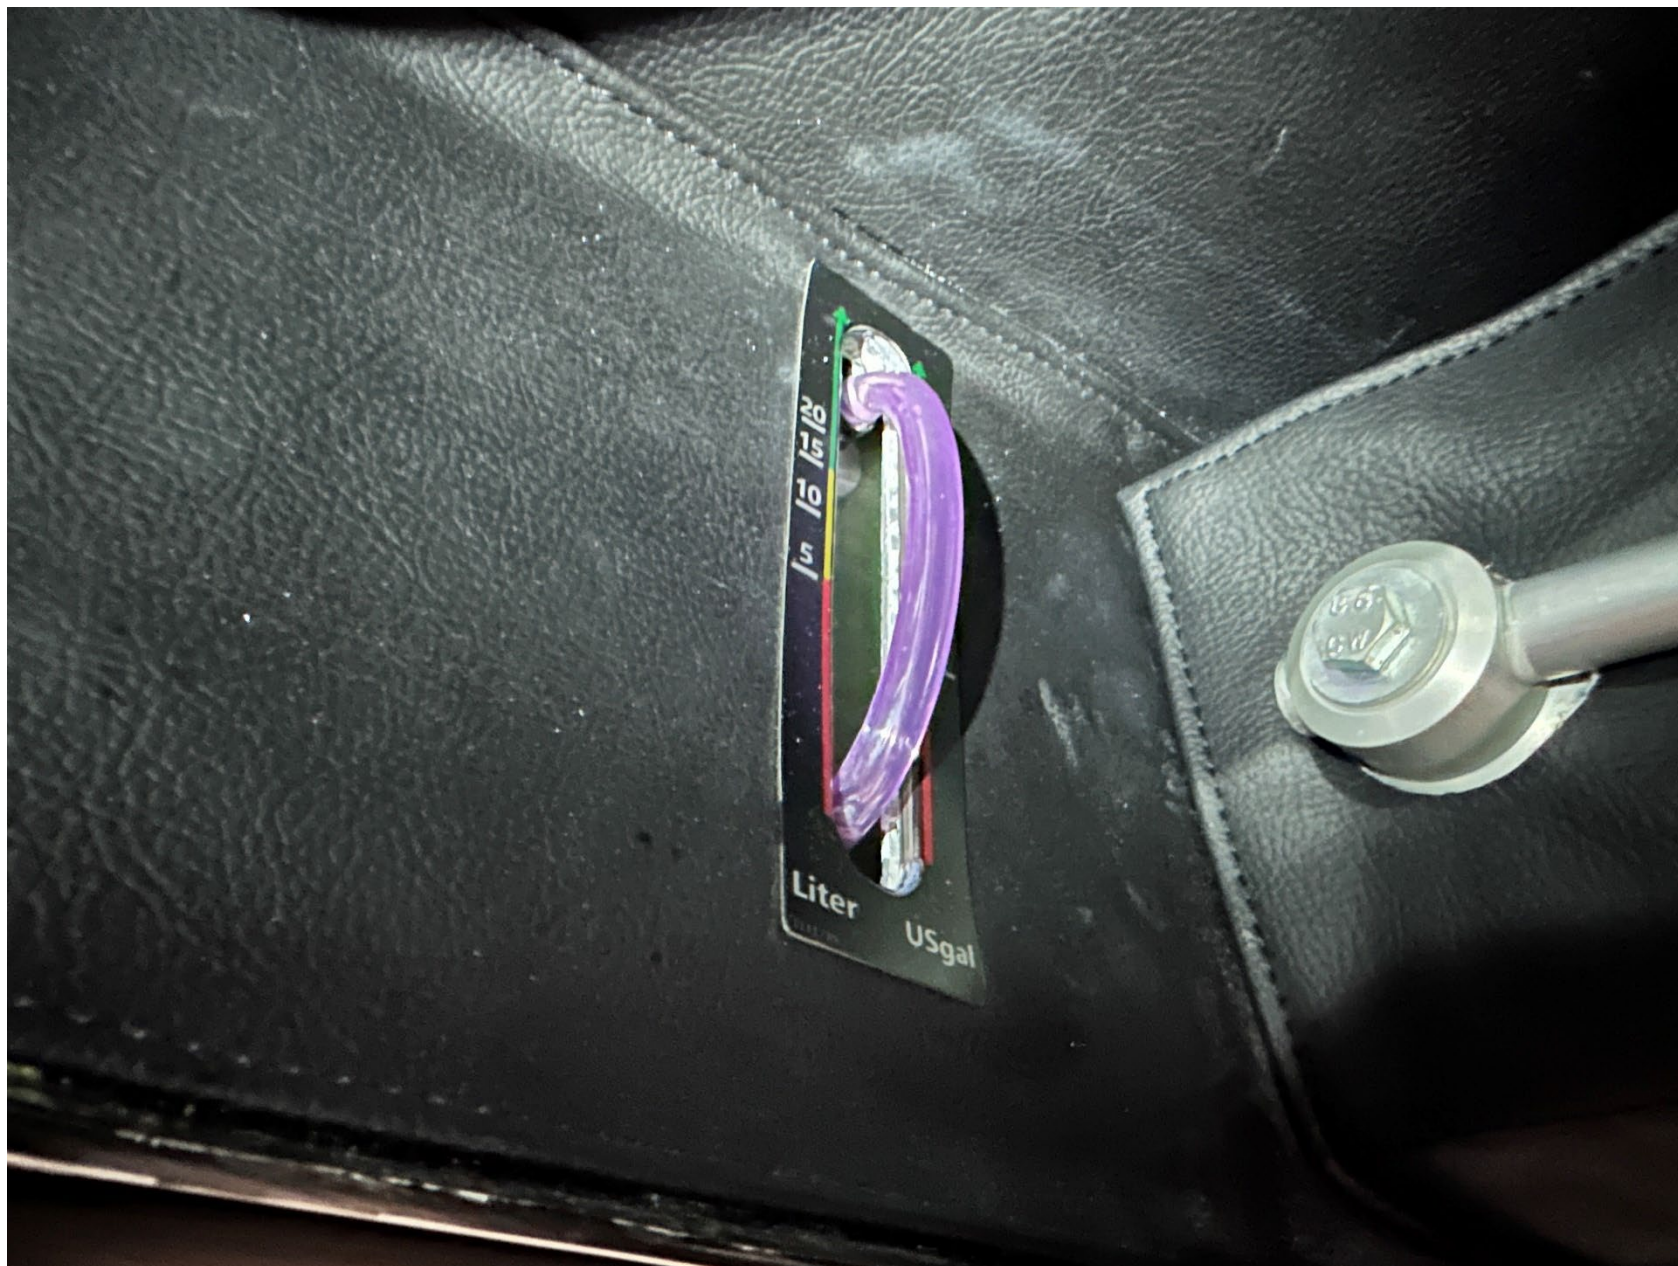
**Photo 5 – Fuel Gauge Showing No Fuel (Right Rudder Aviation Photo)**

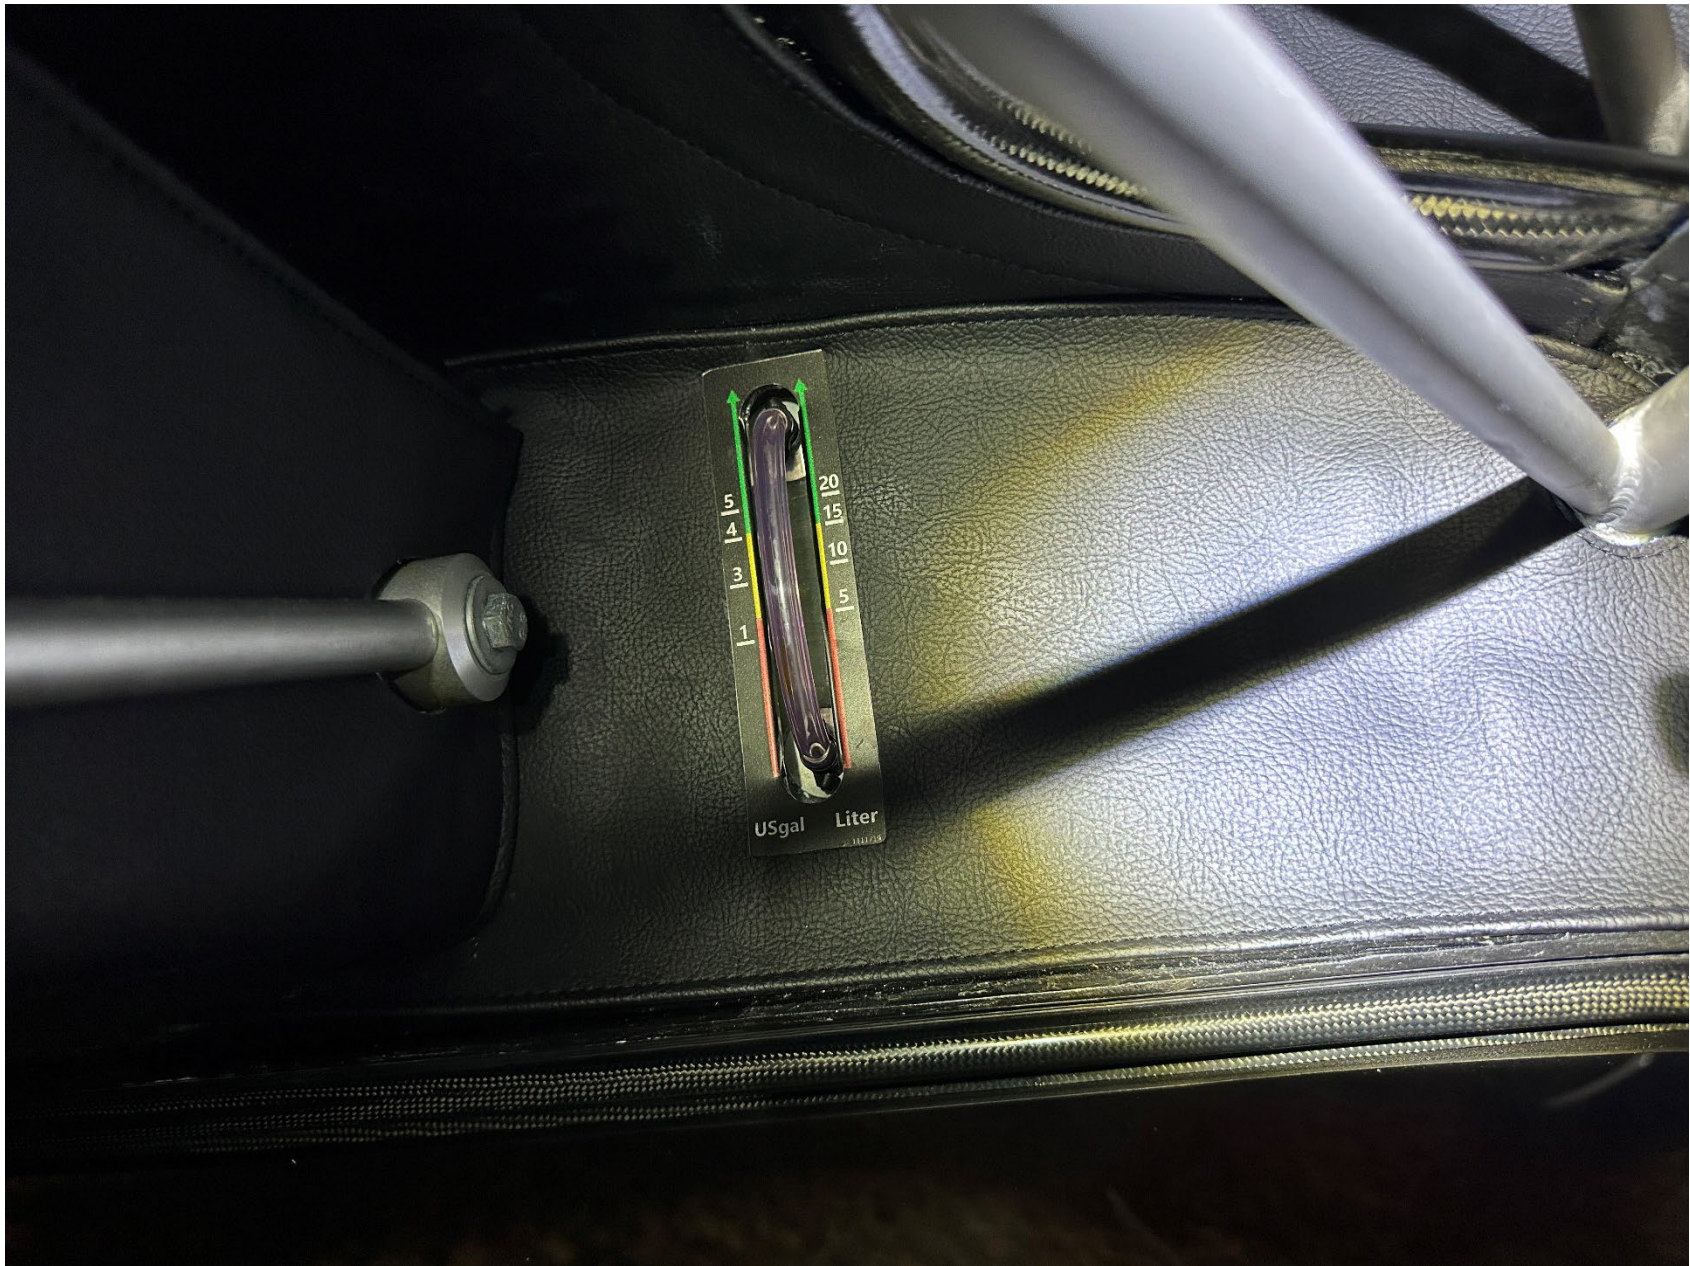
**Photo 6 – Fuel Gauge Showing No Fuel (Right Rudder Aviation Photo)**

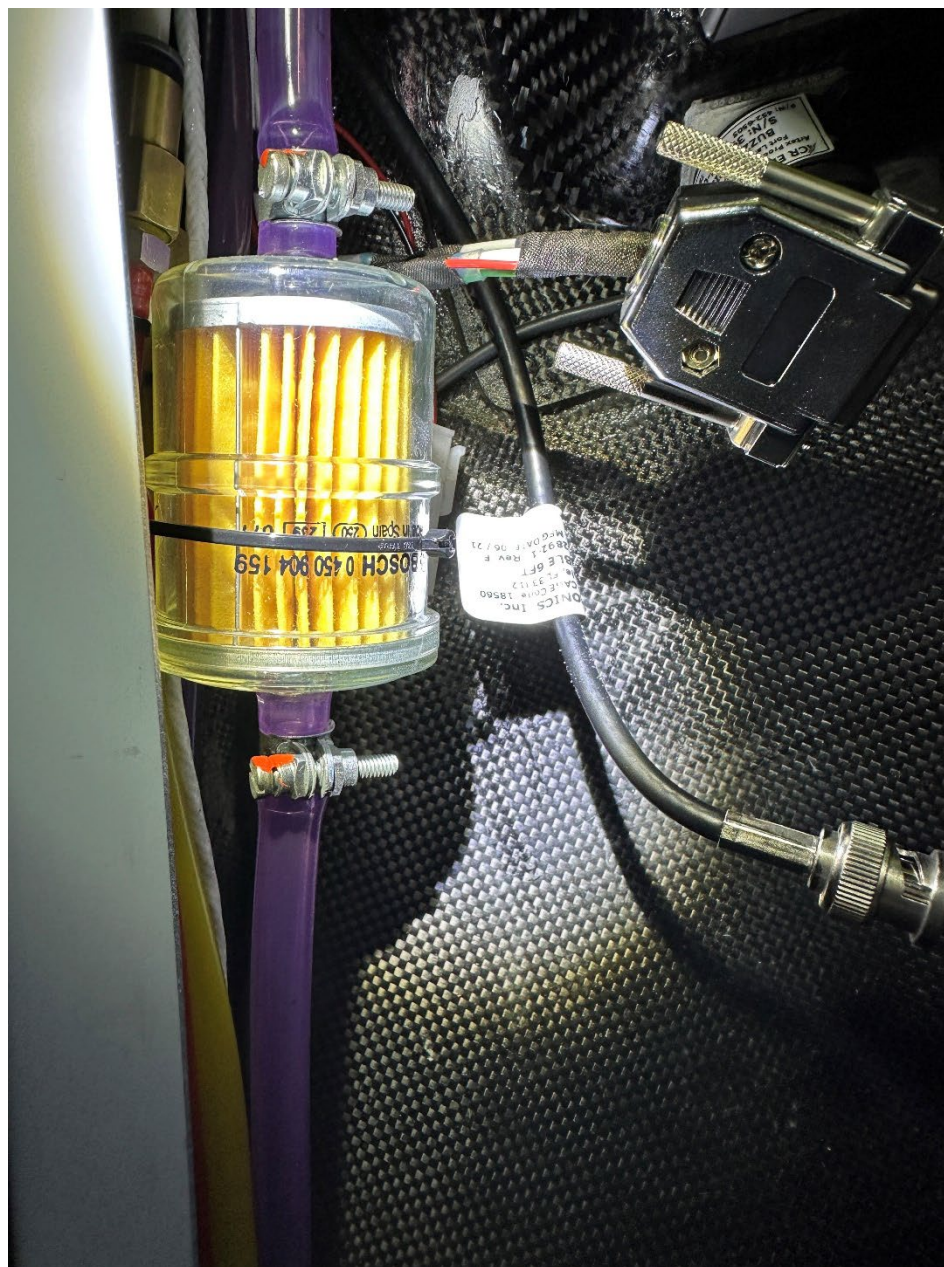
**Photo 7 – In Line Fuel Filter Showing No Fuel (Right Rudder Aviation Photo)**

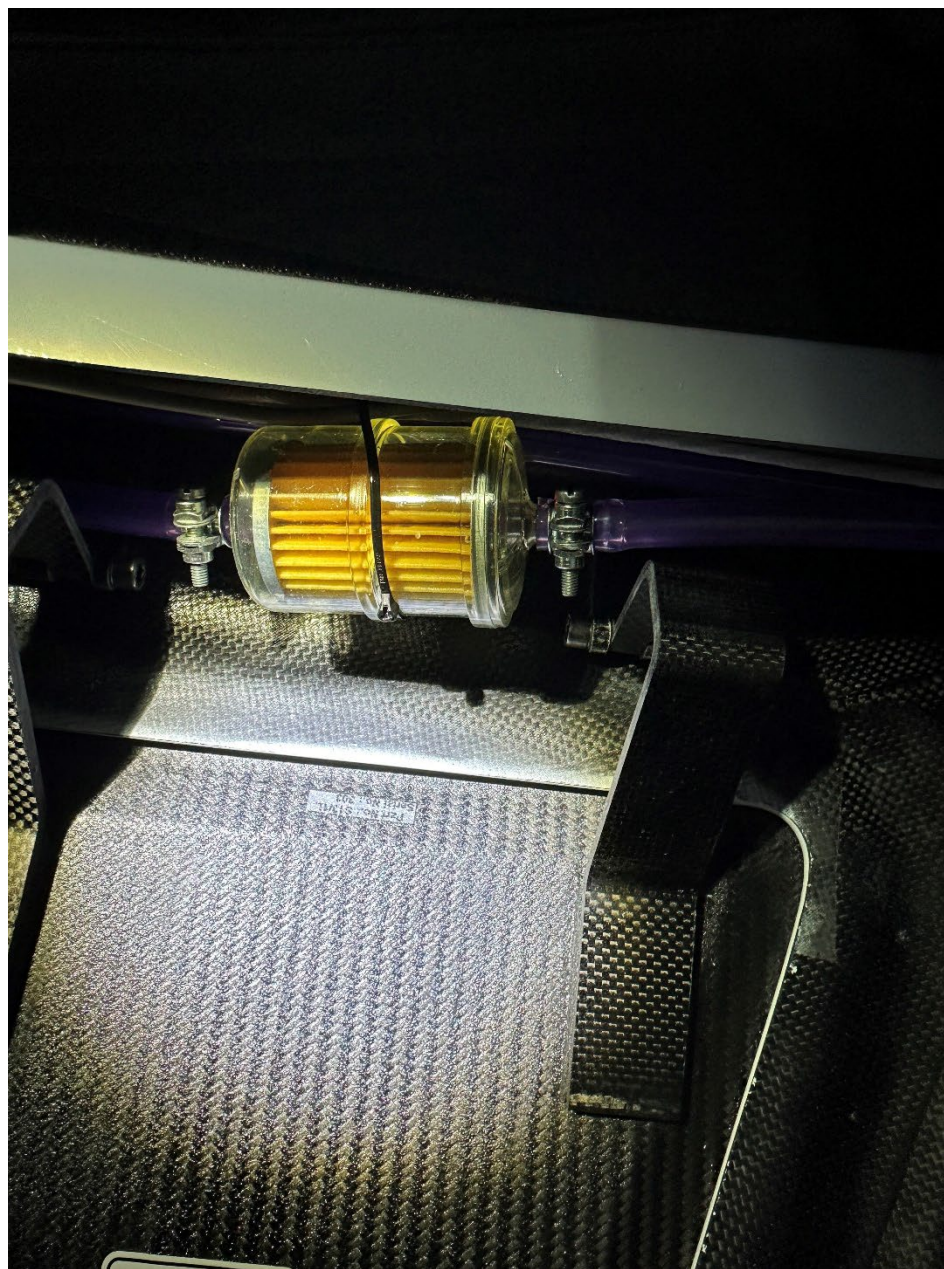
**Photo 8 – In Line Fuel Filter Showing No Fuel (Right Rudder Aviation Photo)**
