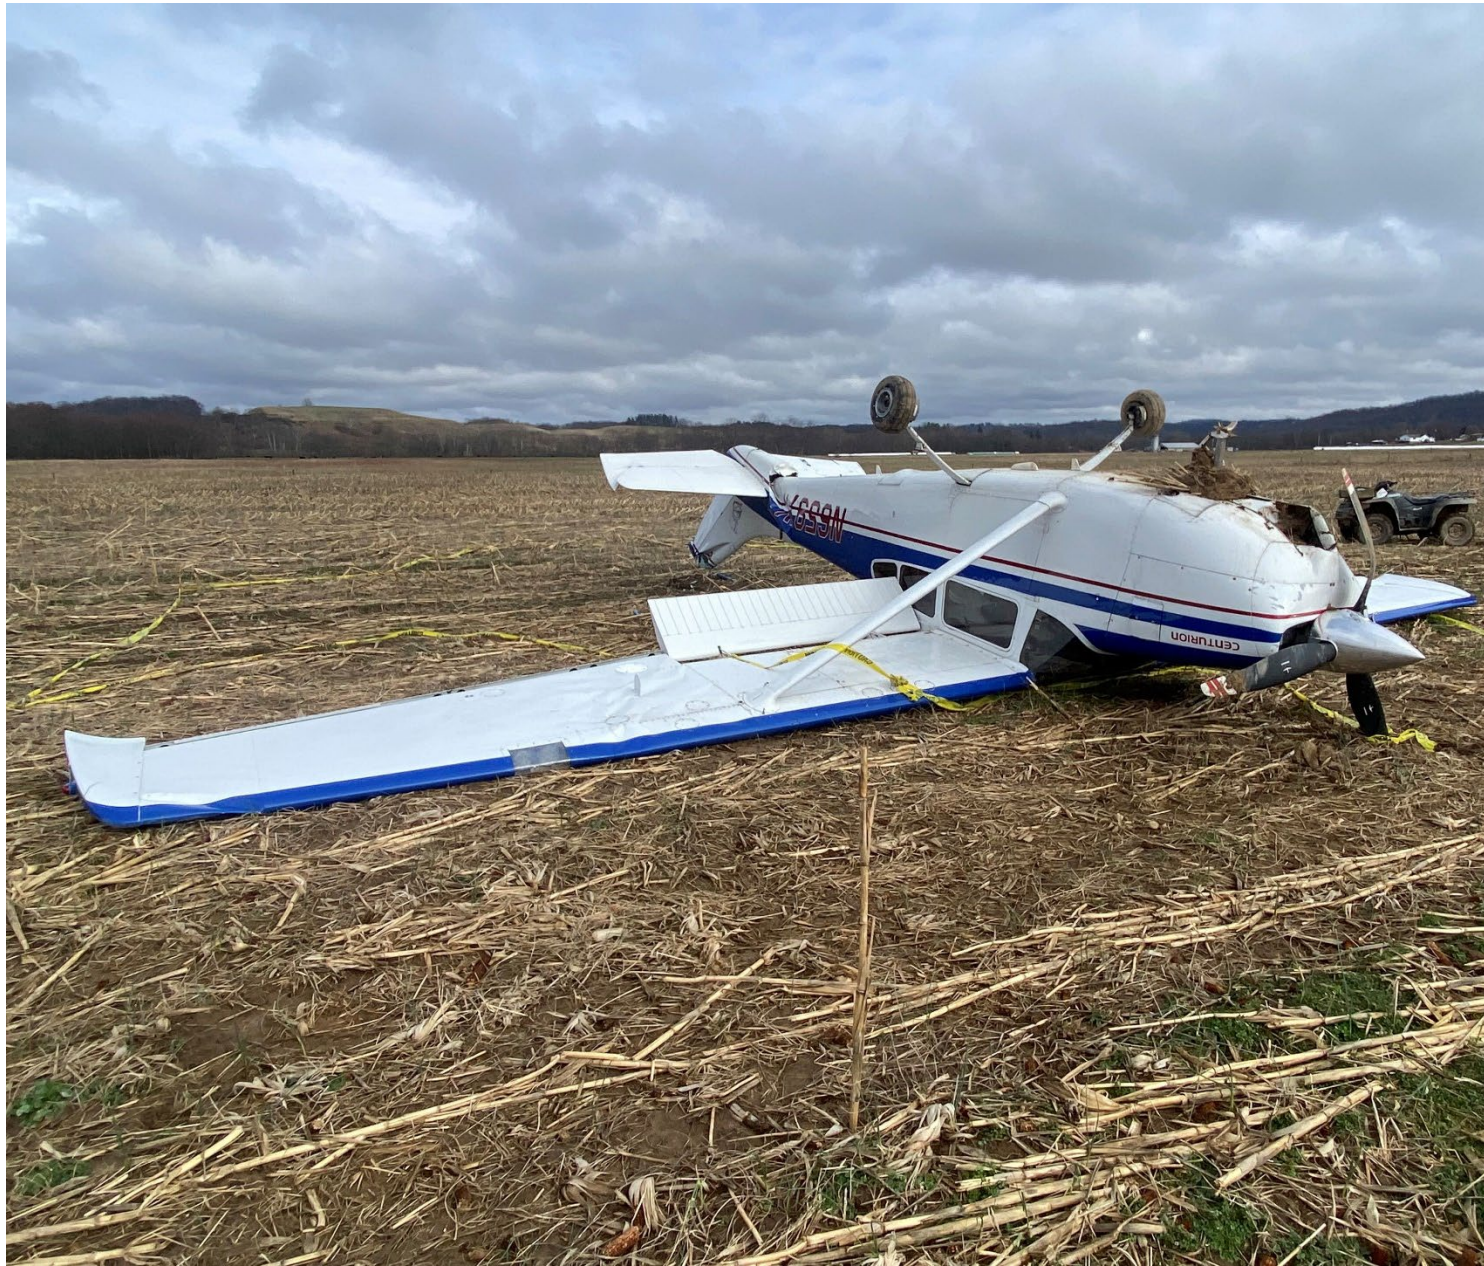
**Photo 1 – AMF Aviation Digital Photograph. Left Forward Quartering View of the Inverted Airplane at the Accident Site. Note the Compression Wrinkles in the Lower Skin of the Left Wing Outboard of the Lift Strut.**

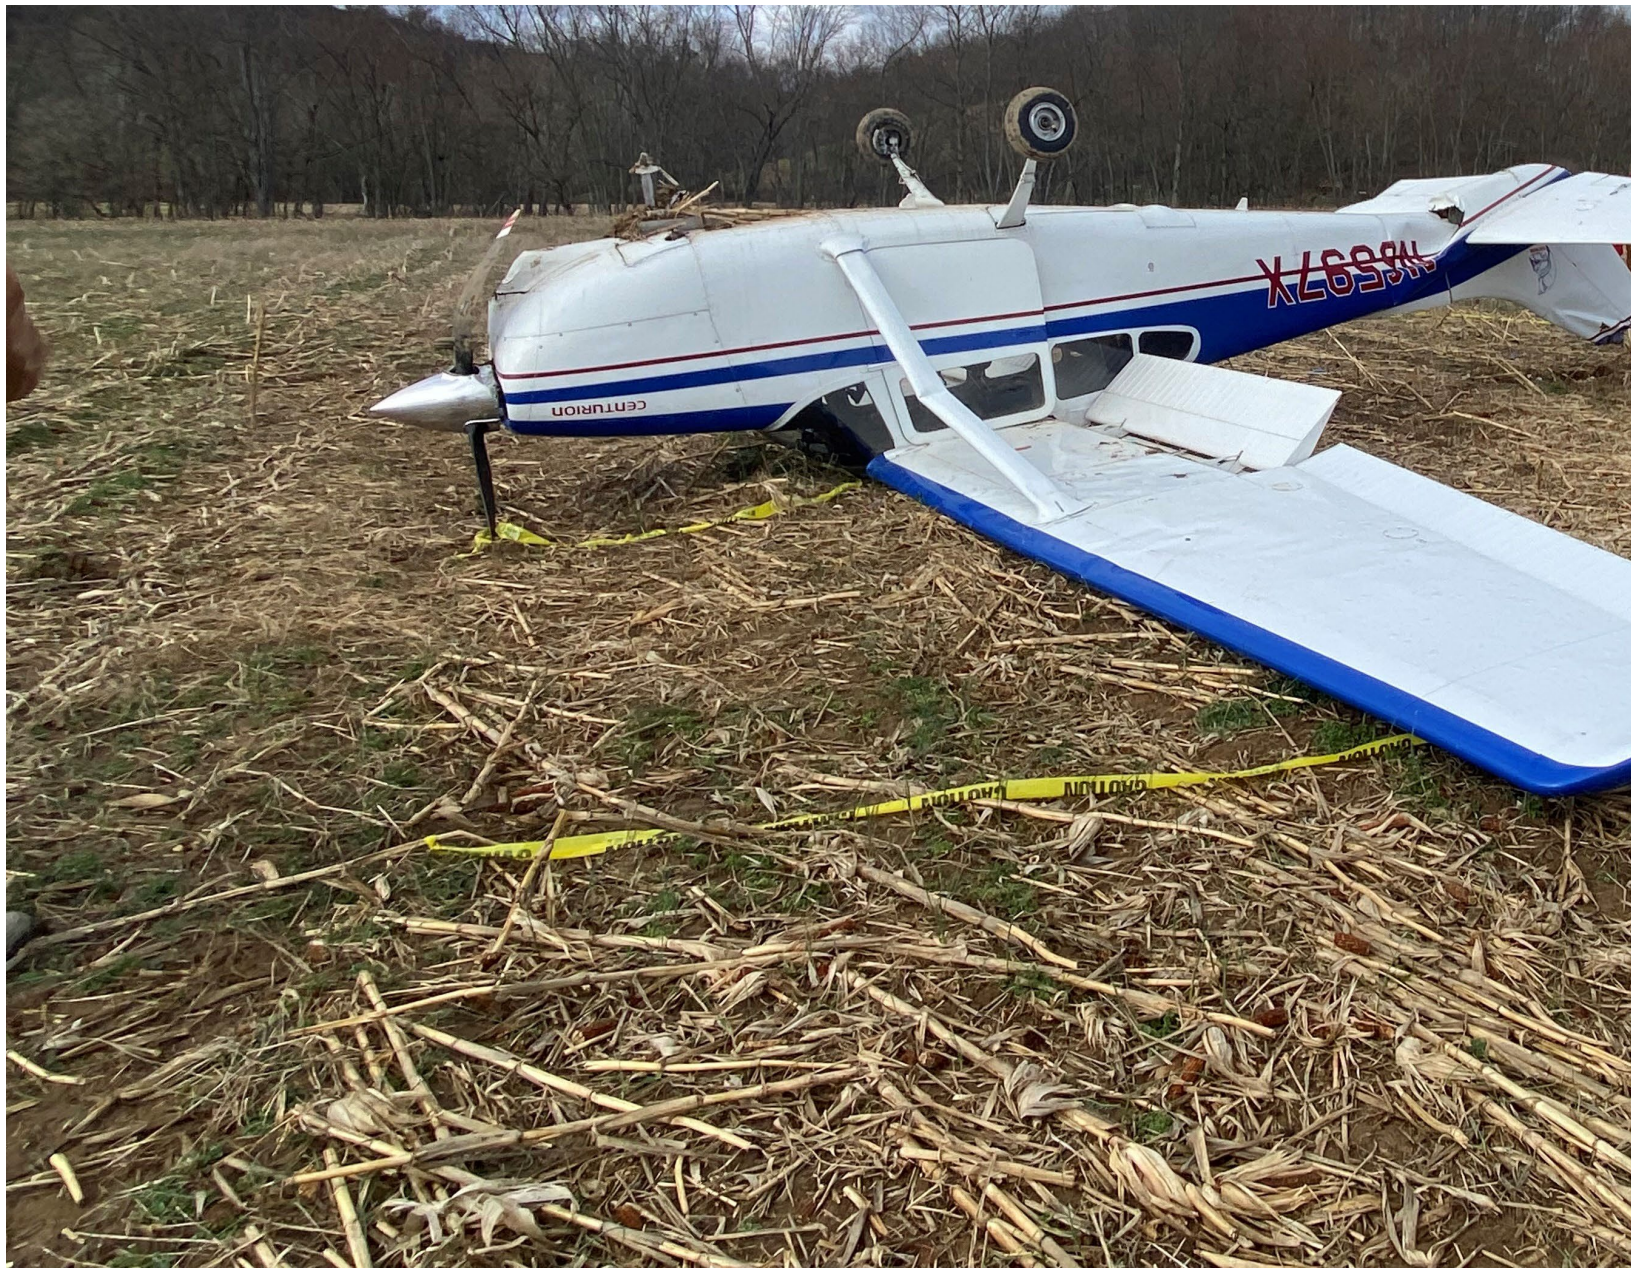
**Photo 2 - AMF Aviation Digital Photograph. Right Side View of the Inverted Airplane at the Accident Site. Note the Damage to the Right Lift Strut, Compression Wrinkles in the Right Wing Lower Skin, and Damage to the Aft Fuselage.**
