# National Transportation Safety Board

ERA23LA293

## **GLOBAL POSITIONING SYSTEM DEVICE**

Location: Waldorf, Maryland  
Date: July 9, 2023  
Time: 1027 eastern daylight time (EDT)  
1427 coordinated universal time (UTC)  
Helicopter: Hughes 369D, Haverfield International Inc, N5027P

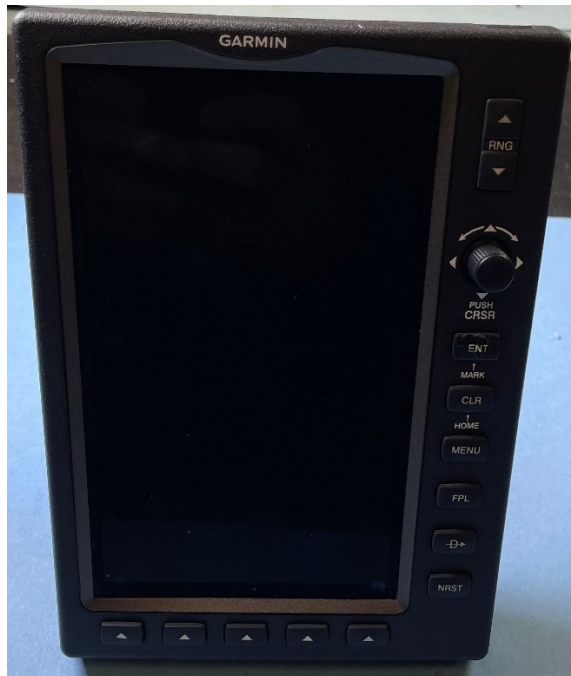
The Garmin GPSMAP 696 was in good condition upon arrival at the Vehicle Recorder Division, as shown in figure 1. The device powered on normally and the data were downloaded normally using the manufacturer's procedure. Figure 2 shows numerous flight logs recorded on the device.

**Figure 1.** Garmin GPSMAP 696 as received by the Vehicle Recorders Division.

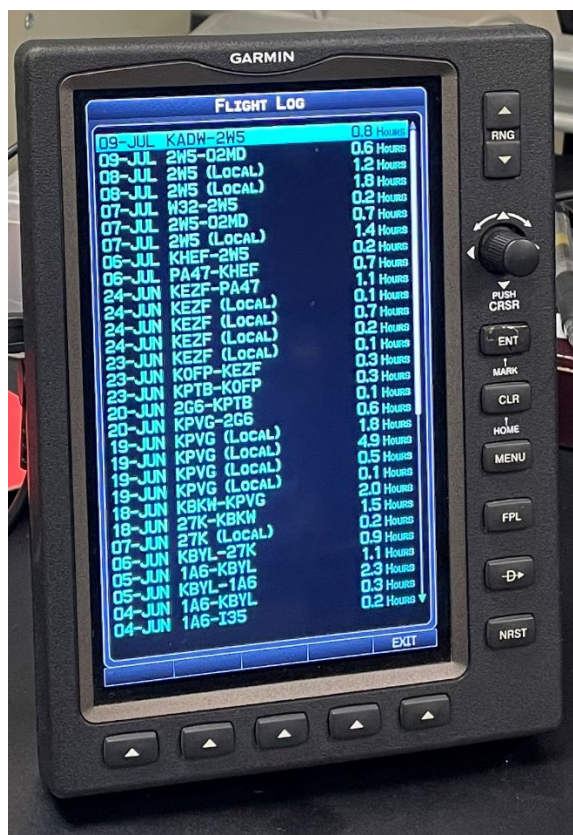
**Figure 2.** Flight Log of the Garmin GPSMAP 696.
