# National Transportation Safety Board

ERA23LA309

## AIRCRAFT PERFORMANCE STUDY

Description: Helicopter impact with terrain during external lift line operations  
Location: Caldwell, Ohio  
Date: July 23, 2023  
Time: 1420 Eastern Daylight Time (EDT), 1920 Coordinated Universal Time (UTC)  
Operator: Sky Aviation Corporation  
Aircraft: Bell 206L4 LongRanger, N482TJ  
Manufacturer: Bell Helicopters (Textron)

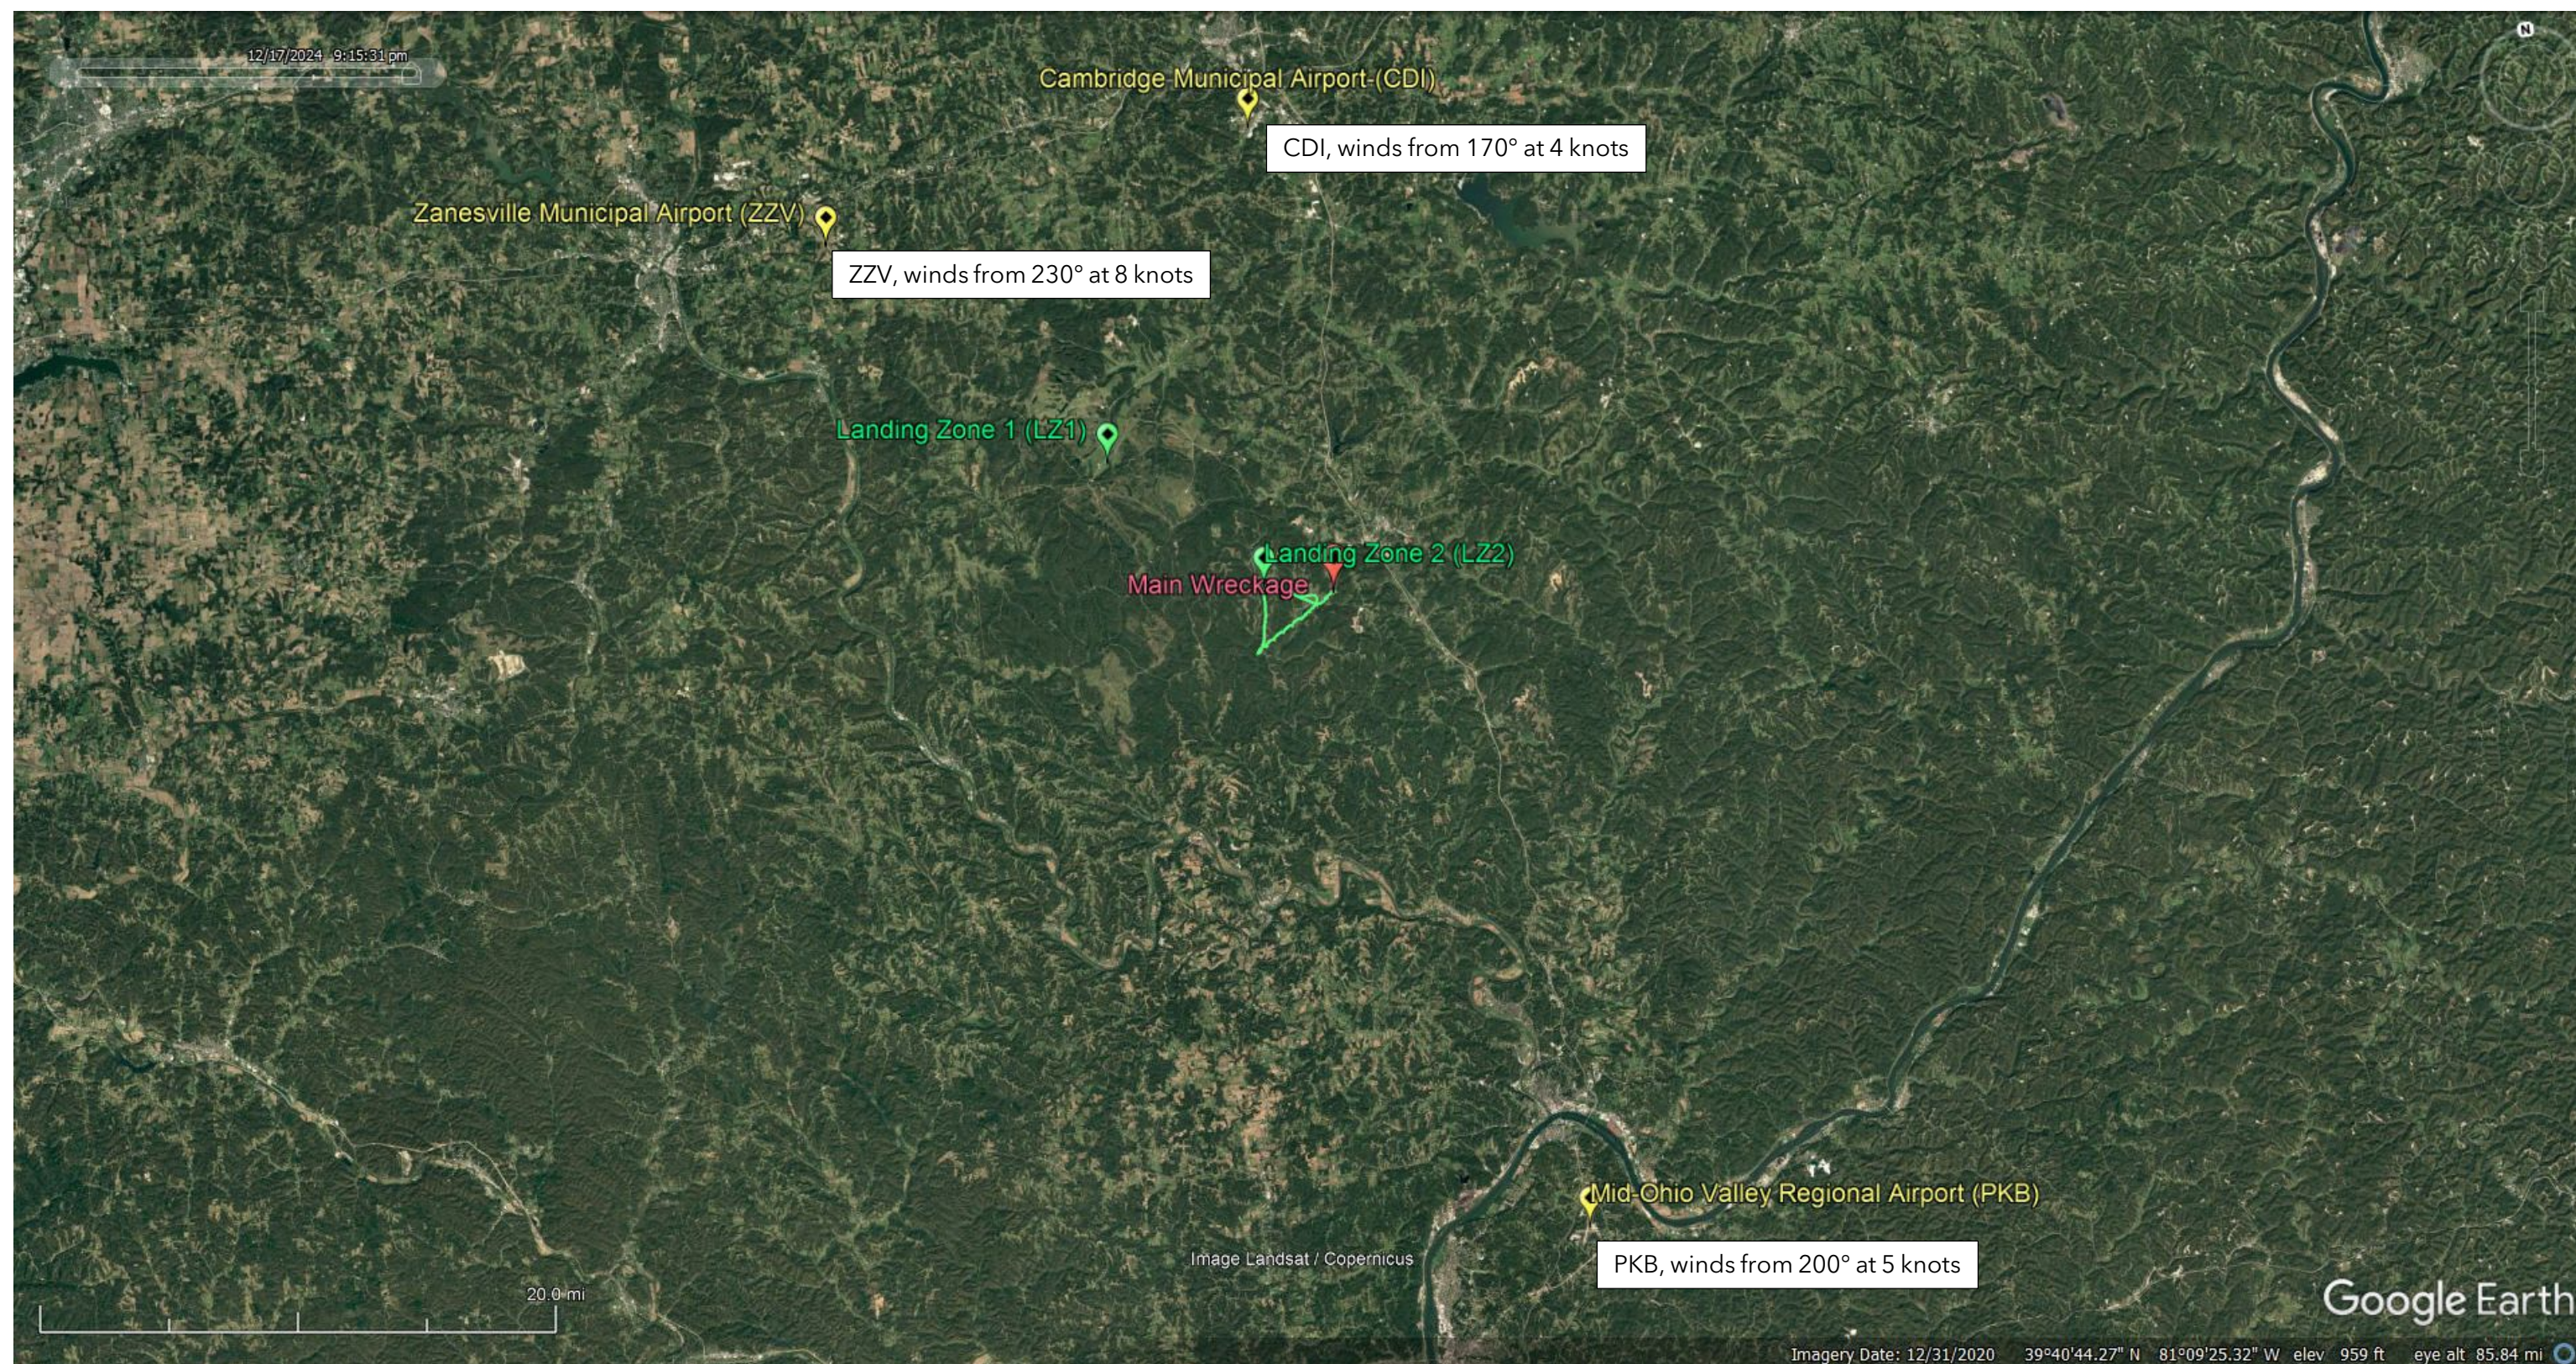
Figure 1: The CDI, ZZV, and PKB ASOS weather locations are defined by the yellow balloon symbols and text. The N482TJ accident flight and immediately preceding flight ground track are highlighted in green toward the center of the page. Landing zones 1 and 2 are identified by the green balloon symbols and text. North is toward the top of the page. Cambridge Municipal Airport (CDI) is located about 15.7 nm north of the wreckage location on a bearing of 357° true. Zanesville Municipal Airport (ZZV) is located about 20.5 nm northwest of the wreckage on a bearing of 312° true. Mid-Ohio Valley Regional Airport (PKB) is located about 22.9 nm south-southeast of the wreckage location on a bearing of 166° true.

The Automated Surface Observing System (ASOS) and observer weather data near the accident time include 20-minute interval data from Cambridge Municipal Airport (CDI) in Cambridge, Ohio; hourly and 5-minute interval data from Zanesville Municipal Airport (ZZV) in Zanesville, Ohio; and hourly observer and 5-minute interval data from Mid-Ohio Valley Regional Airport (PKB) in Parkersburg, West Virginia. The respective ASOS data are shown below with the event data identified by the black (as opposed to gray) text. The ASOS locations are plotted in Figure 1.

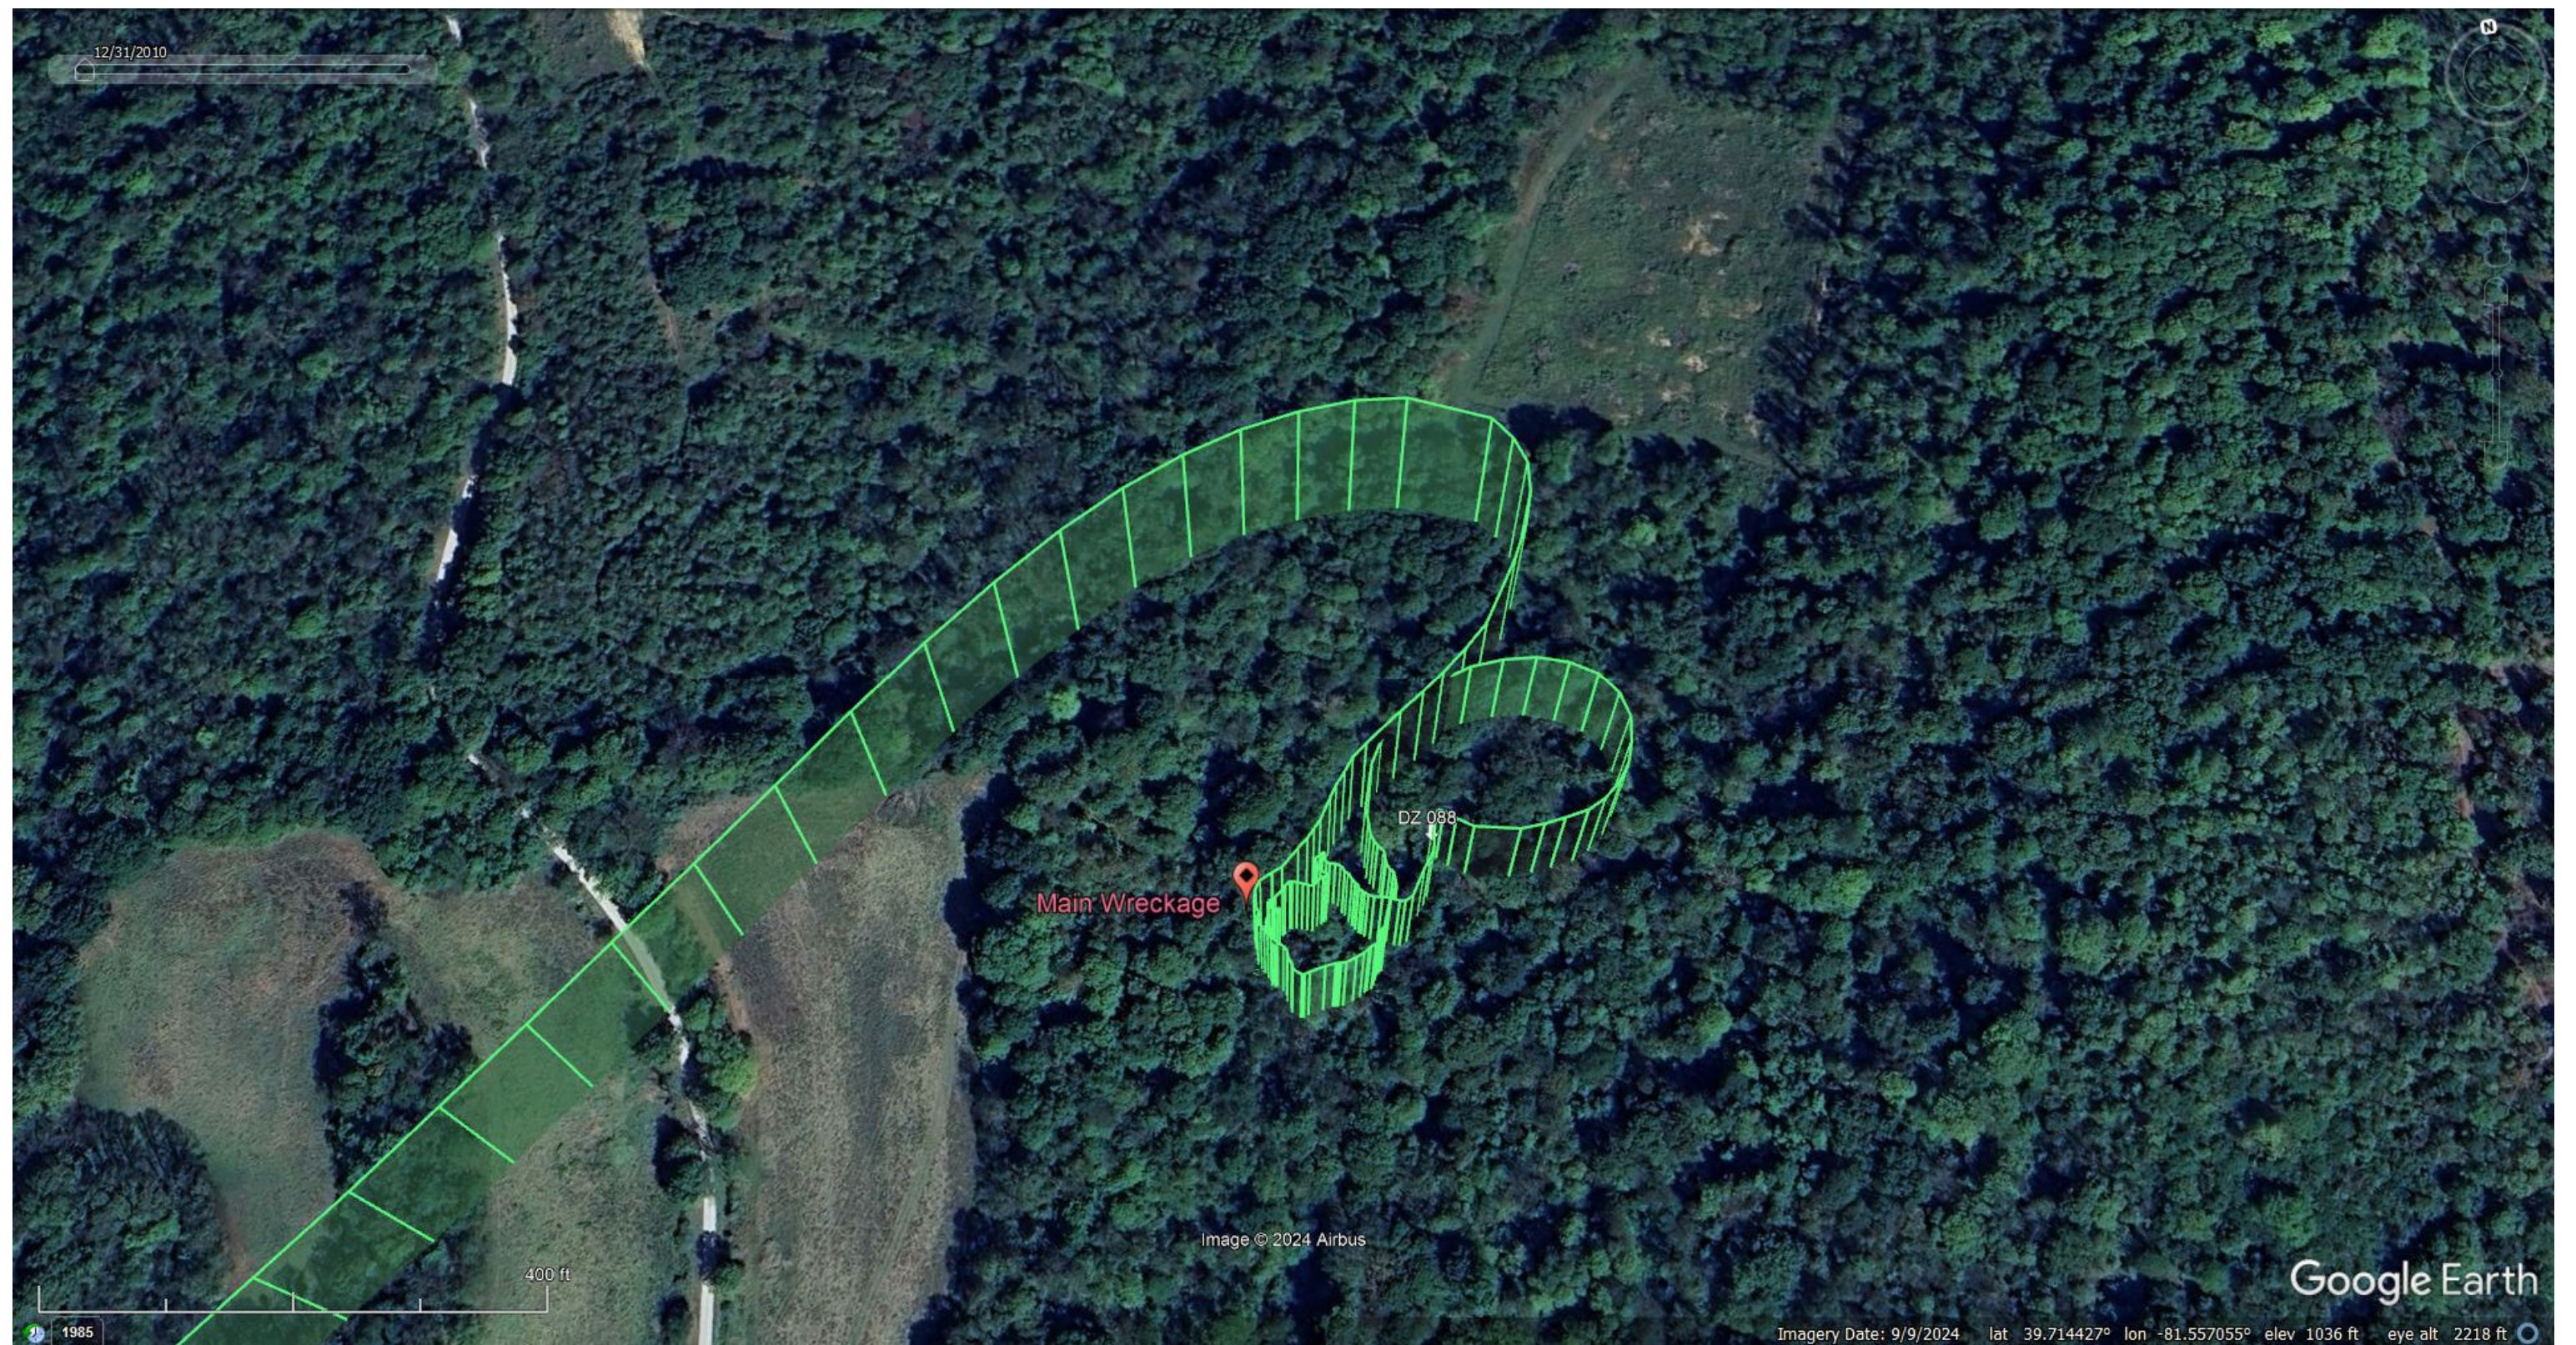
Figure 9: Flight path reconstruction (green lines) of N482TJ making clockwise approach to drop zone 088 during the accident flight, maneuvering, and experiencing an uncontrolled vertical descent and terrain impact. Due north is toward the top of the page.

exemplar flight path snapshots near drop zone 088 are presented in Figures 9 and 10. The Google Earth .kmz file ForeFlight parametric data can be downloaded, opened in Google Earth, and interactively interrogated by individual users.

The helicopter appears to transition from “normal” flight to the crash between 17:57:55 and 17:58:03 (page 43 of Attachment 3). A zoomed-in track of the flight path from 17:57:45 to 17:58:05 was provided (by deleting extraneous flight path data points that follow [what is believed to be] the crash).

In the last 20 seconds preceding the crash, the ground track is contained within about a 20 ft by 20 ft square. About 8 seconds before impact, a rapid loss of altitude occurs without much drift outside of the 20 ft square. The helicopter was about 200 ft agl about 8 seconds before impact.
