# National Transportation Safety Board

ERA24FA026

## **AUTOMATIC DEPENDENT SURVEILLANCE- BROADCAST (ADS-B) STUDY**

Aircraft Performance Study

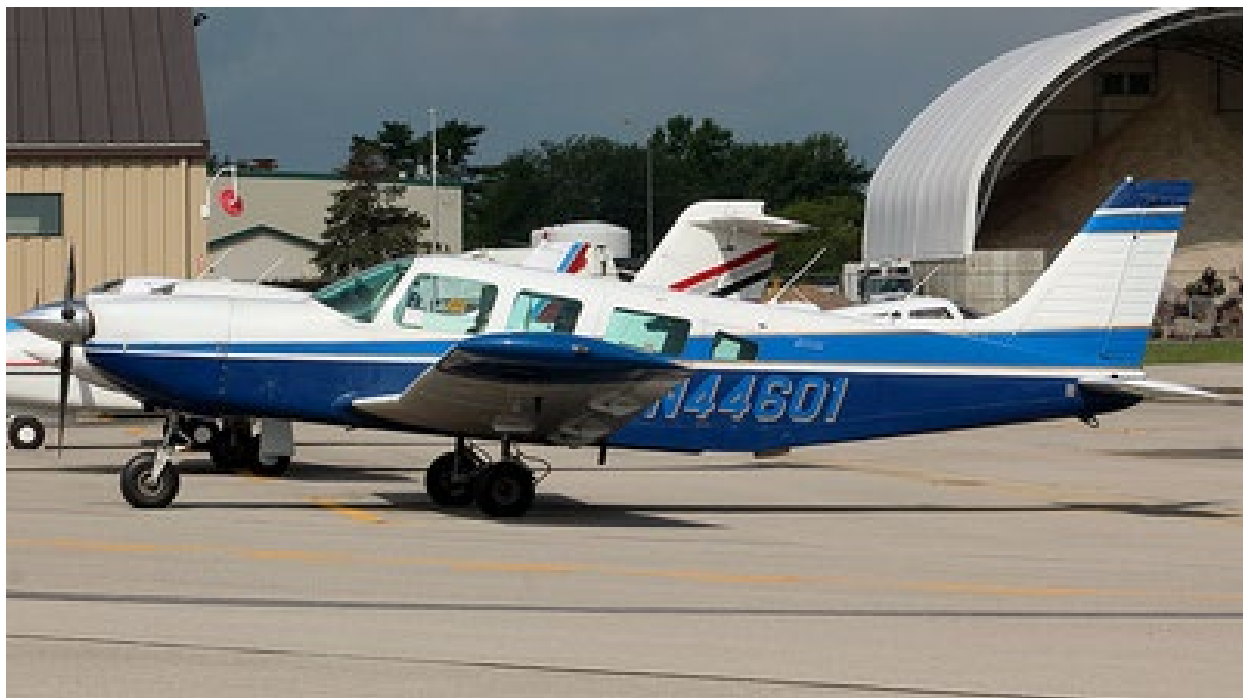
The airplane involved was a Piper PA32-300, or Cherokee Six, a single-engine, fixed-landing-gear light airplane.

**Figure 1.** Piper PA32-300, N44601.

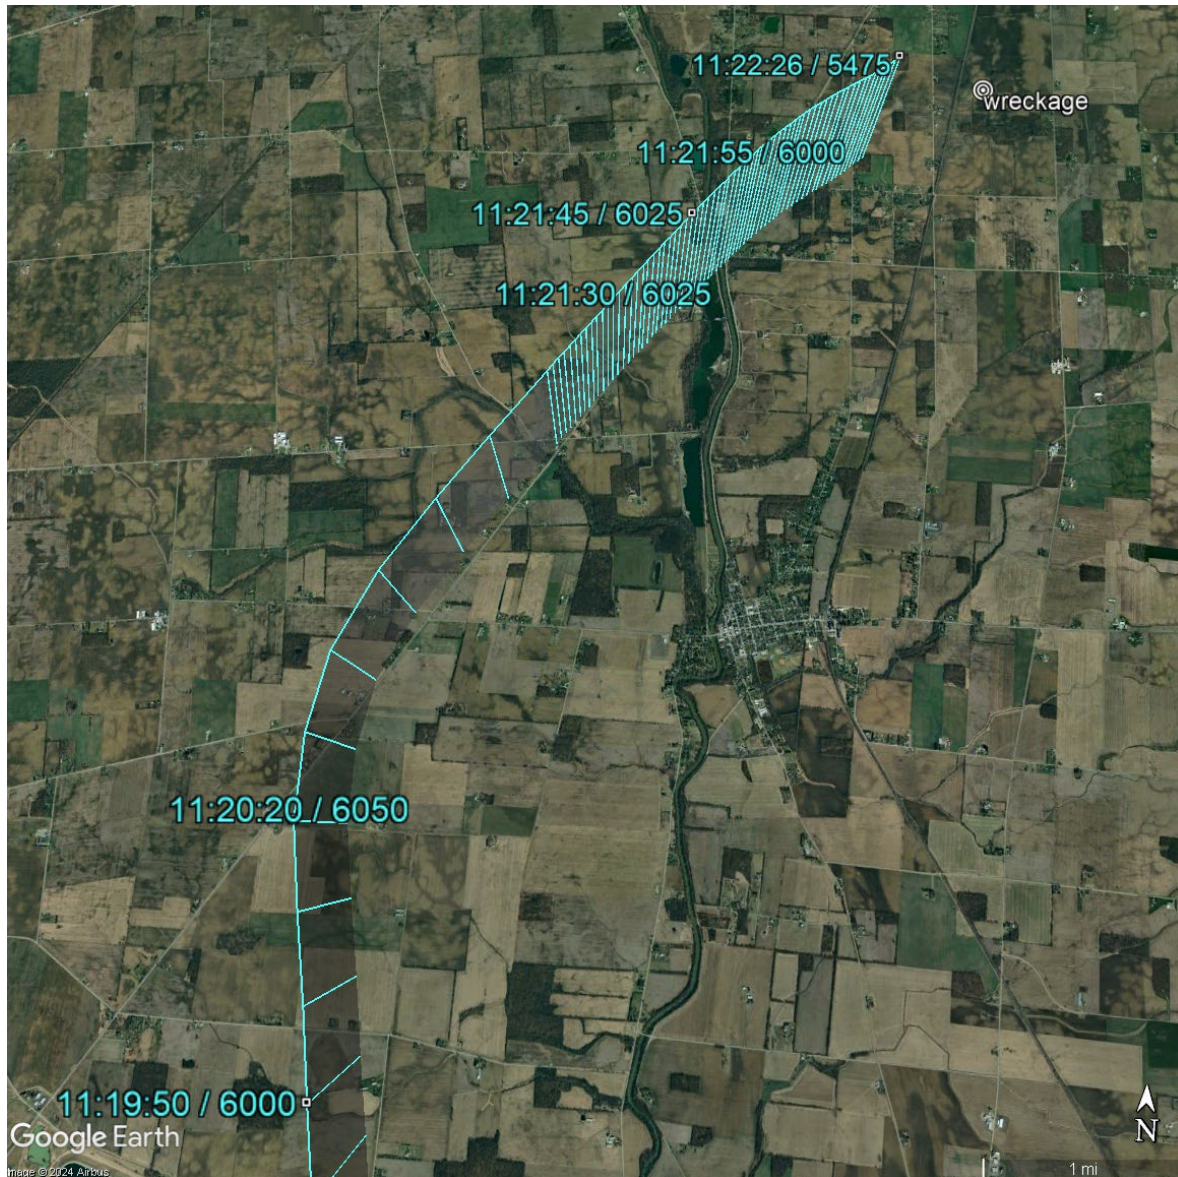
**Figure 5.** End ADS-B flight path with selected times and altitudes notated. Data before 11:18:00 is shown every 10 seconds. Data after 11:18:00 is shown at the full ADS-B resolution of 1 Hz.

At 11:19:50, the airplane's airspeed began to decrease from 108 kts to 101 kts by 11:20:16 while track and altitude remained steady (Figure 4). The airplane then accelerated to 120 kts while turning right onto a heading of 36° (Figure 4 and Figure 5). At 11:21:45, the speed began to drop and by 11:21:55 the airplane was losing altitude at a rate of 1,000 ft/min. While descending, the airplane's airspeed stabilized near 100 kts before the data ended at 11:22:26. The airplane's descent and deceleration after 11:21:50 indicated a reduction in total energy consistent with a loss of thrust.
