# National Transportation Safety Board

ERA24FA038

## **ELECTRONIC DEVICES**

Specialist's Factual Report

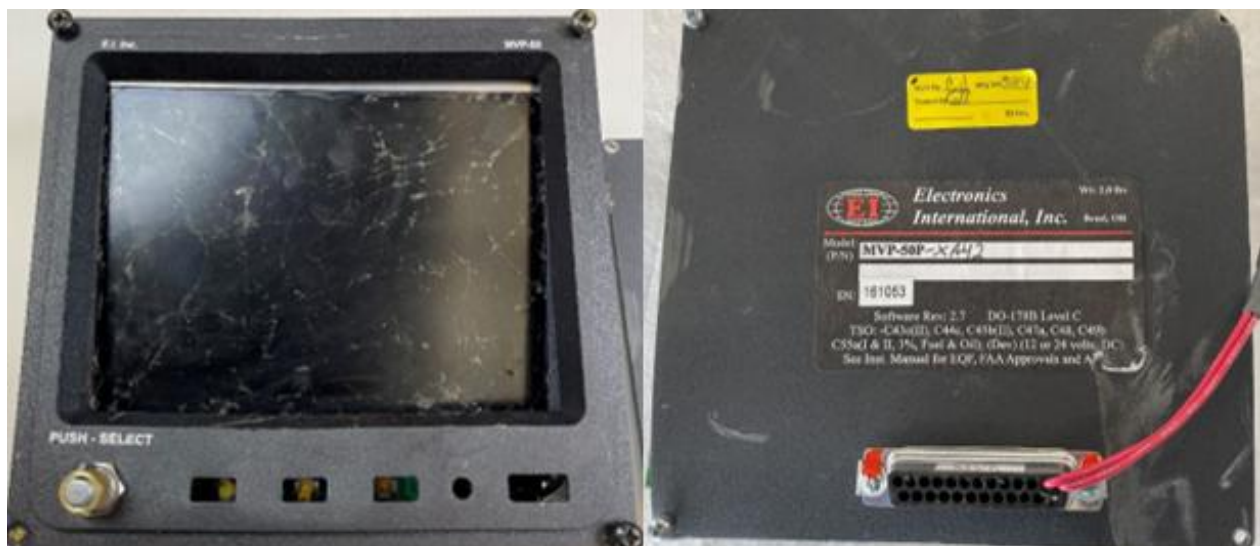
Upon arrival at the Vehicle Recorder Laboratory, it was evident that the EI MVP-50P sustained impact damage as shown in figure 1. The device was taken apart and the internal compact flash card was removed and downloaded via commercially available data forensics software.

**Figure 1.** EI MVP-50P as received by the NTSB Vehicle Recorder Lab.

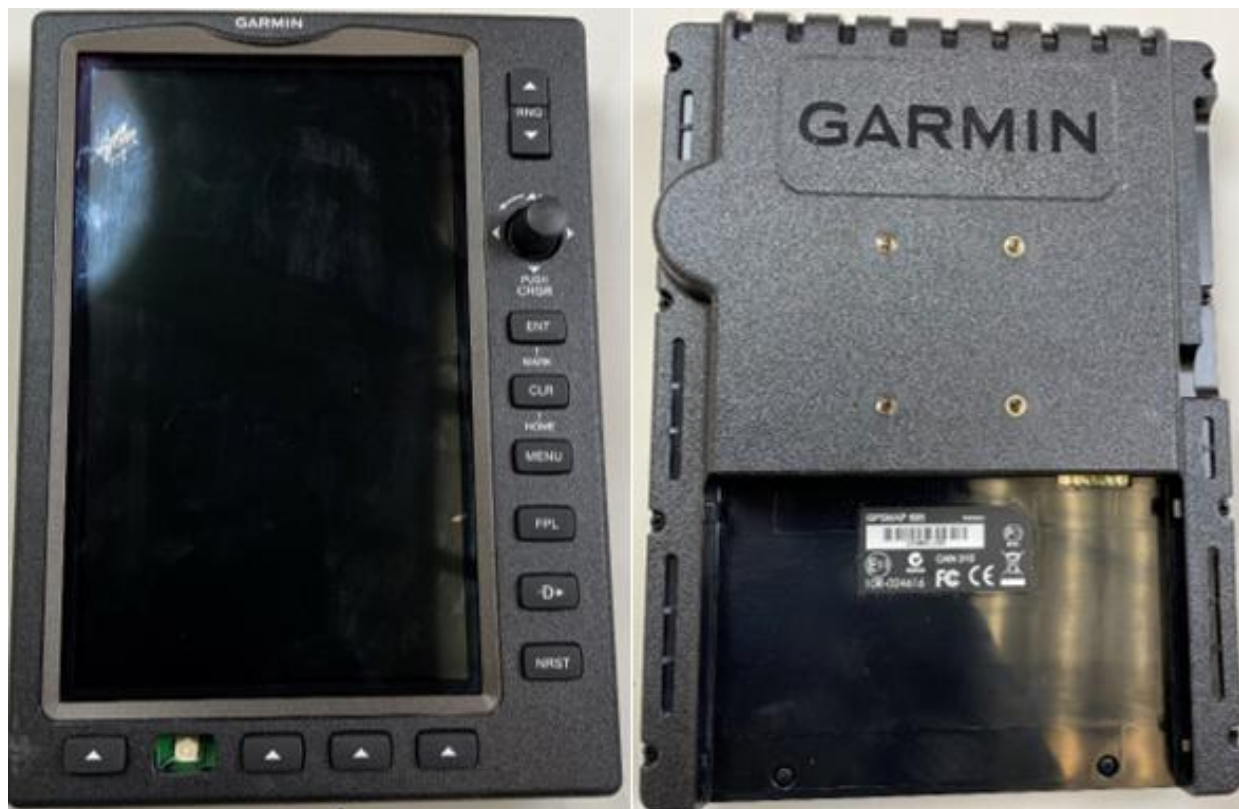
Upon arrival at the Vehicle Recorder Laboratory, it was evident that the Garmin GPSMAP 695 sustained impact damage as shown in figure 2. The device was able to power on, and the data were downloaded normally using the manufacturer's procedure.

**Figure 2.** Garmin GPSMAP 695 as received by the NTSB Vehicle Recorder Lab.

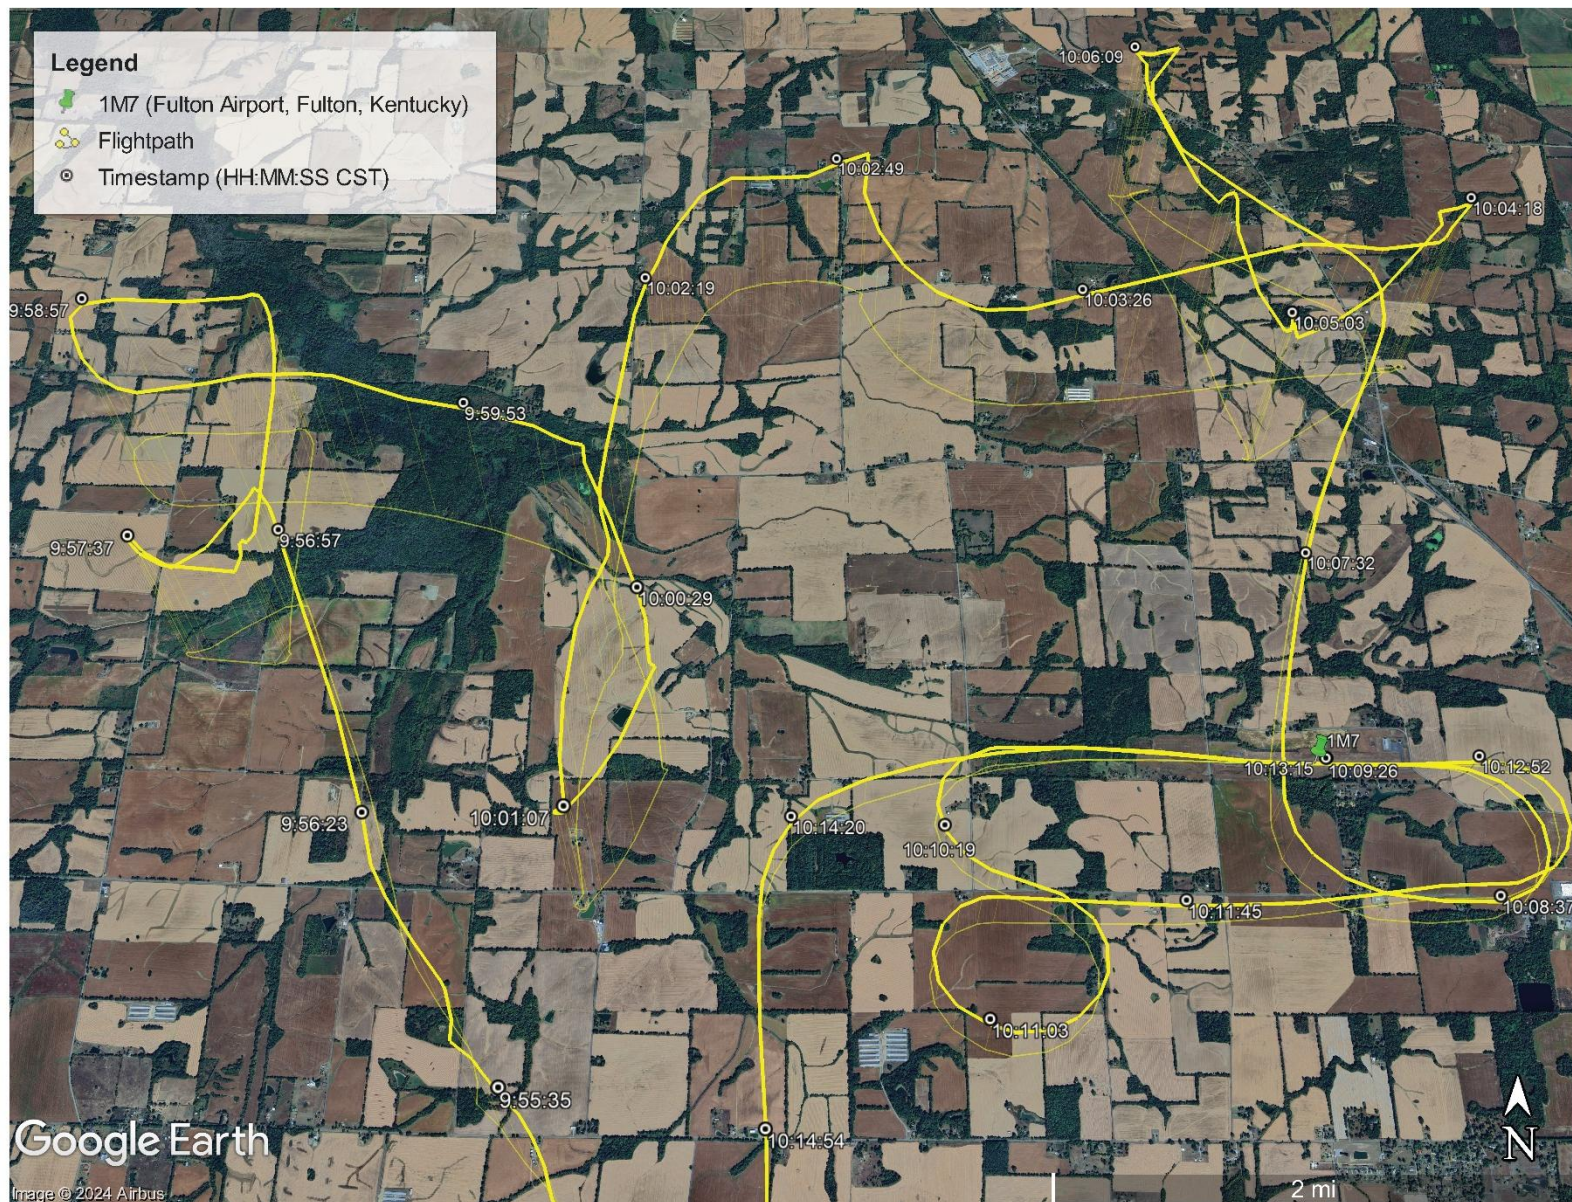
Figures 7 through 9 are graphical overlays derived from the Garmin GPSMAP 695 data and generated using Google Earth presenting the entire accident flight, TGL at 1M7 and maneuvers consistent with aerobatic flight, and the accident location, respectively. Weather and lighting conditions in Google Earth are not necessarily the weather and lighting conditions present at the time of the recording.

**Figure 8.** Google Earth overlay of TGL at 1M7 and maneuvers consistent with aerobatic flight.

- **09:56:57 CST - 10:07:05 CST:** The aircraft GPS data was consistent with the aircraft performing aerobatics.
- **10:09:26 CST:** The aircraft conducted a touch-and-go landing (TGL) at 1M7.

- **10:13:15 CST:** The aircraft conducted a second TGL at 1M7.
- **10:13:46 CST:** GPS altitude was 1014 ft and the track was 270 deg. The aircraft began to make a climbing left turn south towards KUCY.
