# National Transportation Safety Board

ERA24FA050

## **AIR TRAFFIC CONTROL**

ATC Services Review

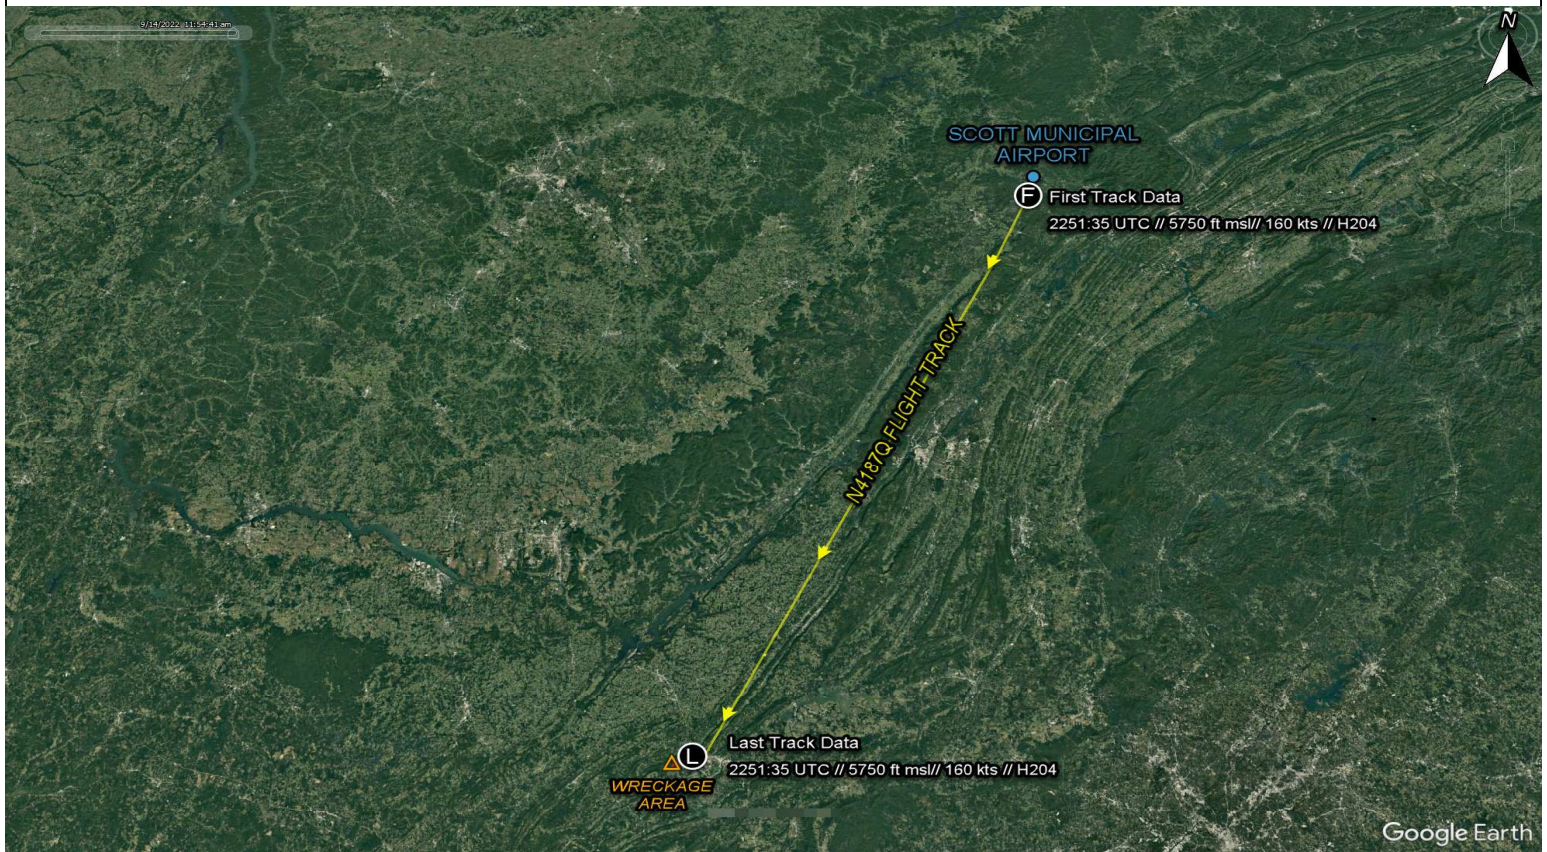
Figure 1

Figure 1: Overhead view of the entire accident flight track of N4187Q.

Caption: Overhead view of the entire accident flight track of N4187Q.

ADS-B data provided by the FAA was used in conducting this Services Review. The pilot of N4187Q was first observed approximately 0.33 nautical miles (nm) southwest of the departure end of runway 23 at Scott Municipal Airport (SCX). The pilot of N4187Q flew runway heading for approximately 2 nm. The pilot of N4187Q then turned left and flew generally south southwest bound for approximately 159 nm. N4187Q was then observed conducting a turn to the southwest approximately 4 nm north of 20A. N4187Q subsequently entered a shallow right turn, then left turn before surveillance data was lost at about 1747 approximately 3.5 nm northwest of 20A.

LAST ADS-B DATA: 1746:35 CST | LAT = 34° 1'7.45"N | LON = 86° 7'45.15" | Barometric Altitude = 2150

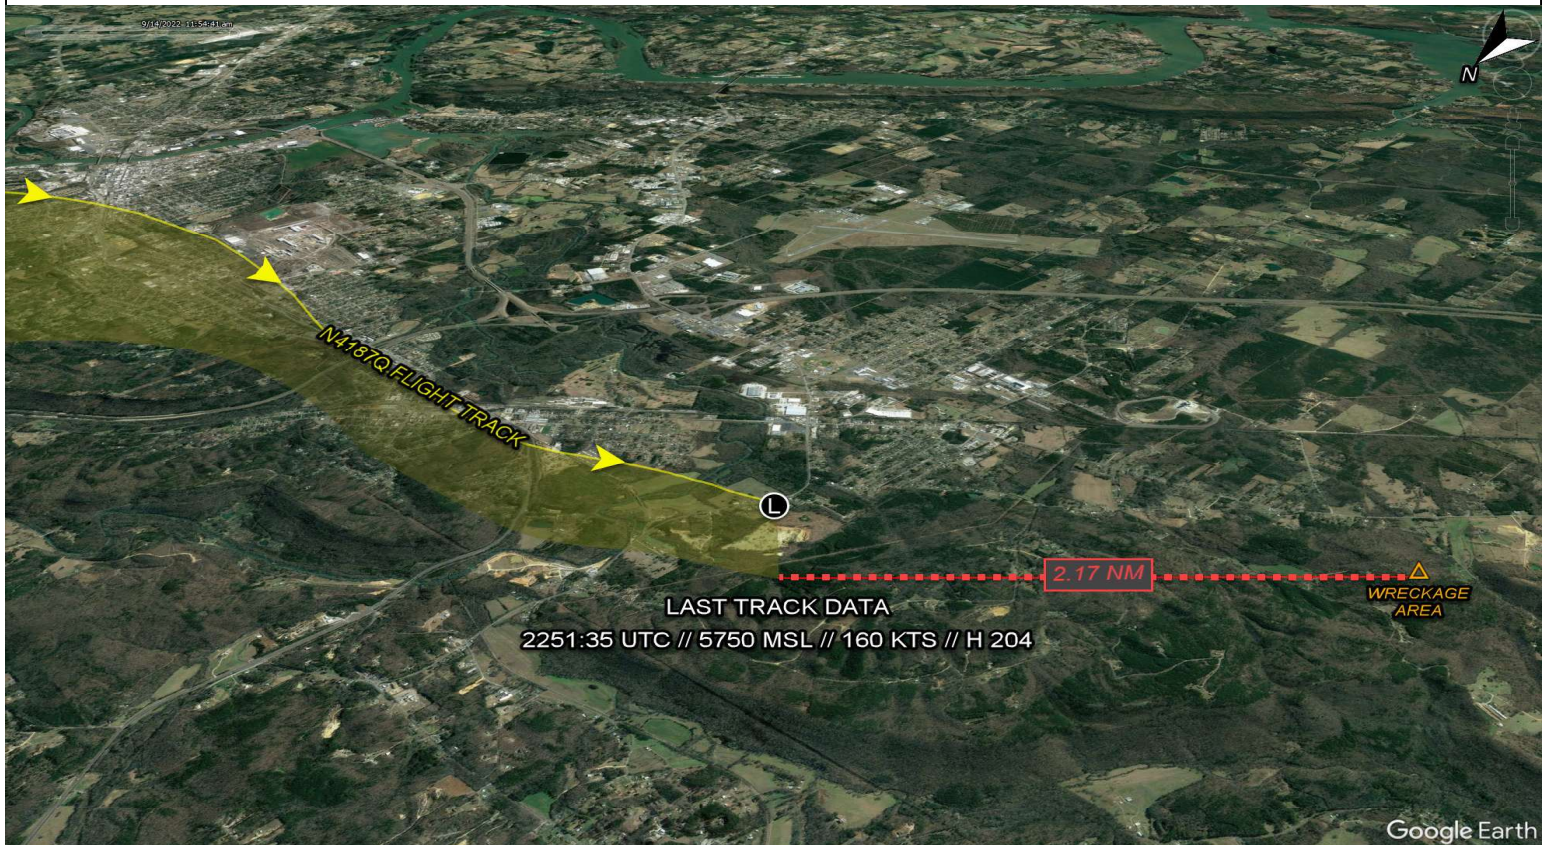
Figure 2

Figure 2: Profile view of the final segment of the accident flight track of N4187Q.

Caption: Profile view of the final segment of the accident flight track of N4187Q.

- 1748 - N4187Q advises he has a terrain warning and is at 1100 and still does not see the airport.
- 1749 - SR calls N4187Q and asks if he was able to dial in 20A in his GPS to navigate better. N4187Q does not respond. SR calls N4187Q again and gets no response.
