# National Transportation Safety Board

ERA24FA110

## **FLIGHT DATA RECORDER**

Group Chair's Factual Report

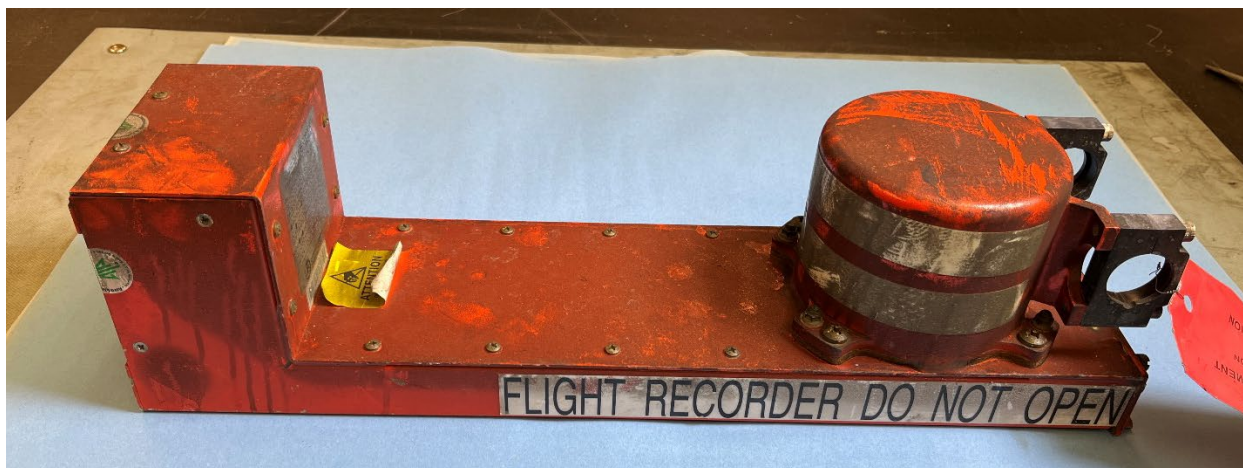
The recorder was hand-carried to the NTSB's vehicle recorder laboratory. The recorder had a coating of soot on the exterior, but inspections showed that it was otherwise undamaged. The data were extracted normally from the recorder.

**Figure 1.** Exterior of flight data recorder exhibiting sooting.

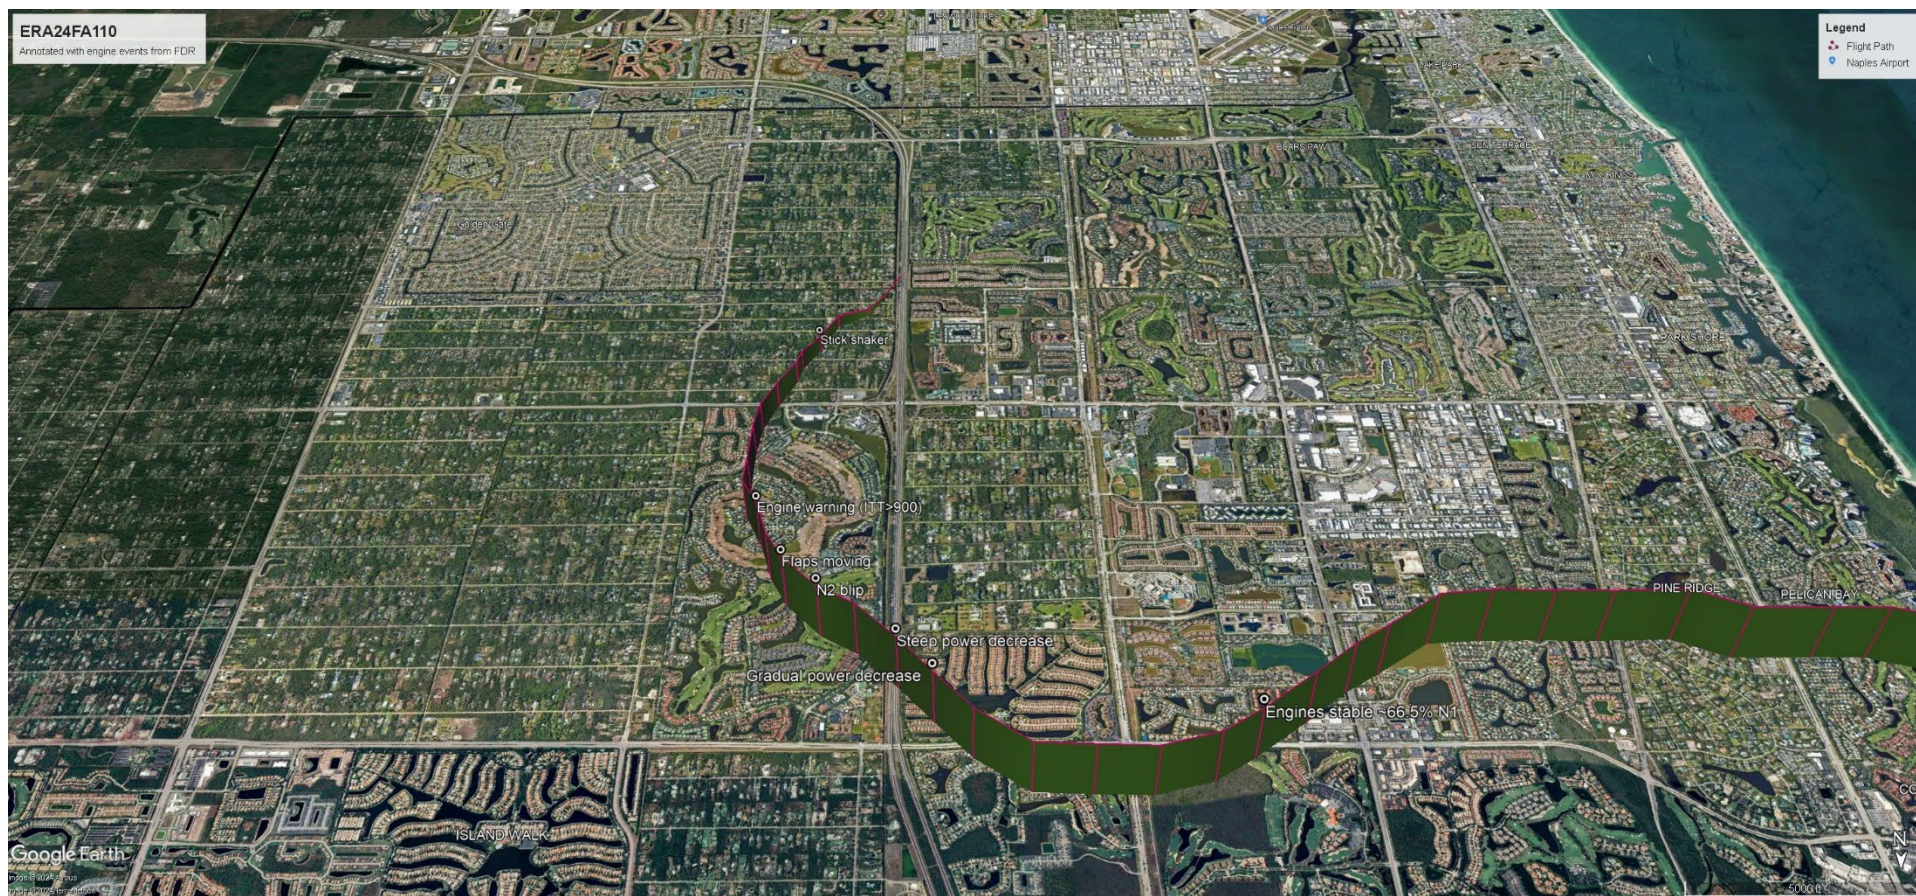
- Stick shaker activation was recorded for two seconds at 15:10:21, at an altitude and airspeed of 490 feet and 112.5 kts. The aircraft's pitch reduced following the stick shaker activation.
- The aircraft touched down at 15:10:47 at about 110 kts in a 15-degree left bank and with about 1.5 degrees of nose up pitch.

**Figure 10. Map overlay of final 3.5 minutes of the FDR recording with FDR events annotated.**

Figures 2, 4, 6, and 8 cover the entire flight from 12:52 EST to 15:12 EST. Figures 3, 5, 7, and 10 cover the final 3.5 minutes of the recording. Figure 9 is a detail of the engine starts prior to the accident flight. These figures are configured such that
