ERA24FA110

Group Chair's Factual Report - Attachment 4  
GE Research CF34 Liquid Fuel Analysis 051624  
May 8, 2025

# — GE Aerospace Research CF34 Liquid Fuel Analysis

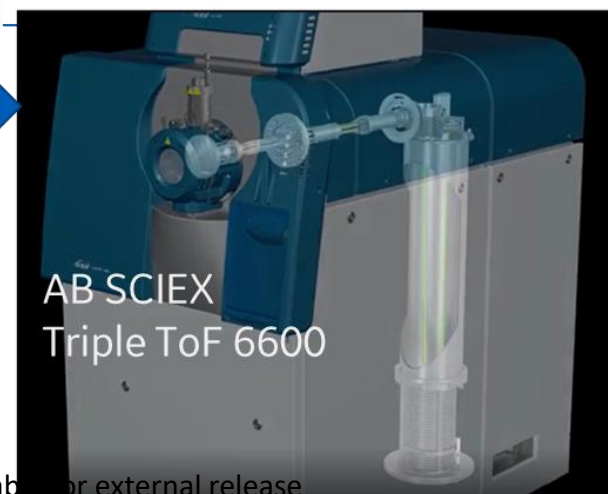
- 1) Flow Rate: 0.2ml / min
  - 2) Solvent A: 99.99% DI Water (+ 0.1% Formic Acid)
  - 3) Solvent B: 99.99% ACN (+ 0.1% Formic Acid)
  - 4) Step Gradient Conditions: 0-5min (100% Solvent A), 5-15min (0-100% Solvent B), 10min Equilibration to Initial Condition
- 
- 1) Column: Intakt Cadenza CD-C18 2mm x 50mm
  - 2) Injection Volume: 5ul

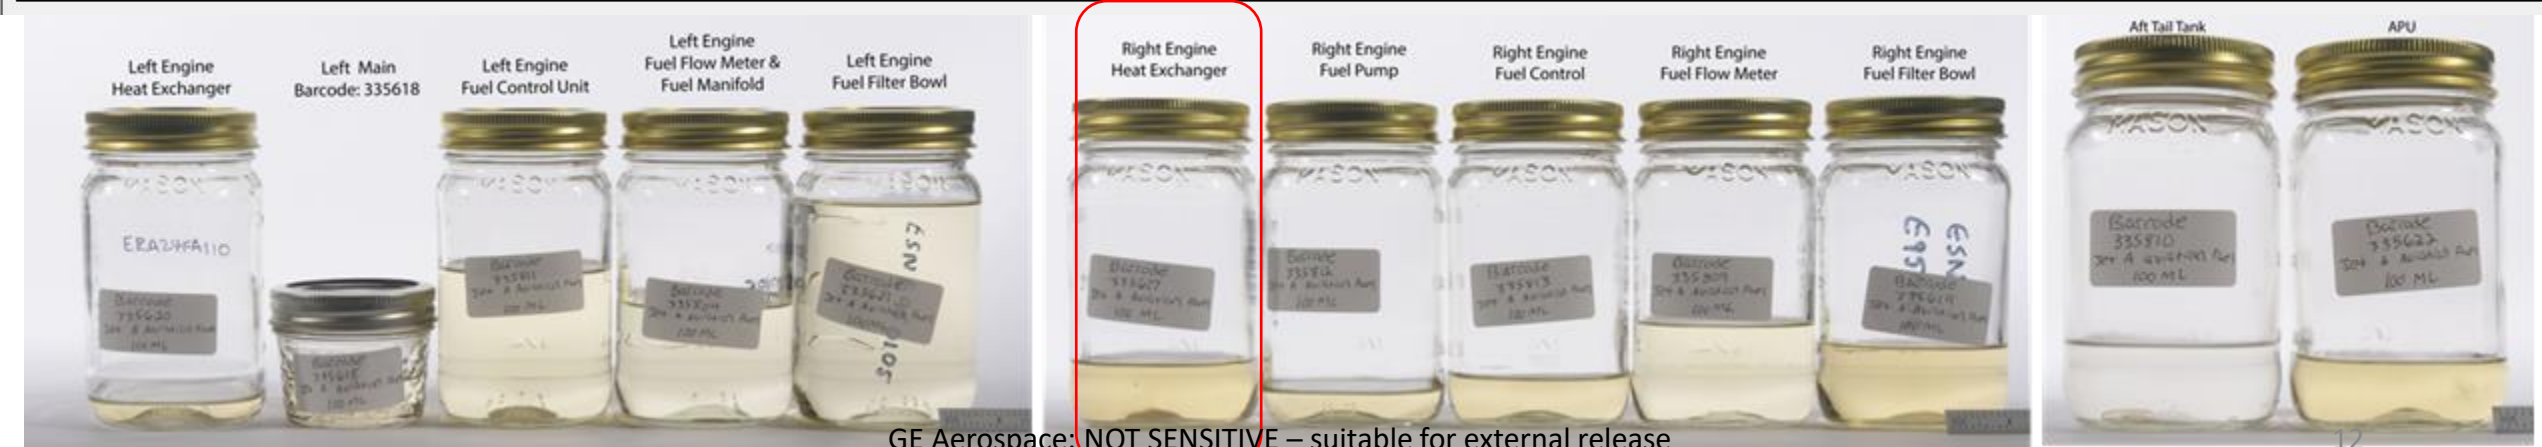
| LIMS ID | Barcode | Sampling location |
|---|---|---|
| NSK24-00850-0001 | 335617 | right engine heat exchanger |

# GE Aerospace Research: Analysis of Jet A Fuels using Direct Injection 2D GC-ToF MS [Contour Plot for TIC]

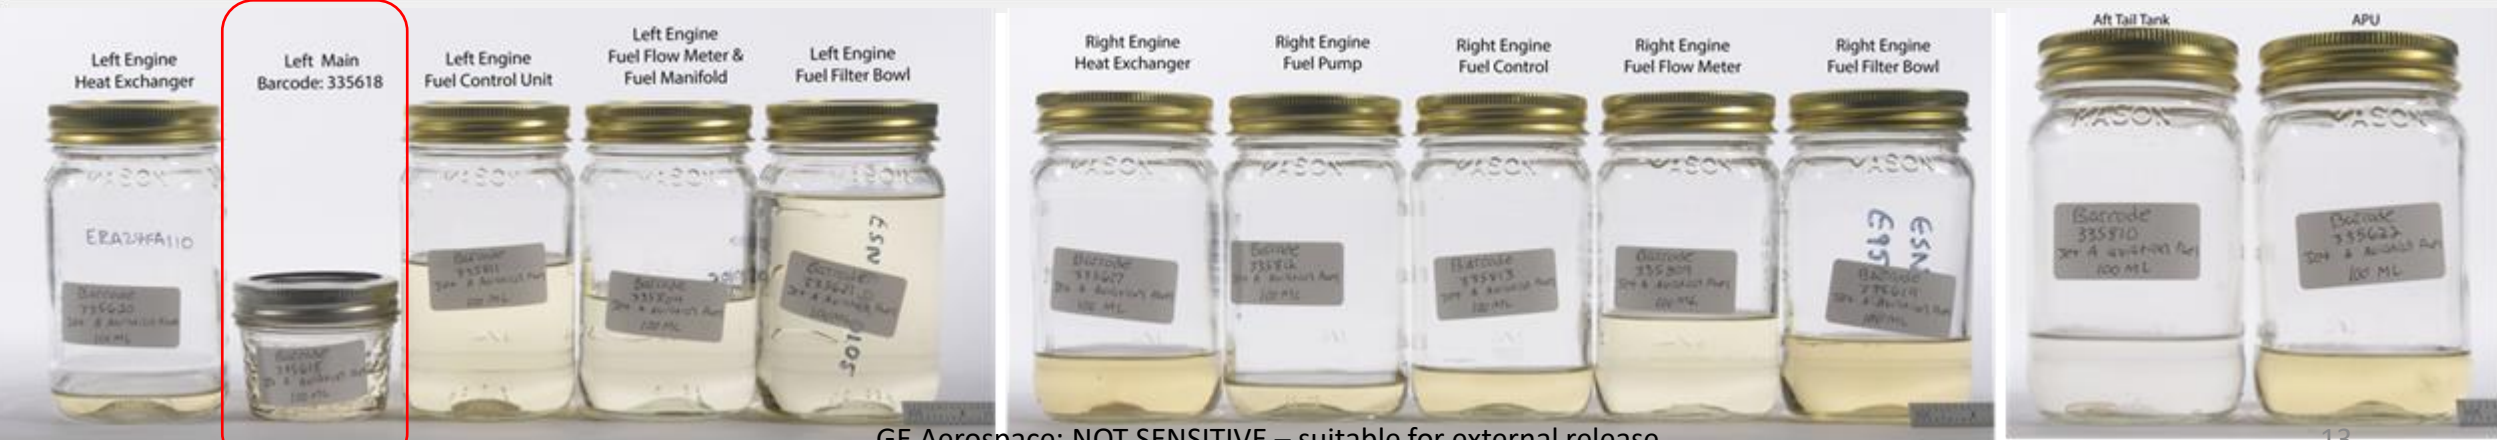
| LIMS ID | Barcode | Sampling location |
|---|---|---|
| NSK24-00850-0002 | 335618 | left main (unreadable) |

# GE Aerospace Research: Analysis of Jet A Fuels using Direct Injection 2D GC-ToF MS [Contour Plot for TIC]

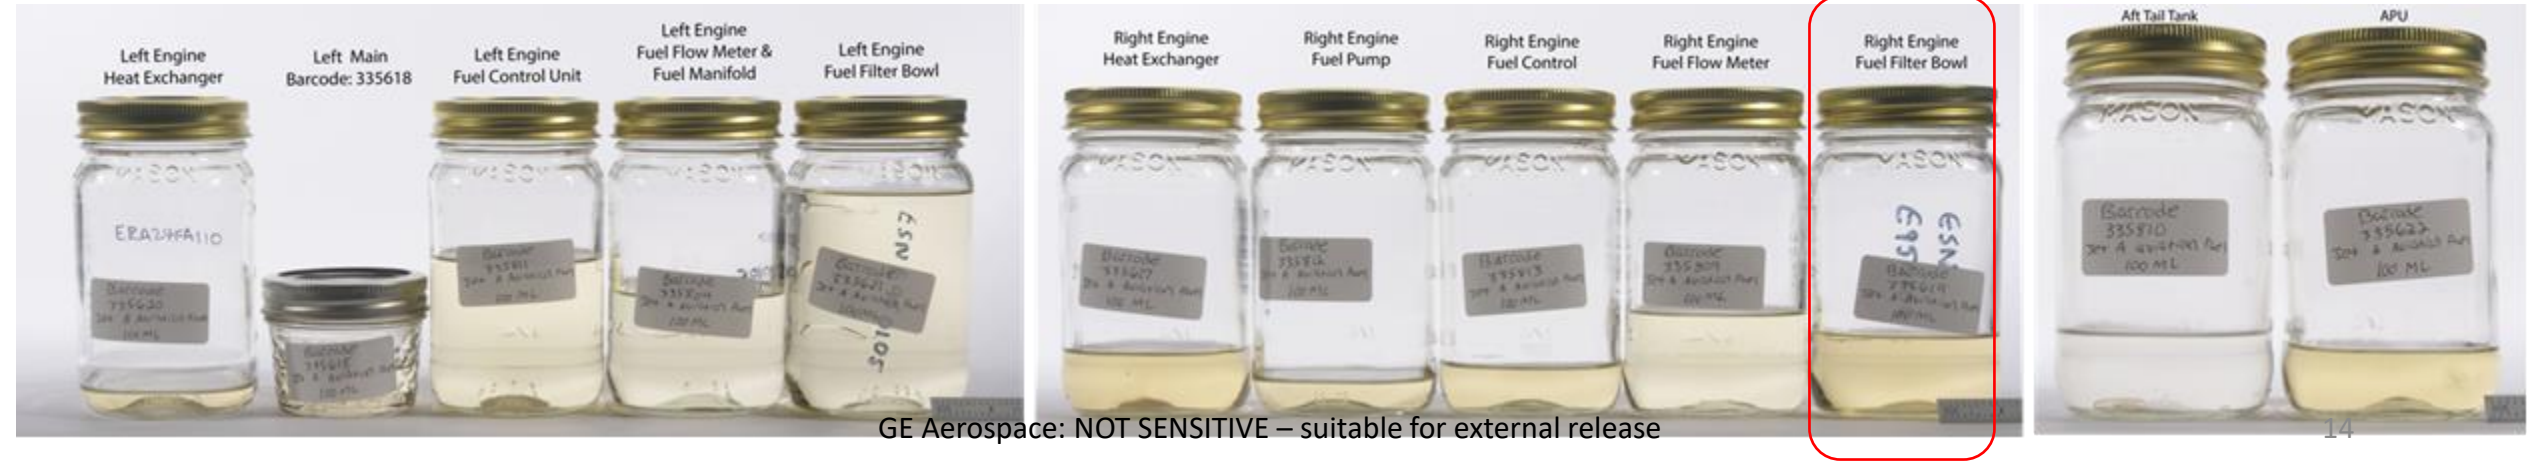
| LIMS ID | Barcode | Sampling location |
|---|---|---|
| NSK24-00850-0003 | 335619 | right engine fuel filter bowl |

# GE Aerospace Research: Analysis of Jet A Fuels using Direct Injection 2D GC-ToF MS [Contour Plot for TIC]

- Sample 335619 right engine fuel filter bowl may contain slightly higher amounts of lower molecular weight species. Further work is needed to identify these lower weight species

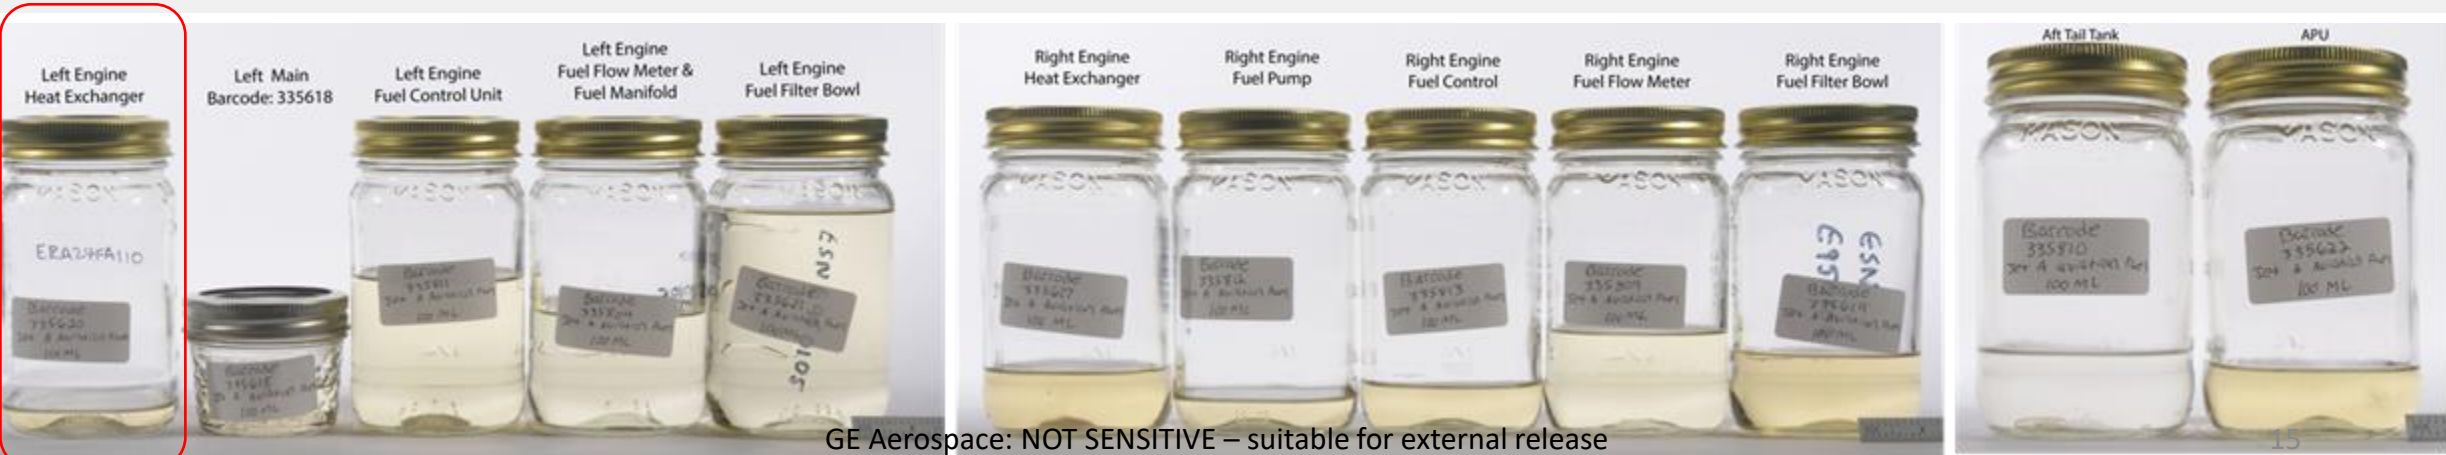
| LIMS ID | Barcode | Sampling location |
|---|---|---|
| NSK24-00850-0004 | 335620 | left engine heat exchanger |

# GE Aerospace Research: Analysis of Jet A Fuels using Direct Injection 2D GC-ToF MS [Contour Plot for TIC]

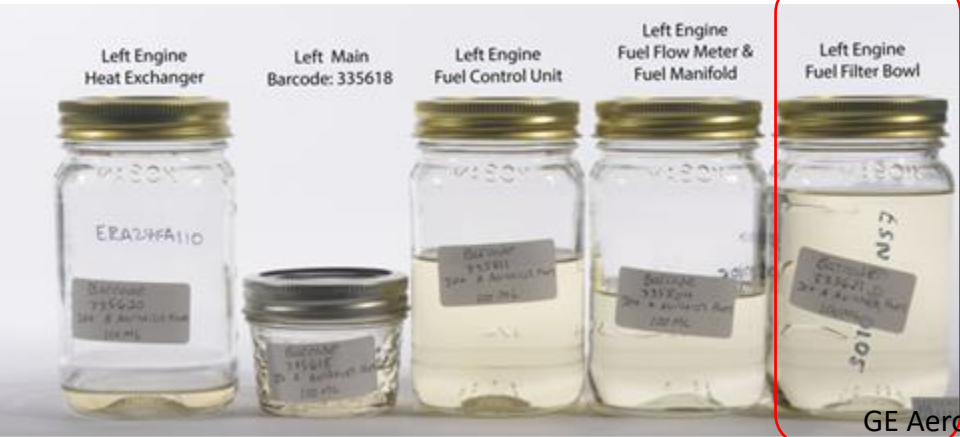
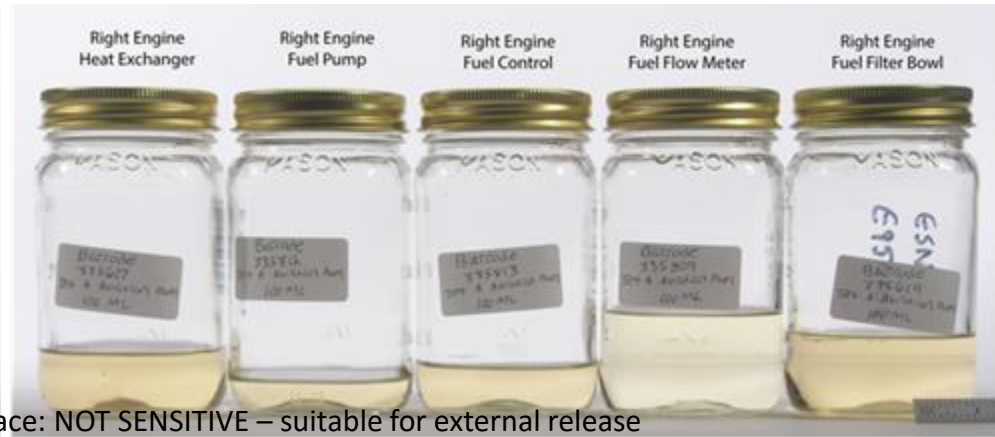
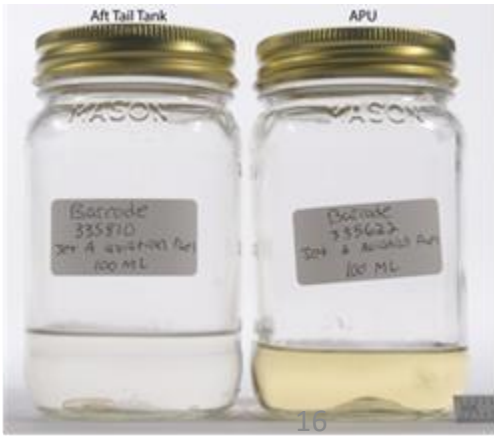
| LIMS ID | Barcode | Sampling location |
|---|---|---|
| NSK24-00850-0005 | 335621 | left engine fuel filter bowl |

# GE Aerospace Research: Analysis of Jet A Fuels using Direct Injection 2D GC-ToF MS [Contour Plot for TIC]

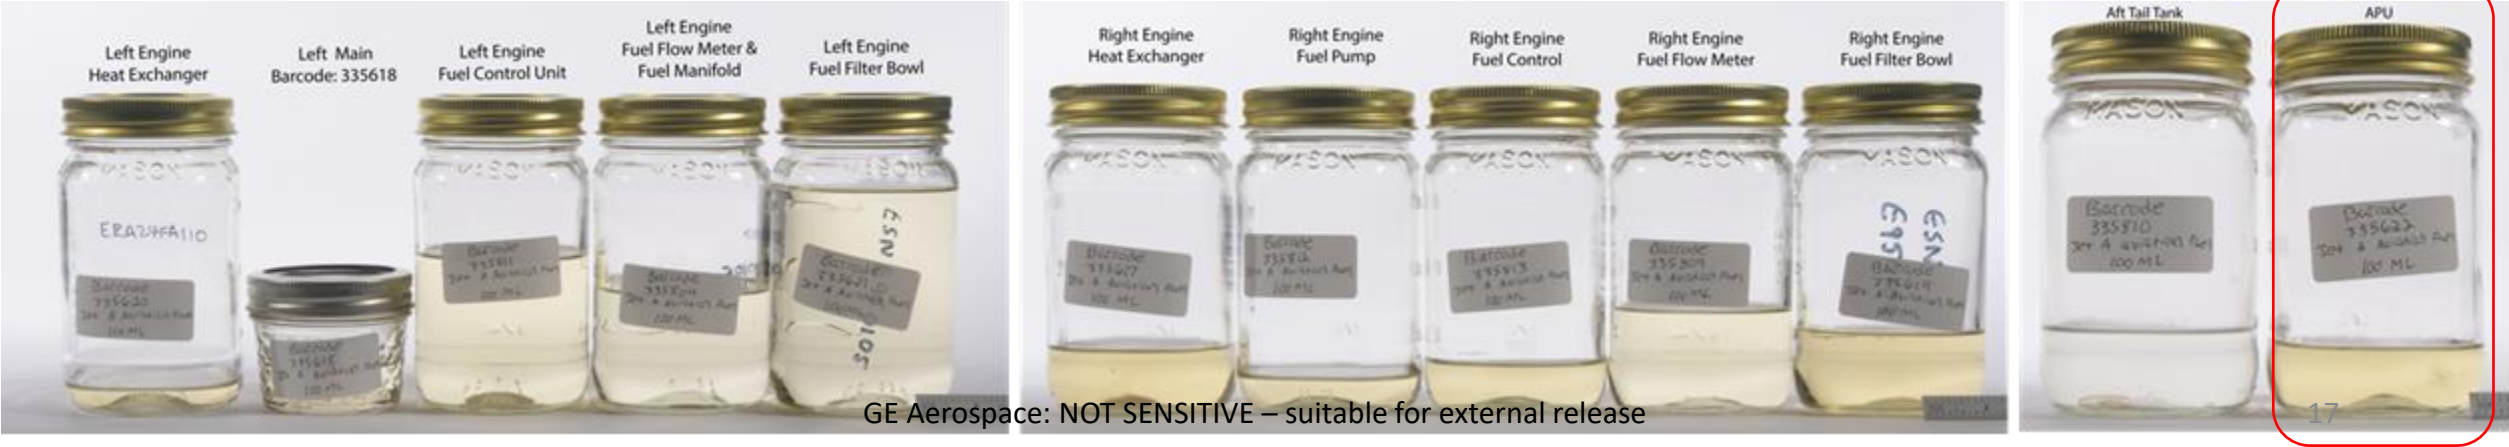
| LIMS ID | Barcode | Sampling location |
|---|---|---|
| NSK24-00850-0006 | 335622 | APU |

# GE Aerospace Research: Analysis of Jet A Fuels using Direct Injection 2D GC-ToF MS [Contour Plot for TIC]

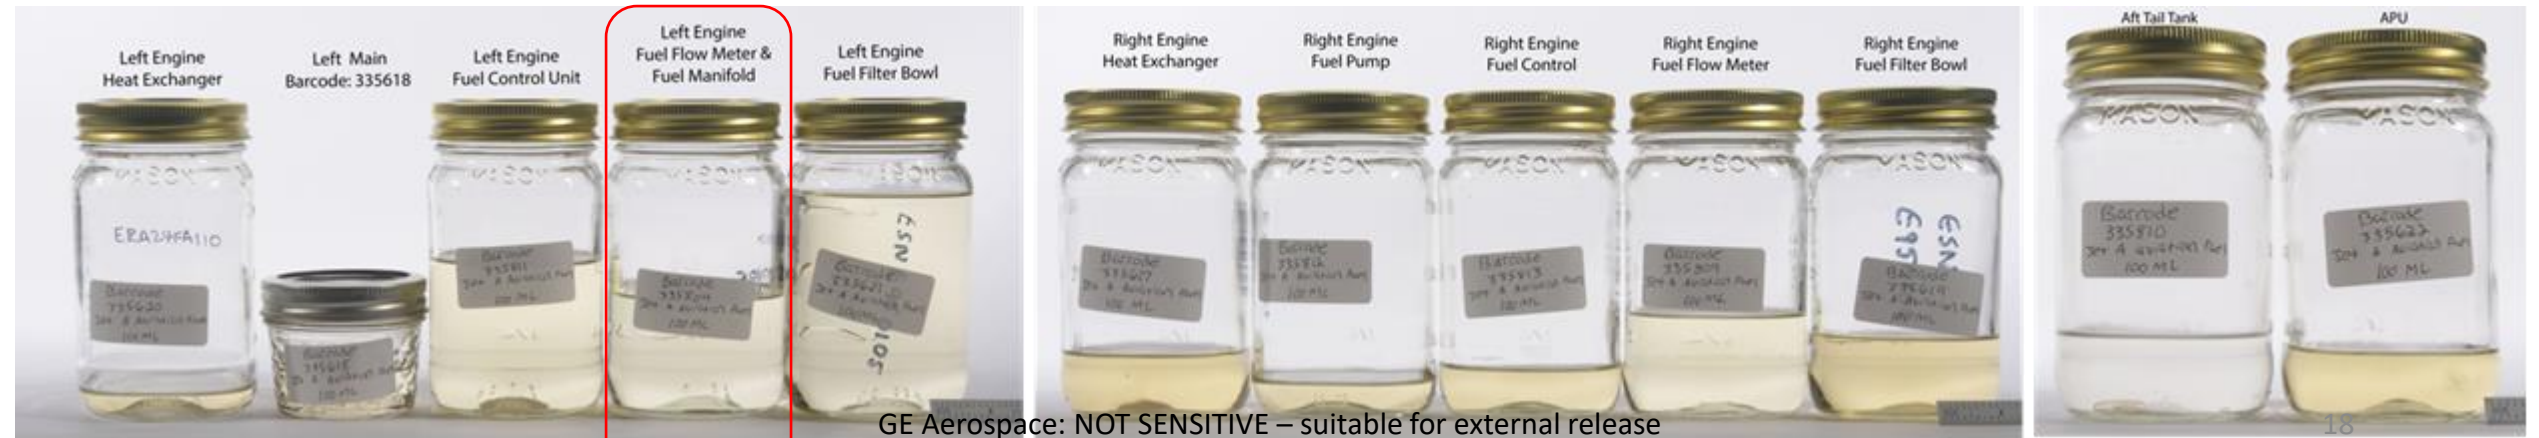
| LIMS ID | Barcode | Sampling location |
|---|---|---|
| NSK24-00850-0007 | 335804 | left engine fuel flow meter and fuel manifold |

# GE Aerospace Research: Analysis of Jet A Fuels using Direct Injection 2D GC-ToF MS [Contour Plot for TIC]

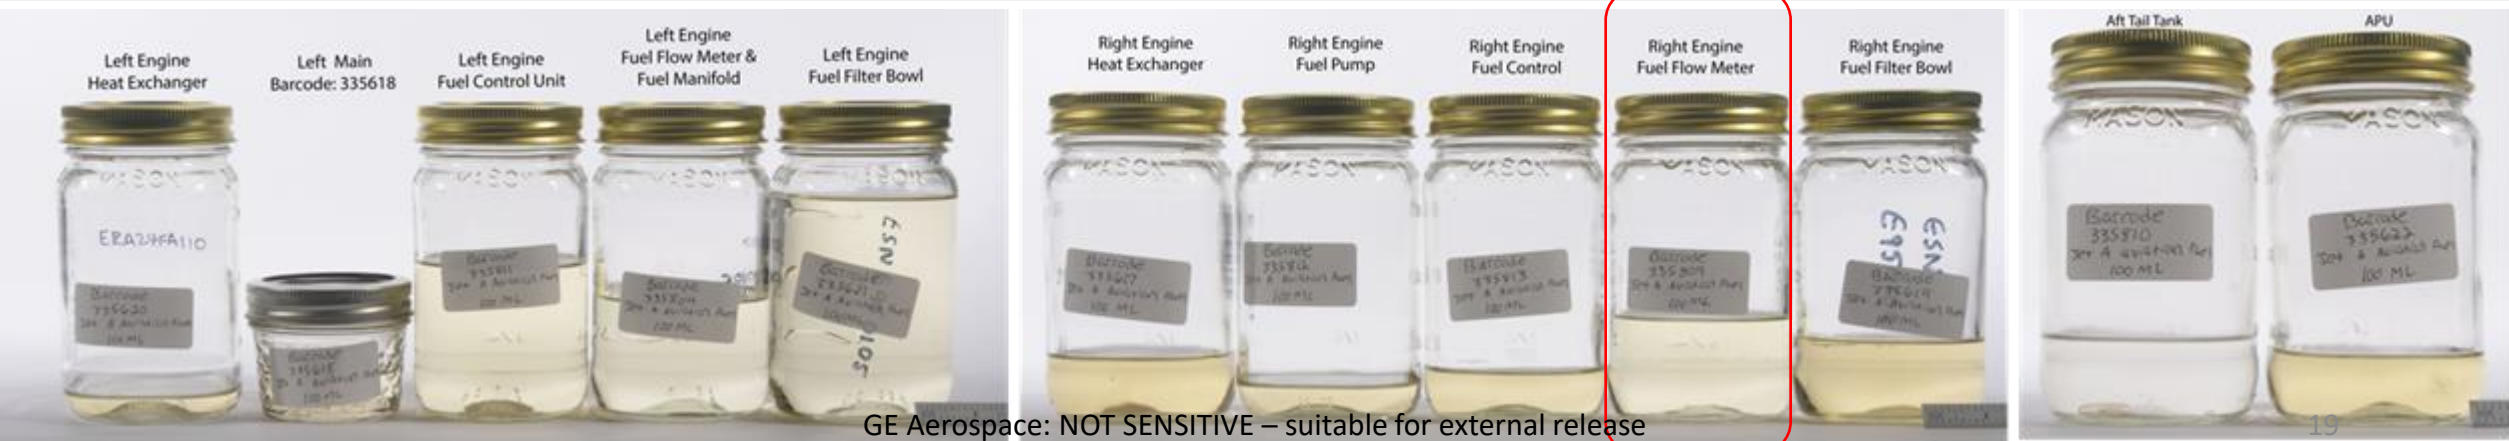
| LIMS ID | Barcode | Sampling location |
|---|---|---|
| NSK24-00850-0008 | 335809 | right engine fuel flow meter |

# GE Aerospace Research: Analysis of Jet A Fuels using Direct Injection 2D GC-ToF MS [Contour Plot for TIC]

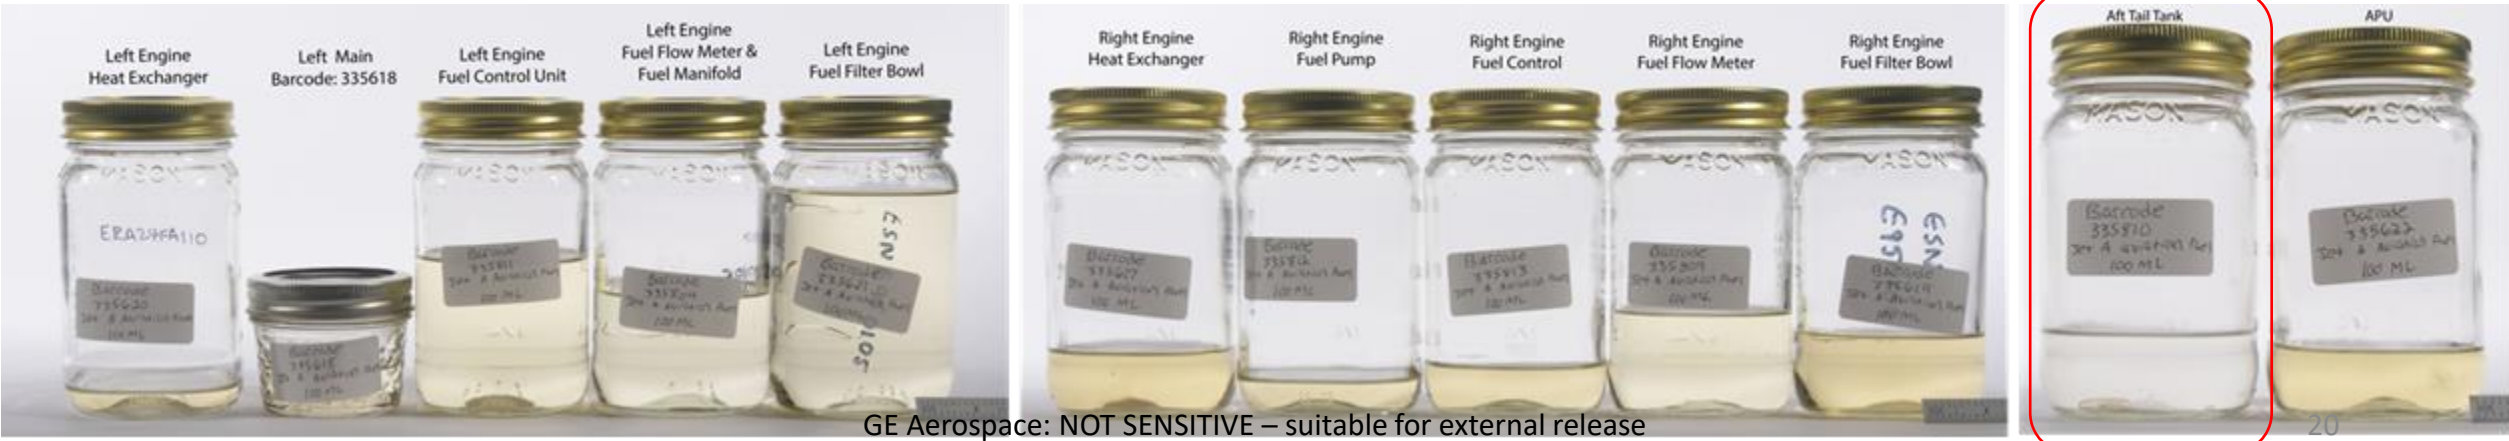
| LIMS ID | Barcode | Sampling location |
|---|---|---|
| NSK24-00850-0009 | 335810 | AFT tail tank |

# GE Aerospace Research: Analysis of Jet A Fuels using Direct Injection 2D GC-ToF MS [Contour Plot for TIC]

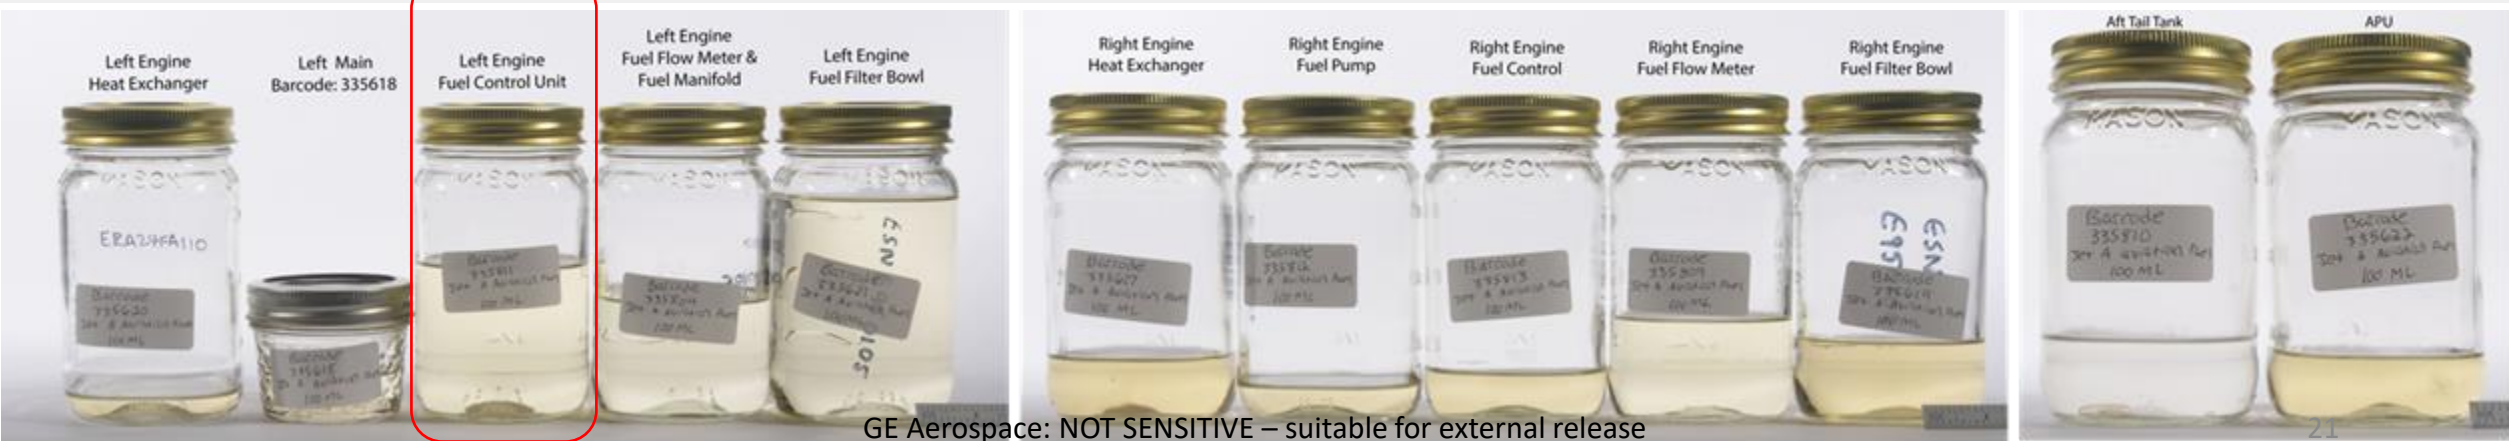
| LIMS ID | Barcode | Sampling location |
|---|---|---|
| NSK24-00850-0010 | 335811 | left engine fuel control unit |

# GE Aerospace Research: Analysis of Jet A Fuels using Direct Injection 2D GC-ToF MS [Contour Plot for TIC]

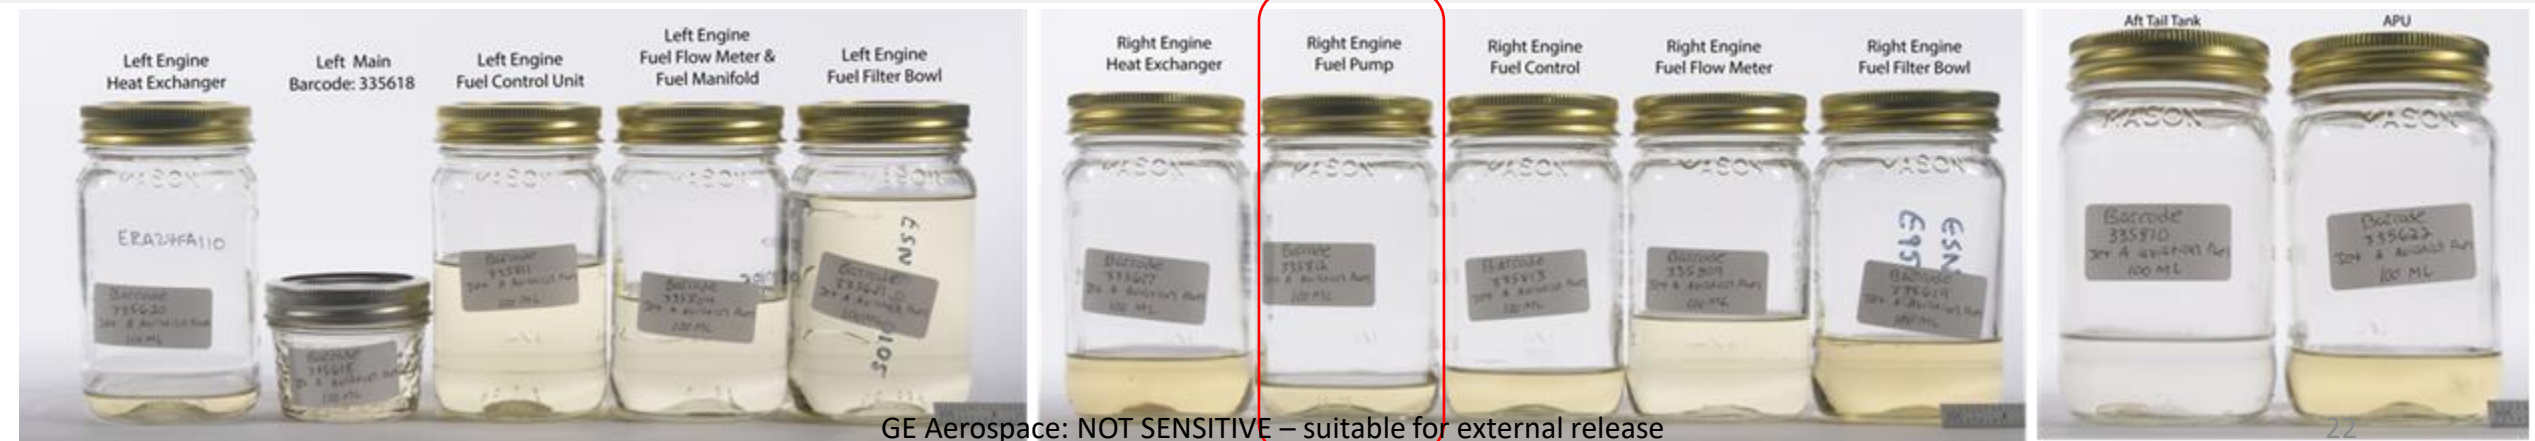
| LIMS ID | Barcode | Sampling location |
|---|---|---|
| NSK24-00850-0011 | 335812 | right engine fuel pump |

GE Aerospace Research: Analysis of Jet A Fuels using Direct Injection 2D GC-ToF MS [Contour Plot for TIC]

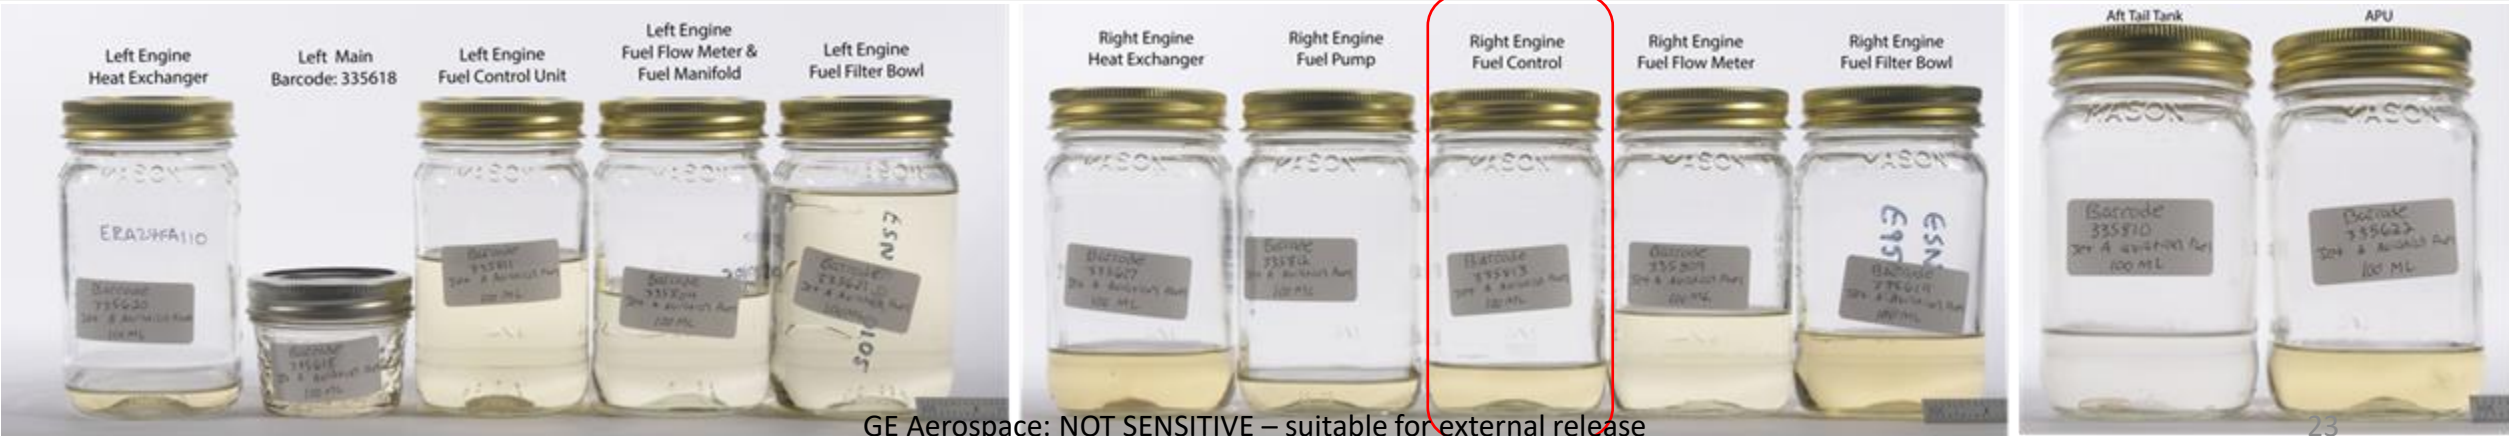
| LIMS ID | Barcode | Sampling location |
|---|---|---|
| NSK24-00850-0012 | 335813 | right engine fuel control |

# GE Aerospace Research: Analysis of Jet A Fuels using Direct Injection 2D GC-ToF MS [Contour Plot for TIC]
