## INCIDENT INVESTIGATION REPORT

### Component Inspection and Flow Check - RSA Fuel Injection

PAM Work Order Number: \_\_\_\_\_  
Aircraft Type: Piper PA-32RT  
Engine Model Number: TIO-540-S1AD  
Incident Location: Nashville, TN

Component Type: Servo

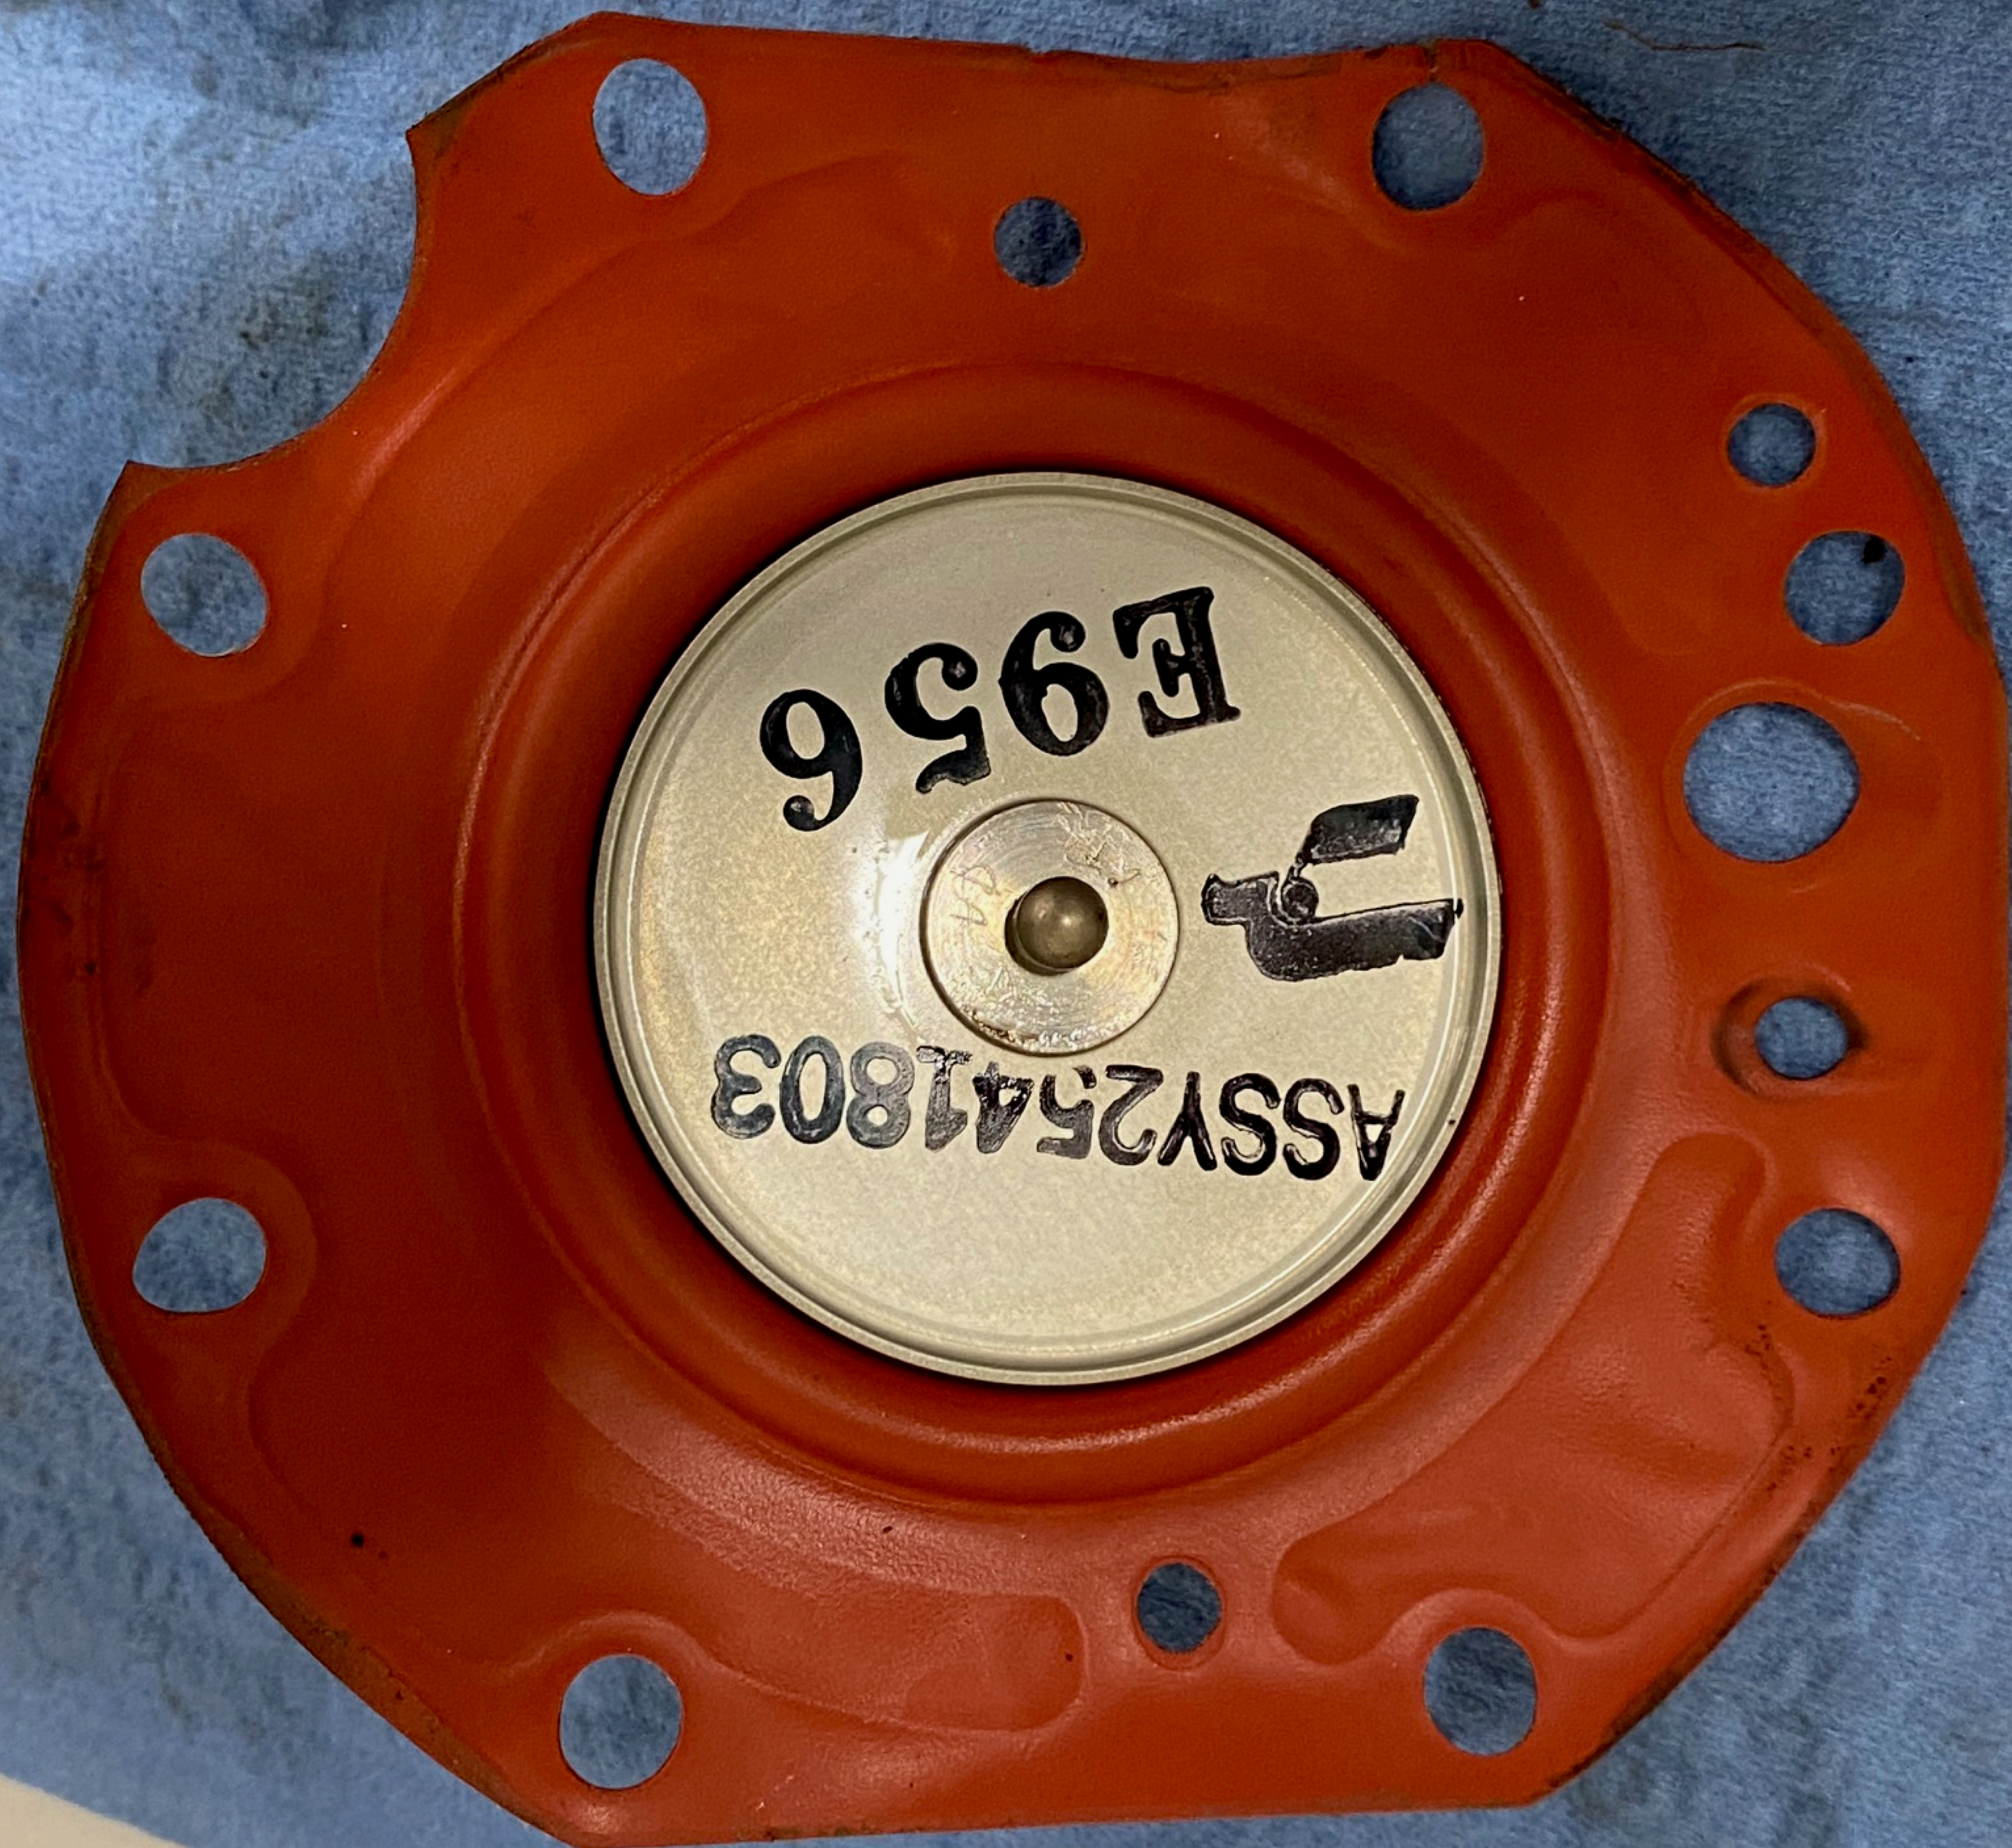
RSB-10E-D

69748

2524693-1

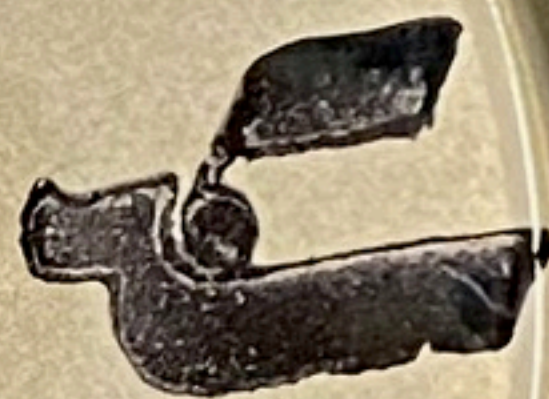
E956

OK, P/N 2541803, code: E956.
