# National Transportation Safety Board

ERA24FA206

## **AIRCRAFT PERFORMANCE**

Specialist's Study

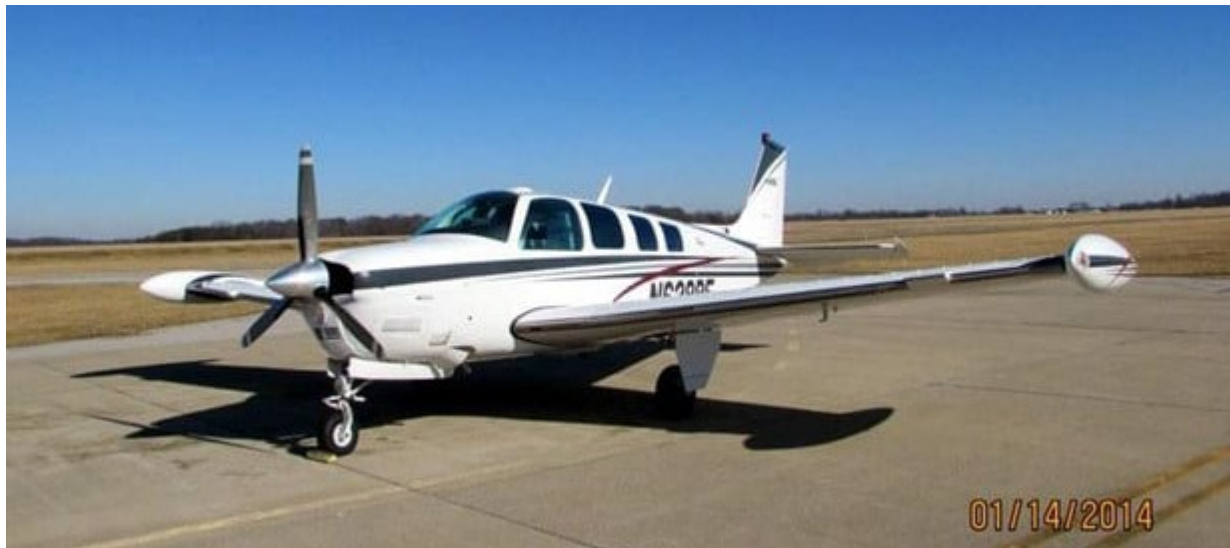
Figure 1. The accident airplane, N629BE. Photograph from AIRCRAFT.COM.

The airplane was a Raytheon Aircraft Company A36, a low-wing, single-engine airplane with retractable gear that seats six. The A36 is a variant of the Beechcraft Bonanza produced from 1970 to 2005. N629BE was serial number E-3287, manufactured in 1999, equipped with a Continental IO-550 motor and registered to WBME LLC<sup>1</sup>. A photograph of the airplane is shown in Figure 1.

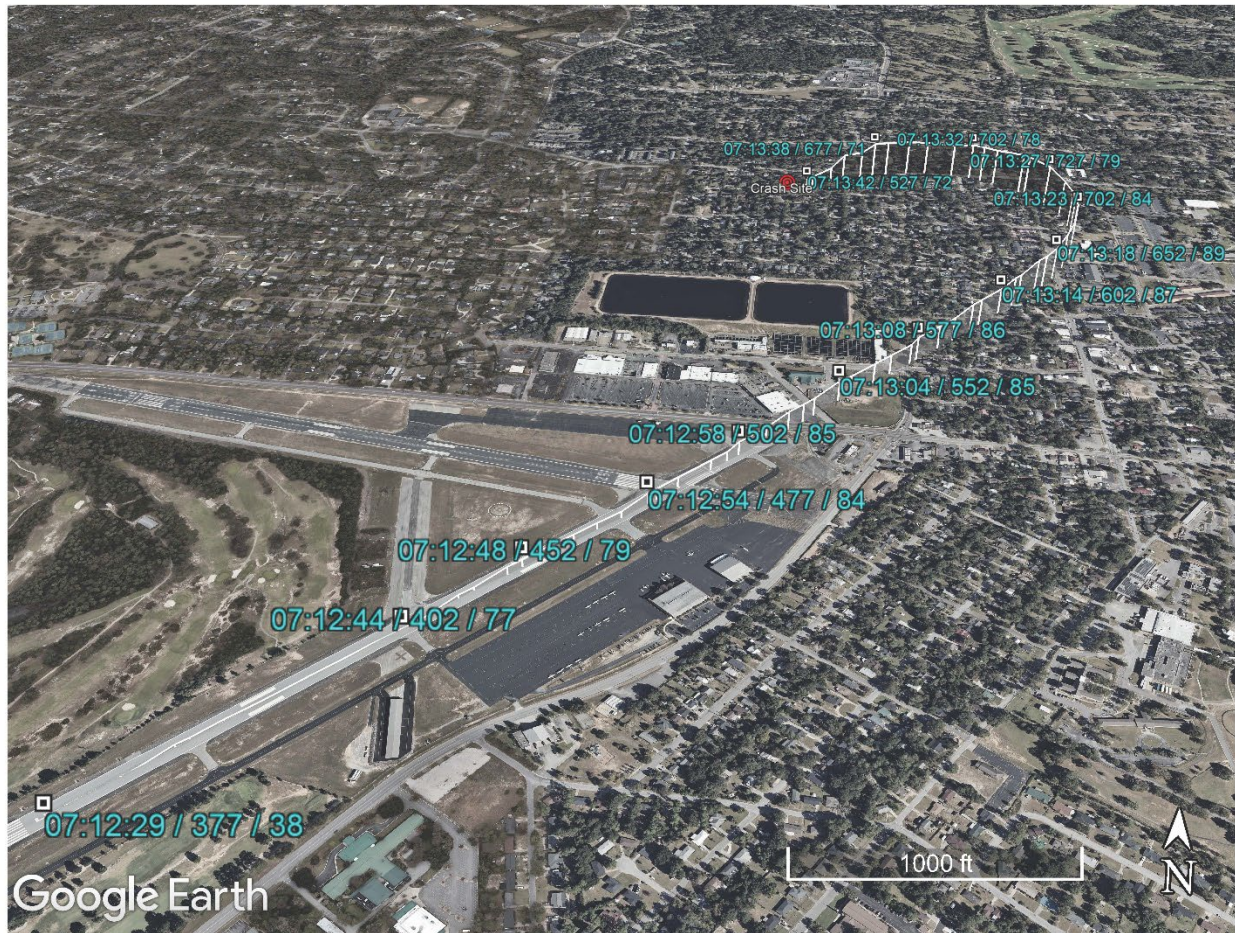
Figure 2. Overall view of the flight path with selected points annotated with time EDT (hh:mm:ss), MSL altitude in ft, and calibrated airspeed in kt. The crash site is indicated with a red symbol.

An overall view of the flightpath is shown in Figure 2. The ADS-B data recorded 73.6 seconds of ground roll and flight. The crash site was located at 33.47759° North, 82.03308° West.
