# National Transportation Safety Board

ERA24FA217

## **METEOROLOGY**

Specialist's Factual Report

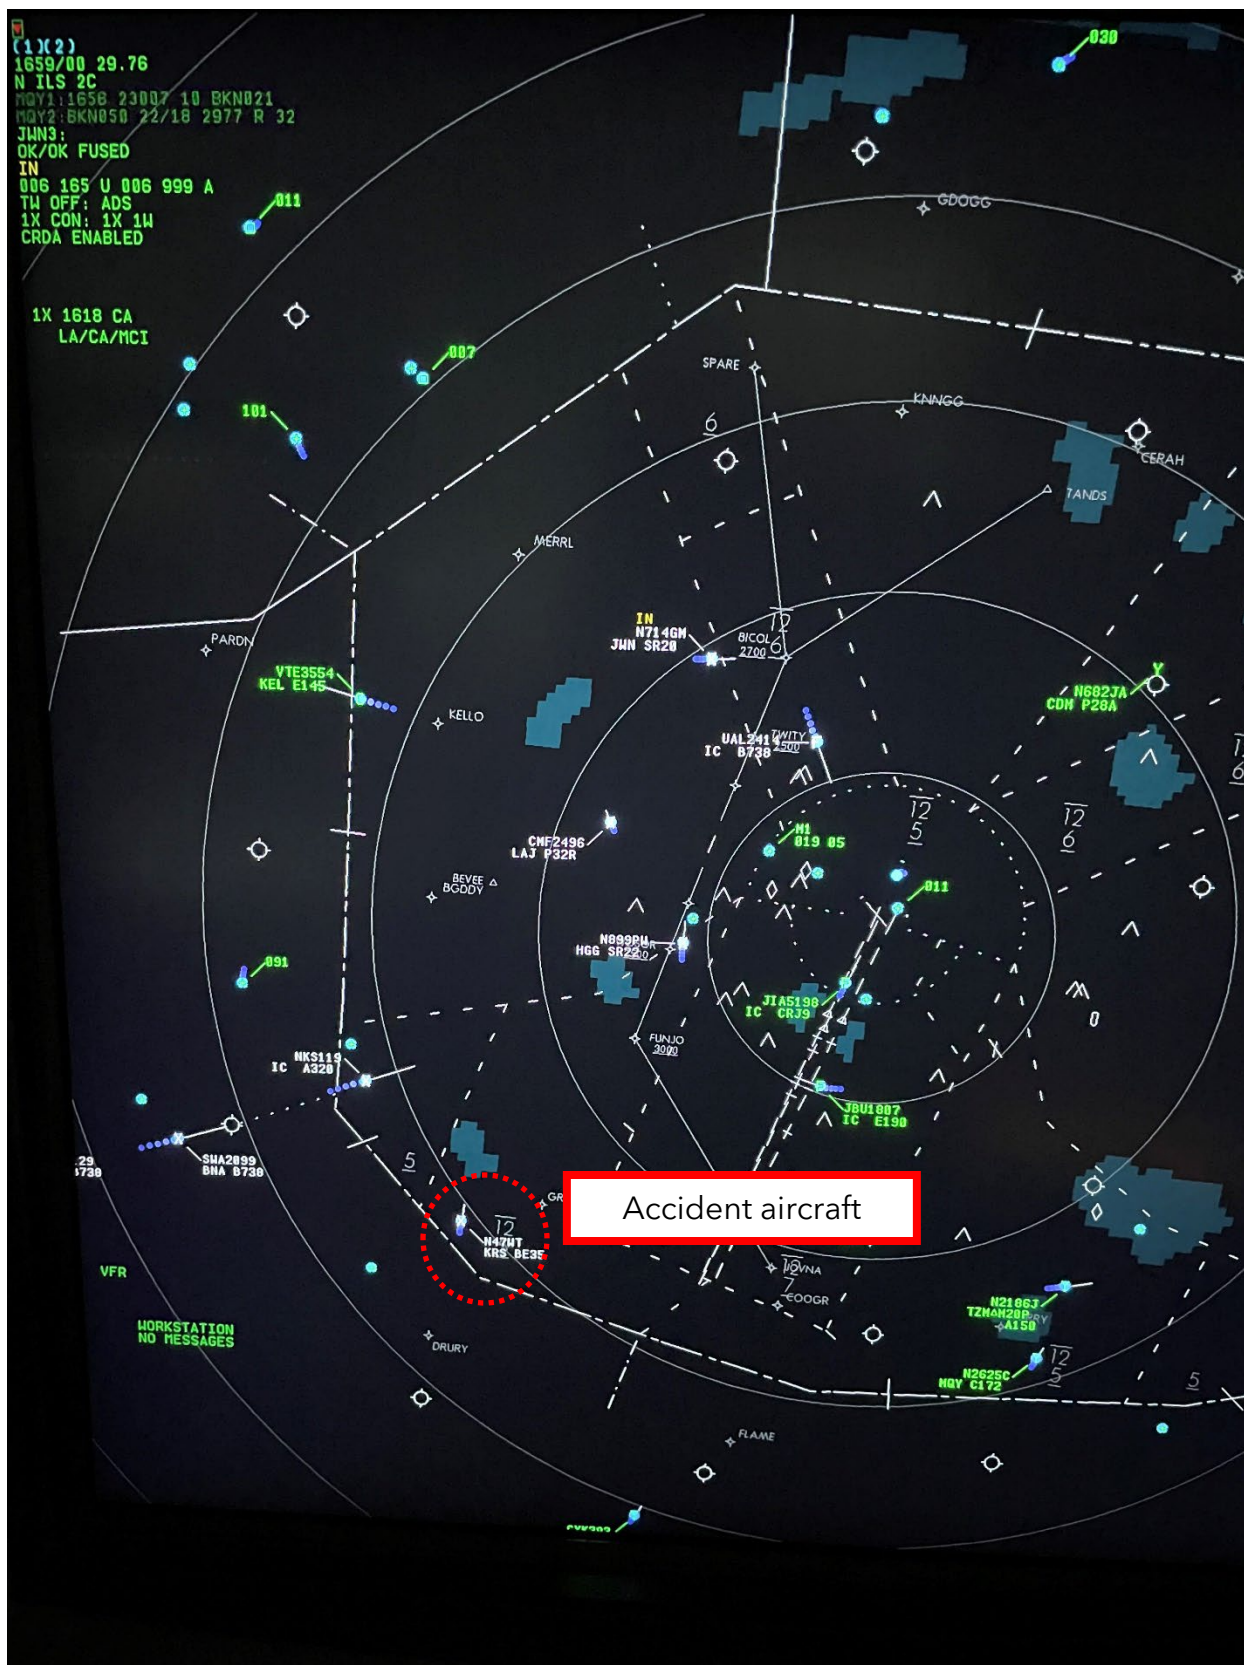
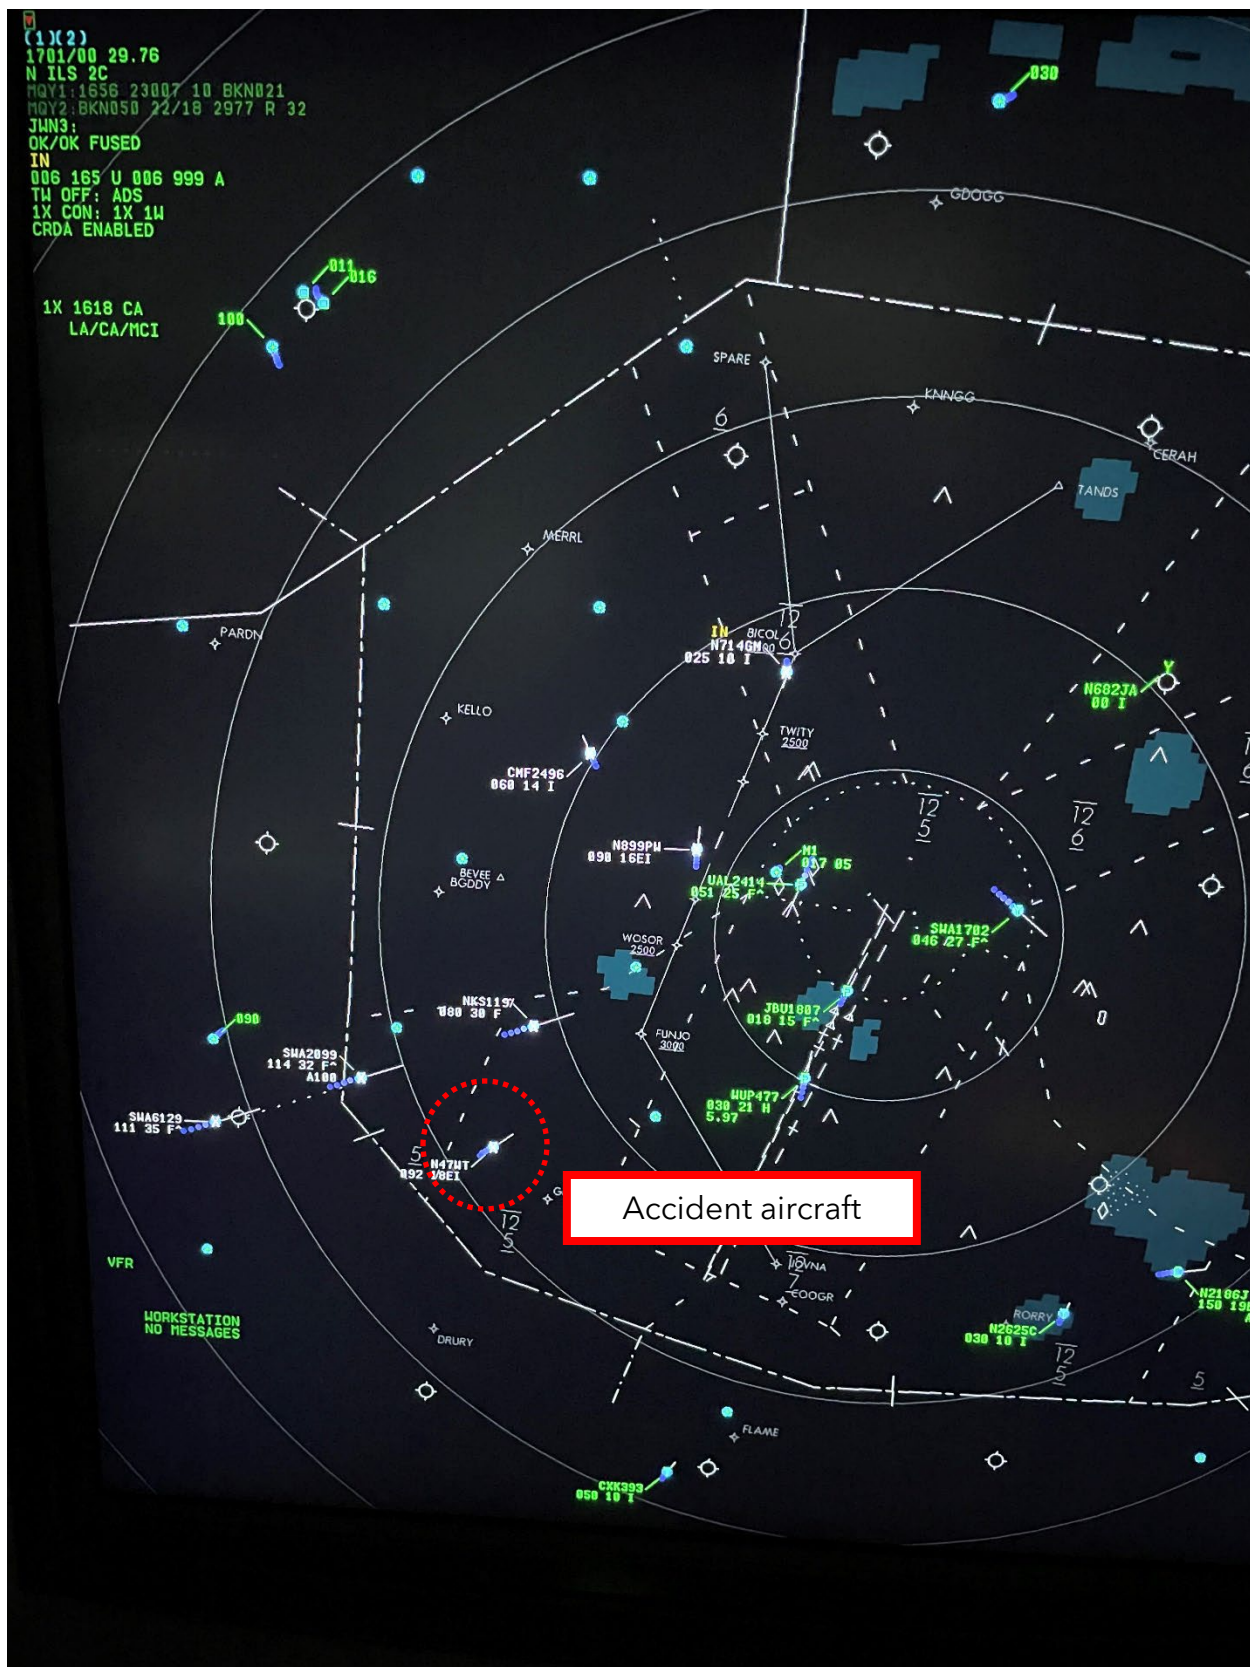
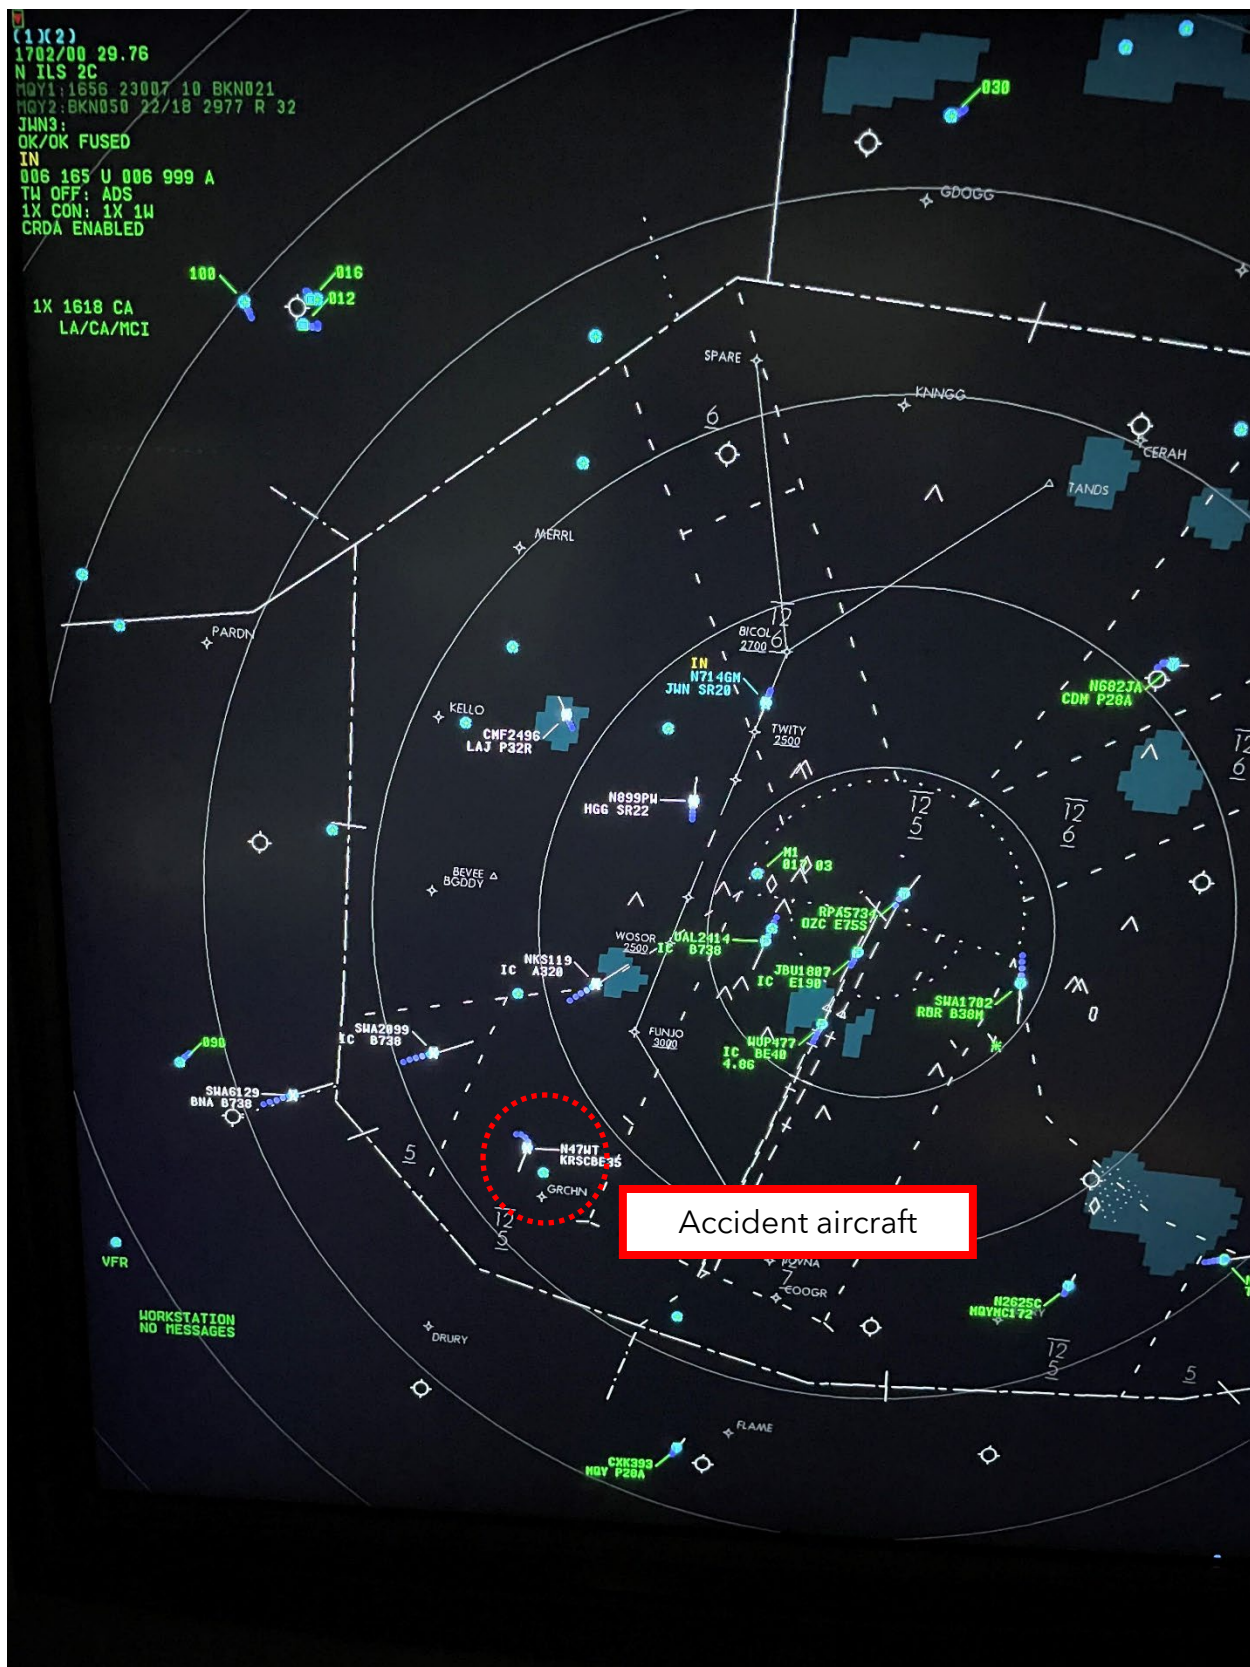
Figure 24 provides an exemplar view of what precipitation levels 1 through 6 look like on STARS display of precipitation. Level 1 is described as "light", level 2 is described as "moderate", level 3 and 4 are described as "heavy", and level 5 and 6 are described as "extreme." Figures 25 through 27 show the STARS display of precipitation used and seen by the accident controller at 1159, 1201, and 1202 CDT. The accident aircraft did not encounter any precipitation noted on STARS throughout the last 11 minutes of the accident flight. For more imagery please see attachment 3.

**Figure 25.** Screenshot of the DRW displayed precipitation from 1159:00 CDT.

**Figure 27.** Screenshot of the DRW displayed precipitation from 1202:00 CDT.

Daily facility logs from BNA TRACON indicated several weather display concerns for STARS to include, "6 level wx works in linear mode and ASR weather intermittent." For more information on these details please see the ATC factual report for this accident and attachment 4.

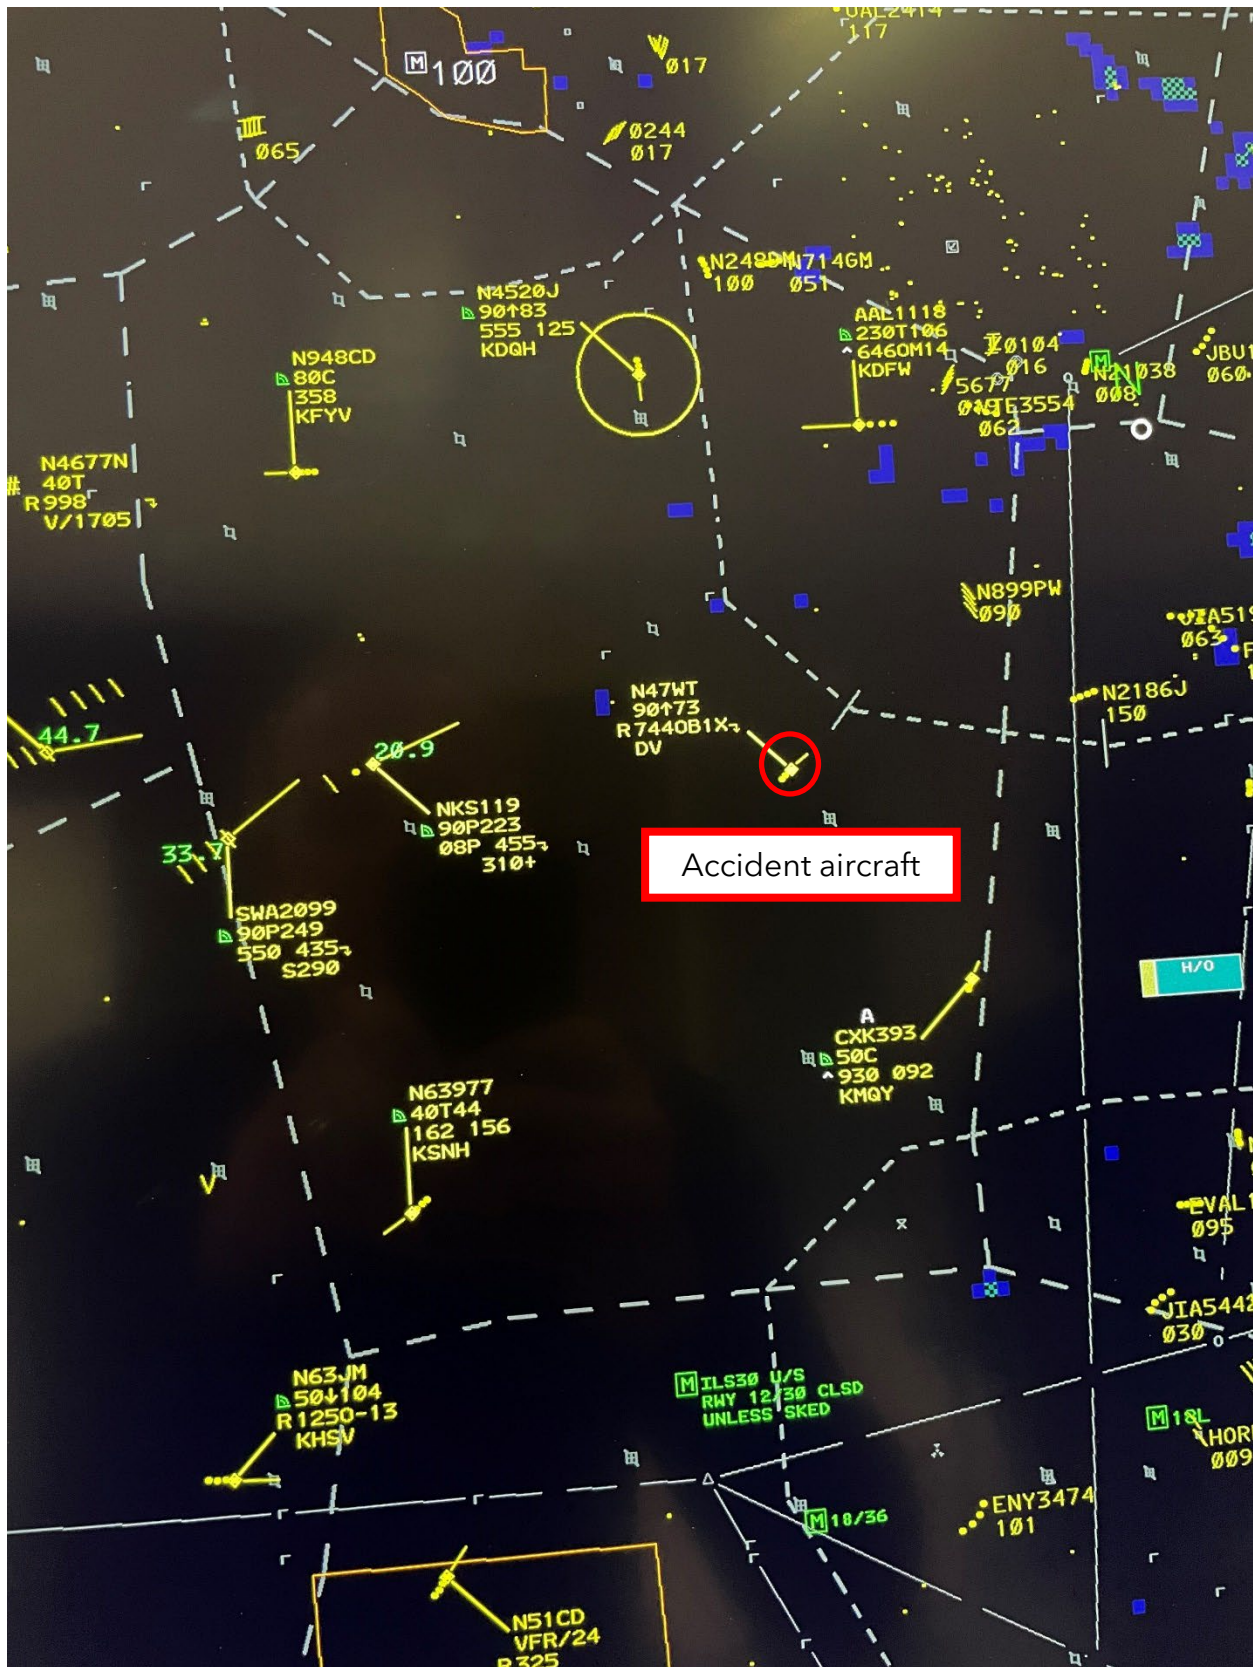
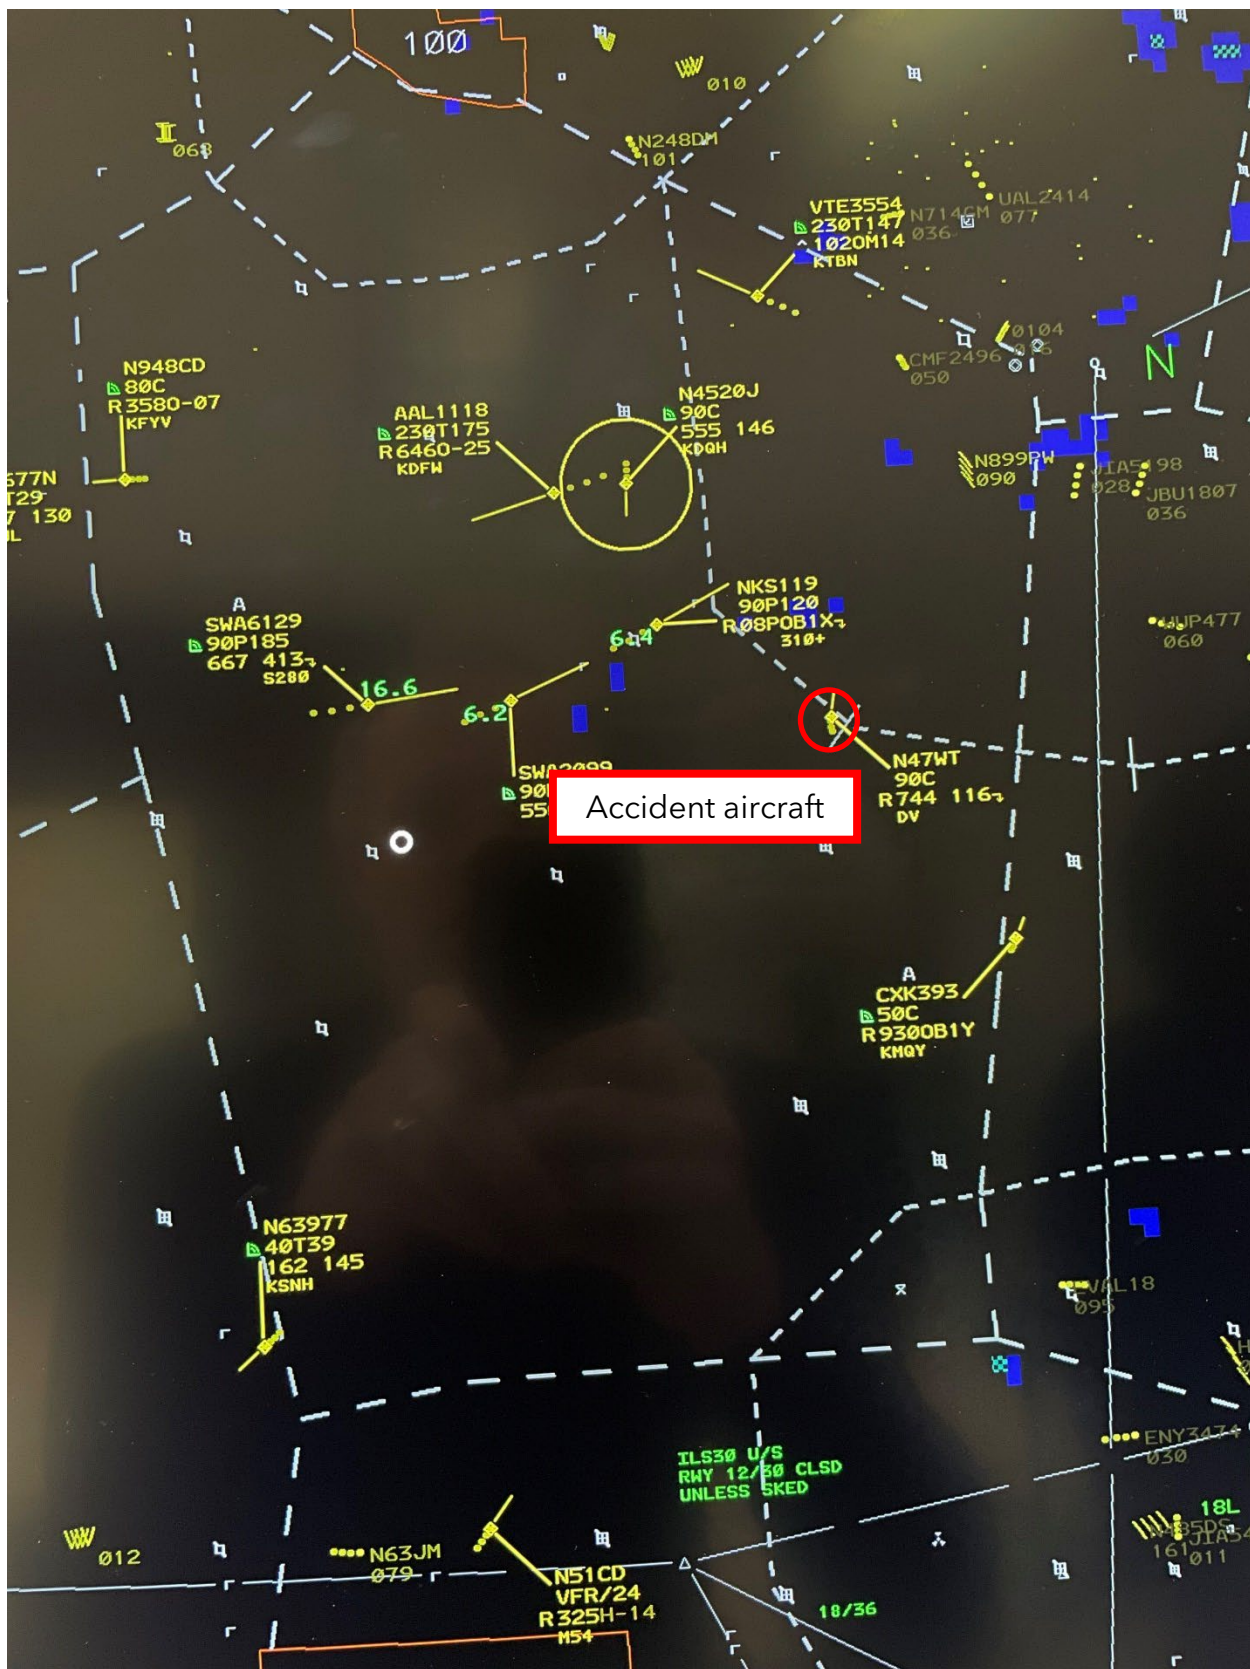
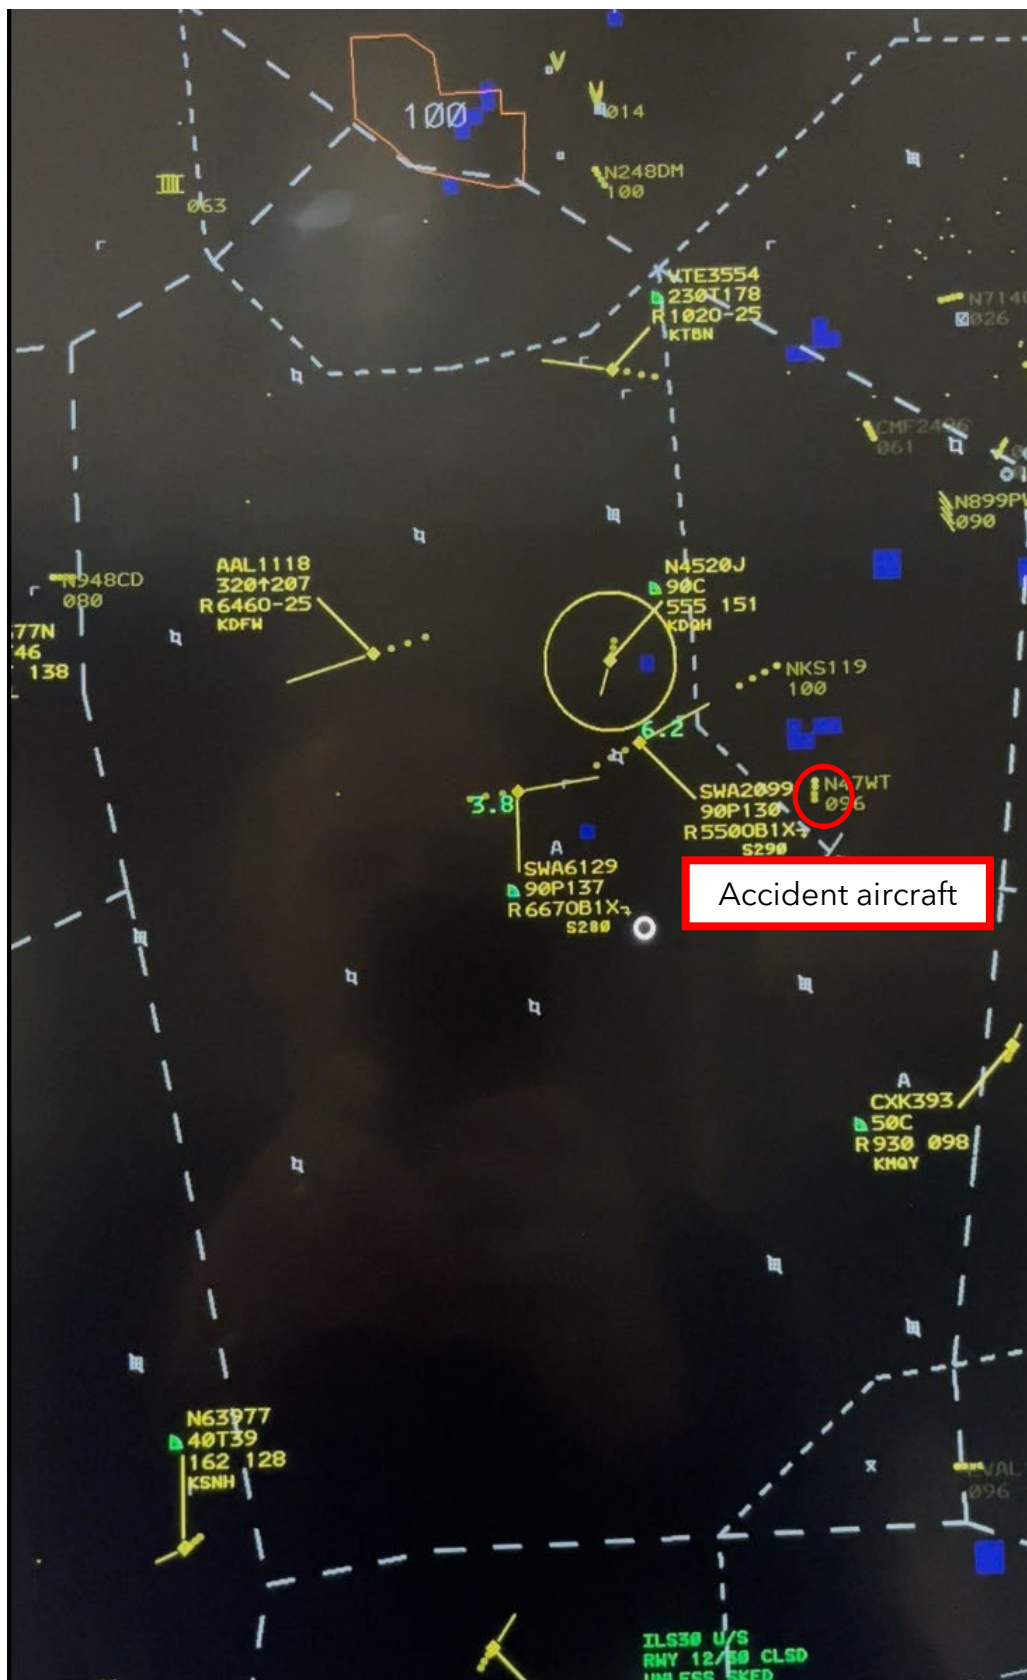
Figure 28 provides an exemplar display of ERAM-displayed precipitation. Precipitation levels follow the categories in section 6.3. Figures 29 through 32 show the sector R14/R42 ERAM displayed precipitation at 1148, 1154, 1158, and 1200 CDT. For more imagery please see attachment 5.

**Figure 29.** Screenshot of the sector R14/R42 ERAM displayed precipitation from 1148:00 CDT.

**Figure 30.** Screenshot of the sector R14/R42 ERAM displayed precipitation from 1154:00 CDT.

**Figure 31.** Screenshot of the sector R14/R42 ERAM displayed precipitation from 1158:00 CDT.

**Figure 32.** Screenshot of the sector R14/R42 ERAM displayed precipitation from 1200:00 CDT.
