# **NATIONAL TRANSPORTATION SAFETY BOARD**

## **UAS Aerial Imagery Summary**

### **A.     ACCIDENT                      ERA24FA217**

Location:                      Franklin, Tennessee  
Date:                              May 15, 2024  
Time:                              1204 Local Time (CDT)  
Event:                              Airplane in-flight breakup and impact with terrain

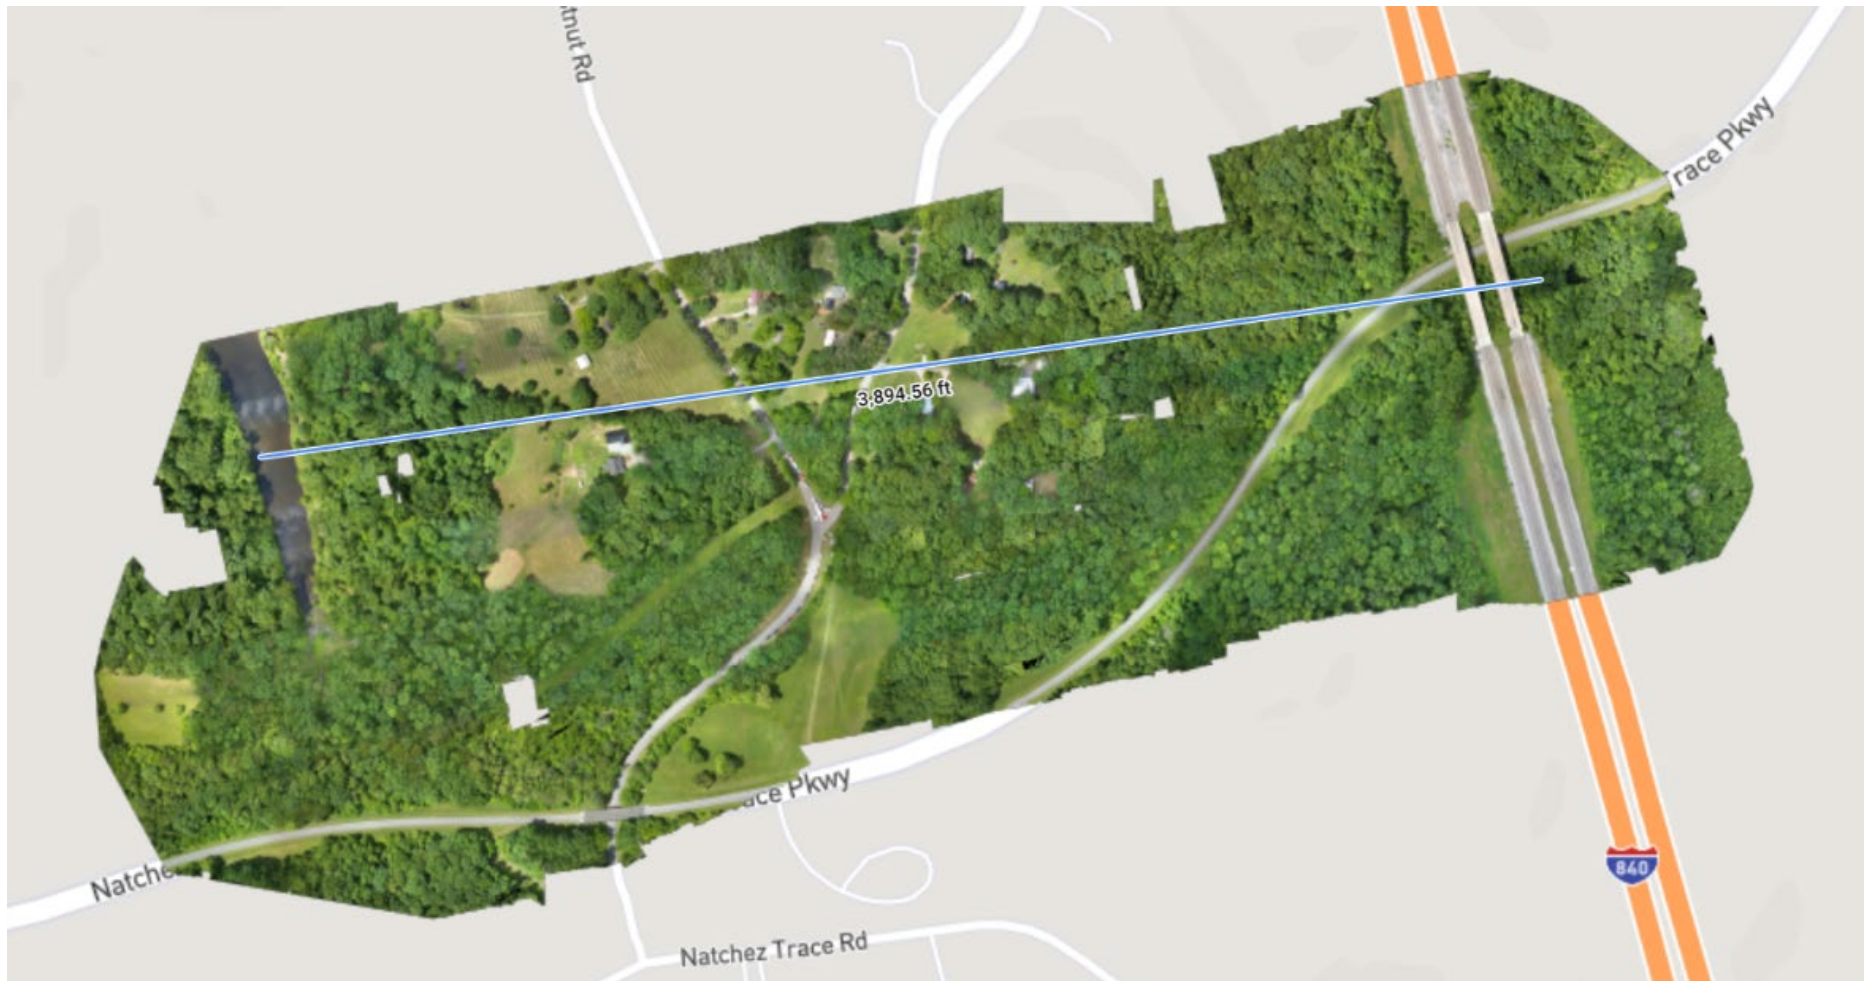
**Figure 2. Orthomosaic overlay on Google Earth with debris field (area of initial and final debris) measurement.**

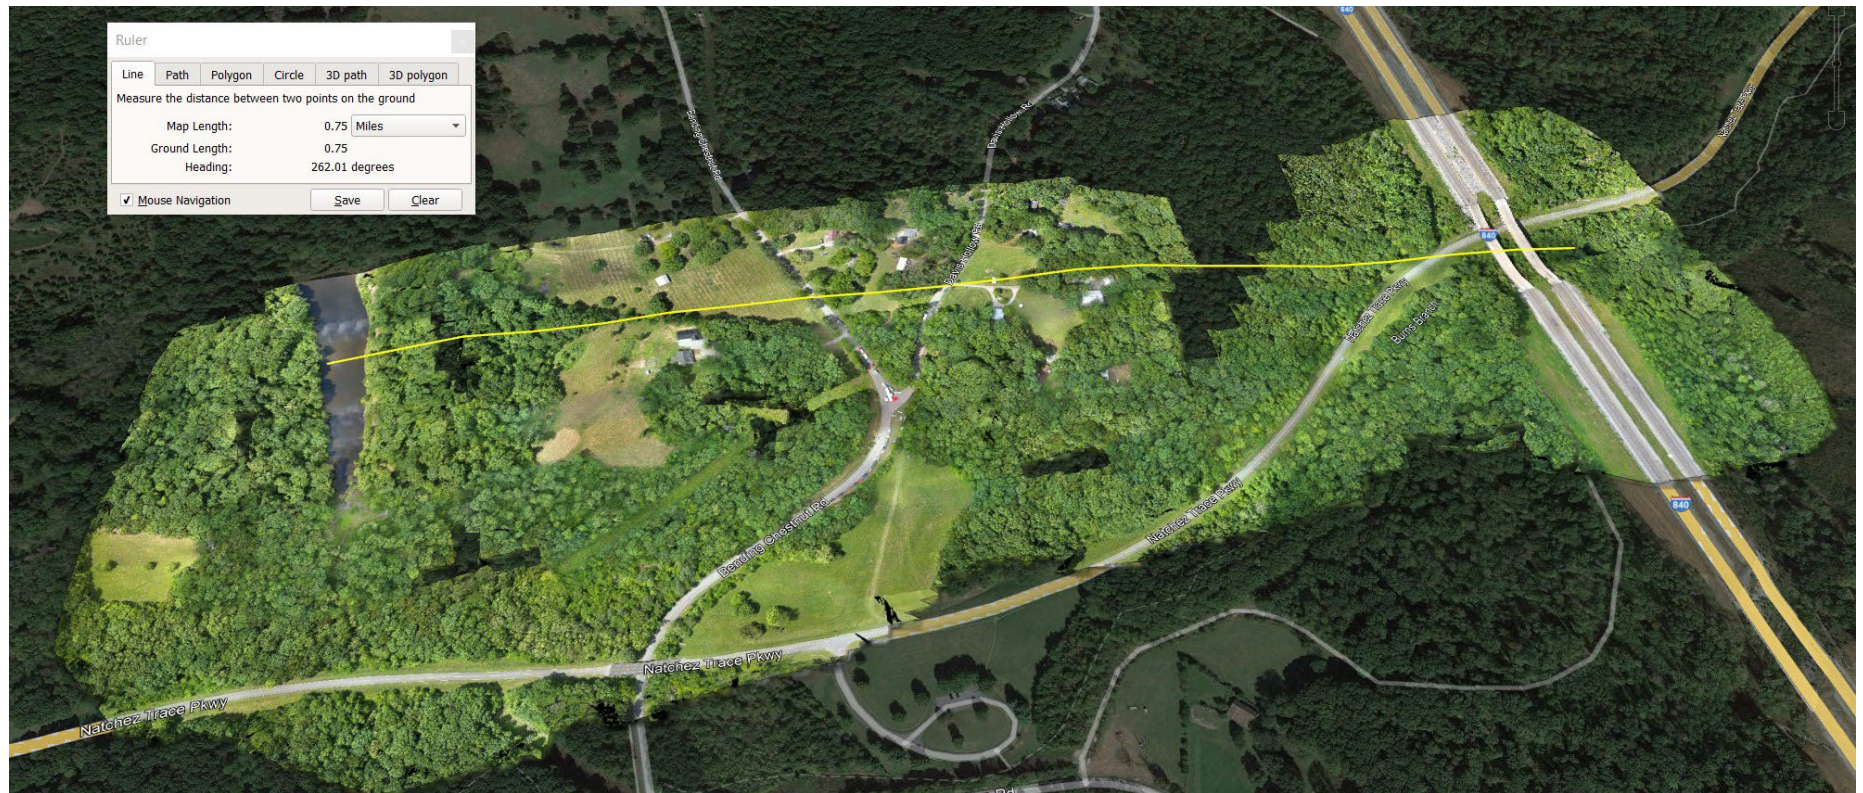
**Figure 3. Orthomosaic overlay on Google Earth with debris field measurement (area of initial and final debris) and heading.**

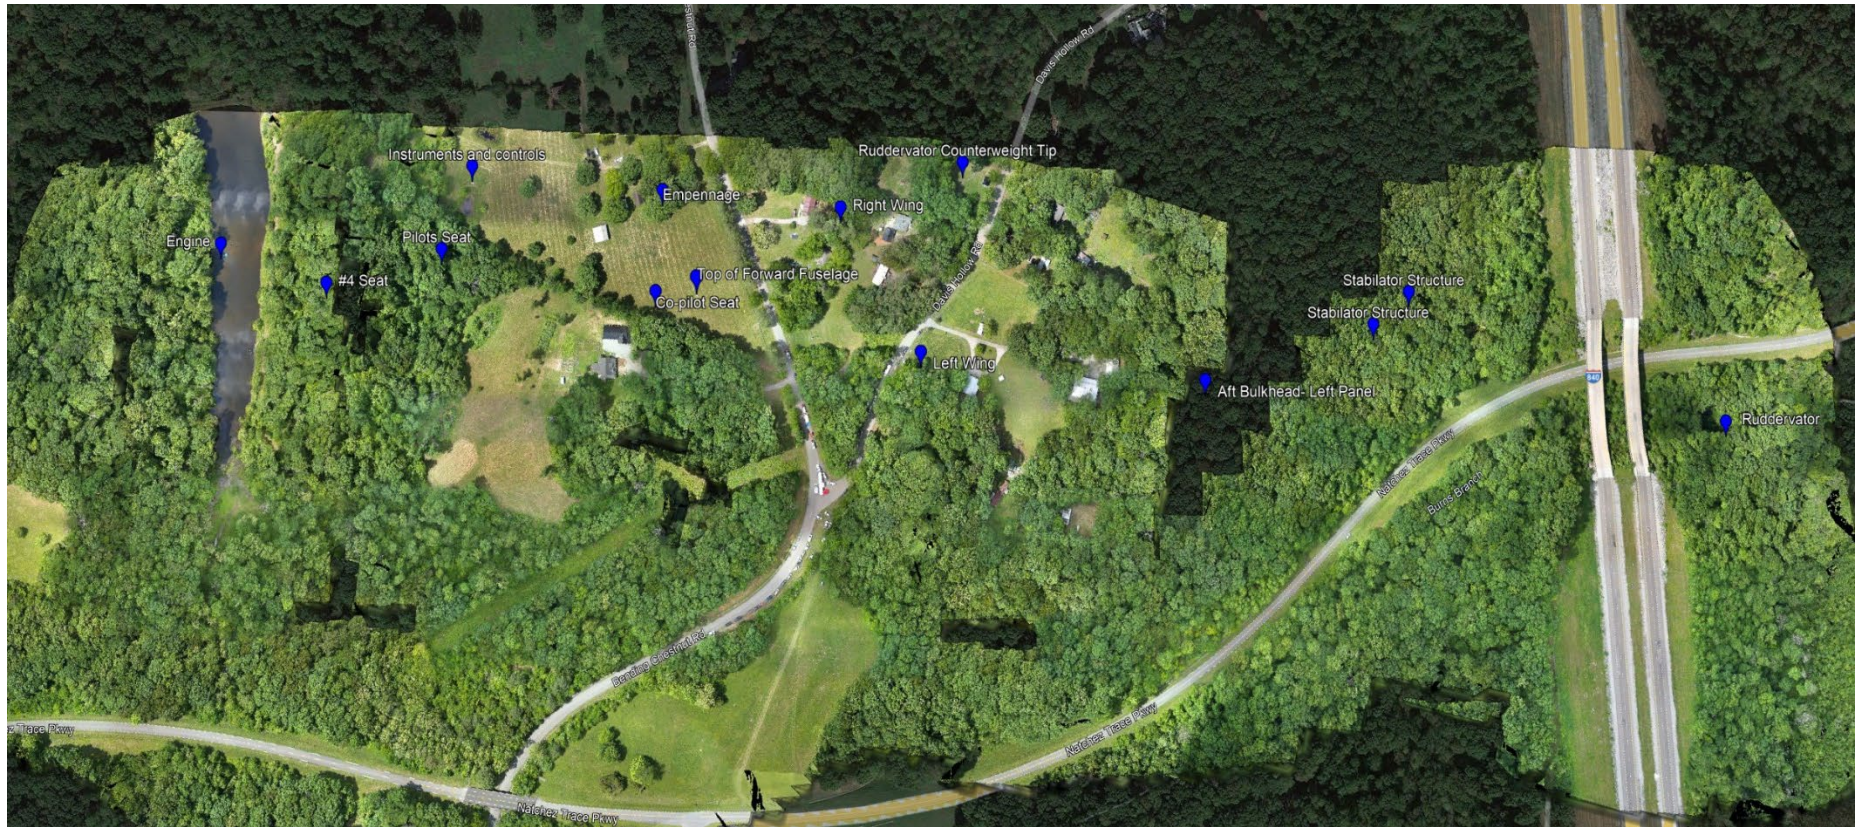
**Figure 4. Orthomosaic overlay on Google Earth with some major debris components identified.**

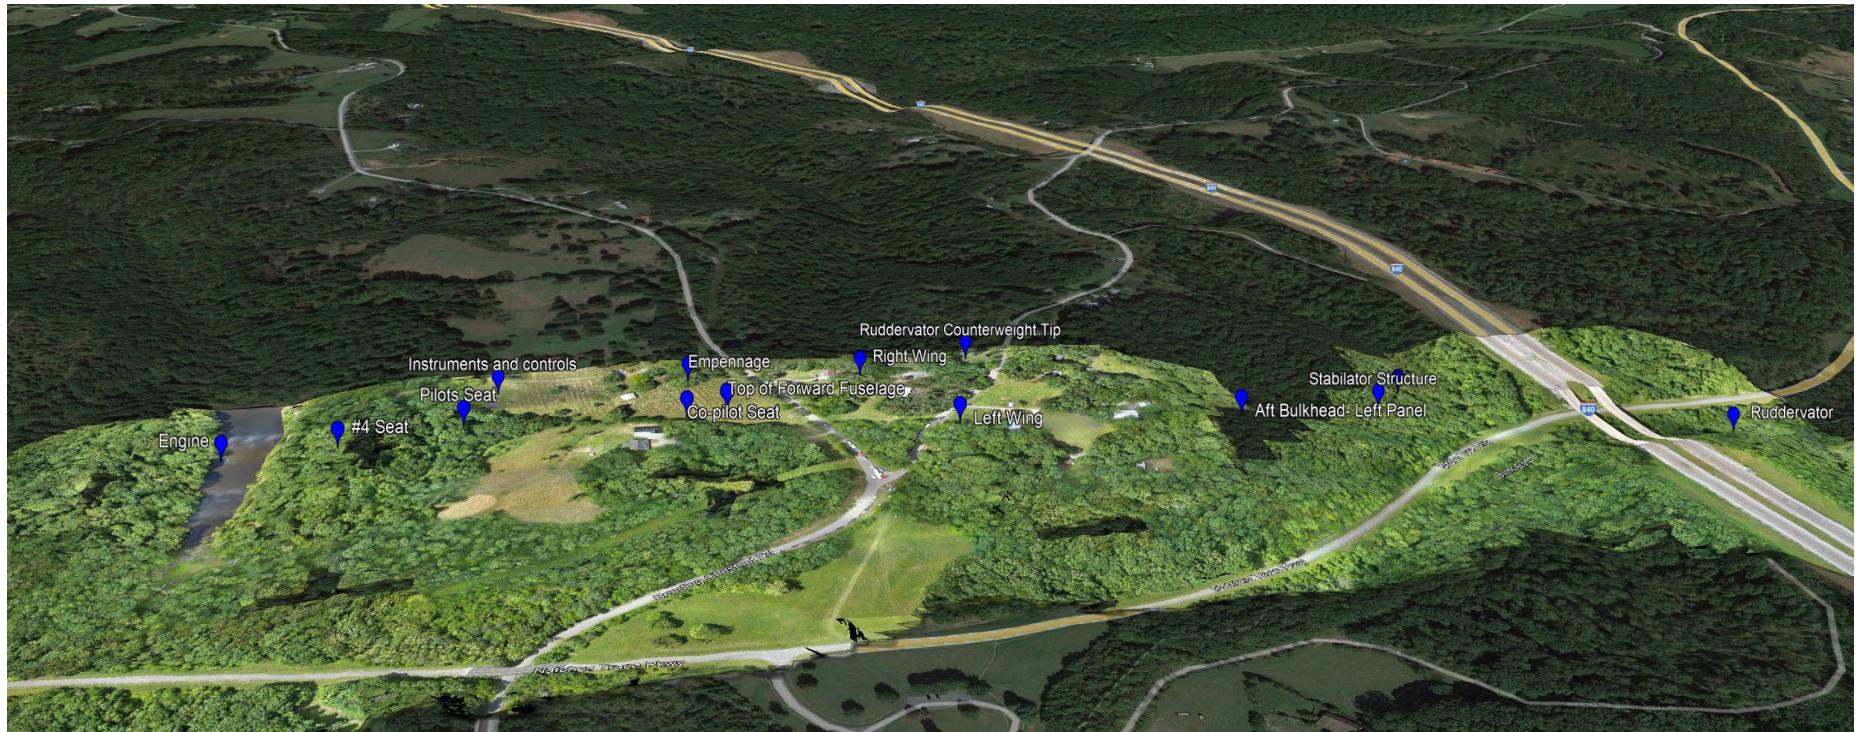
**Figure 5. Orthomosaic overlay on Google Earth with some major debris components identified.**

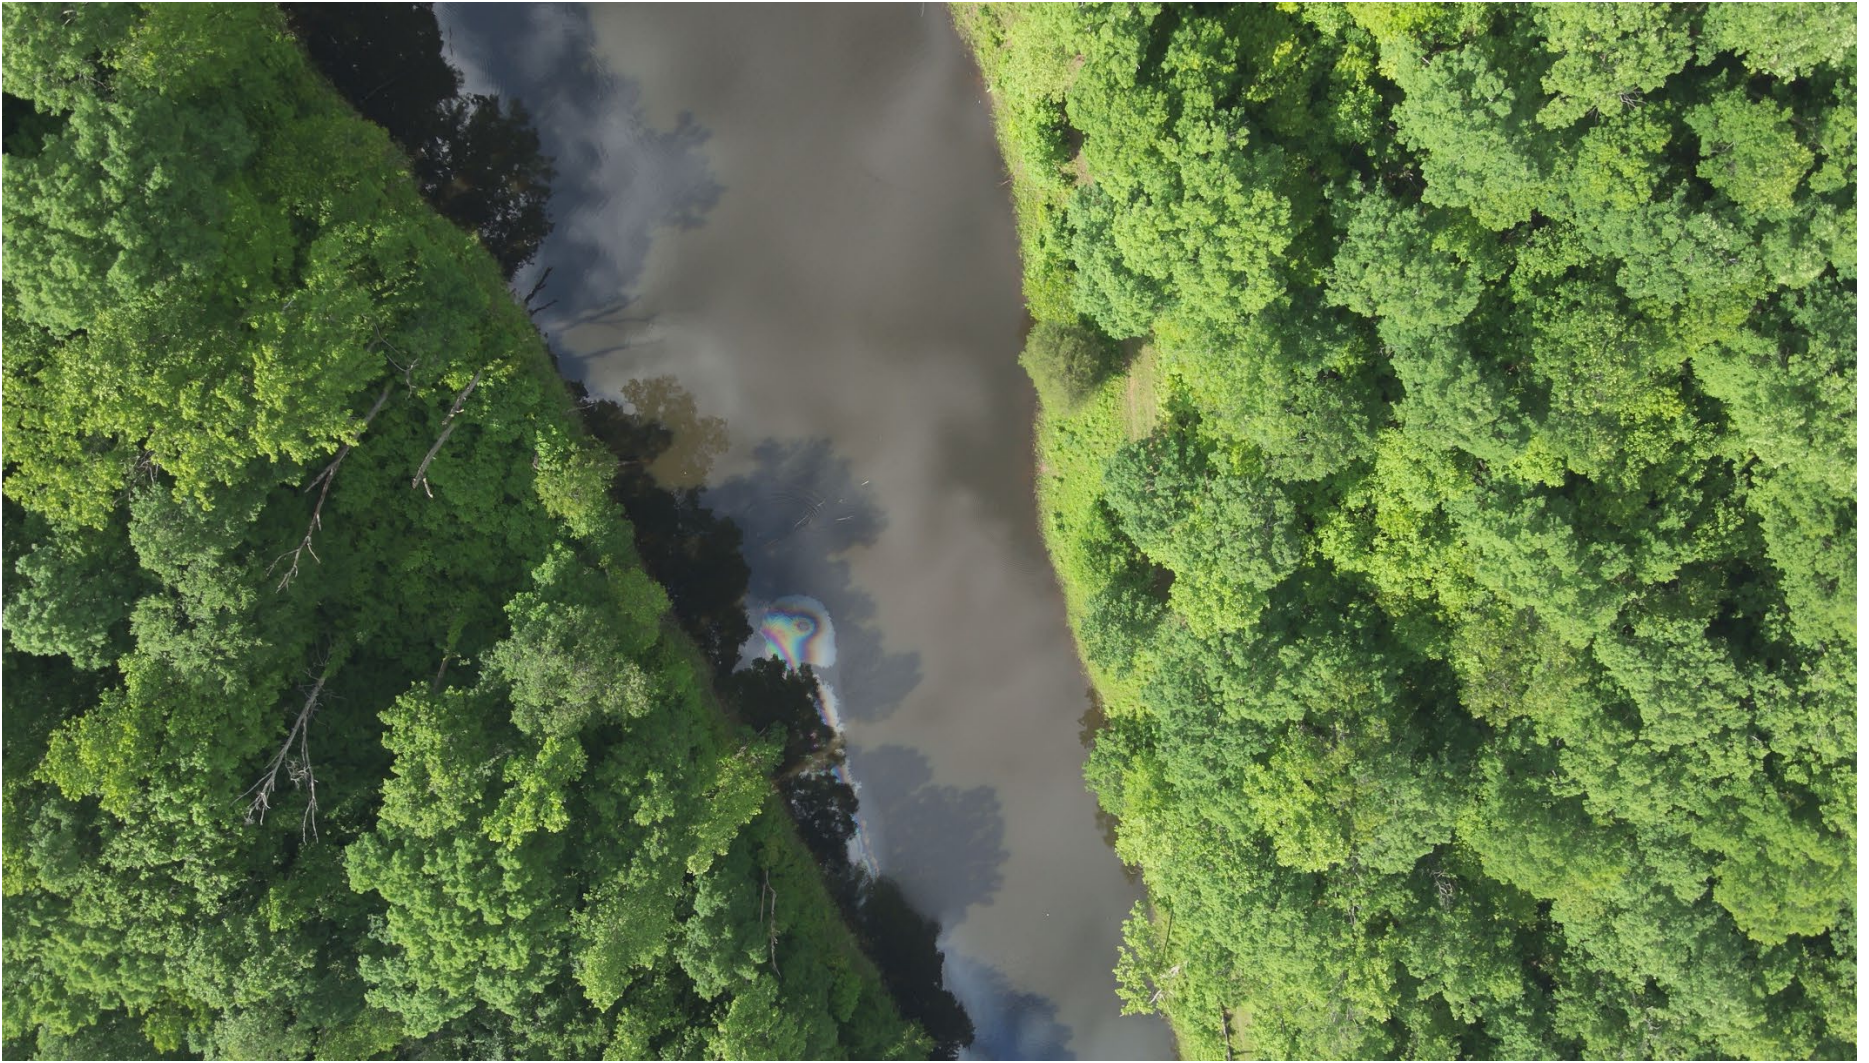
**Figure 8. Oil/fluid sheen in a small lake; location of airplane engine and propeller.**
