# National Transportation Safety Board

ERA24FA217

## **ELECTRONIC DEVICES**

Location: Franklin, Tennessee  
Date: May 15, 2024  
Time: 1202 central daylight time (CDT)  
Airplane: Beech V35, Private, N47WT

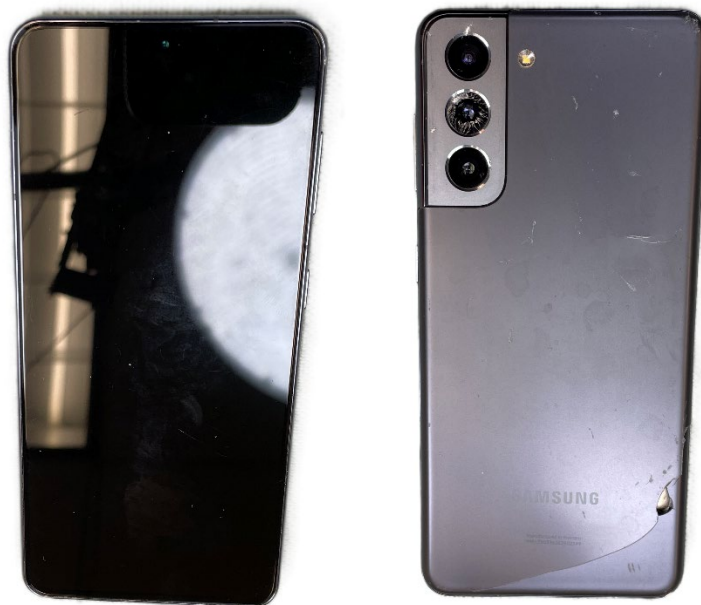
Upon arrival at the Vehicle Recorder Laboratory, an exterior examination revealed impact damage to the rear cover (figure 1). The front screen was intact, but the device could not be powered on. An internal inspection showed that the daughterboard's primary and secondary interconnect cable sockets were damaged. Due to the extent of the damage, normal recovery procedures were not possible. After consulting with the Investigator-in-Charge, additional recovery procedures were not performed, and no data pertinent to the accident were recovered.

**Figure 1.** Samsung Galaxy S21 PED, as received.
