# National Transportation Safety Board

ERA24FA217

## **AIR TRAFFIC CONTROL**

Group Chairman's Factual Report

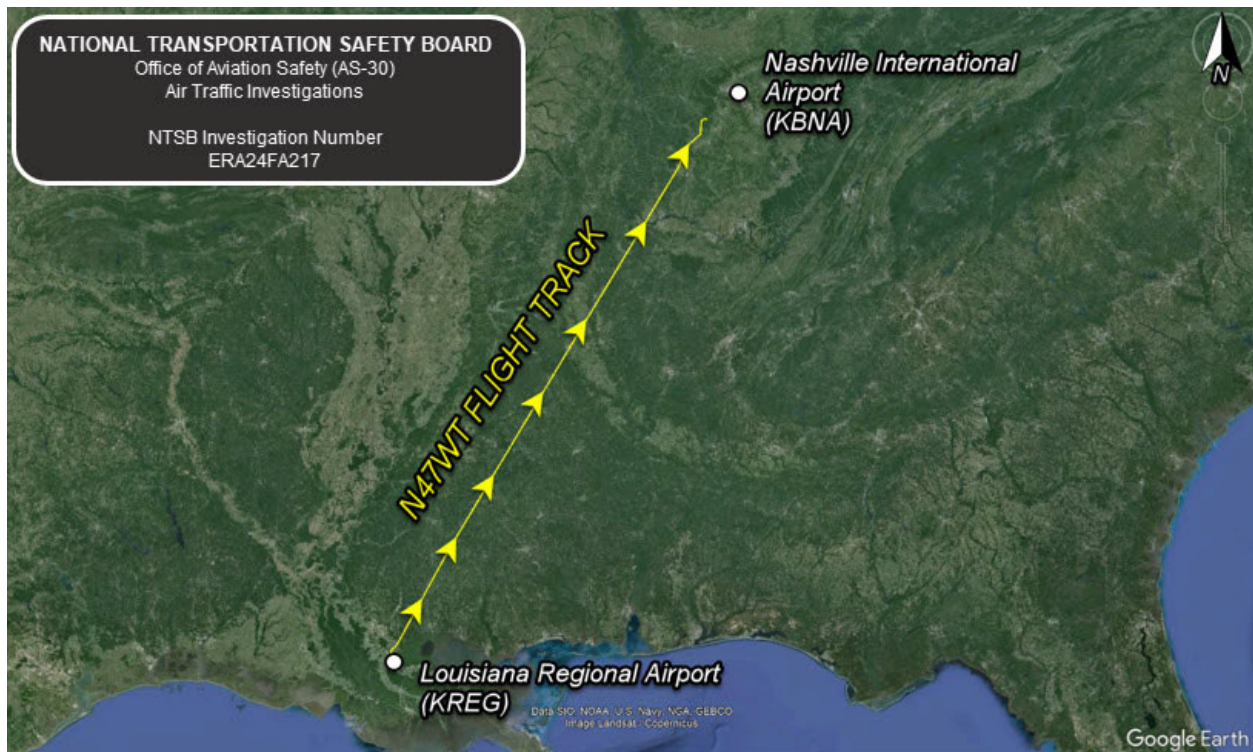
OpsVue data and ADS-B data were both used in creating figures 1-3 below. The flight track is indicated in yellow, with data from the final portion of the flight indicated in blue.

**Figure 1.** Overhead view of entire flight.

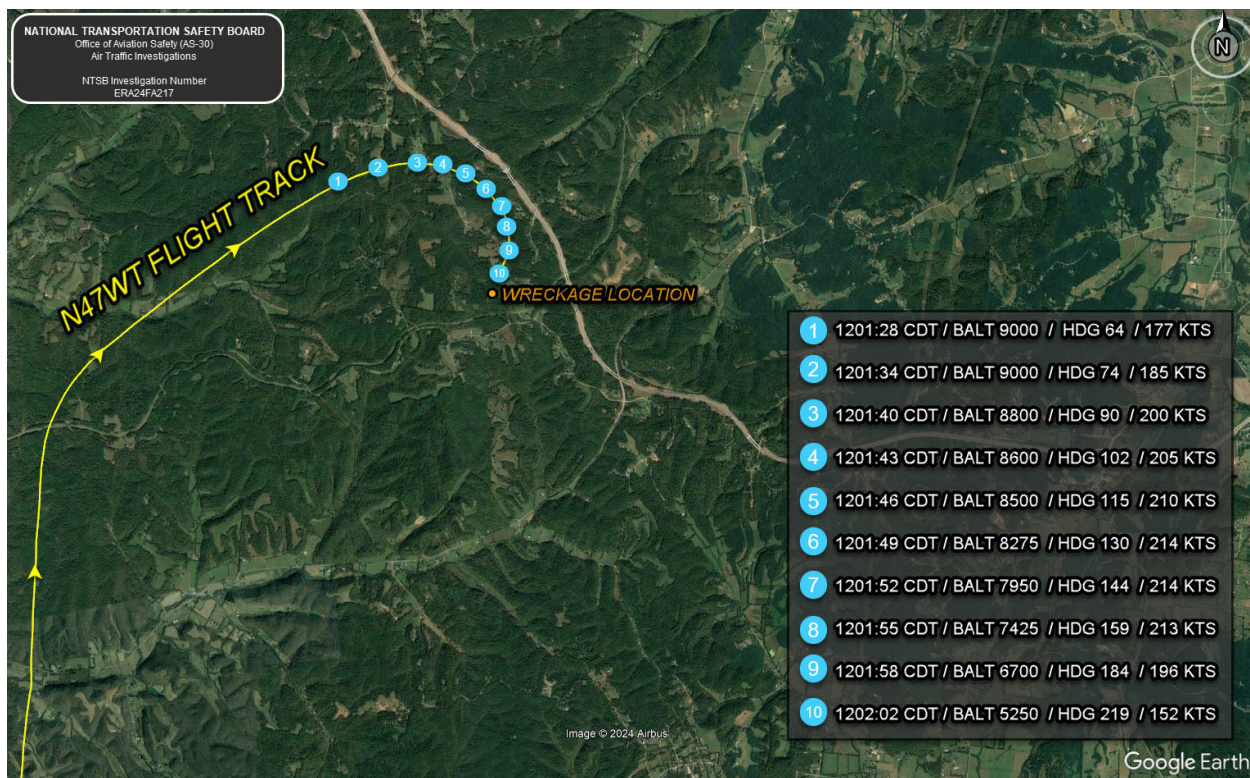
**Figure 2.** Overhead view of final segment of flight.

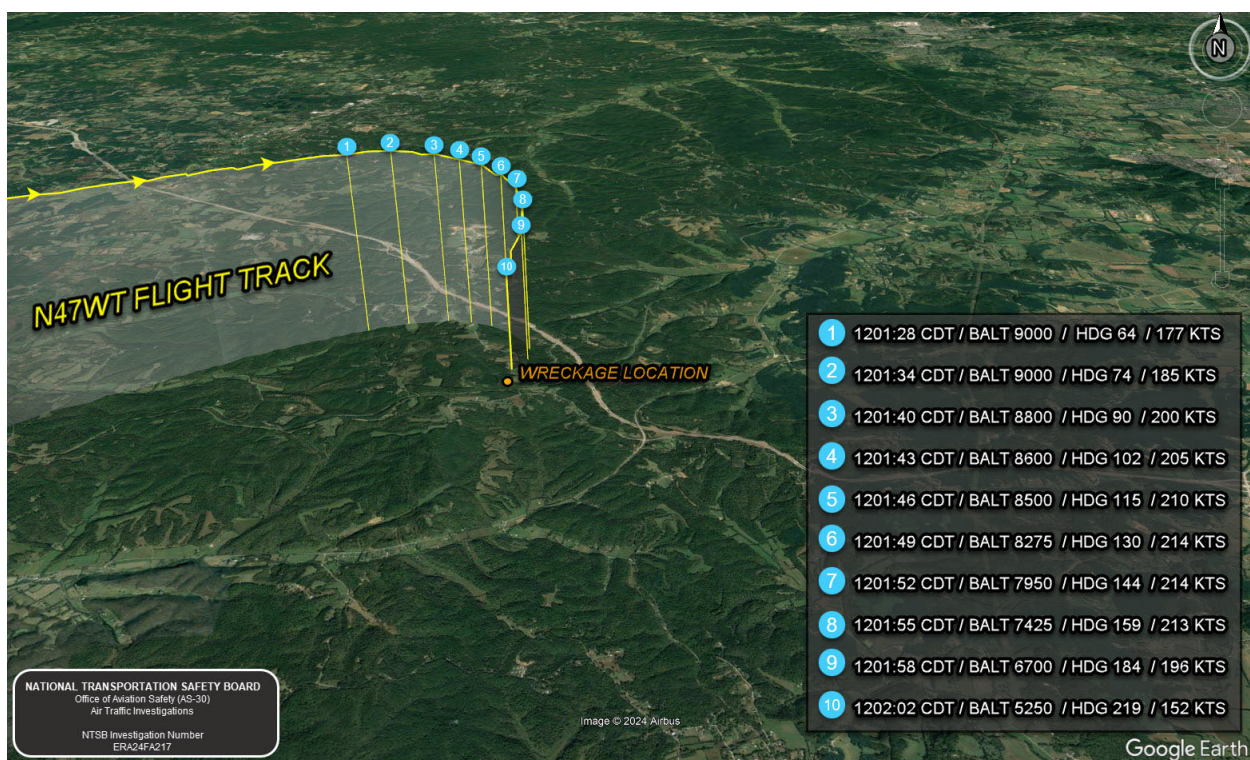
**Figure 3.** Profile view of final segment of the flight.

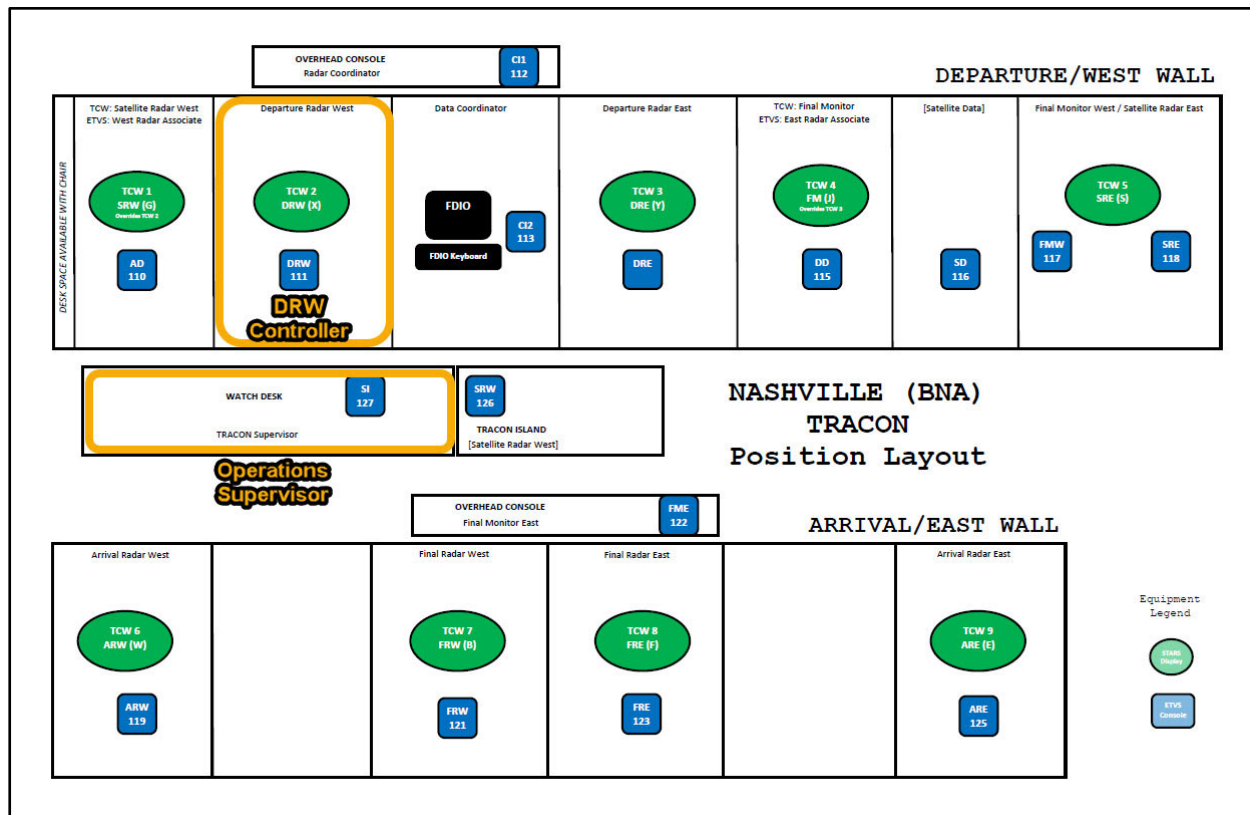
The BNA ATCT TRACON had 9 control positions broken into two sections. The first section was the Departure/West Wall. This included the accident radar position along with four other positions. The Arrival/East Wall included four control positions. Between the two walls was the Operations Supervisor desk. Figure 5 in section 2.1 shows the BNA ATCT TRACON layout diagram.

**Figure 5.** TRACON layout with Departure Radar West and Operations Supervisor positions labeled. Source NTSB.

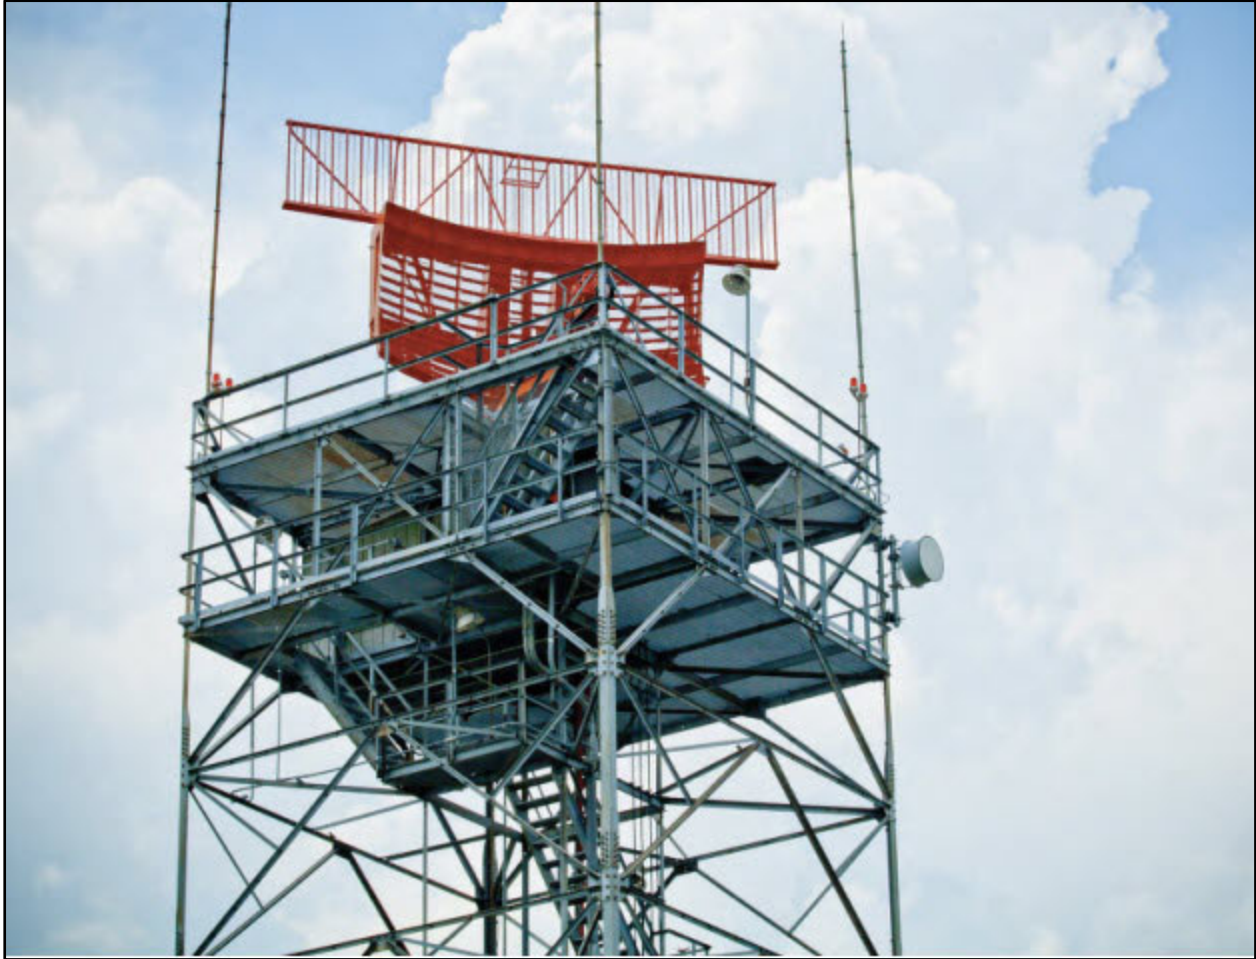
Approach control radar was used to detect and display an aircraft's position in the terminal area. ASR provides range and azimuth information but does not provide elevation data. Coverage of the ASR can extend up to 60 miles. At the time of the accident, BNA ASR-9 had a known outage relating to polarization. More information is available in section H of this report. Figure 6 is a photograph of an exemplar ASR-9.

**Figure 6.** ASR-9. Source: FAA.

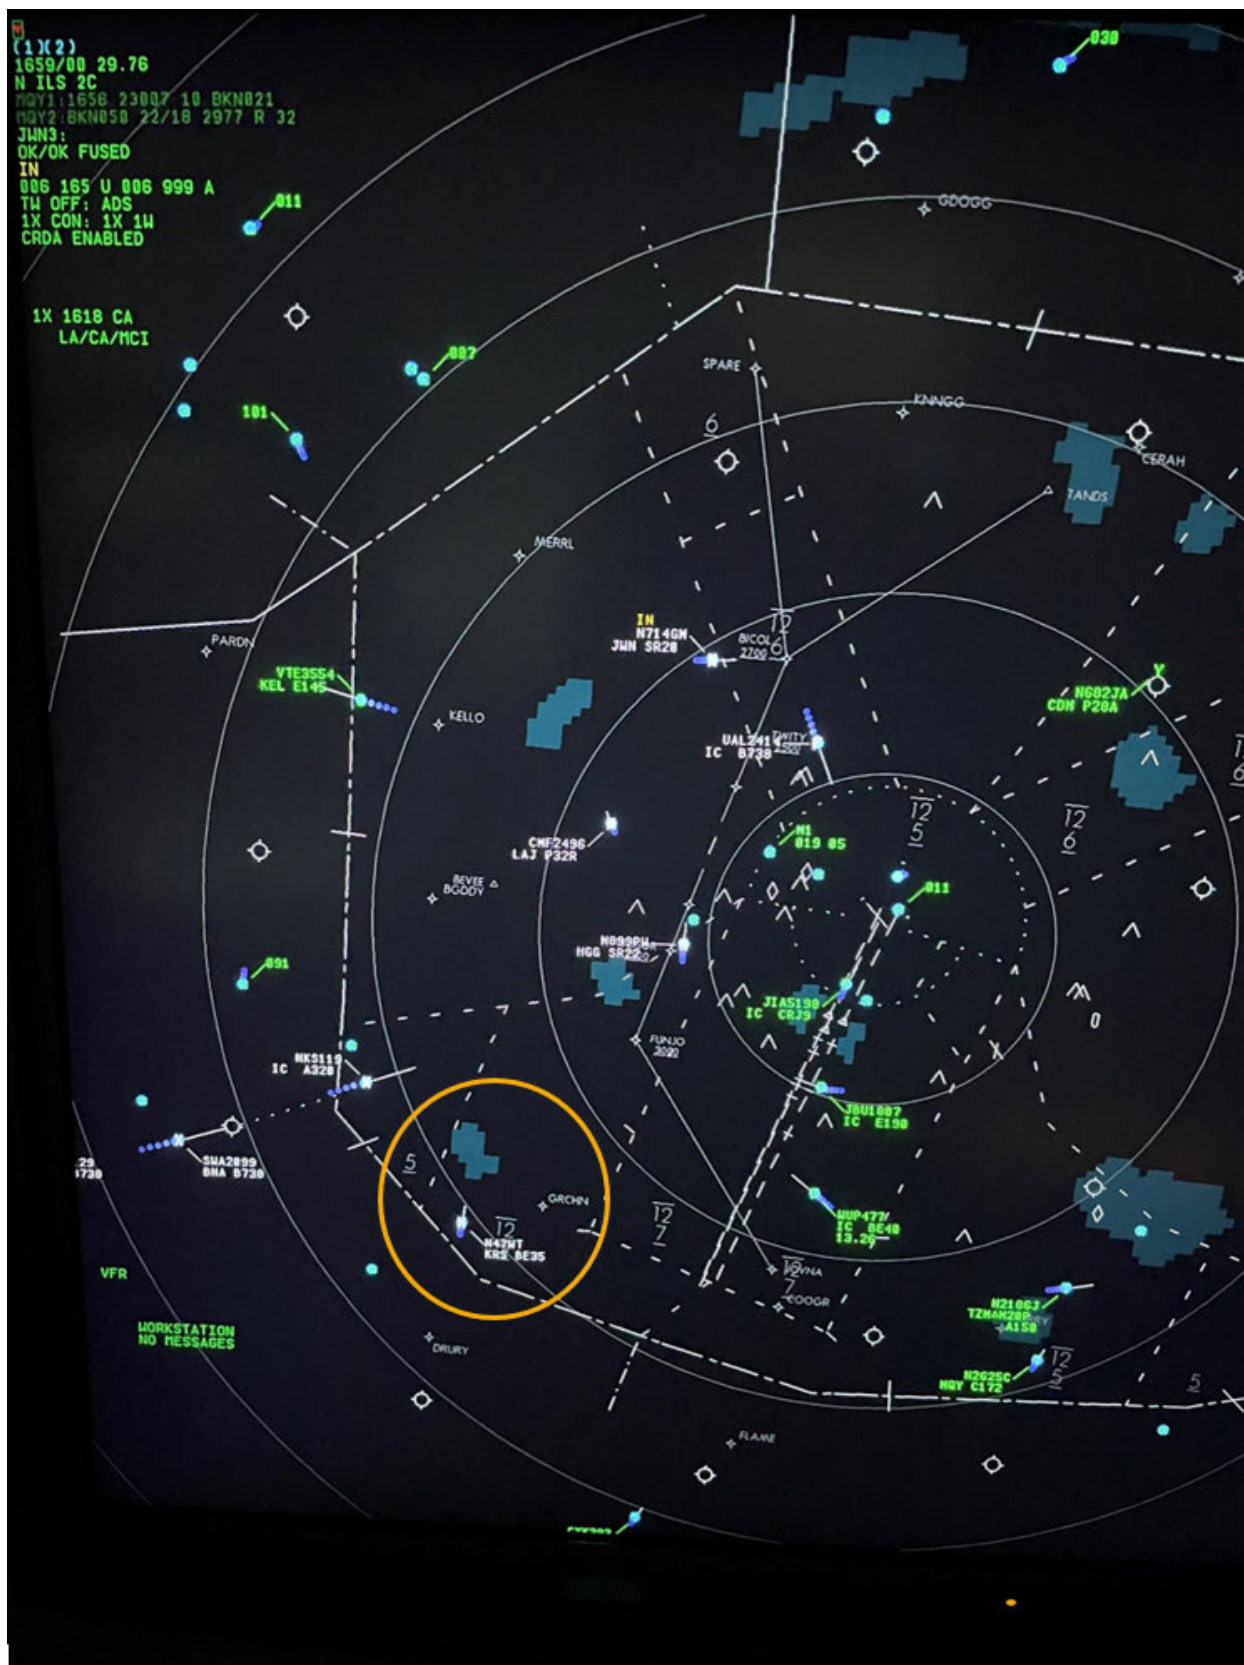
STARS was a system that receives radar data and flight plan information and presents the information to air traffic controllers on high resolution, 20" x 20" color displays. This allowed the controller to monitor, control, accept hand-off of air traffic, and assist with weather avoidance. Figures 7-9 below show images of the STARS radar display with the accident aircraft circled.

**Figure 7.** STARS radar display photo showing the accident aircraft and depicting weather in the route of flight at 1159:00. Source: NTSB.

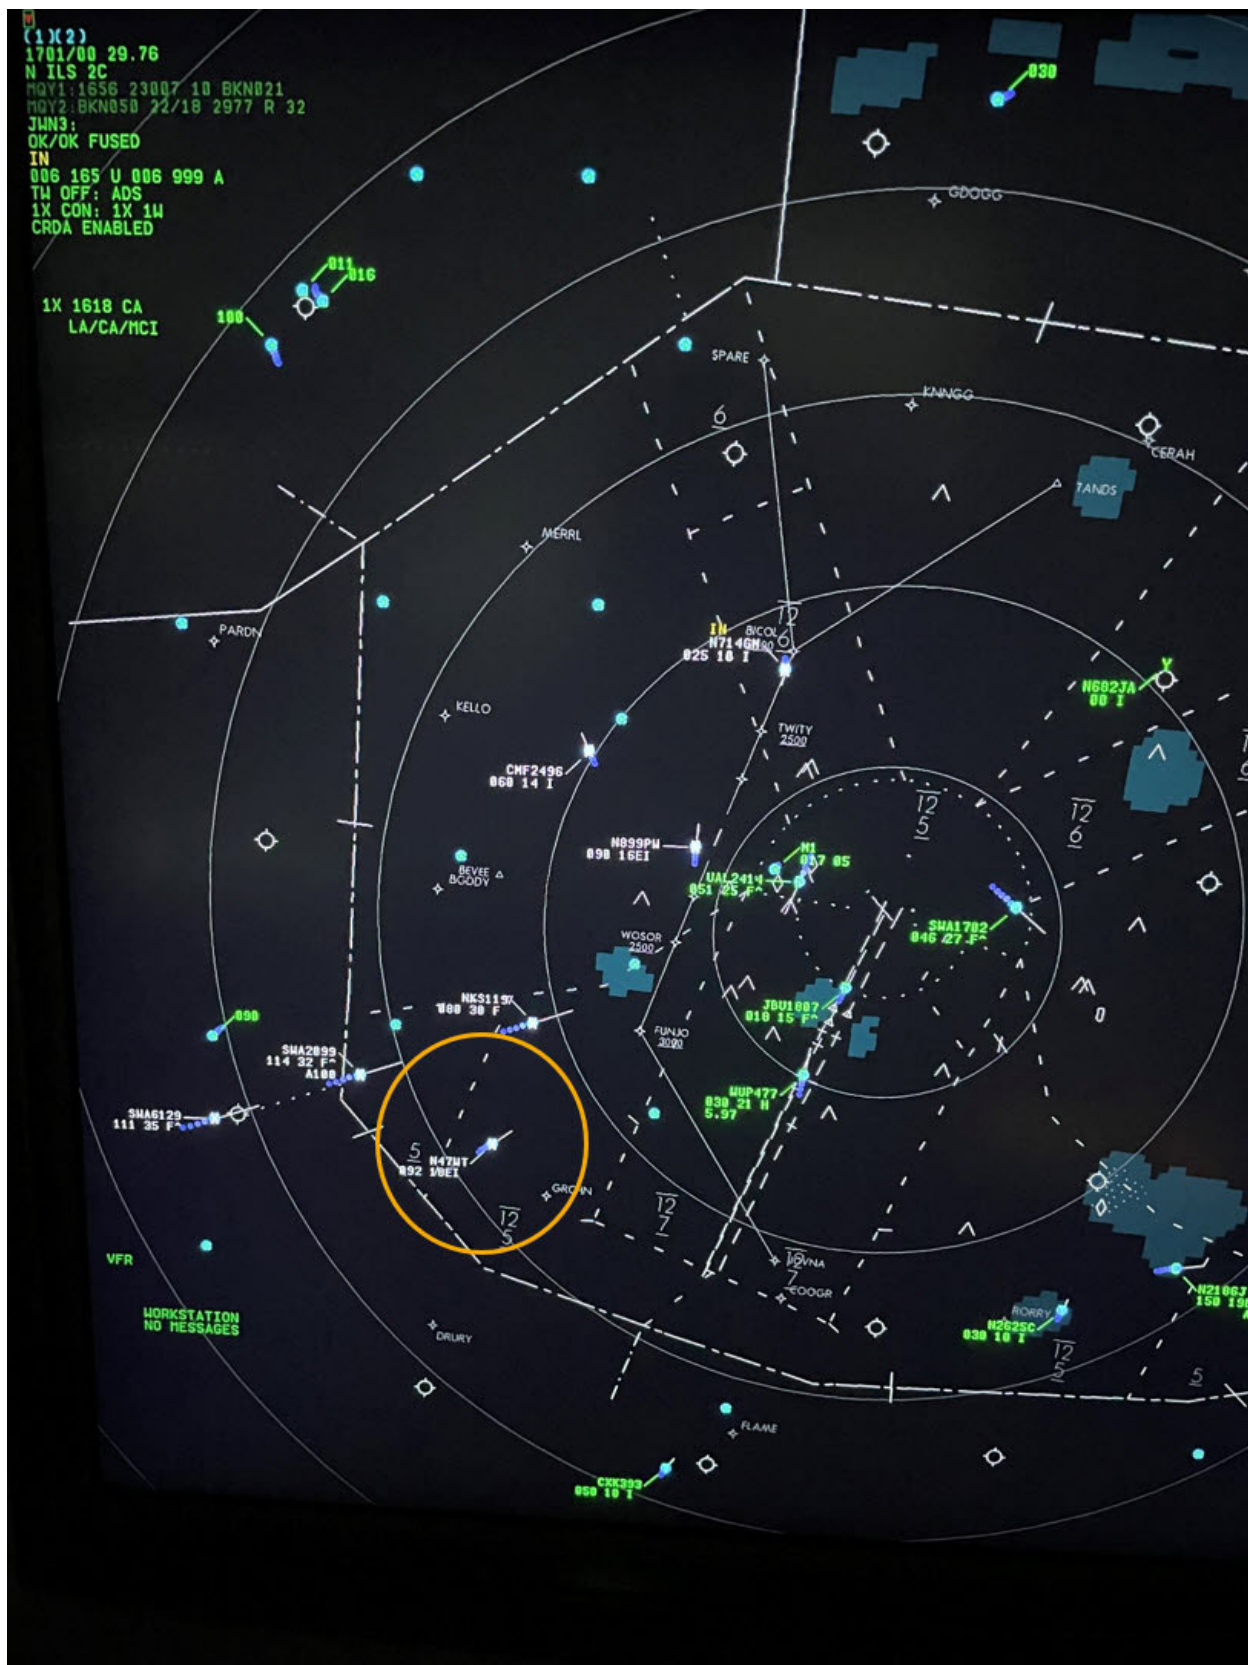
**Figure 8.** STARS radar display photo showing the accident aircraft and not depicting weather in the route of flight at 1201:00. Source: NTSB.

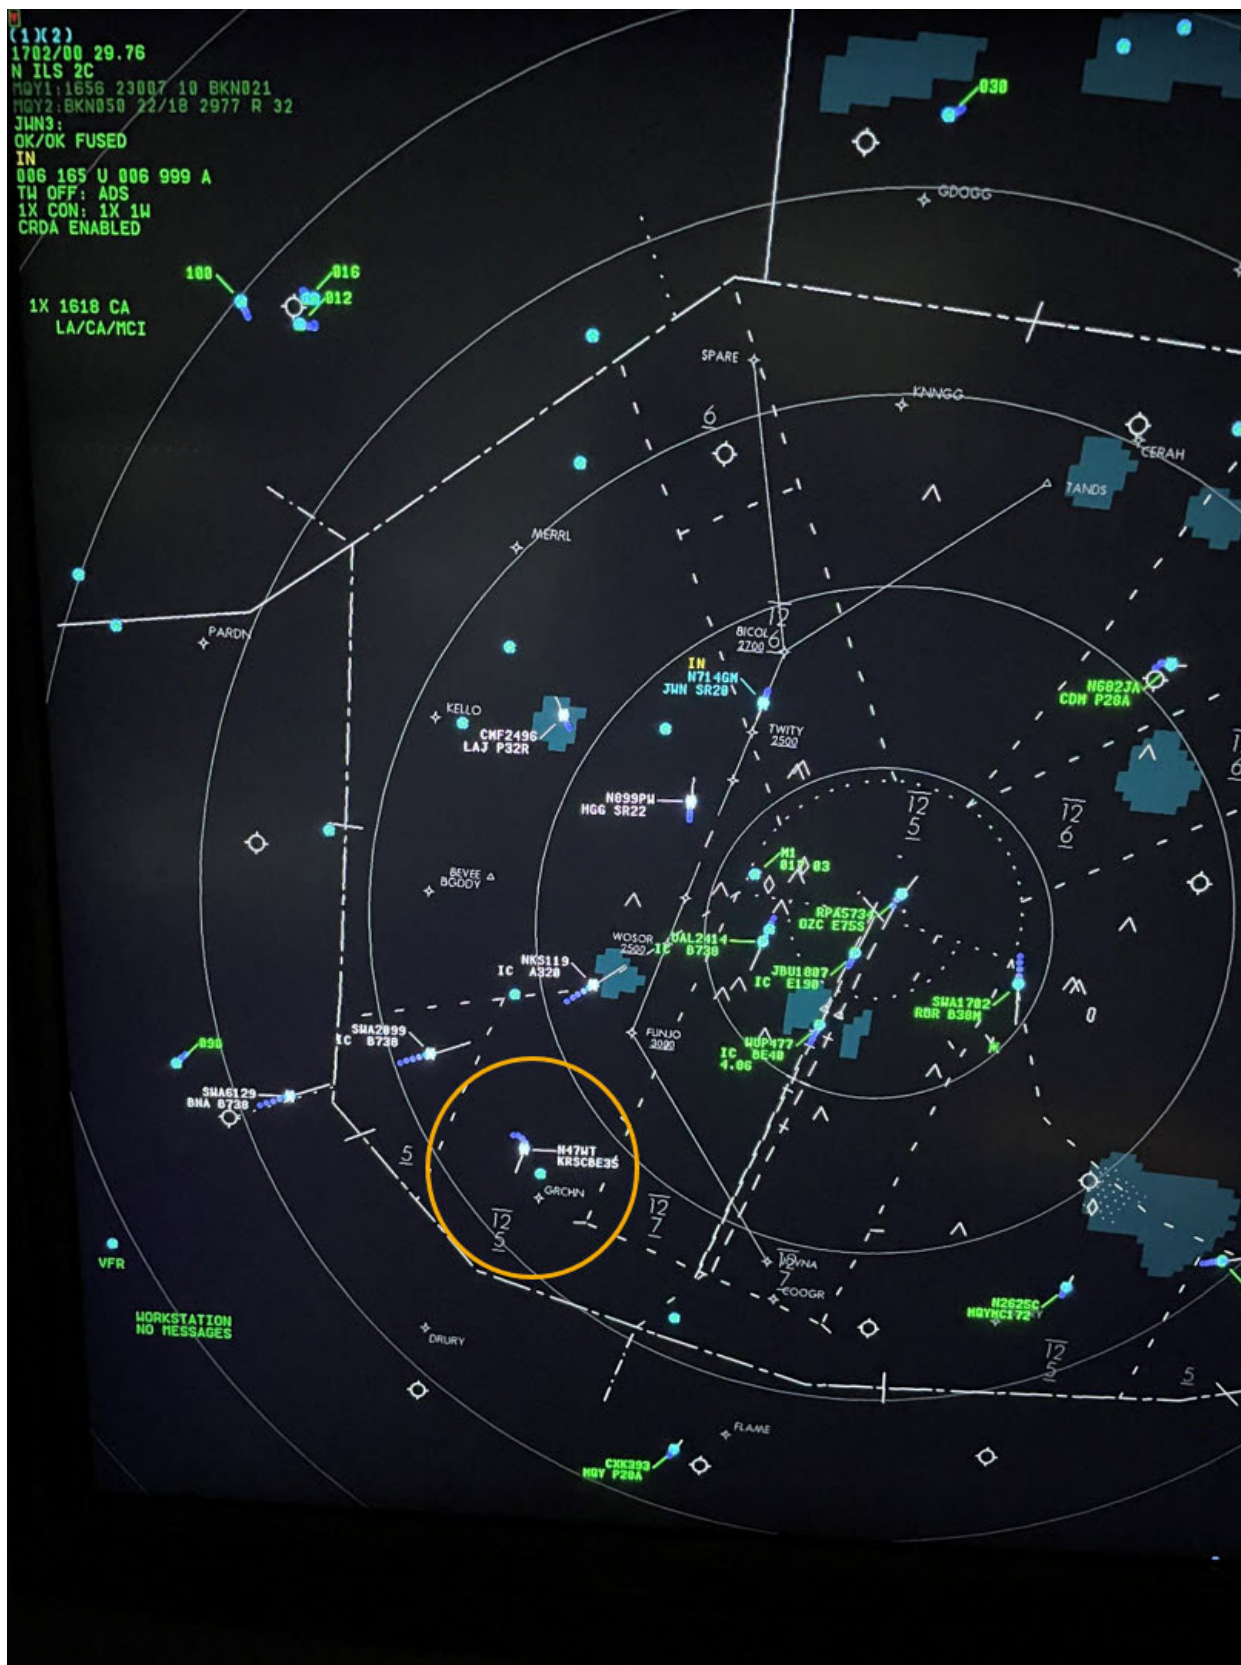
**Figure 9.** STARS radar display photo showing the accident aircraft and not depicting weather in the route of flight at 1202:00. Source: NTSB.

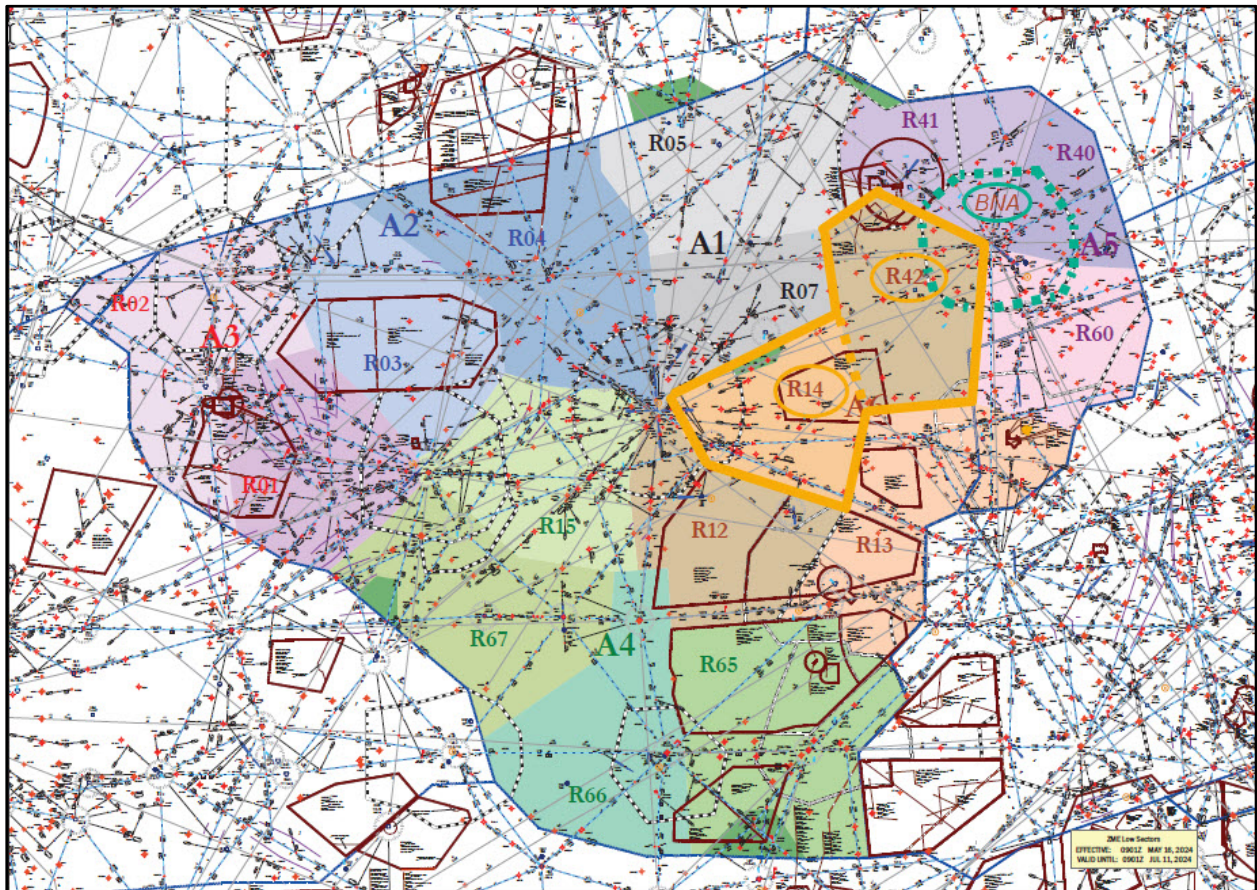
The Radar 14 (R14) sector was providing ATC services prior to the accident. The Radar 42 (R42) sector was combined to the R14 sector at the time. Figure 11 shows the overall ZME airspace with sectors R14, R42 and BNA ATCT airspace

**Figure 11.** ZME Sector Map. Source: FAA.

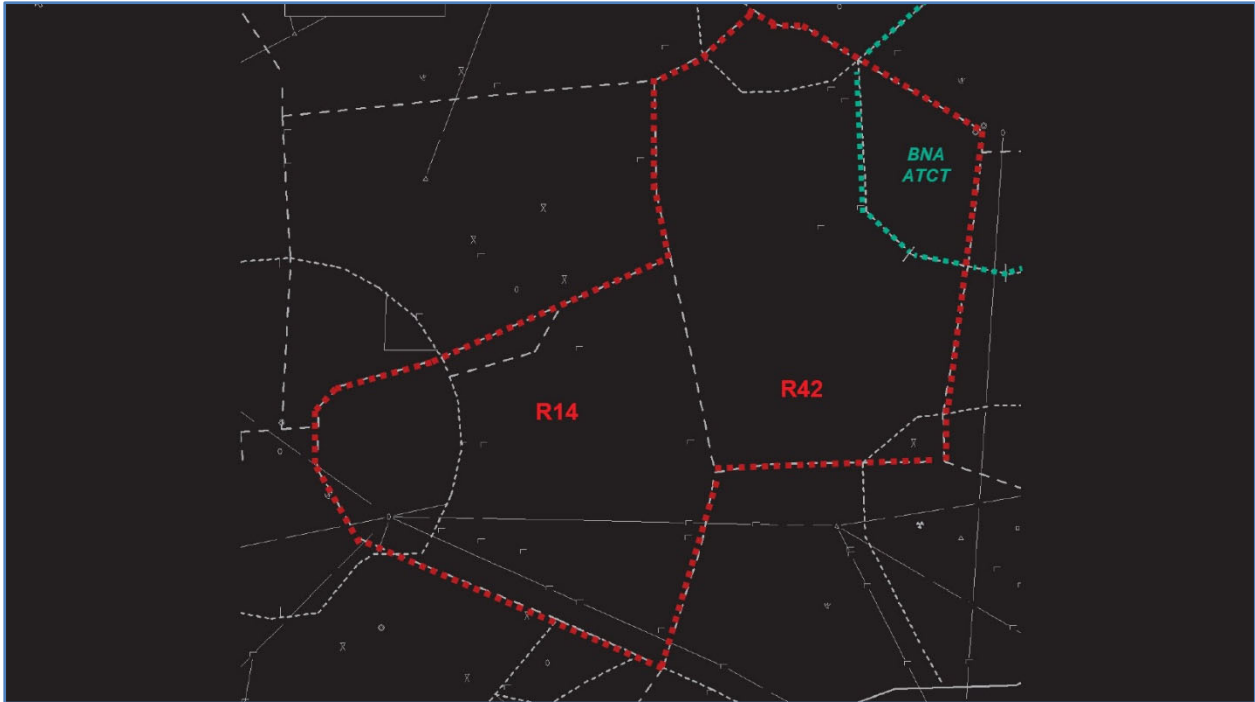
identified. Figure 12 shows the R14 and R42 sector video map with ZME sector boundaries outlined in red and BNA ATCT boundary outlined in green.

**Figure 12.** ZME Radar 14 / Radar 42 Video Map. Source: FAA.

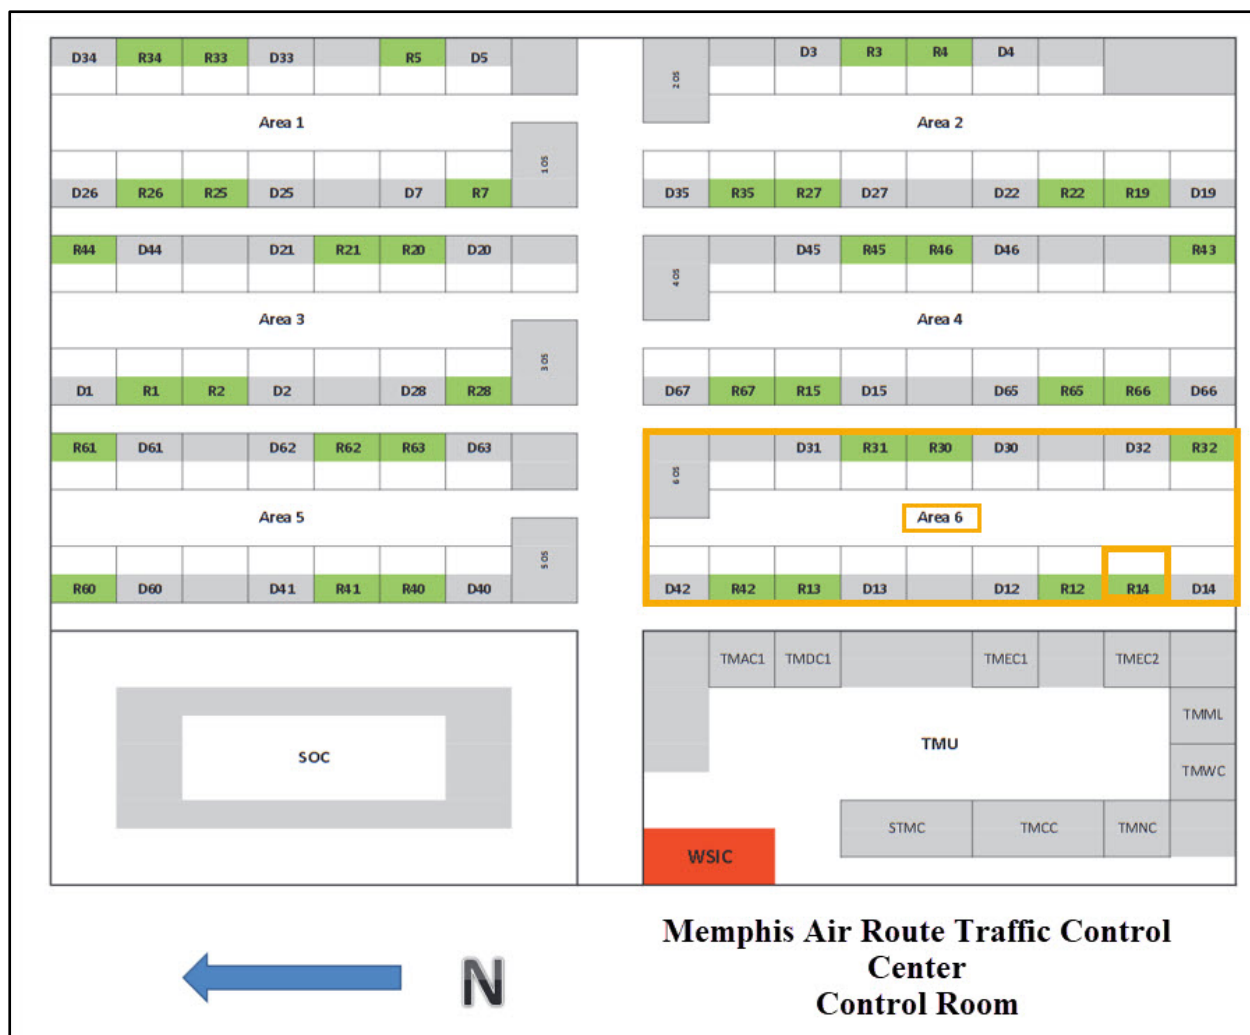
The ZME control room consisted of 6 control areas, one traffic management unit, one service operations center, and one watch supervisor-in-charge desk. Figure 13 below shows the layout of the control room with area 6 and the sector R14 position location identified.

**Figure 13.** ZME ARTCC control room layout.

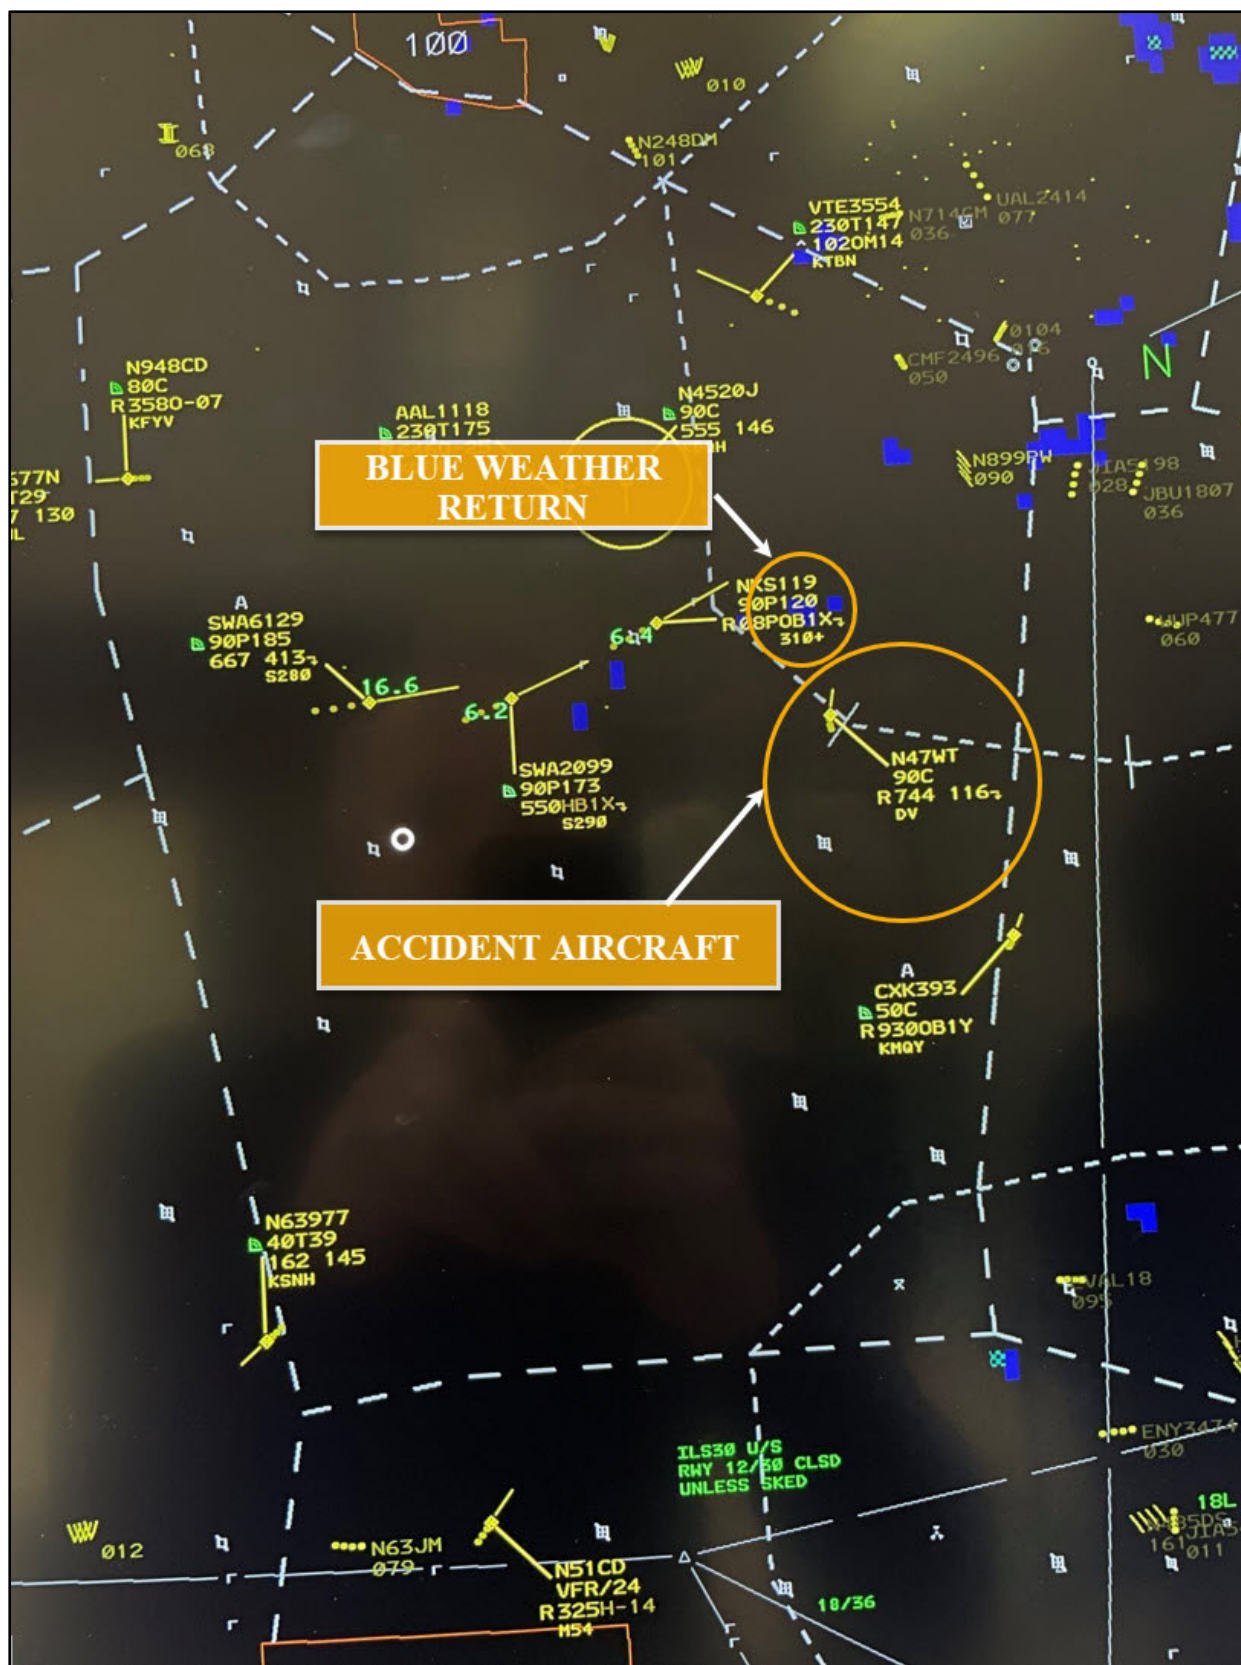
ERAM was the Next Gen system designed to replace the En Route Host and backup system previously utilized at Air Route Traffic Control Centers and allows for faster processing of route requests and in-flight route changes. ZME was utilizing this system on the day of the accident. Figure 14 below shows the area of precipitation that was shown just prior to the time of the accident.

**Figure 14.** Screenshot of the sector R14 ERAM displayed precipitation (shown in blue pixels) from 1158:00. Source: NTSB.

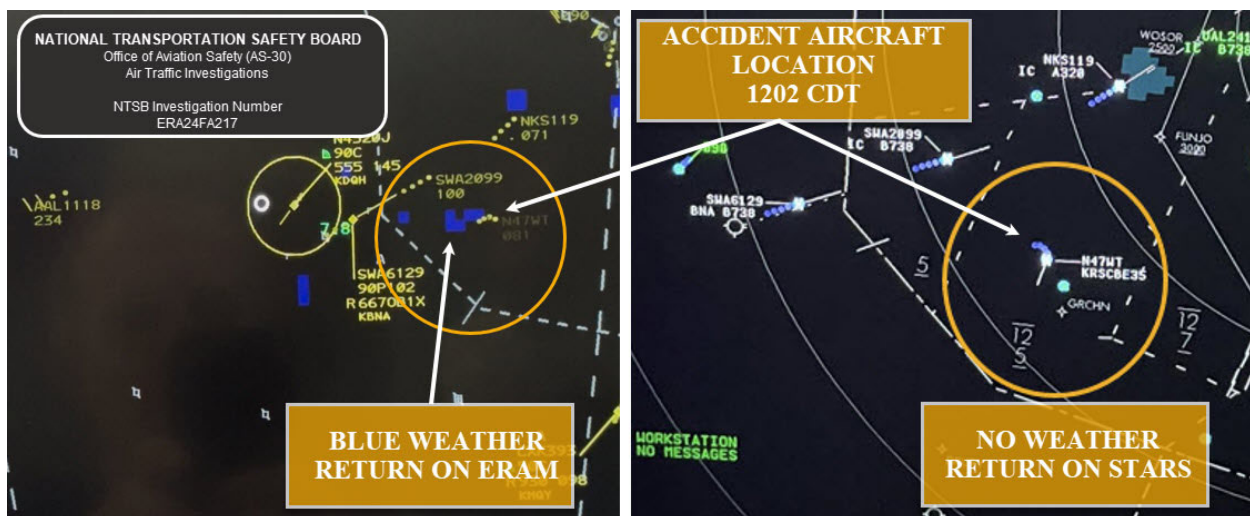
During the on-scene investigation, members of the ATC group compared radar display replays at both ATC facilities. Figure 15 is a side-by-side comparison of weather returns from ERAM and STARS at 1202 CDT.

**Figure 15.** ERAM and STARS comparison for 1202 CDT.

The STARS replay did not show the weather depiction at the time of the accident. The discrepancy was brought to the attention of the FAA. At the time of the accident BNA ATCT had a known outage that had been reported to the FAA Technical Operations personnel. Technicians from the FAA's Surveillance and Weather Group AJW-1434 conducted a study to determine whether the ASR-9 level 6 polarization outage as reported by BNA ATCT was a factor to the under reporting of the weather.<sup>26</sup>

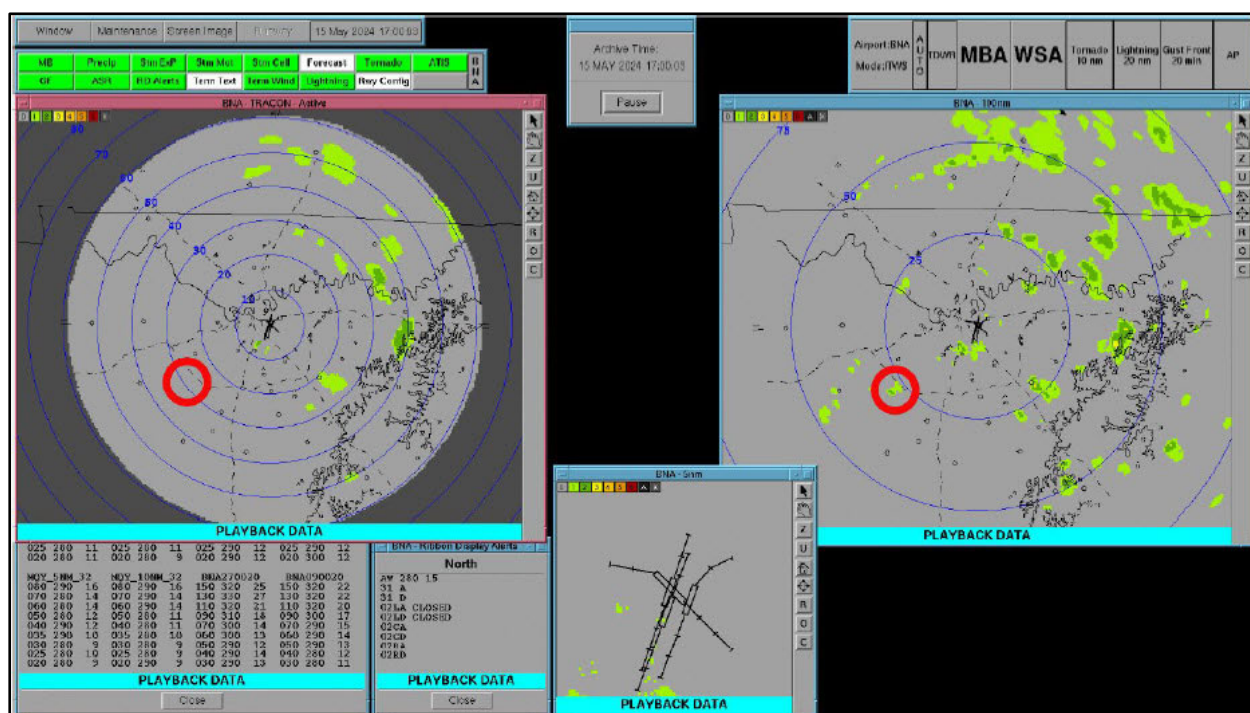
shows the area of precipitation. The report indicated that "the ASR-9 appeared to be slightly underreporting the weather. According to ITWS personnel, this difference was within normal range of deviation."<sup>27</sup> For more comprehensive information refer to Attachment 9.

**Figure 16.** Comparison between ASR-9 weather returns and NEXRAD/TDWR returns. Source: FAA.

The report concluded that although the BNA ASR-9 was having issues with the circular polarization and was experiencing intermittent loss of data in the communication path between the radar and the TRACON, the issues did not affect the weather presentation provided to the STARS. Additionally, the report concluded that the primary reason the storm was not displayed to the controller was that the storm was too small to survive the special smoothing processing in the ASR-9. The report recommended further study to determine if the BNA ASR-9 was consistently underreporting the weather compared to the ITWS. If it was, it was recommended to take further action. The report noted that Terminal Precipitation on the Glass (TPoG) was an upcoming program meant to better display the weather product on STARS. At the time of this writing, there was no known timeline for installation of TPoG at BNA ATCT.<sup>28</sup>
