# National Transportation Safety Board

ERA24FA397

## **RECOVERABLE DATA MODULE**

Specialist's Factual Report

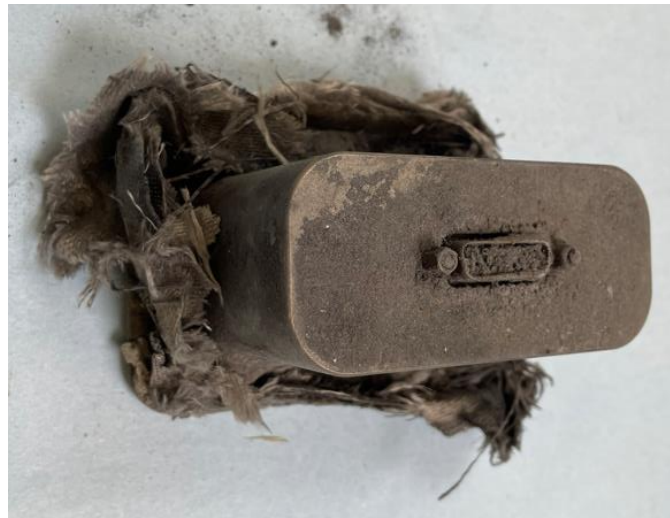
The Appareo RDM-300 had sustained severe fire damage from the accident, as shown in Figure 1. Figure 2 shows its internal circuit board. The non-reversible temperature indicator had turned dark grey from its original color (white), indicating the circuit board had exposed to temperatures of over 138 degrees Celsius. Furthermore, the white potting compound powder stiffened and attached to the circuit board, indicating there had been water or moisture intrusion. As a result, the memory module, shown in Figure 3, exhibited signs of tear damage on its printed circuit board (PCB) and damaged solder joints at its connector.

**Figure 1.** Appareo RDM-300 as received.

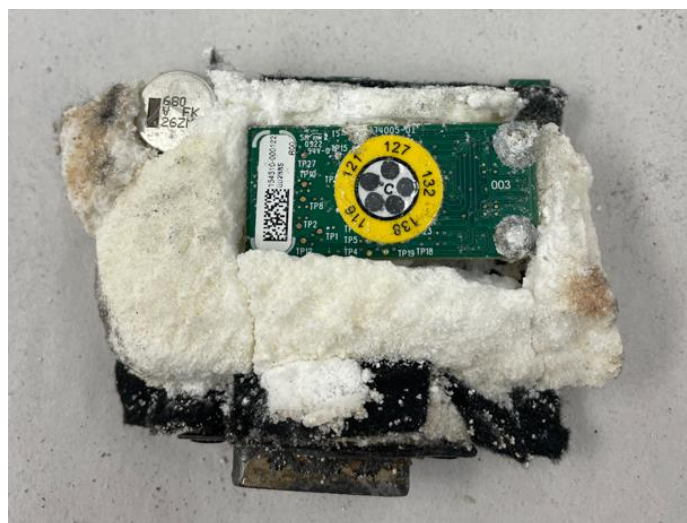
**Figure 2.** Internal circuit board of the Appareo RDM-300.

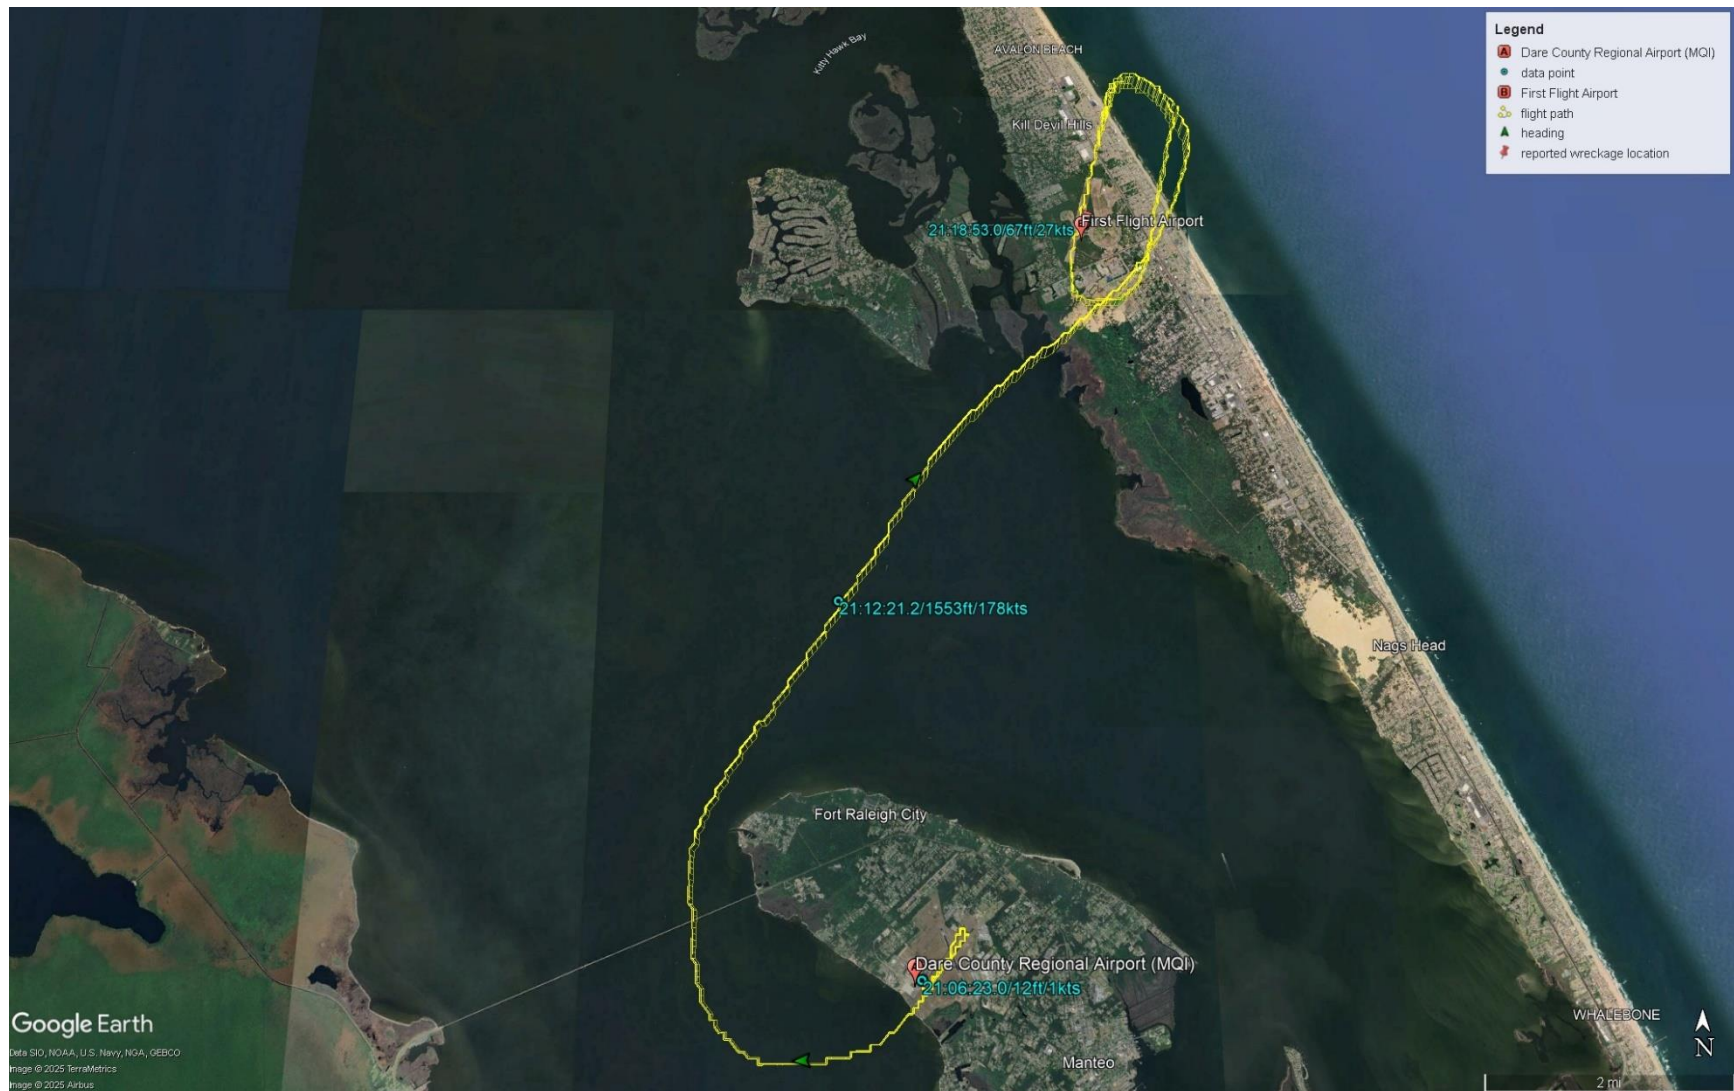
Figure 14 is a Google Earth overlay of the entire accident flight.

**Figure 14.** Google Earth overlay of the entire accident flight. Note that the zig-zag shape flight path was due to an Appareo RDM issue in recording GPS location data and not necessarily the exact flight pattern.

The weather and lighting conditions in Google Earth are not necessarily the weather and lighting conditions present at the time of the recording. Note that the entire flight path of the accident flight recorded on the RDM presents in an abnormal zig-zag shape rather than a smooth line. This is a known issue with Appareo RDM in recording GPS location data, and the appearance of the flight track may not be representative of the airplane's actual flight track. This pattern may be attributed to the update rate of GPS parameters as well as the software encoding of the GPS input to the device.

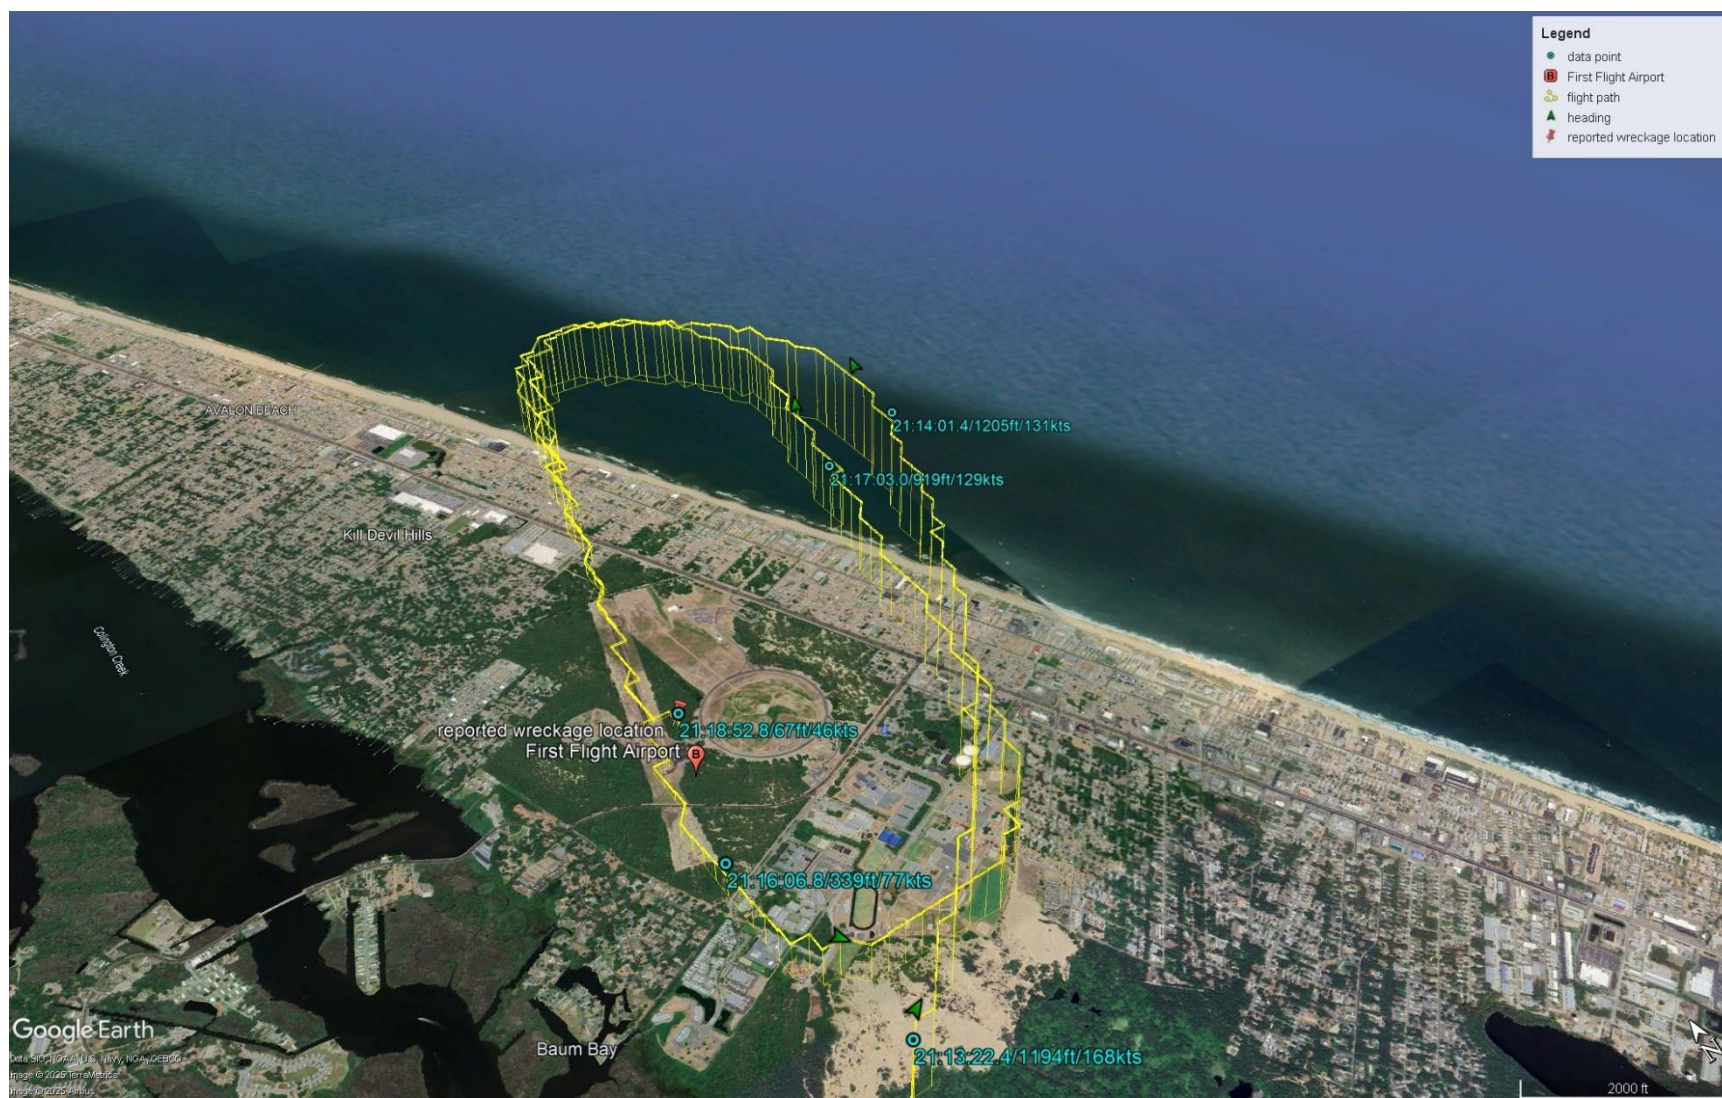
Figure 15 is a Google Earth overlay of approximately the last 6 minutes of the accident flight.

**Figure 15.** Google Earth overlay of the final portion of the accident flight. Note that the zig-zag shape flight path was due to an Appareo RDM issue in recording GPS location data and not necessarily the exact flight pattern.
