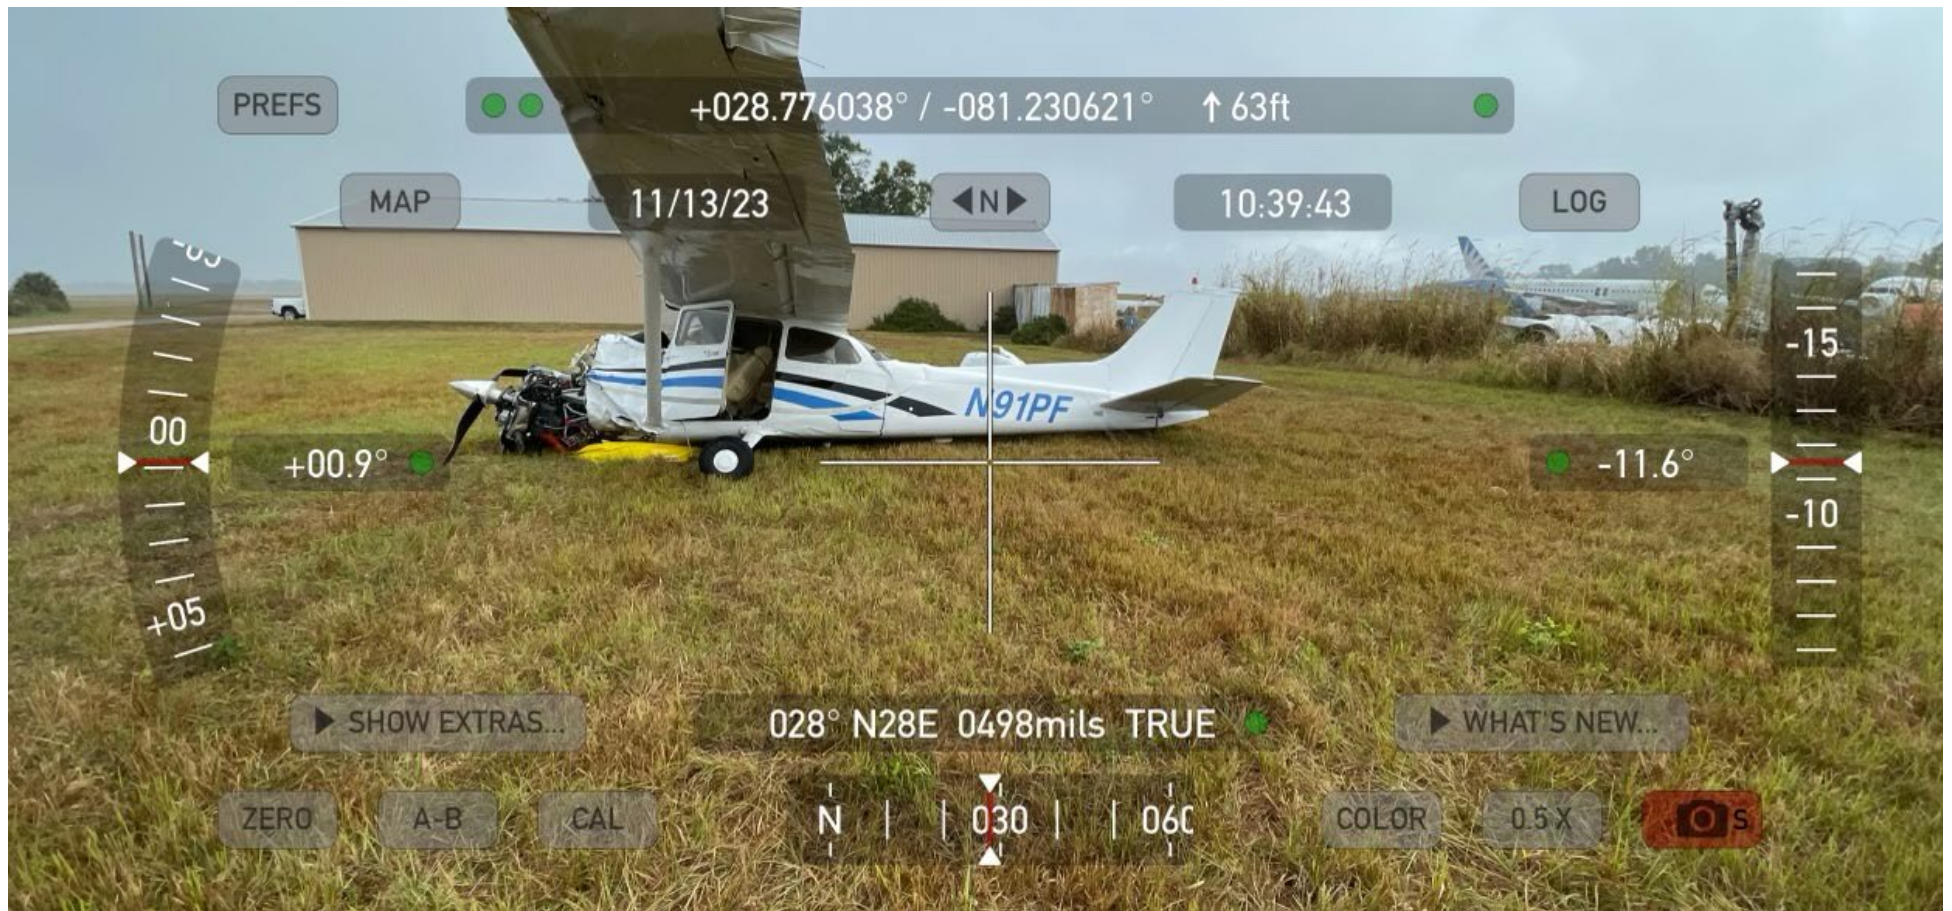
**Photo 1 – View of crashed airplane with Lat/Long coordinates**

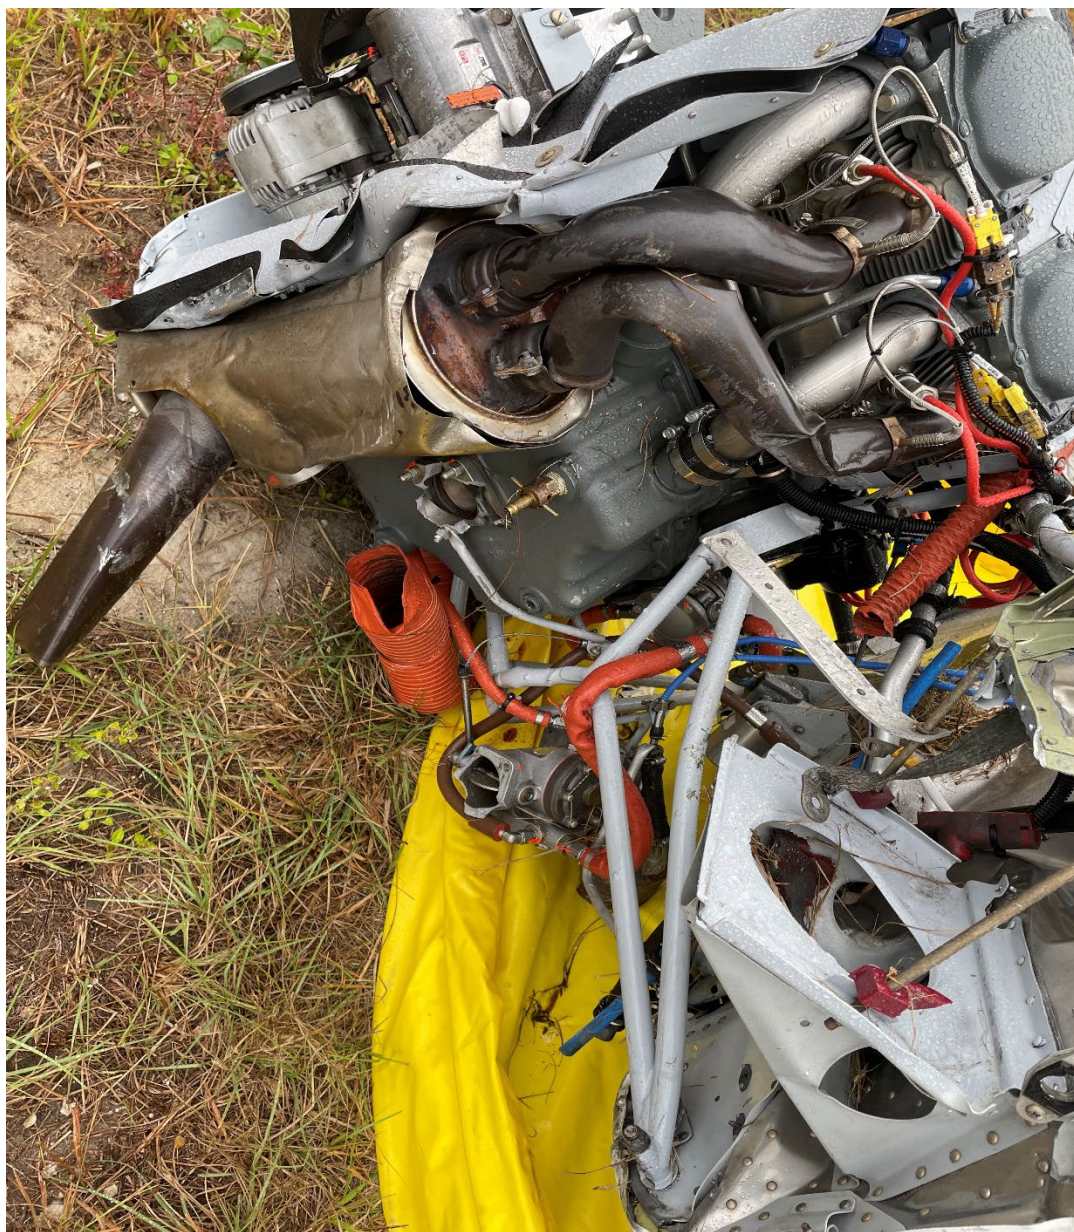
**Photo 2 – View of engine separated from firewall showing bent engine mount and separated fuel servo.**

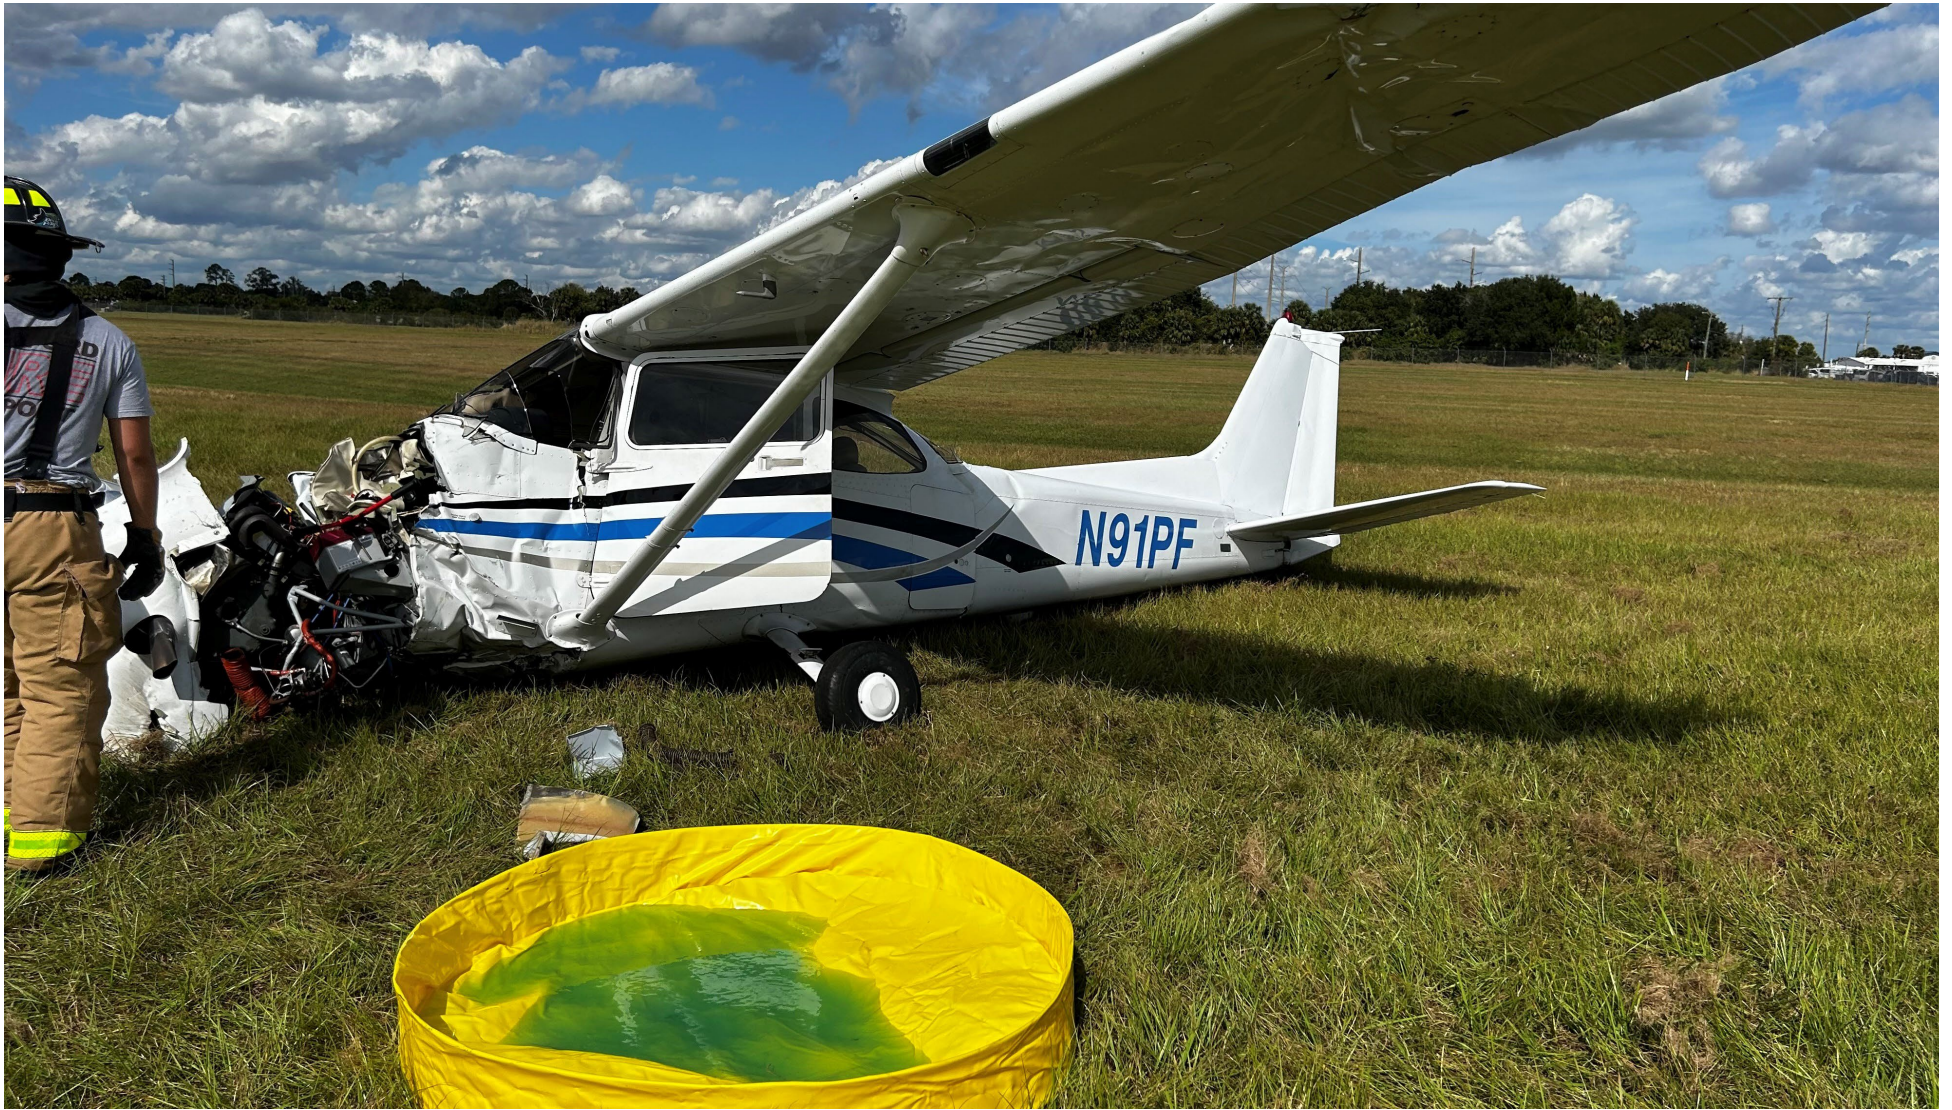
**Photo 3 – View of airplane showing crushed nose section.**
