ERA24LA054

## INVESTIGATION PHOTOGRAPHS

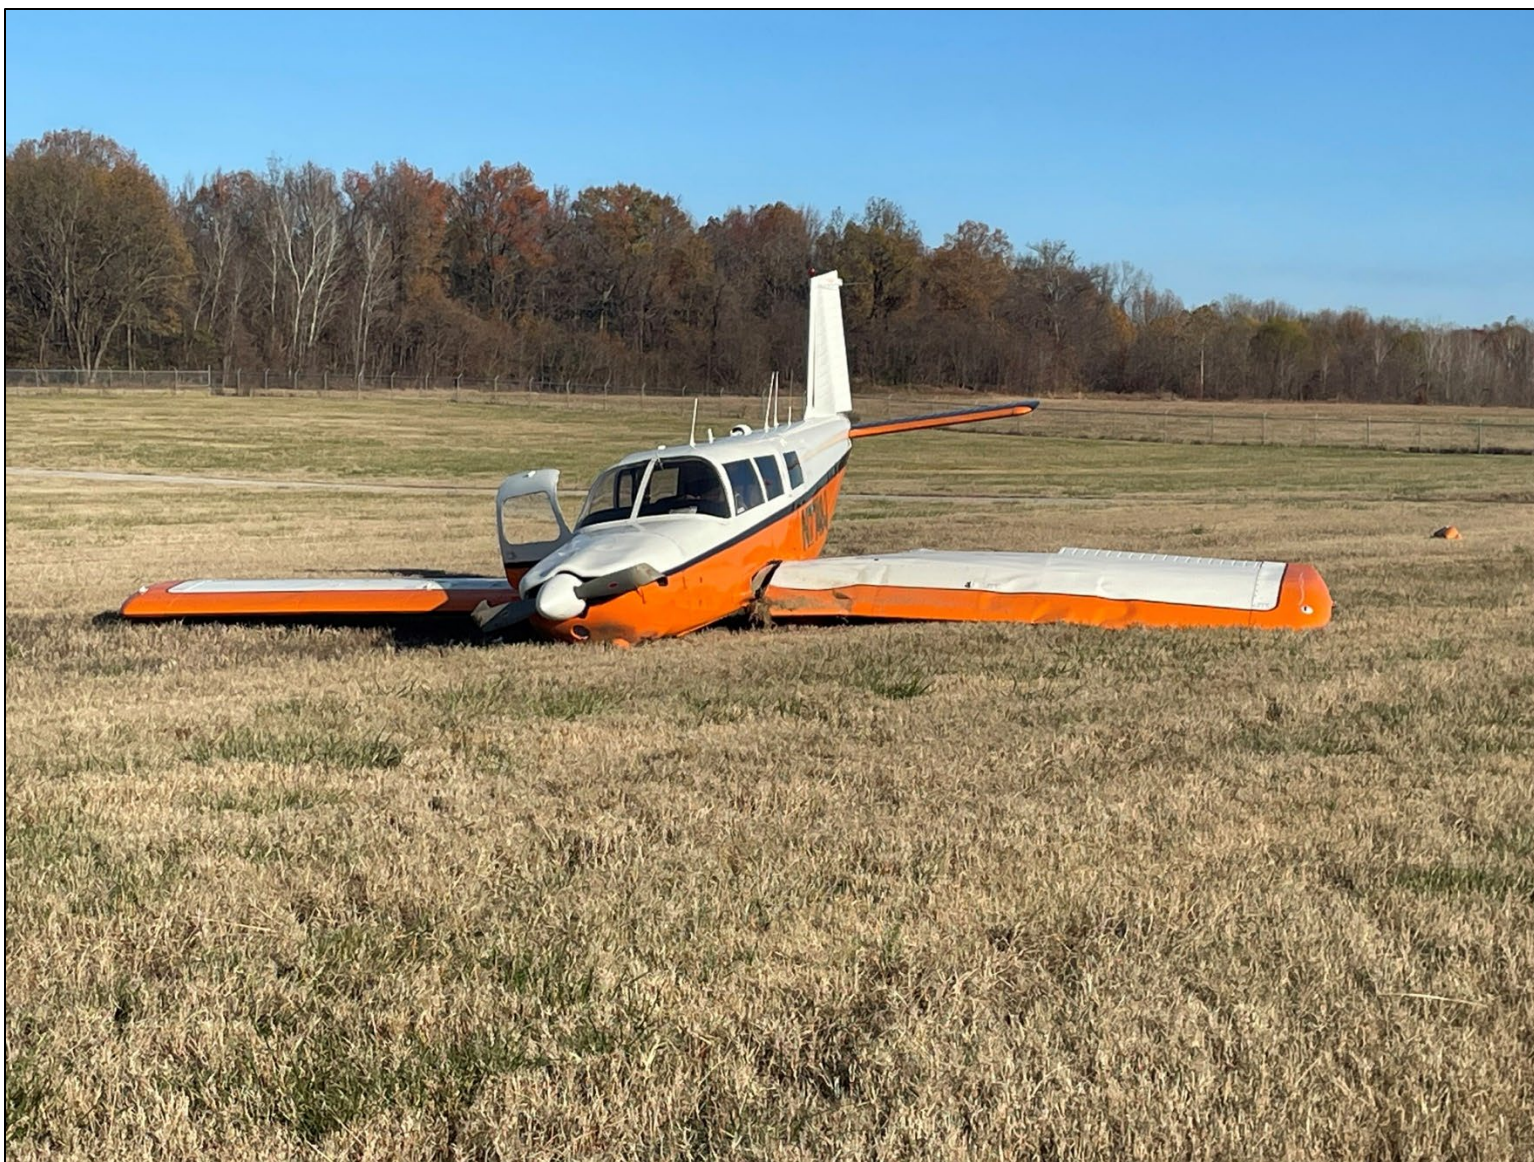
**Photo 1: View of the airplane at the accident site (Photo Courtesy FAA)**

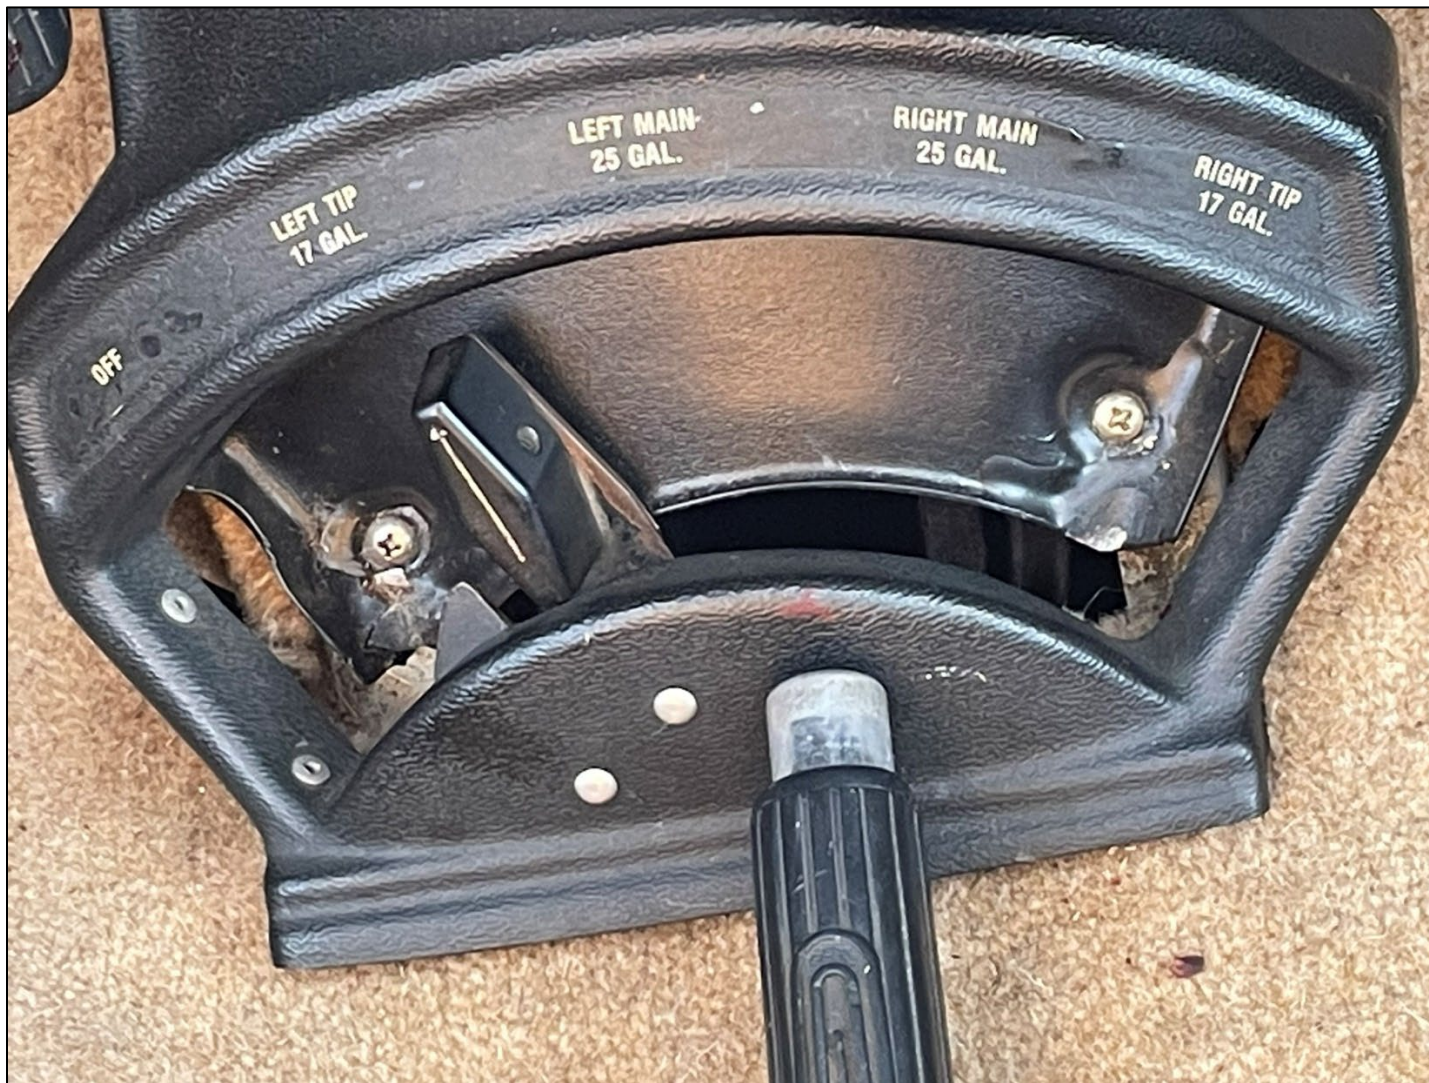
**Photo 2: View of the fuel selector as observed at the accident site (Selected, Left Tip) (Photo Courtesy FAA)**

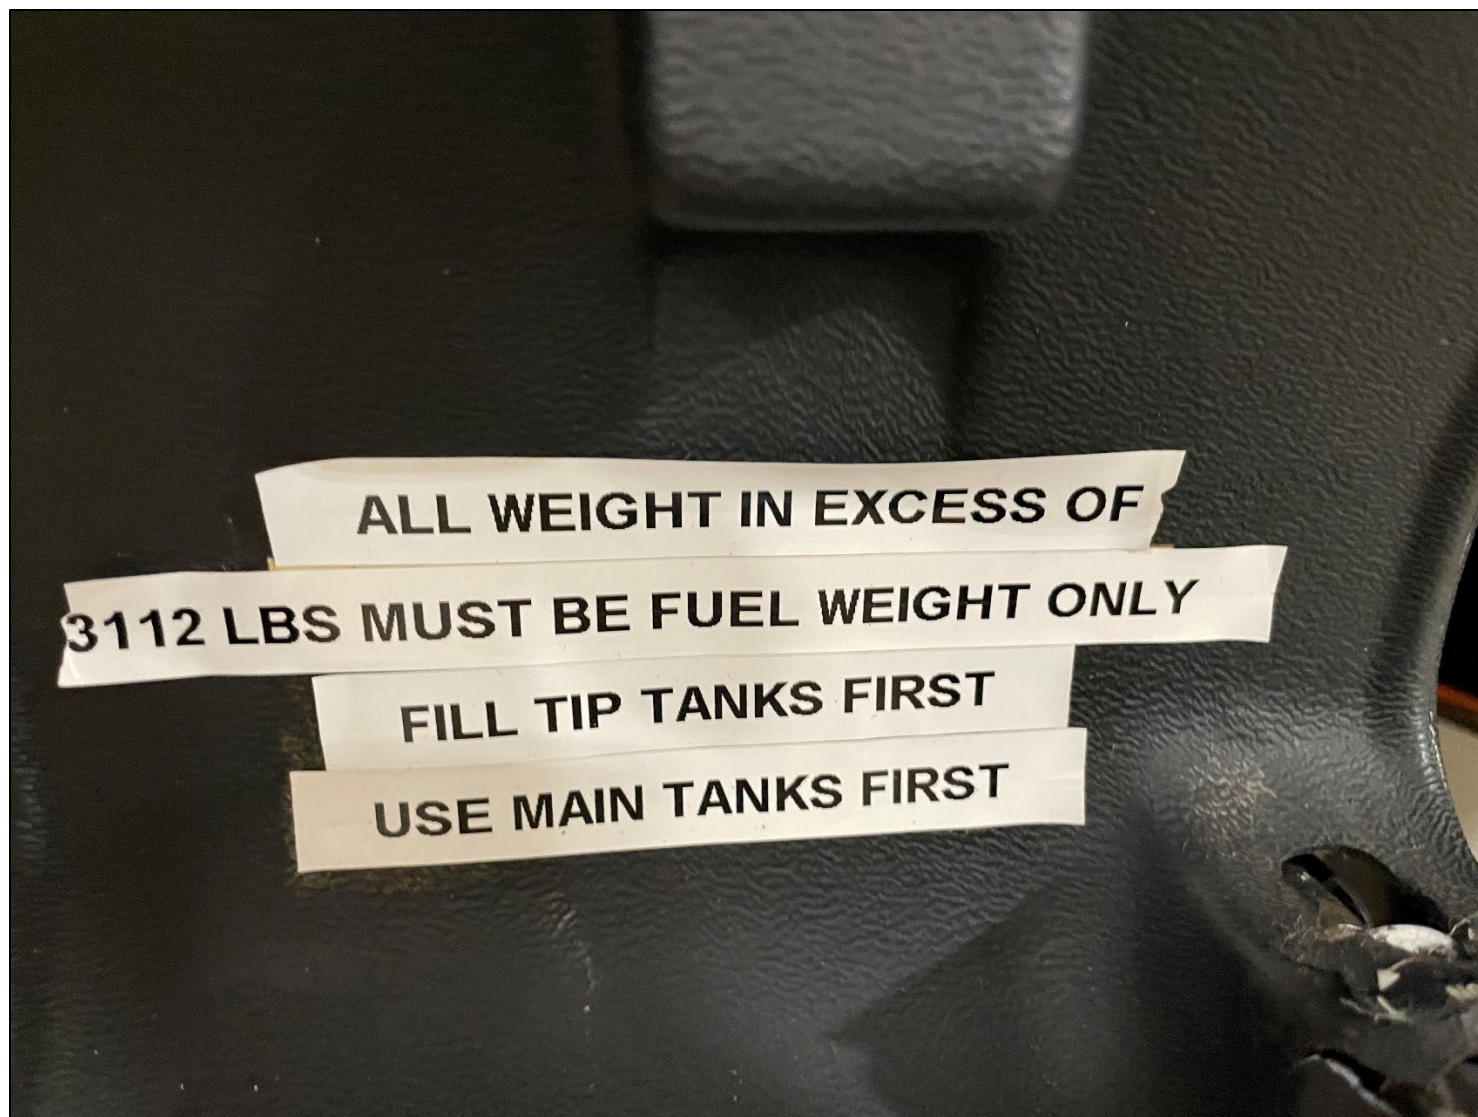
**Photo 3: Placard located in the cockpit.**

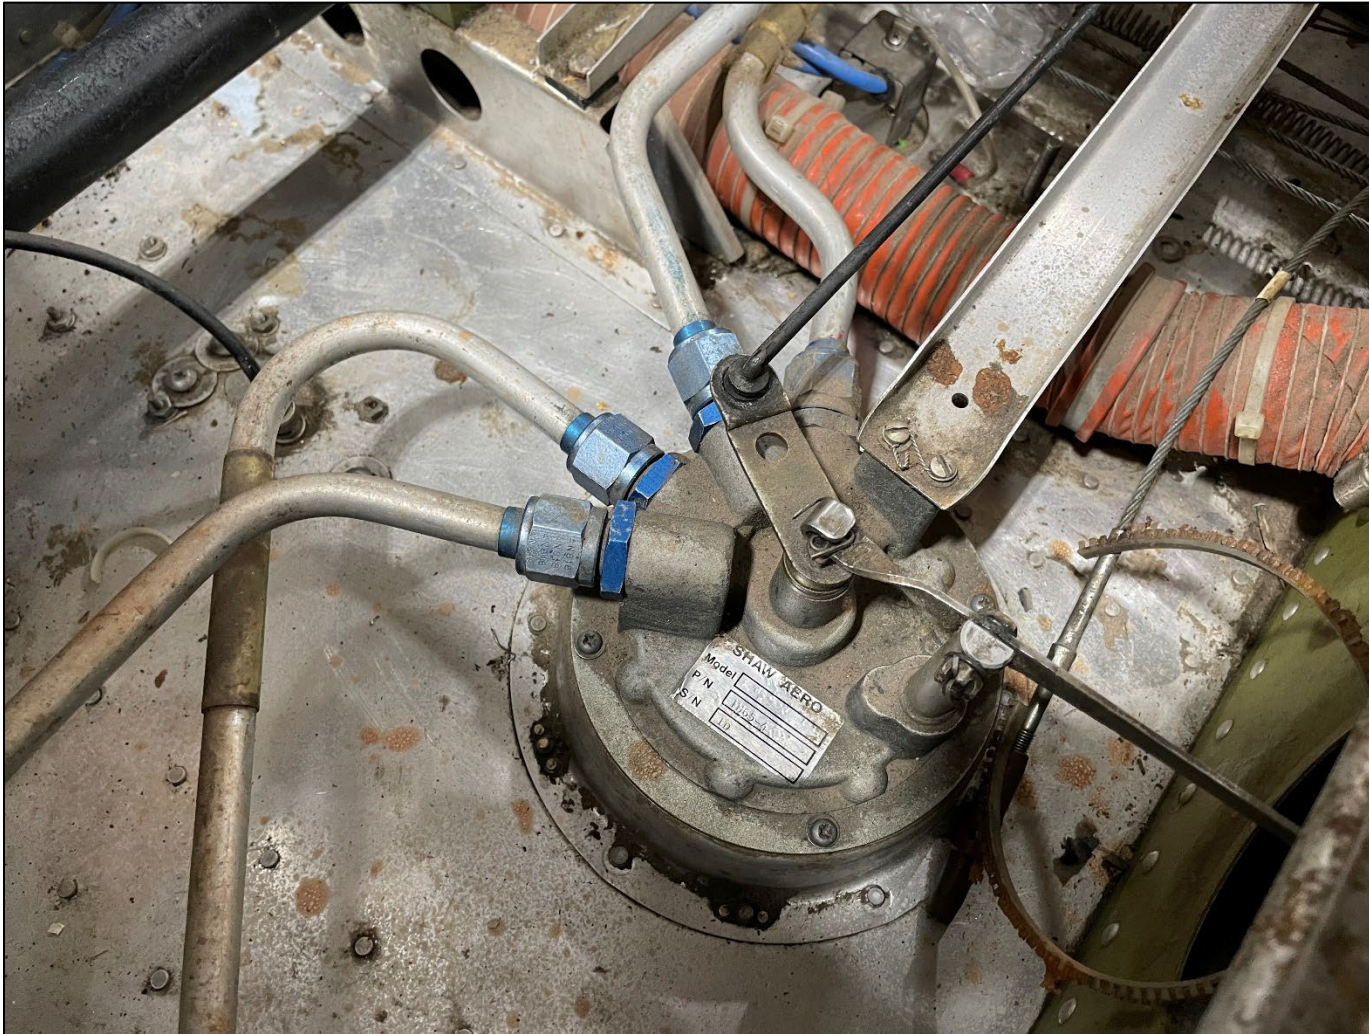
**Photo 4: View of the fuel selector valve.**

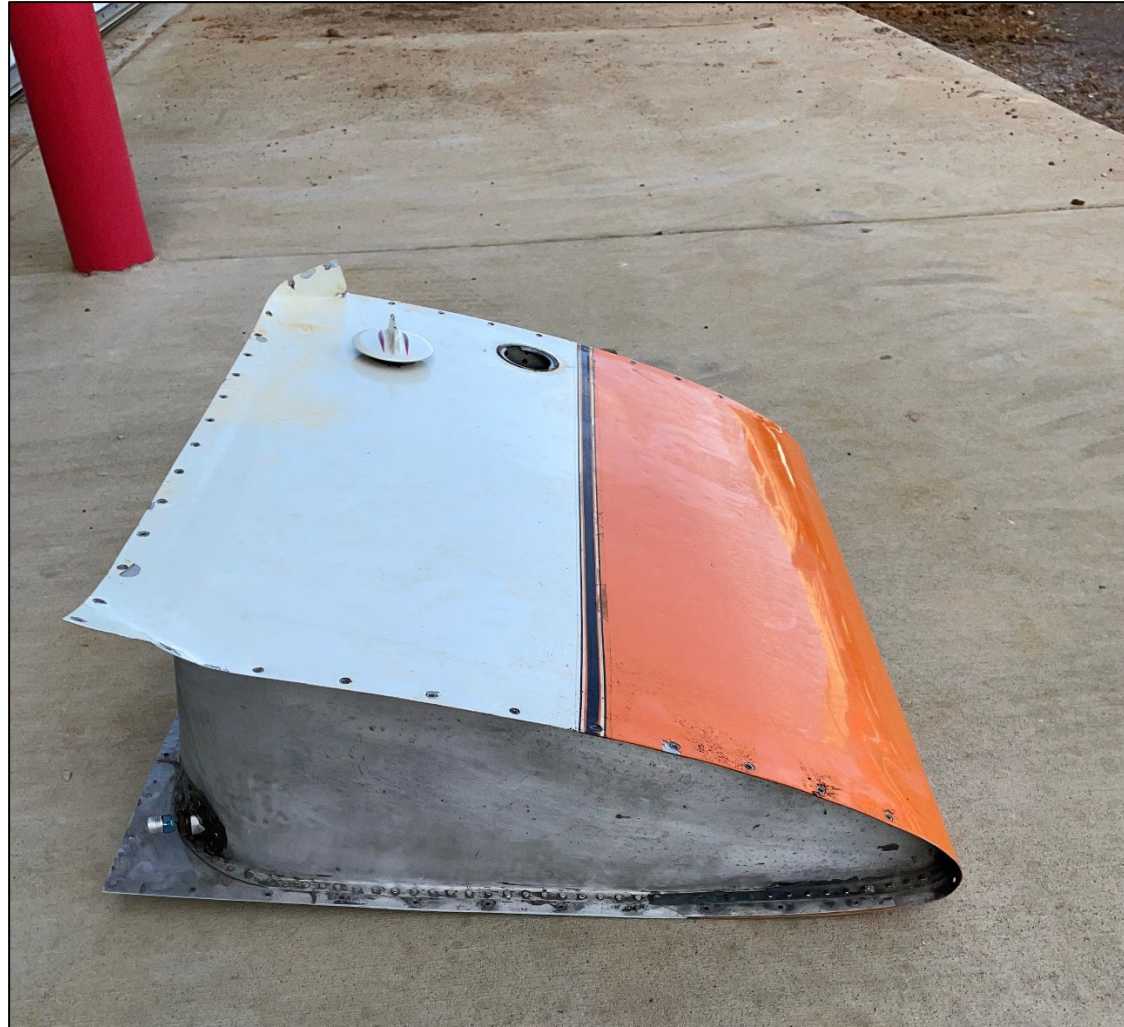
**Photo 5: View of the left main tank separated from the wing, with no leaks observed upon filling with water.**

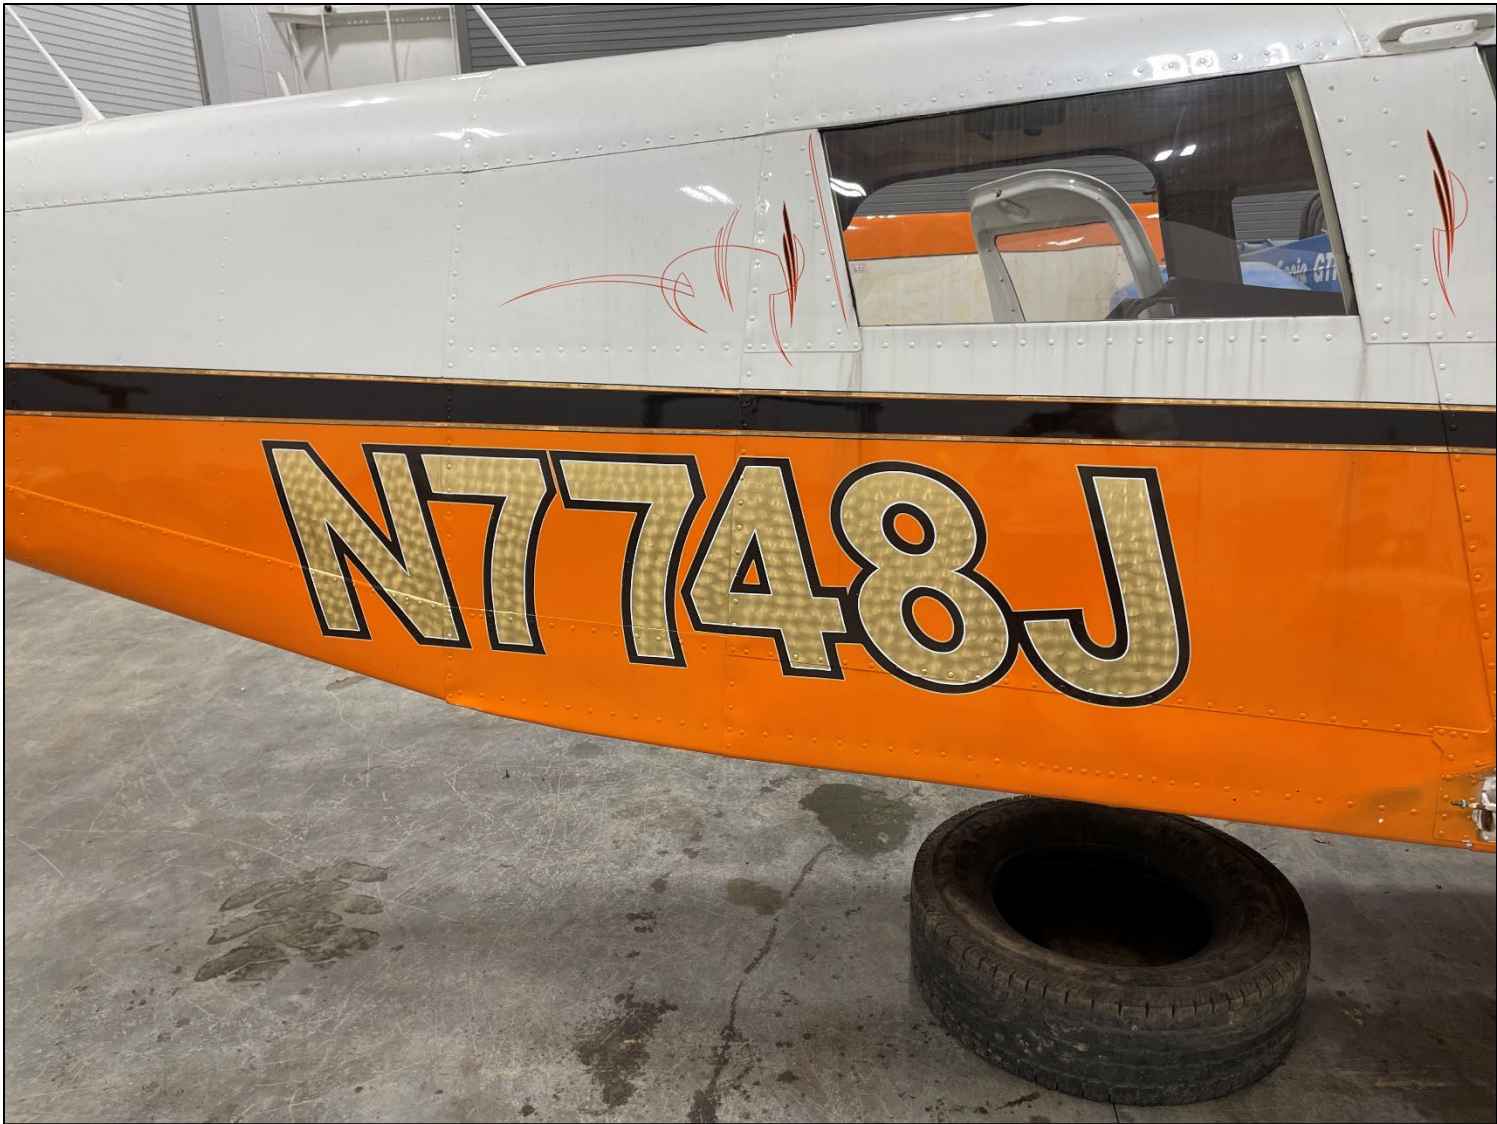
**Photo 6: View of the registration number.**
