ERA24LA250

## INVESTIGATIVE PHOTOS

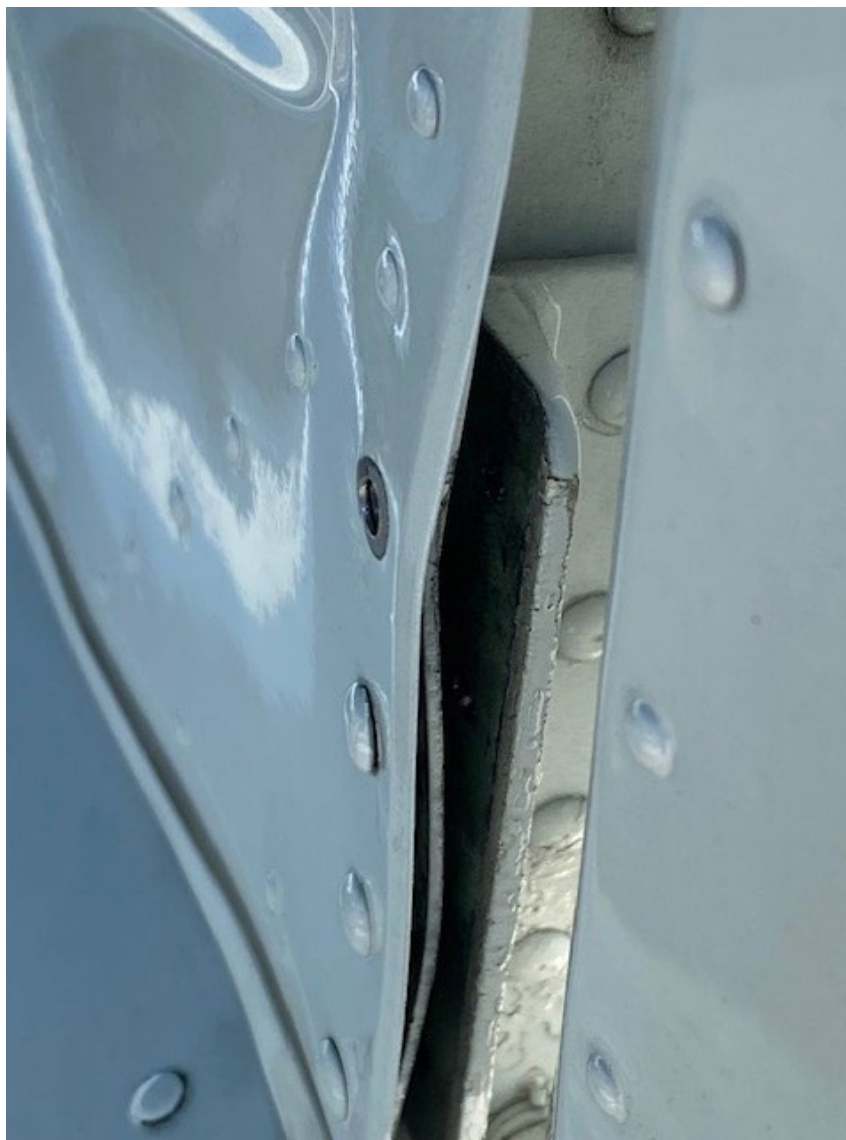
**Photograph 1 - Left side vertical stabilizer with missing rivet (Courtesy of Skyborne)**

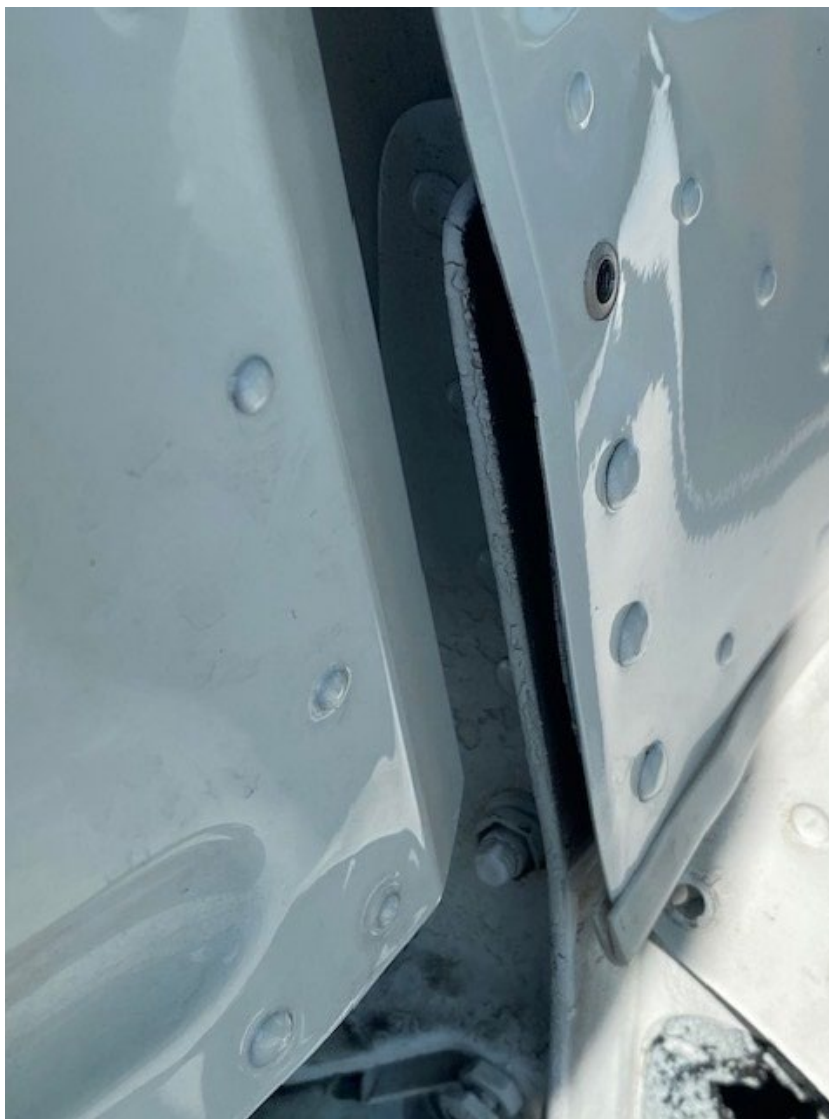
**Photograph 2 - Right side Vertical stabilizer with missing rivet (Courtesy of Skyborne)**

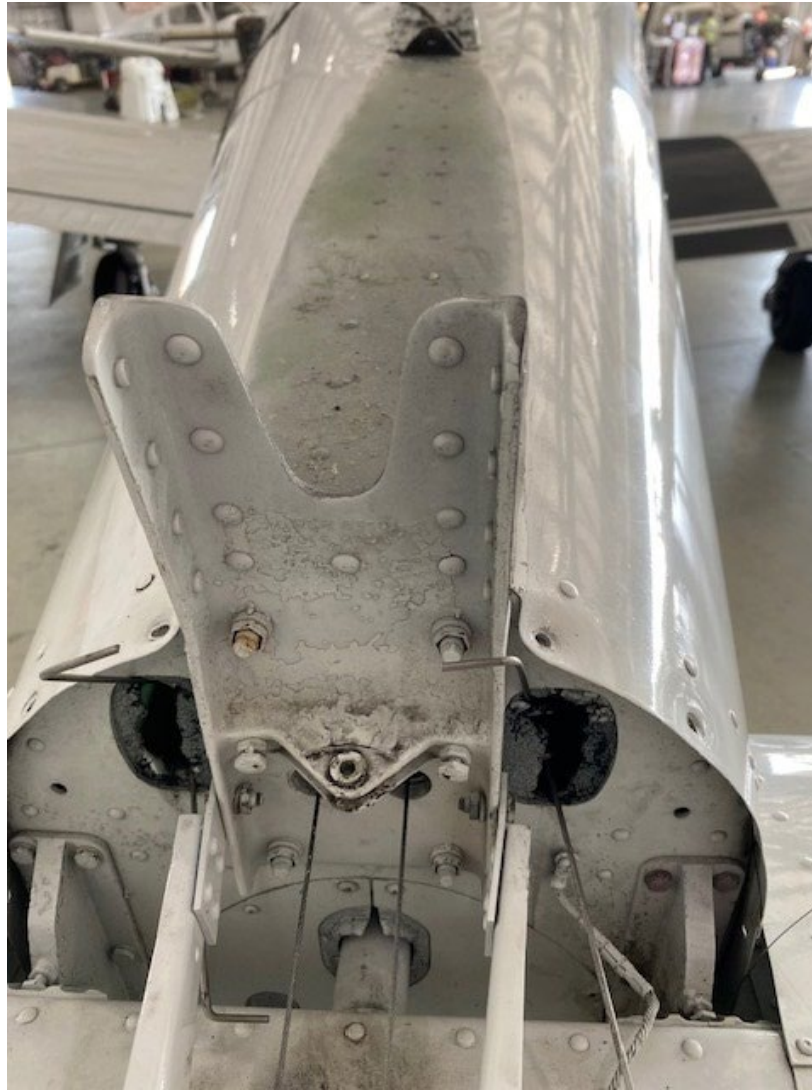
**Photograph 3 - Aft mounting bracket, 17 fractured rivets (Courtesy of Skyborne)**

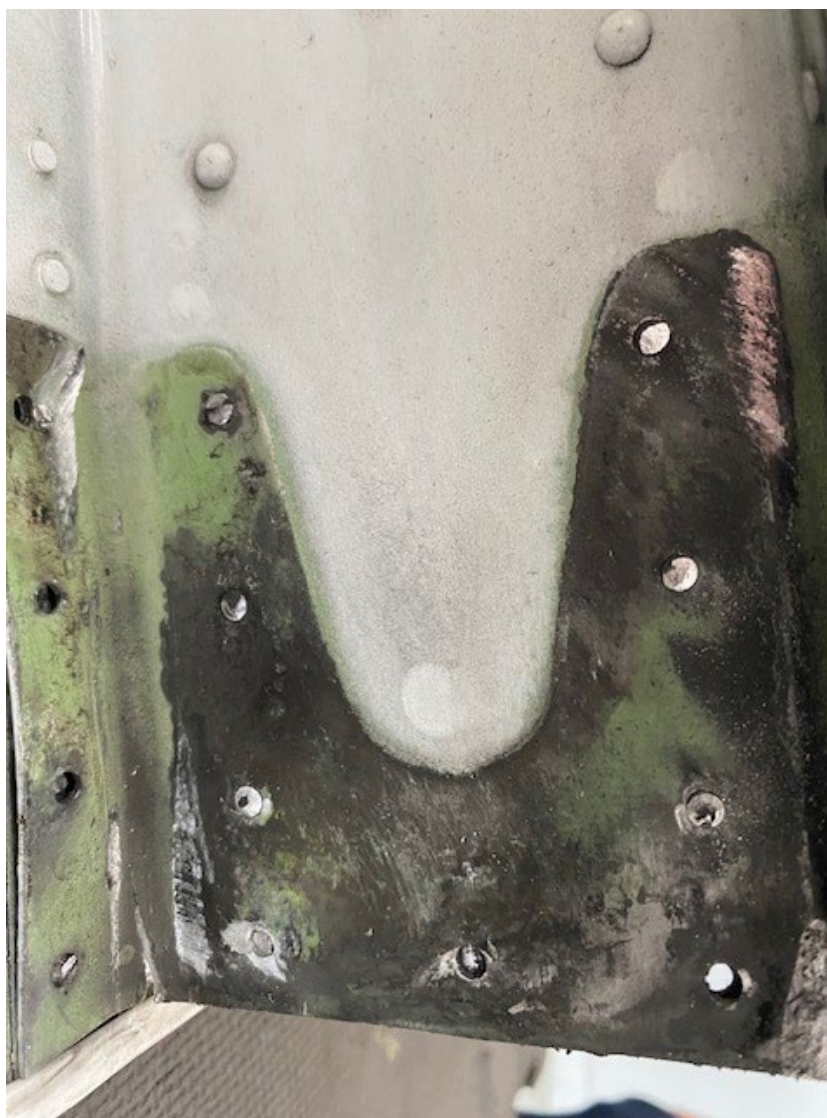
**Photograph 4 - Vertical Stabilizer, note: fractured rivets (Courtesy of Skyborne)**
