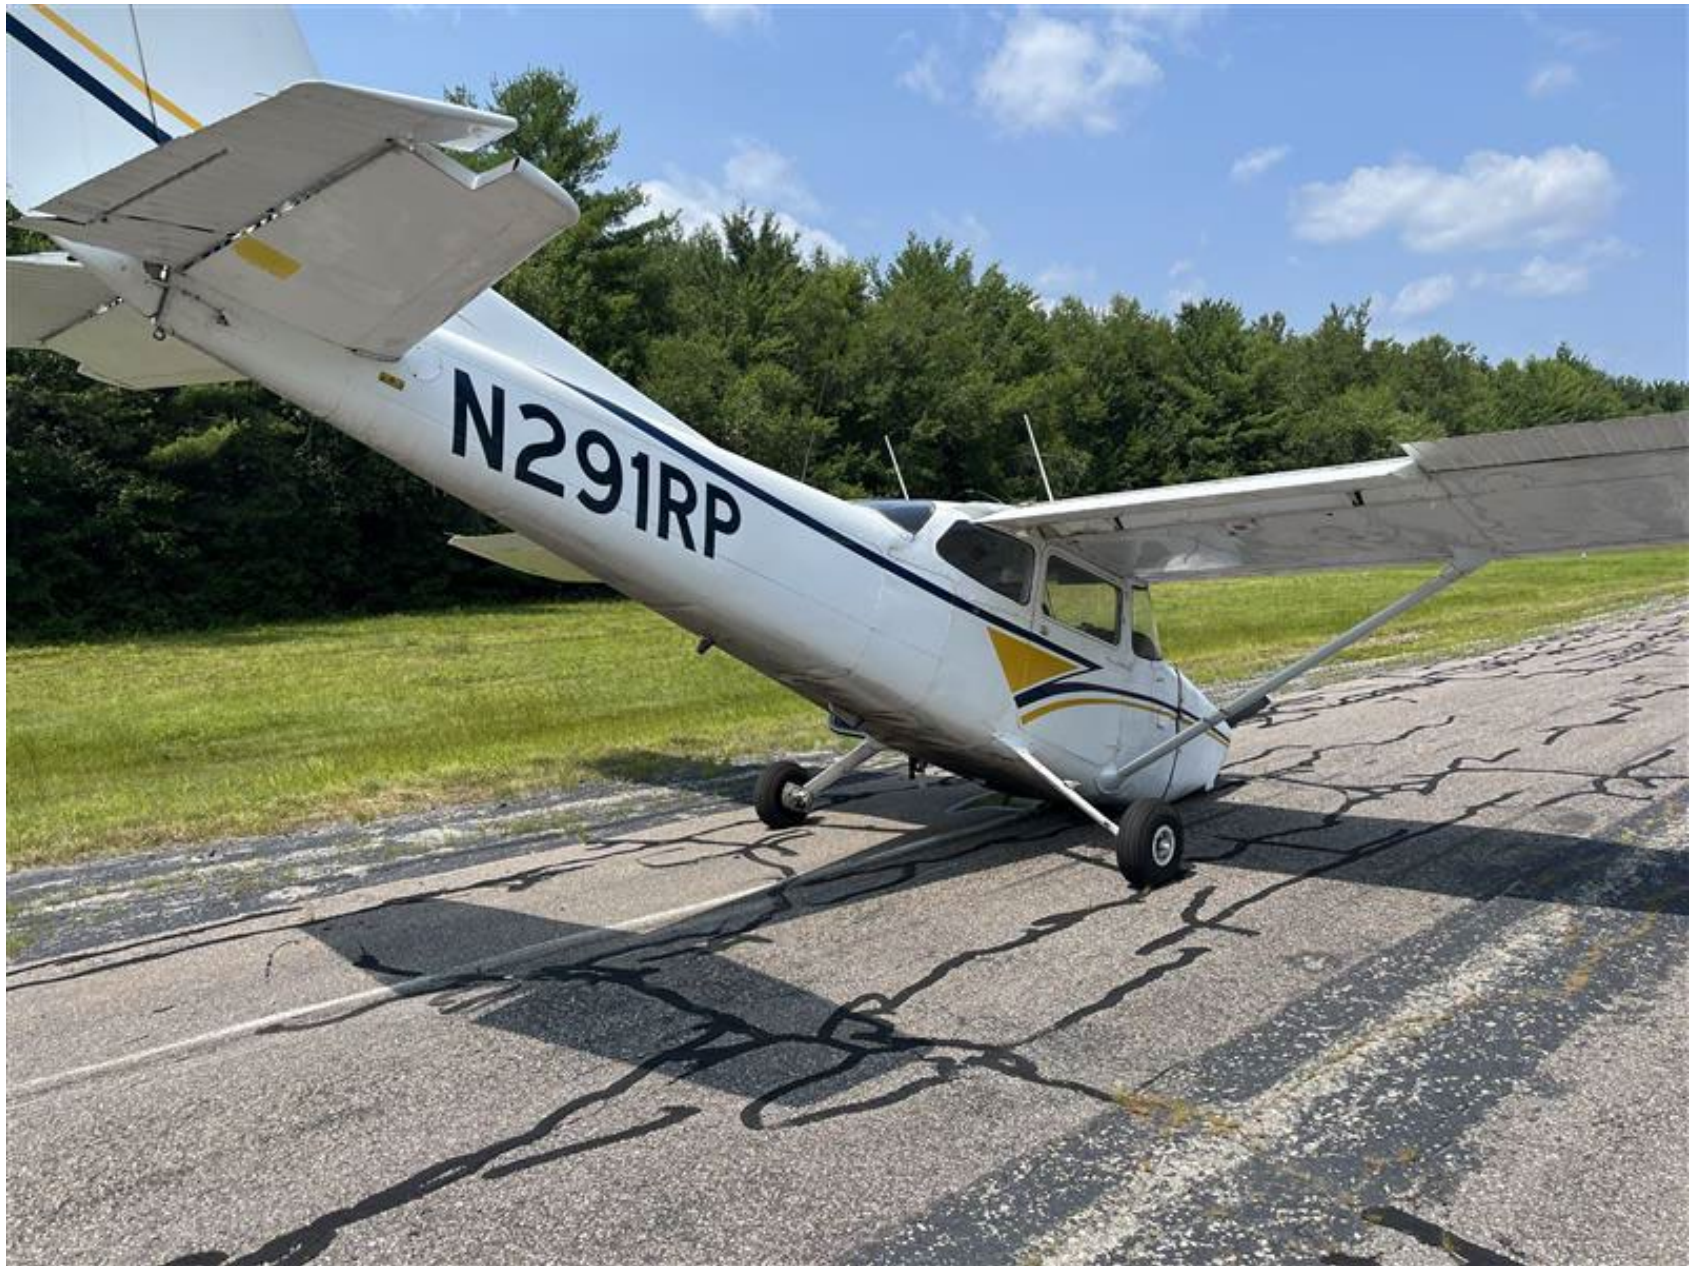
**Photo 1 – Aft Quartering View of Airplane as Found (FAA)**

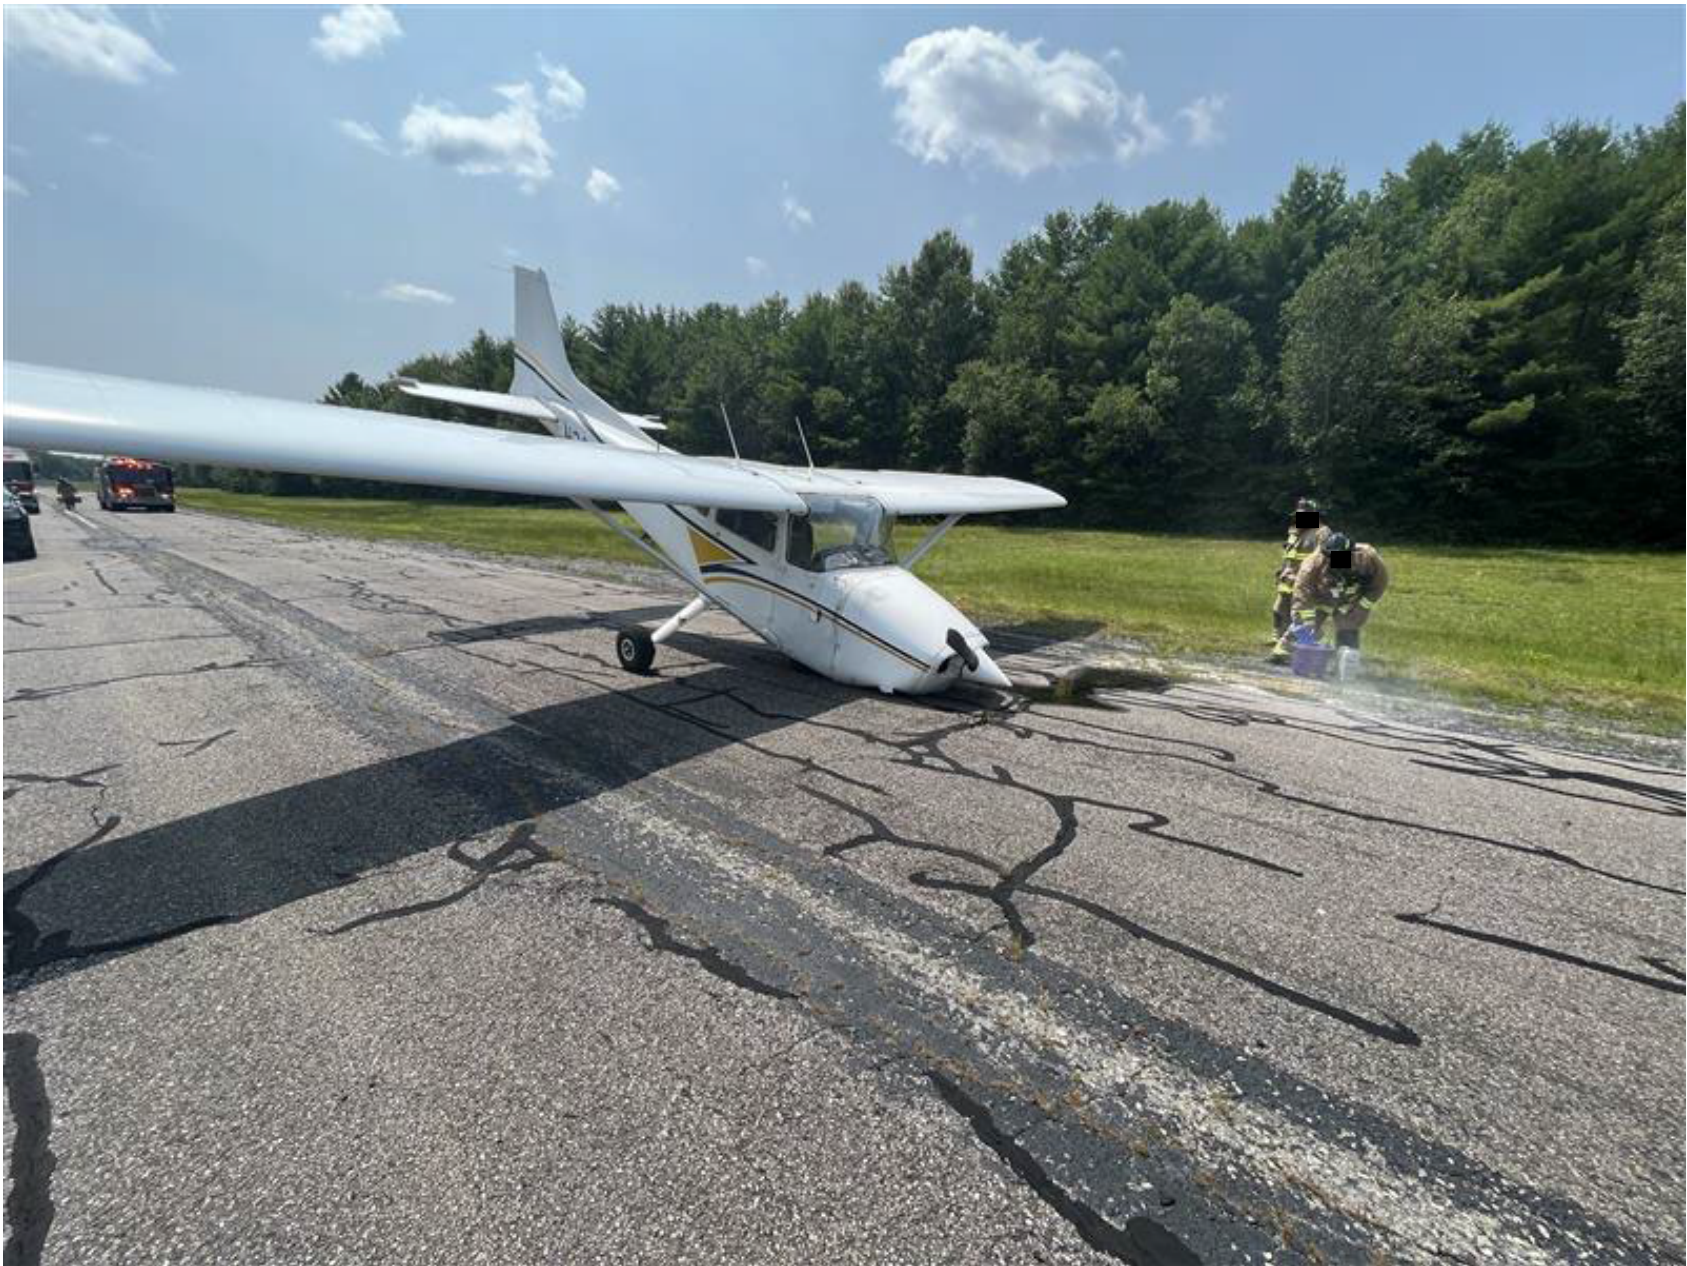
**Photo 2 – Front Quartering View of Airplane as Found (FAA)**

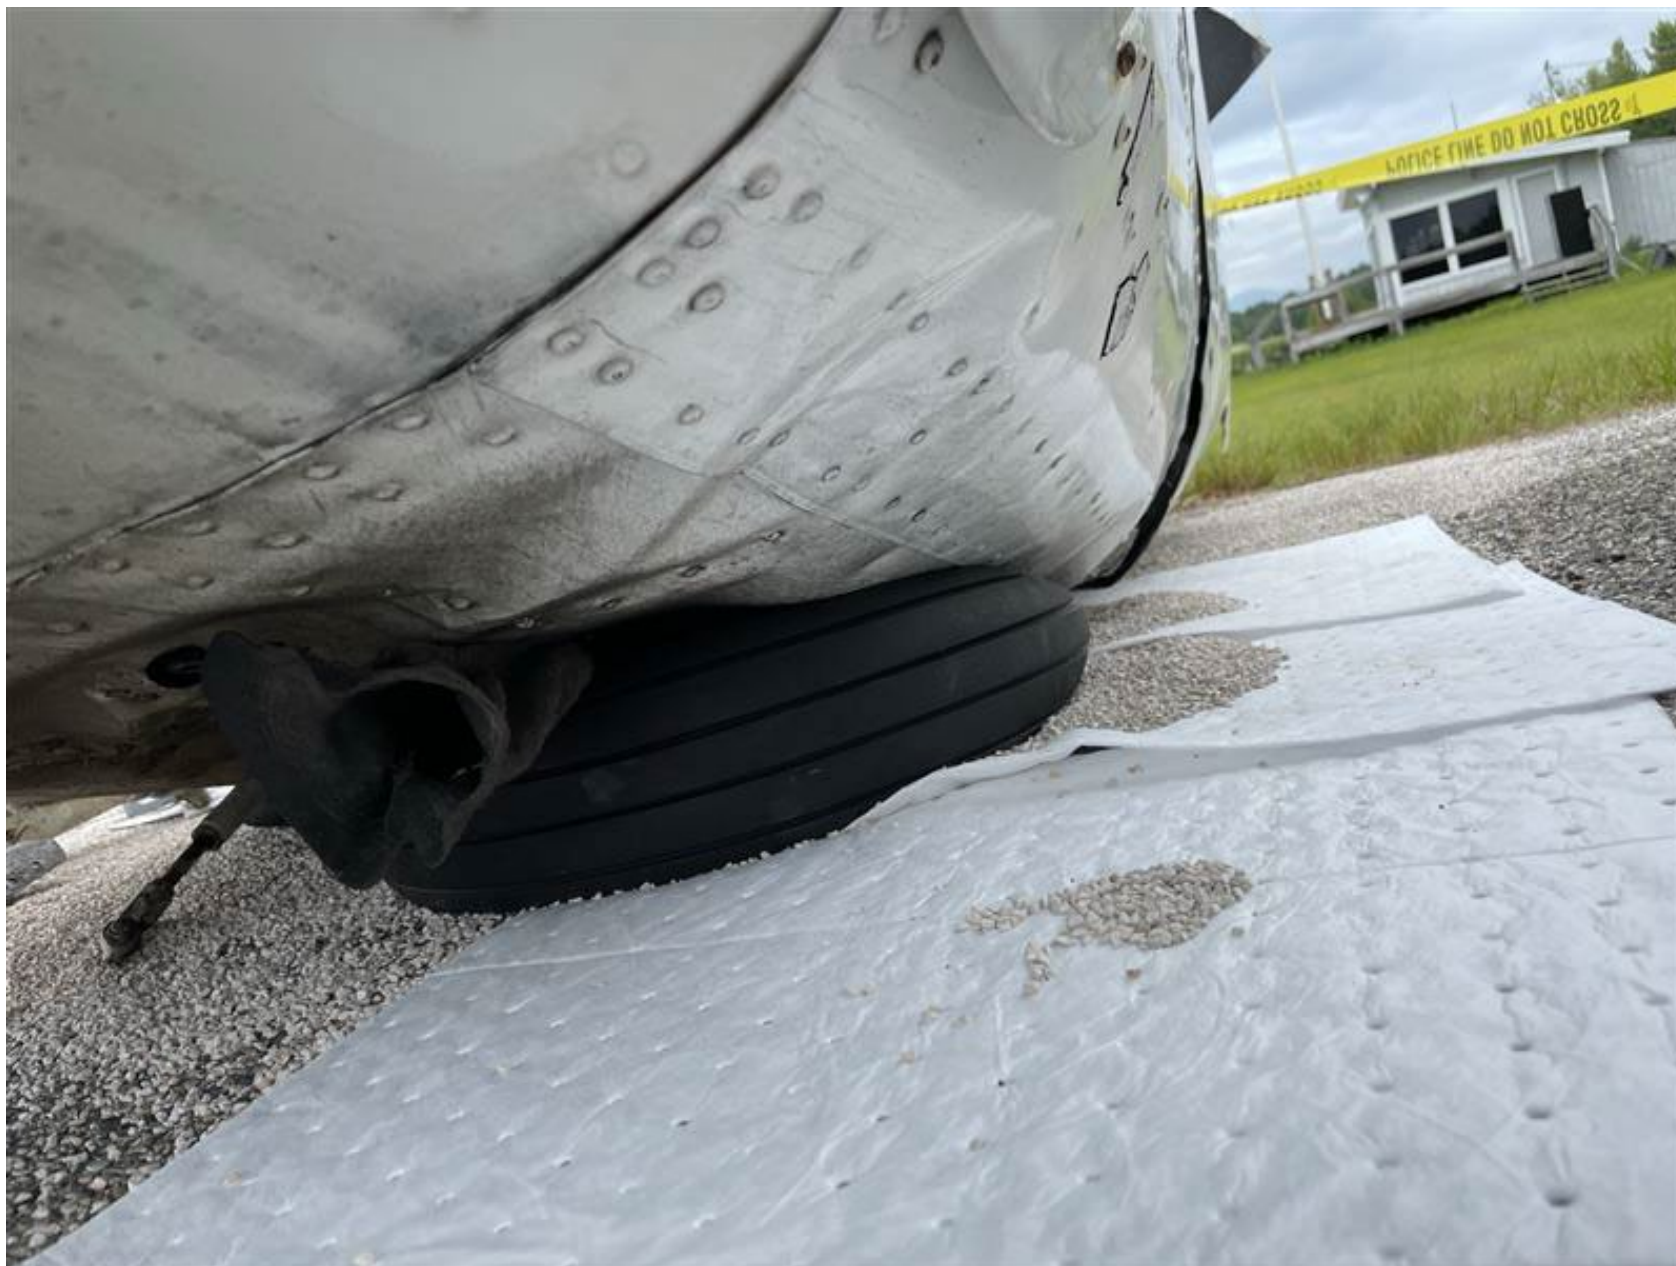
**Photo 3 – View of Wrinkled Cabin Structure (FAA)**

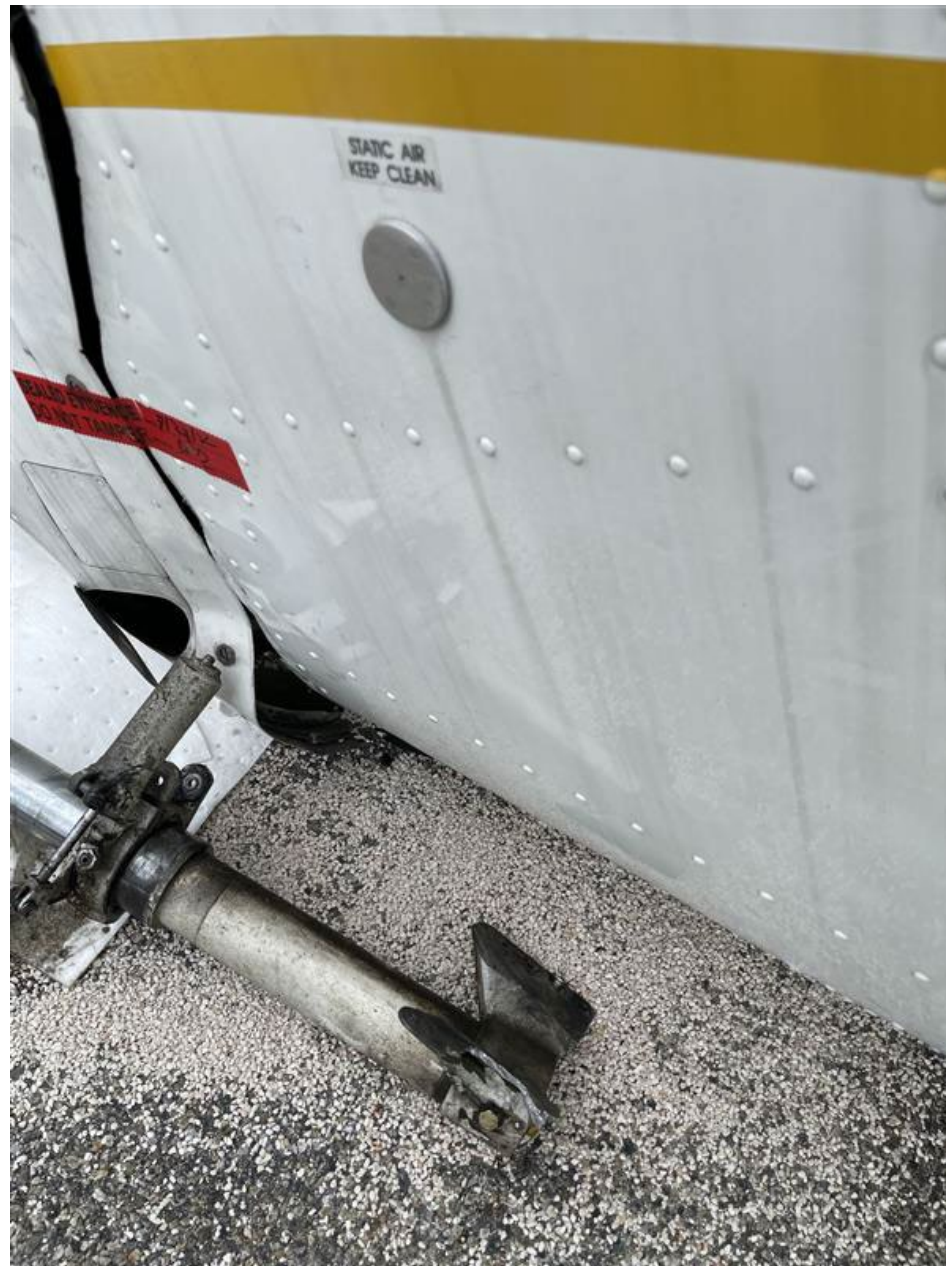
**Photo 4 – View of Fractured Nose Landing Gear (N/L/G) Mount Structure Attached to Separated N/L/G (FAA)**
