**MEMORANDUM FOR RECORD**

**Subject:** ERA24LA345, KDED 5-Minute AWOS Observations and Accident Time

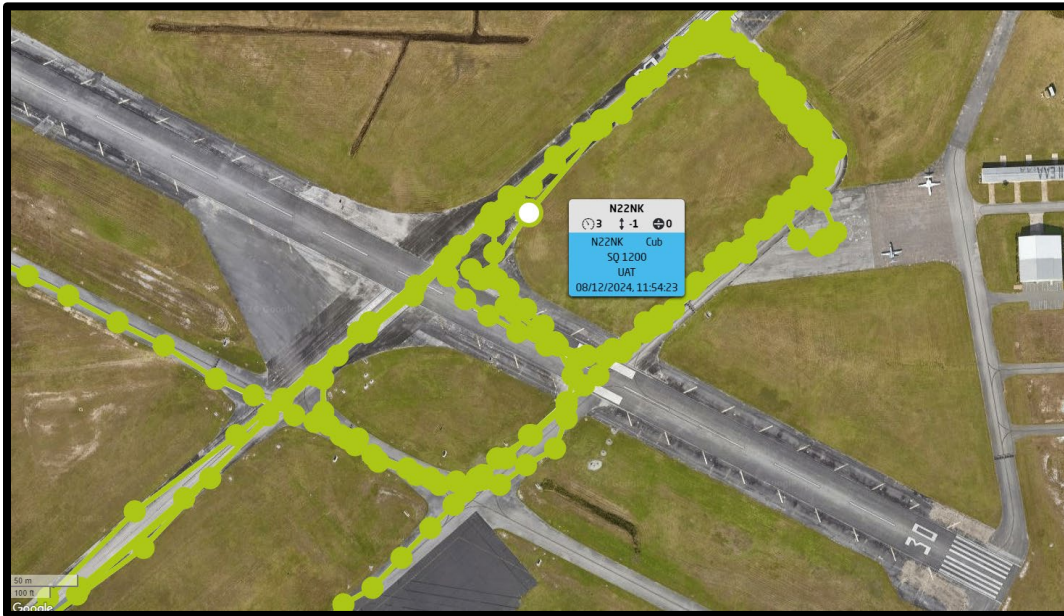
The DeLand Municipal Airport-Sidney H Taylor Field Airport (DED), DeLand, Florida, was equipped with VIR Tower<sup>1</sup>. Airport operations personnel provided NTSB an image showing the accident airplane in close proximity to the impacted sign at 1154:23 (Figure 1).

**Figure 1: VIR Tower Image Depicting Accident Airplane in Close Proximity to the Impacted Sign at 1154:23**
