## MEMORANDUM FOR RECORD

**Date:** October 22, 2024  
**Subject:** ERA24LA366, Witness and Touch Down Locations  
**Contact:** Hunter Bennett

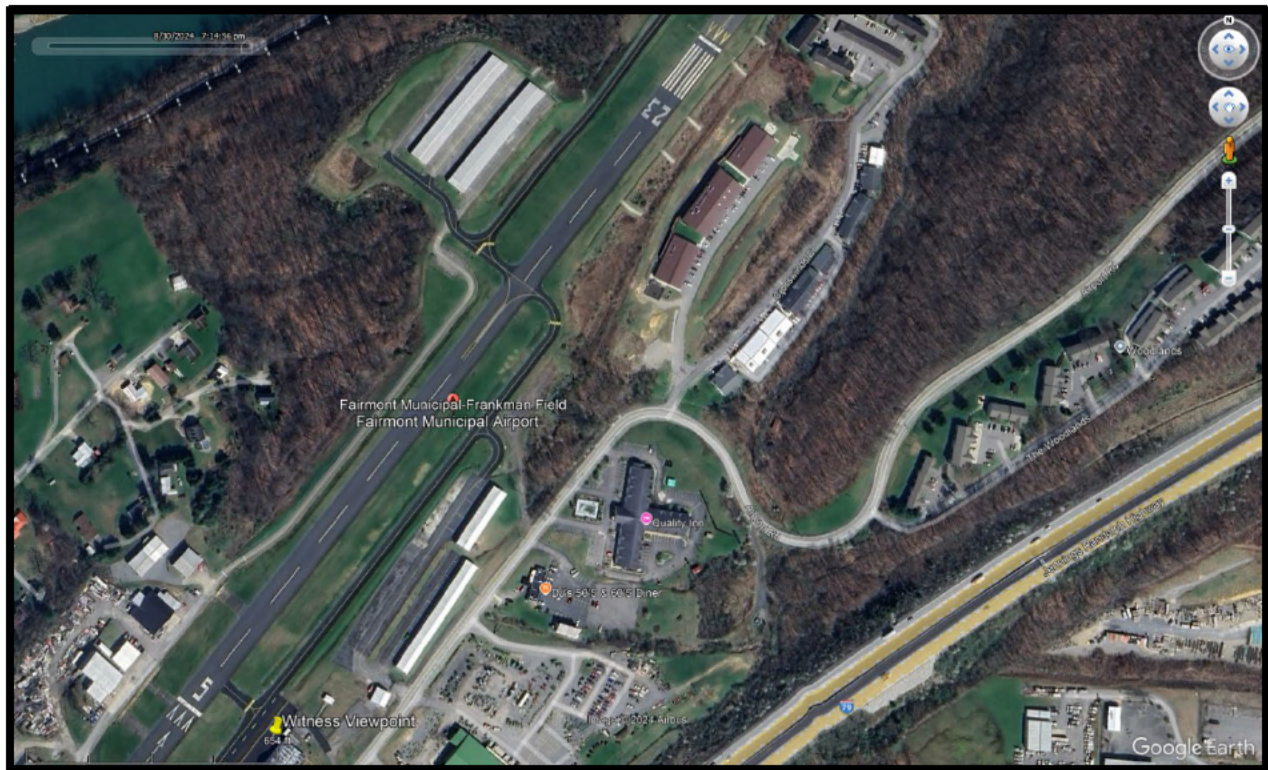
As part of the investigation Mr. Bennett was contacted to obtain his exact location when he witnessed the accident. Using Google Earth, he reported he was located at

39.445691° north latitude and -80.168511° west longitude, or about 234 ft and 111° from the runway 5 threshold marking (Figure 1).

**Figure 1: Google Earth Plot Showing 4G7 Runway and Witness Location**

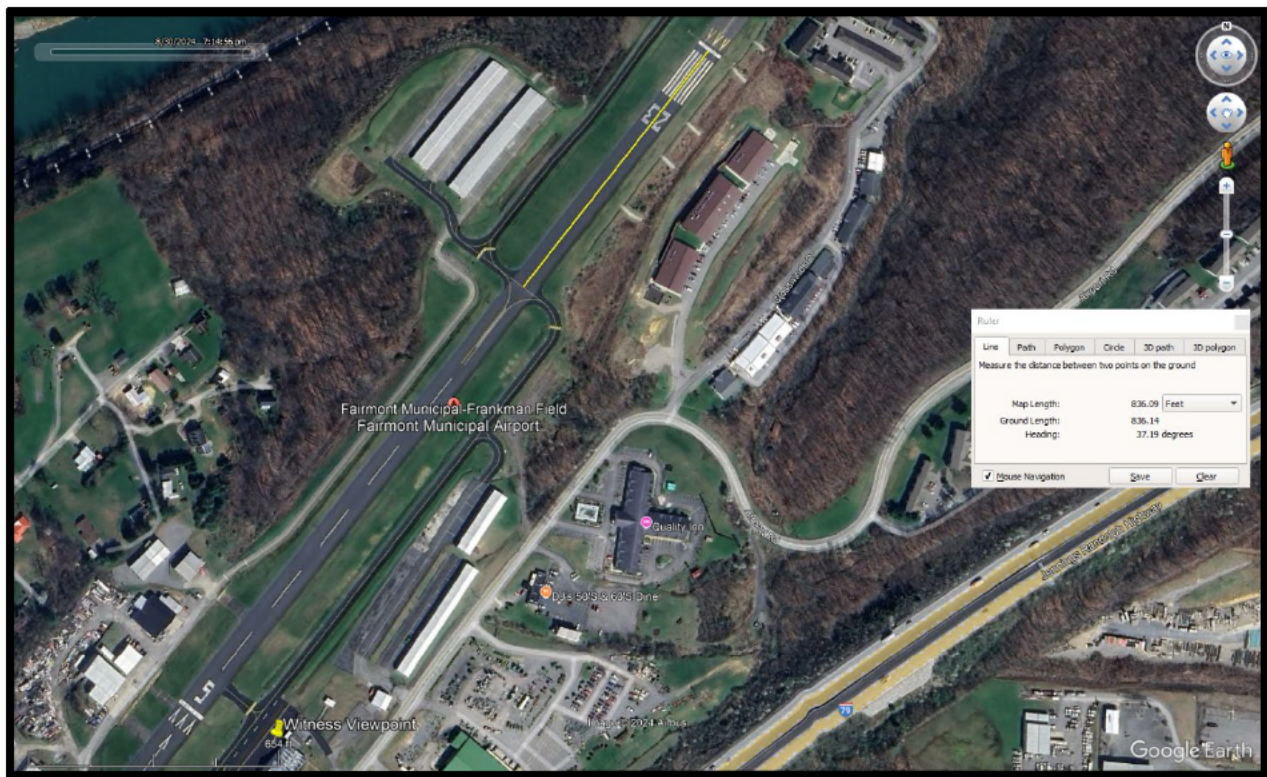
Based on his account of seeing the airplane touch down past the last taxiway crossing, using Google Earth it was located about 836 ft before the departure end of runway 5 (Figure 2).

**Figure 2: Google Earth Plot Showing 4G7 Runway, Witness Location, and Distance From Last Taxiway Crossing to Departure End of Runway 5**
