# National Transportation Safety Board

ERA25LA003

## **COCKPIT DISPLAY - RECORDED FLIGHT DATA**

Specialist's Factual Report

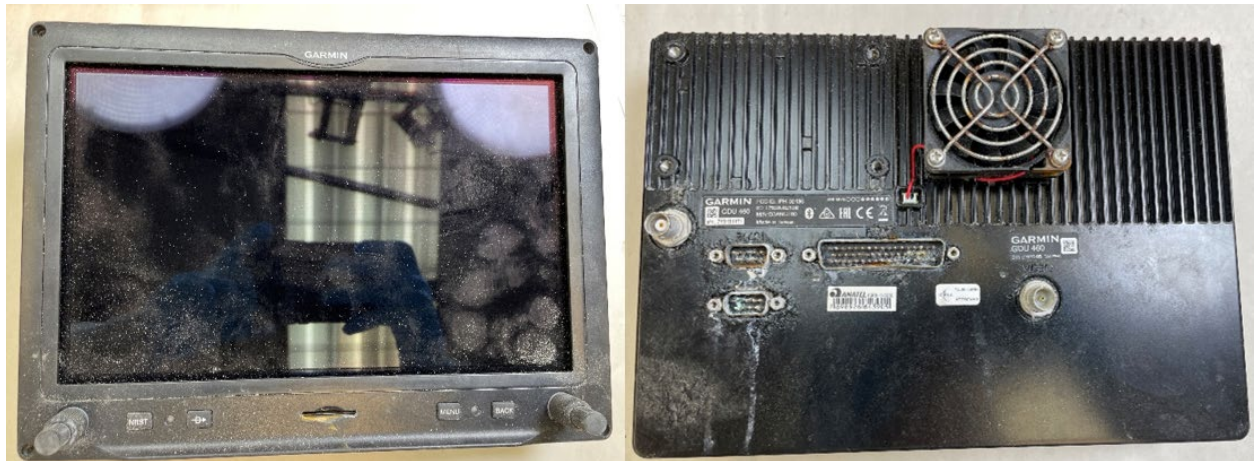
The device was submerged in salt water during the accident event and was dry upon arrival at the NTSB Vehicle Recorder Laboratory. The device as shown in figure 1, and an SD card, as shown in figure 2, sustained corrosive damage rendering each inoperable. The internal NVM chip was removed and a binary image of the chip was created using laboratory tools. The image was written to a blank exemplar chip and

**Figure 1.** Front and back of the Garmin GDU 460 as received.

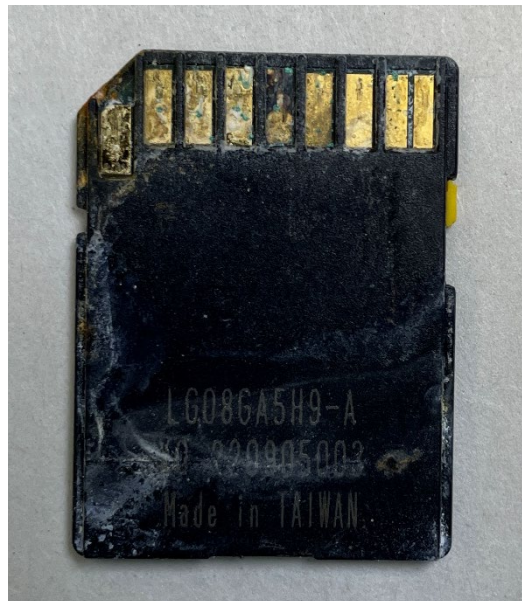
**Figure 2.** SD card as received.
