ERA25LA233

## INVESTIGATION PHOTOGRAPHS

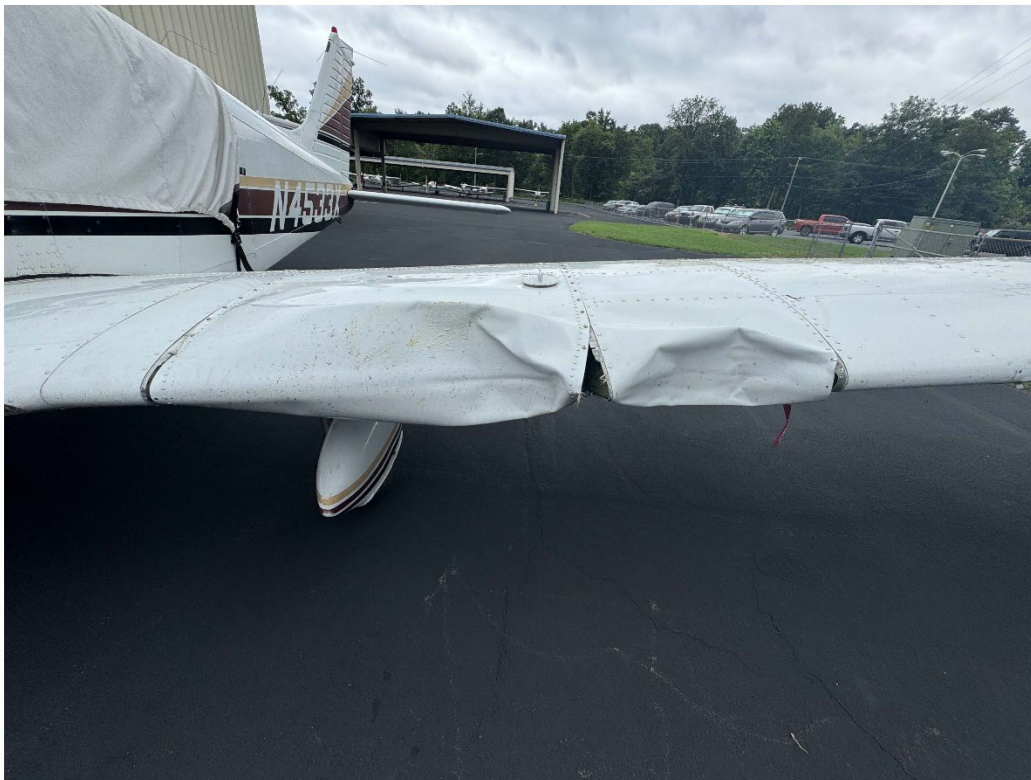
**Photograph 1 - FAA Digital Photograph. Frontal View of a Portion of the Left Wing Showing the Leading Edge Impact Damage**

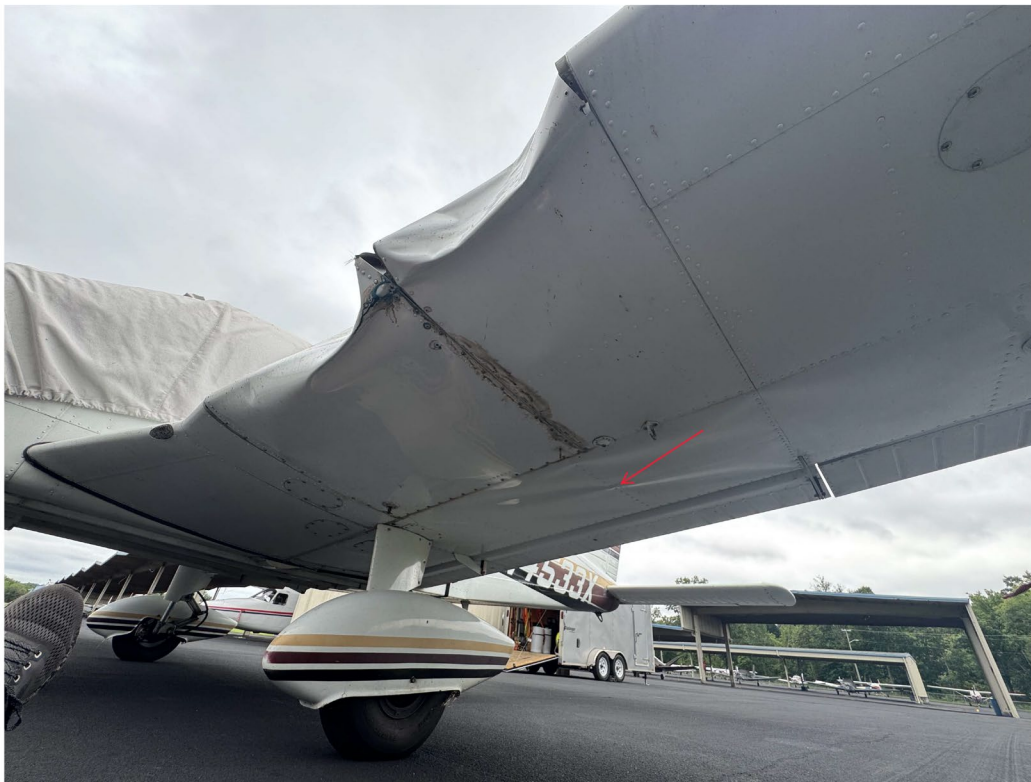
**Photograph 2 - FAA Digital Photograph. View of the Bottom of a Portion of the Left Wing.  
Arrow Points to Buckling of the Lower Wing Skin Aft of the Main Spar**

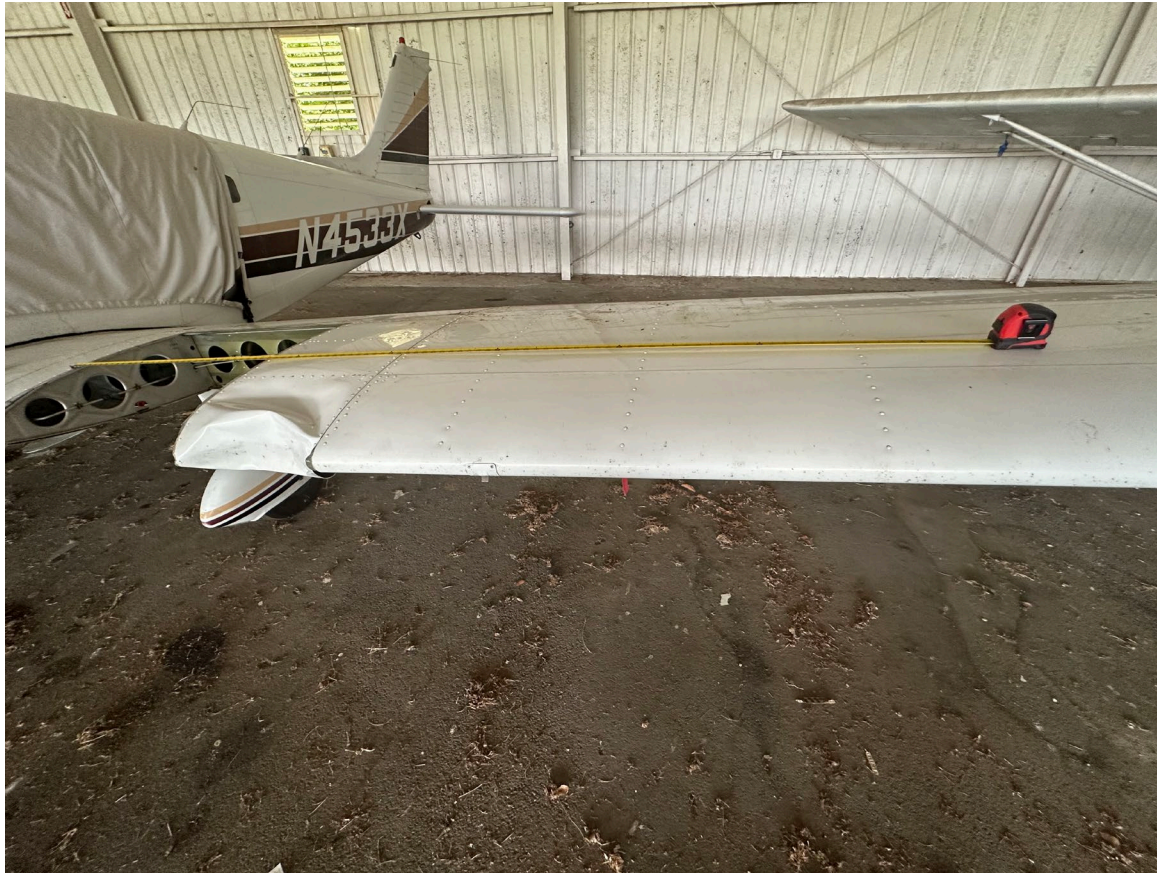
**Photograph 3 - FAA Digital Photograph. View Showing the Approximate 48 Inches of Span Damage to the Leading Edge**
