ERA25LA321

## INVESTIGATION PHOTOGRAPHS

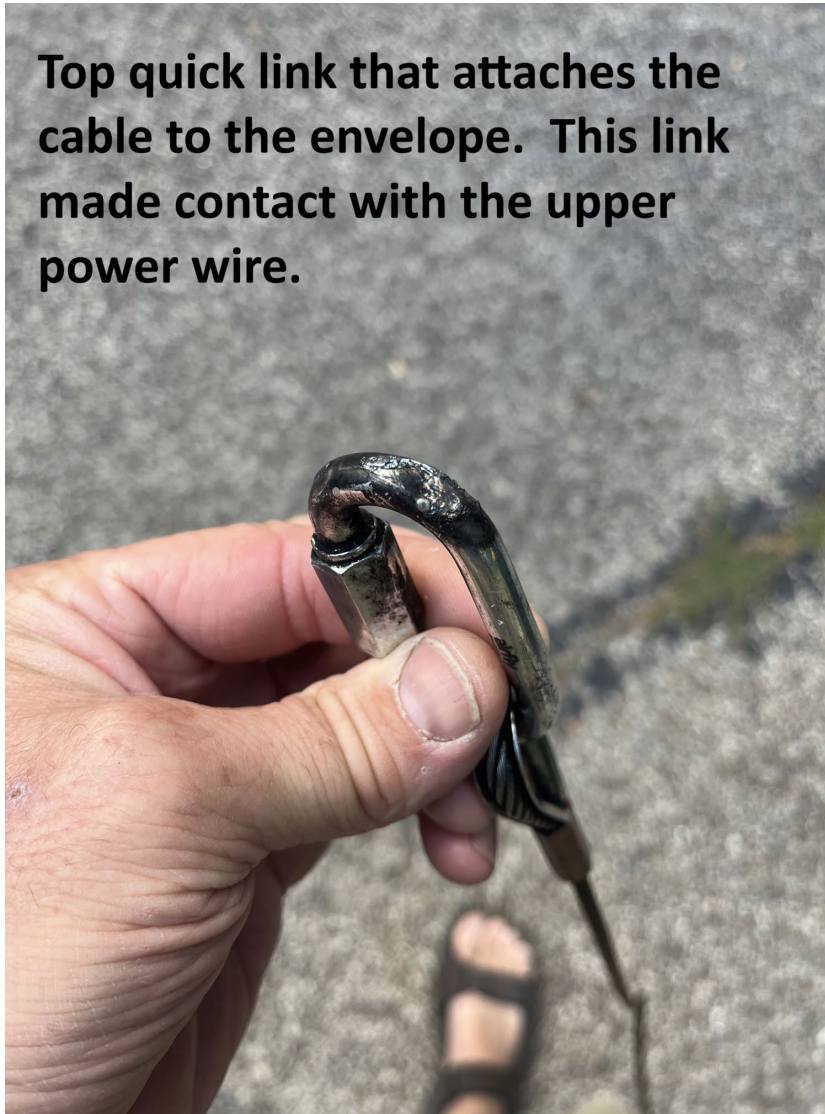
**Photograph 1 - Arc on quick link (Courtesy of Owner)**

**Top quick link that attaches the cable to the envelope. This link made contact with the upper power wire.**

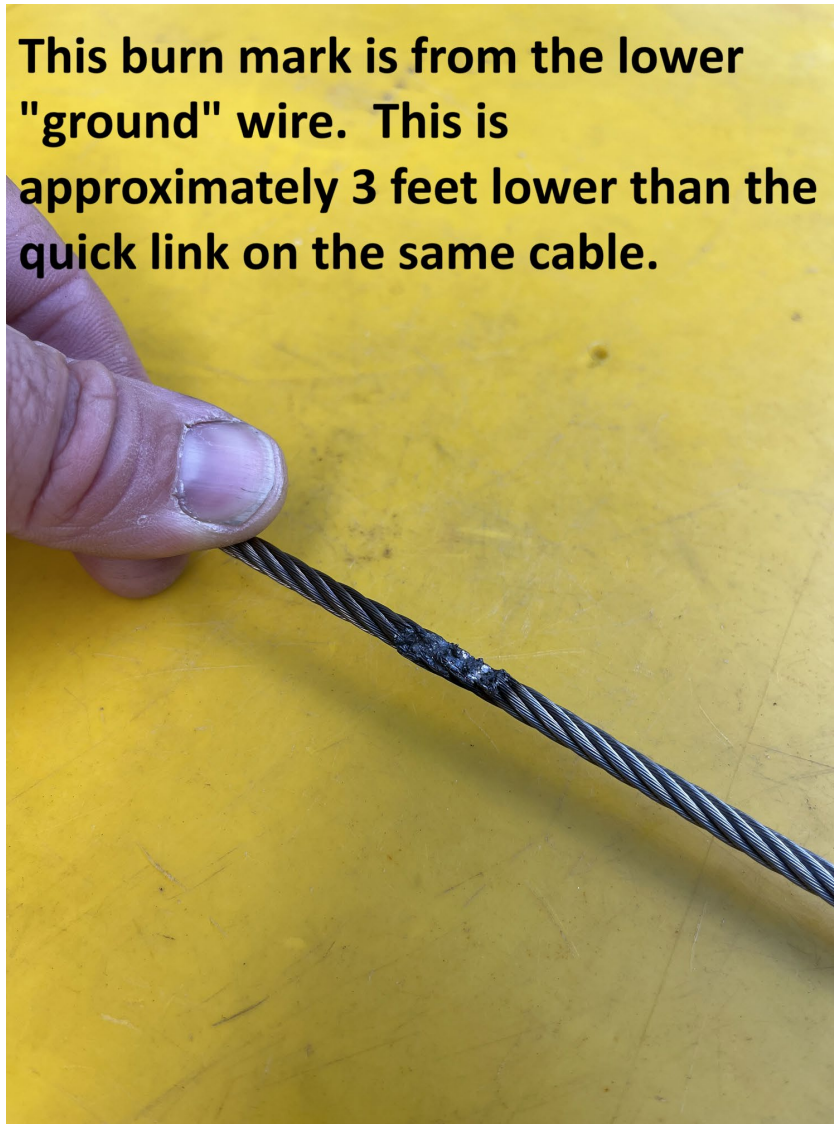
**Photograph 2 - Burnt cable (Courtesy of Owner)**

**This burn mark is from the lower  
"ground" wire. This is  
approximately 3 feet lower than the  
quick link on the same cable.**
