# National Transportation Safety Board

ERA25MA106

## MISCELLANEOUS DEVICES

Specialist's Factual Report

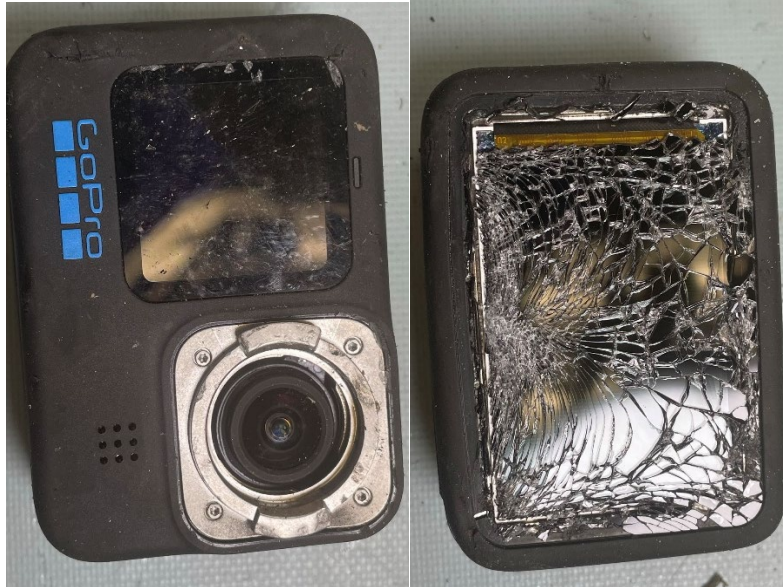
The GoPro camera was recovered in a parking lot near the accident site and was damaged in the event. The extent of the damage is shown in figure 1.

**Figure 1.** Damaged Go Pro

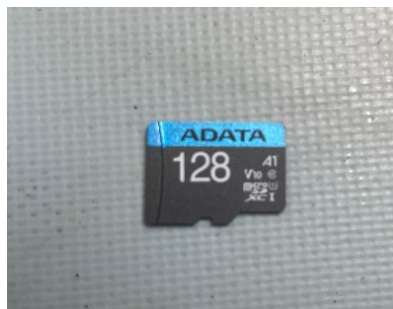
The microSD card in the Go Pro (figure 2) was working but had no aviation video or any data useful to the investigation when downloaded. The GoPro was never conclusively determined to be from the accident aircraft.

**Figure 2.** microSD card found in GoPro.

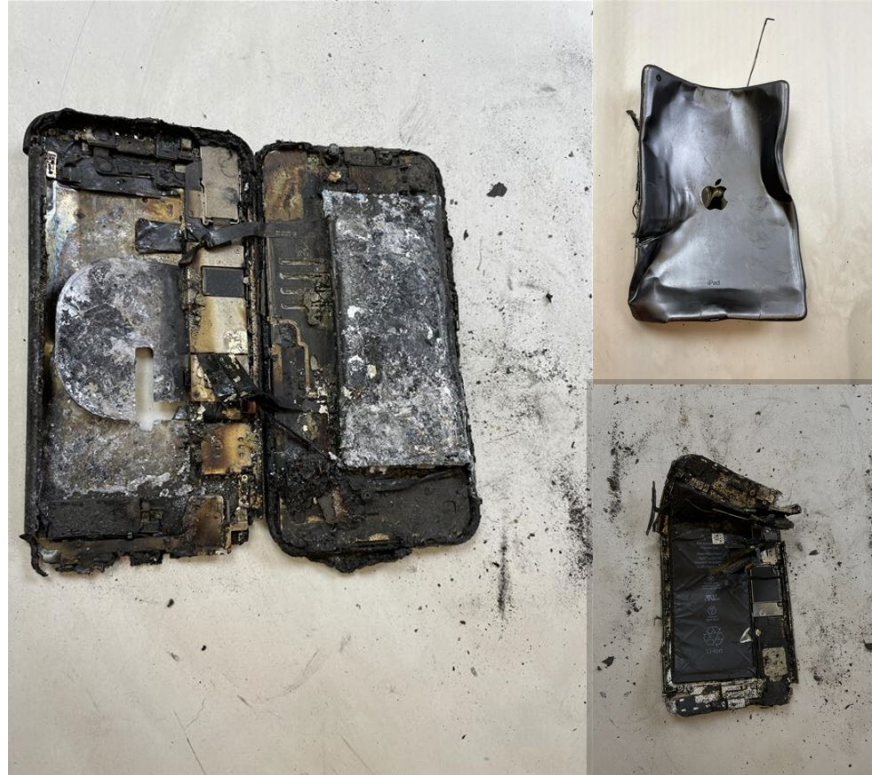
All phones and tablets were destroyed and unrecoverable, figure 4 shows the condition of these devices post accident. One of the Apple watches was in good condition (figure 5), however, this was later determined to have belonged to one of the ground victims. Data recovery from this device was not pursued. An additional Apple watch (figure 6) was destroyed and no data was recovered.

**Figure 4.** Damaged smart devices (iPhone - left, iPad - top right, iPhone - bottom right)

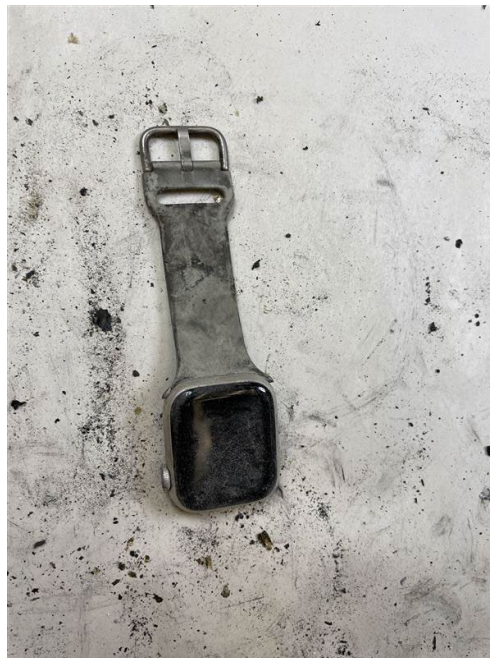
**Figure 5.** Working Apple Watch which was determined to have belonged to a ground victim.

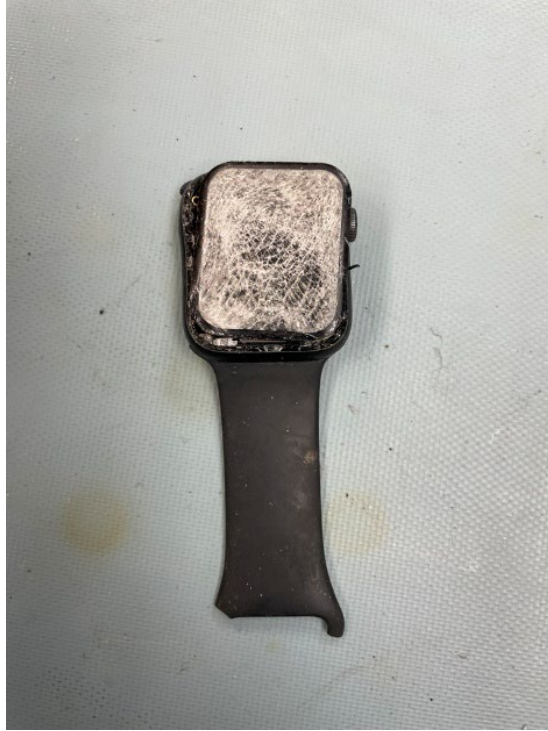
**Figure 6.** Damaged Apple Watch
