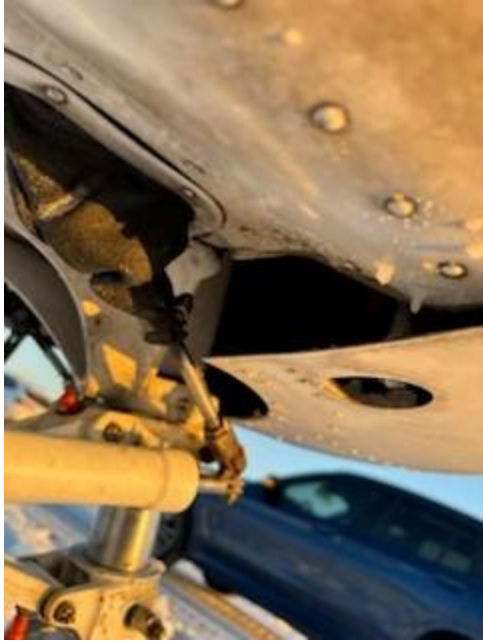
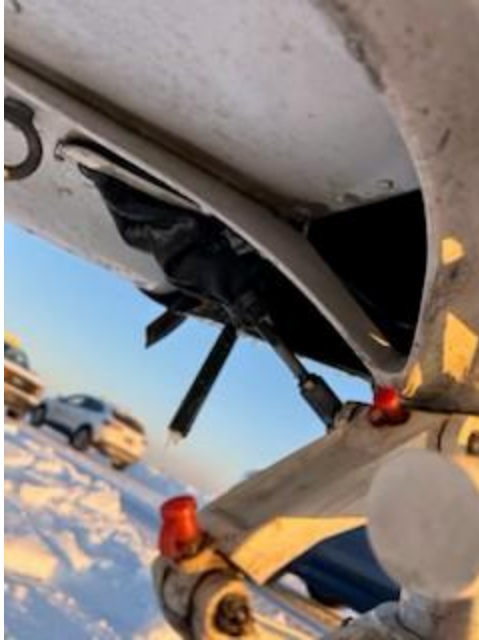
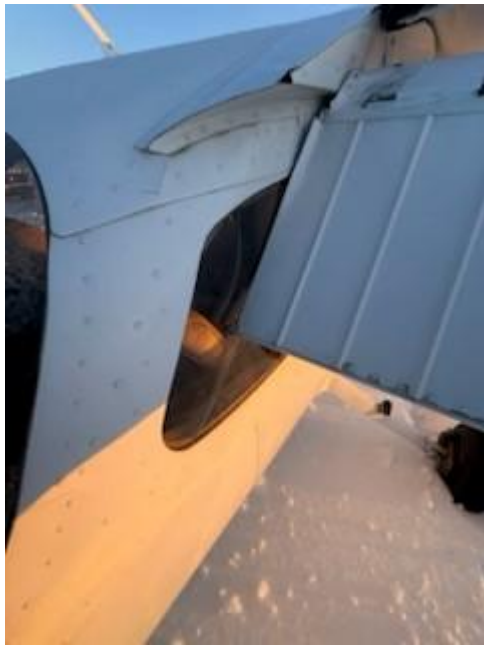
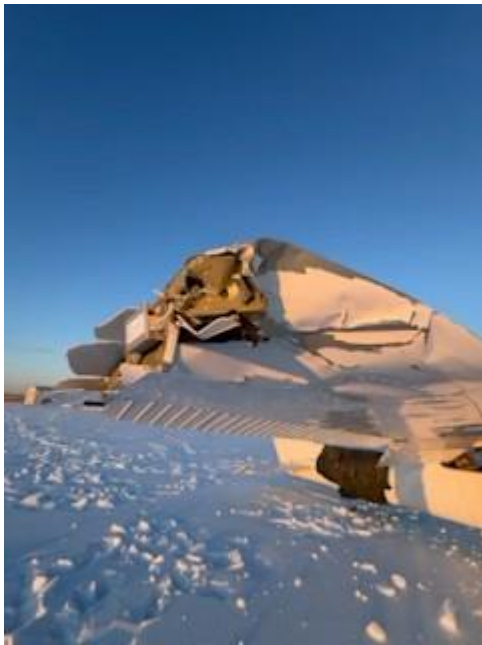
Compressed right wing root. Right flap broke right rear window.  
Spinner shows evidence of contact with pavement during cartwheel  
with engine running

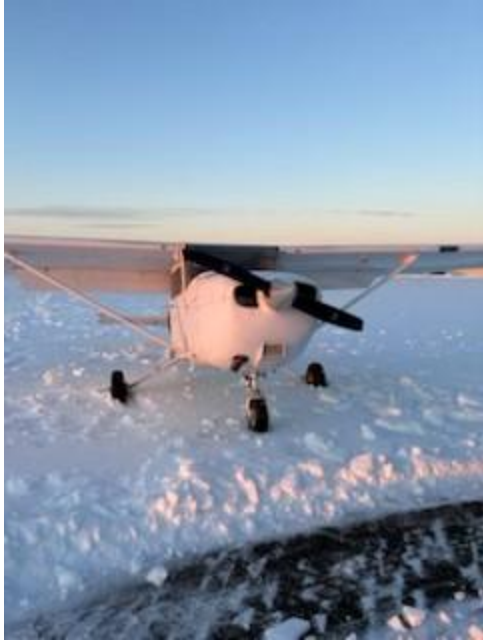
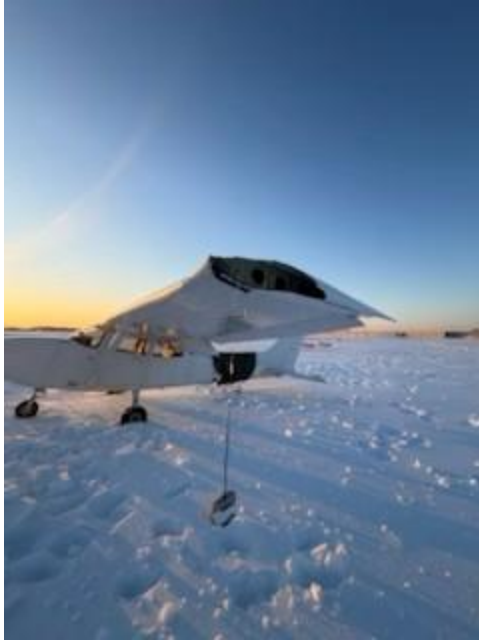
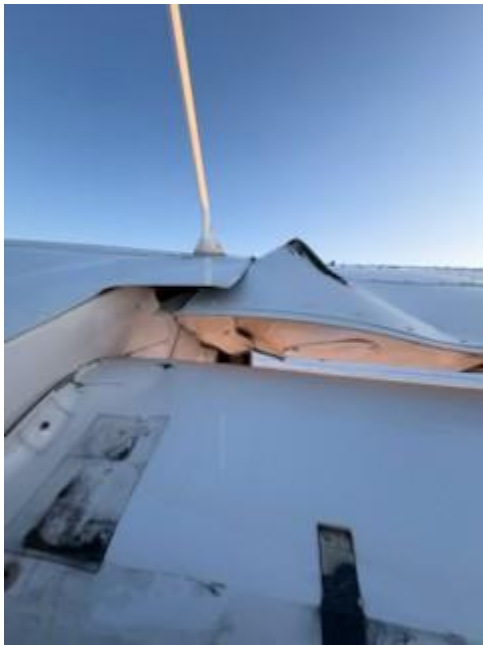
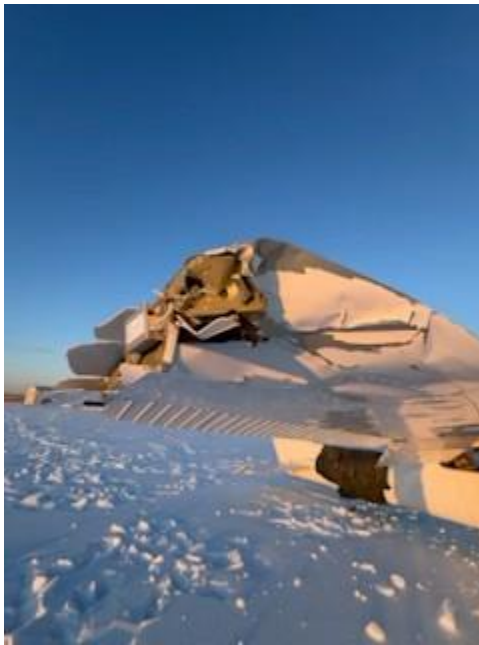
Damage to Rt. Horizontal Stabilizer at the hinge point

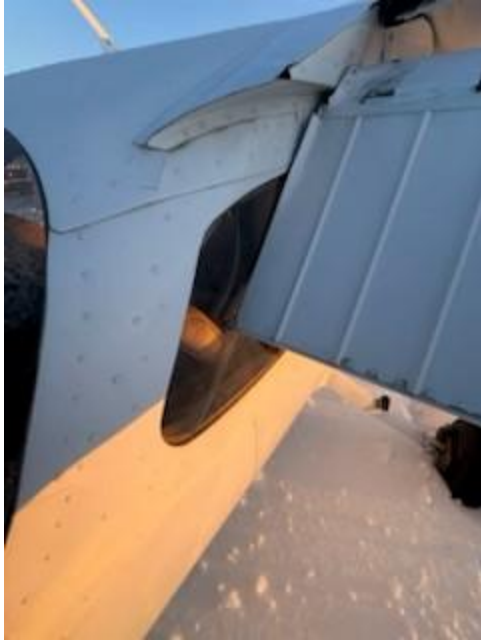
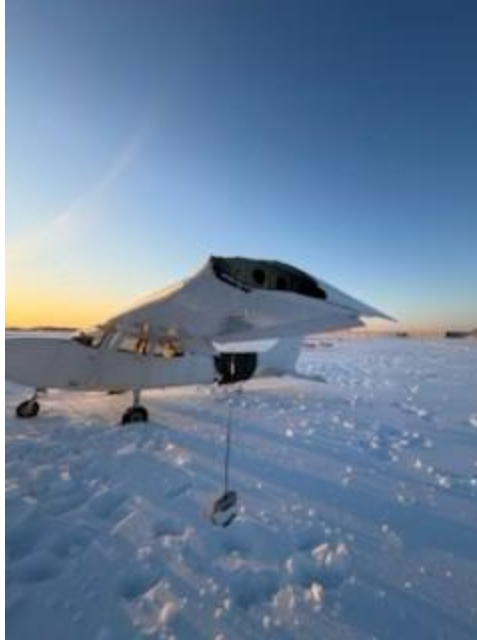
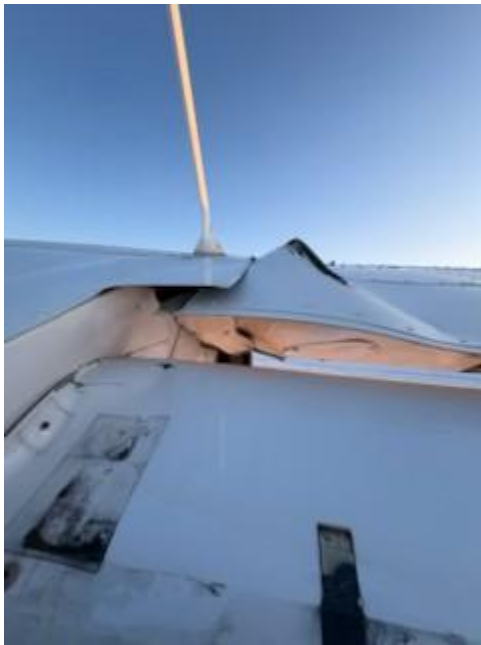
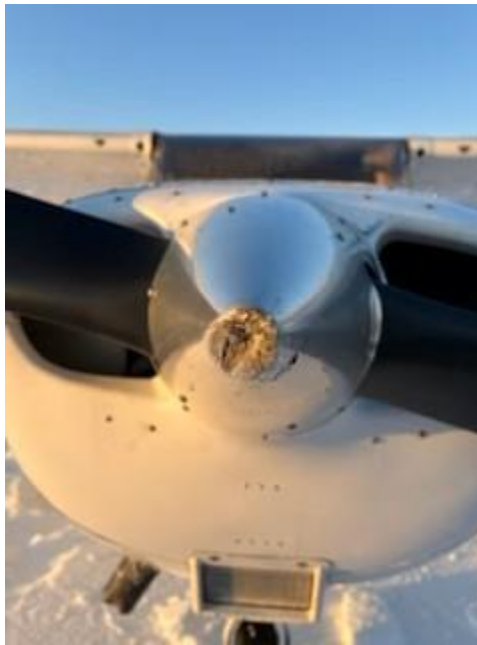
Photo taken less than 2 hours after occurrence from the closest plowed taxiway ( "D"? ) Note the aircraft in the background and that the runway lights are still on for R/W 32 that is unplowed and Notamed closed. Also no lit "X" at the threshold.

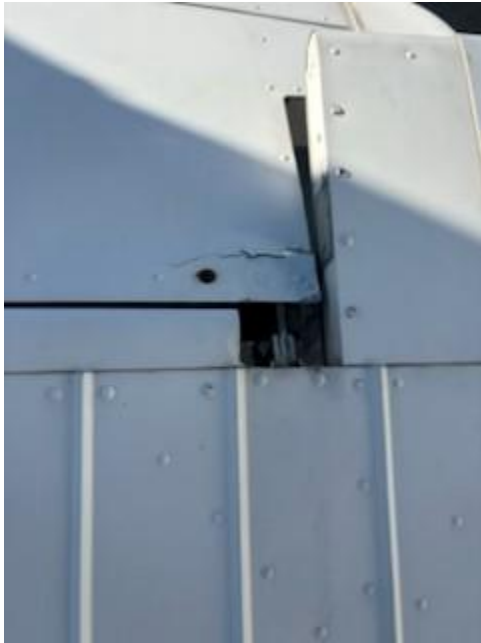
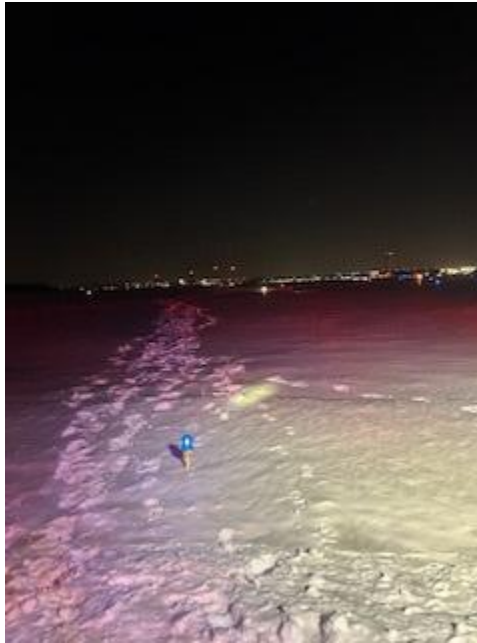
Note in both of these photos the lack of tire tracks in the snow. This is because the A/C cartwheeled in to its final position.
