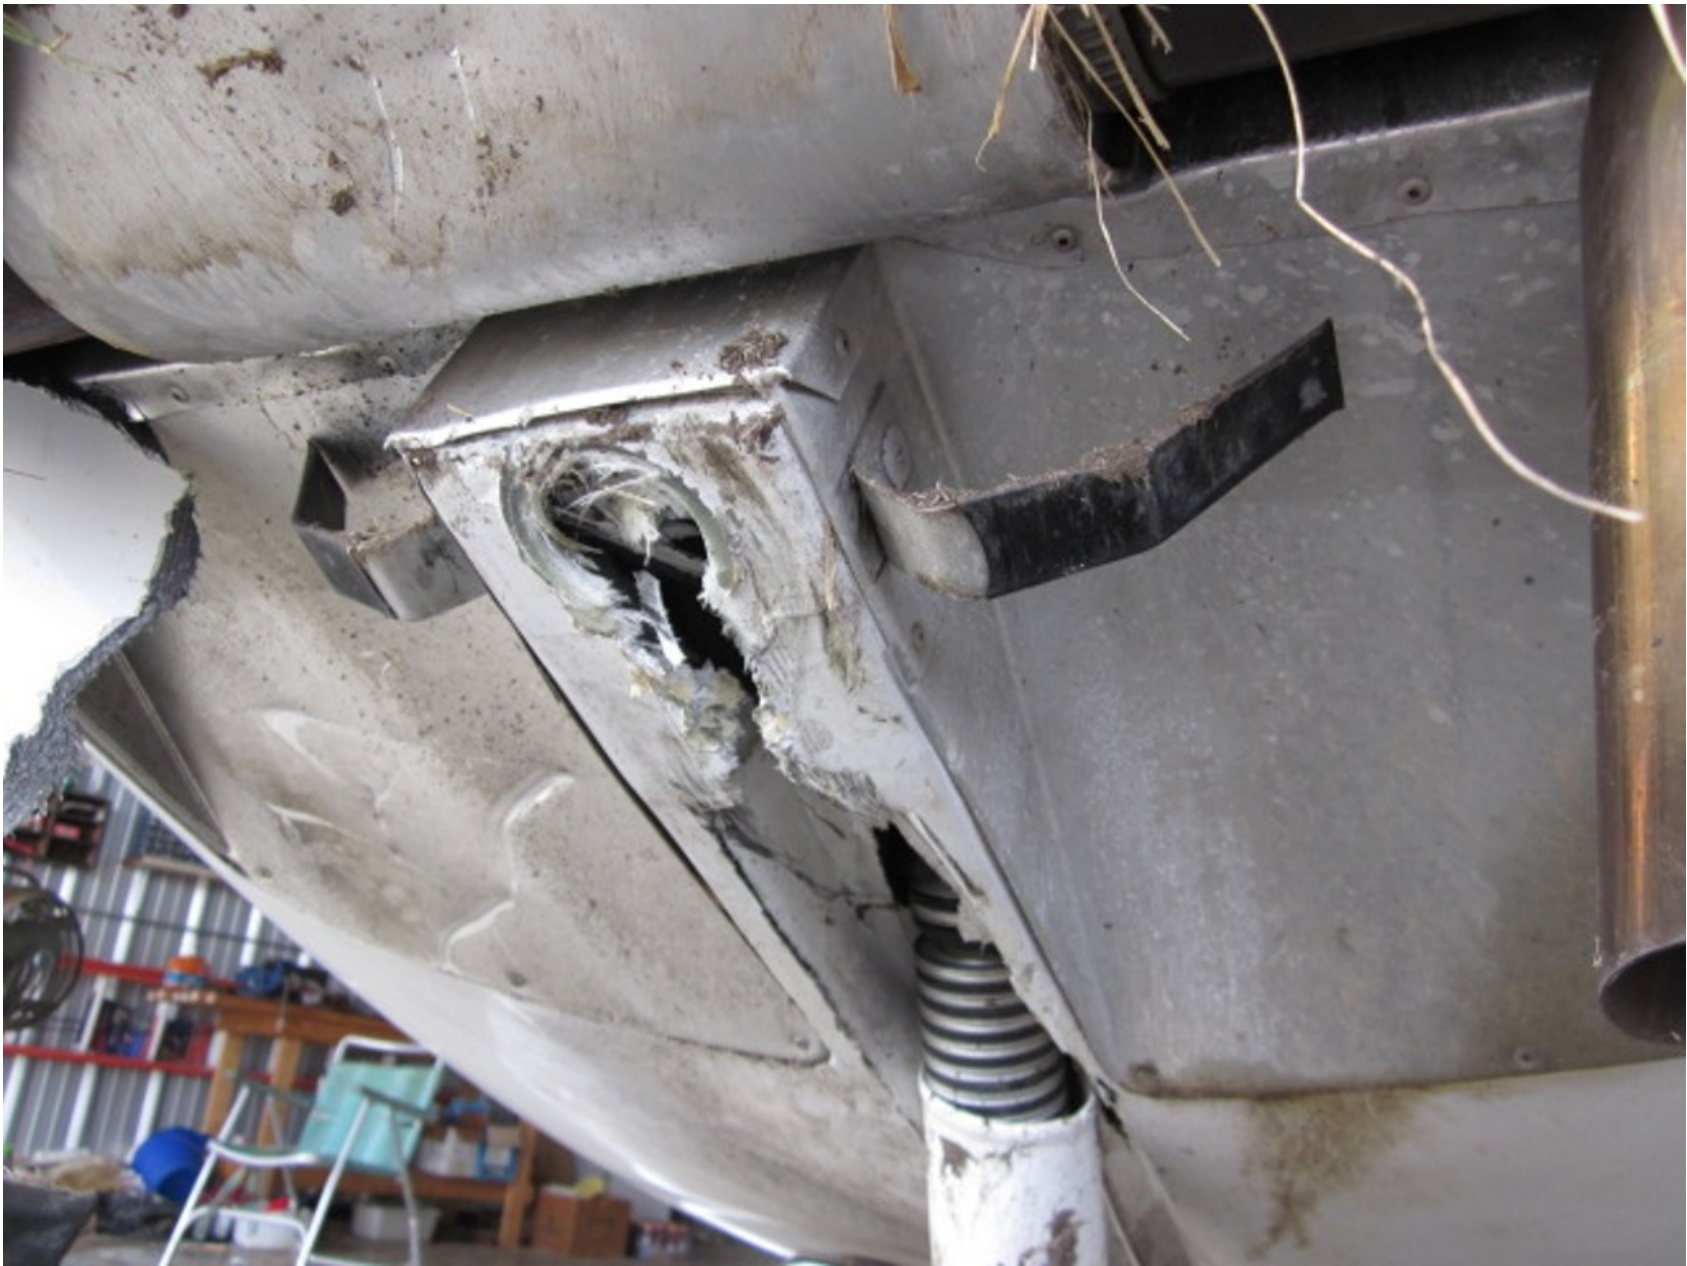
**Photo 1 – View of damage to composite fuselage (Courtesy of FAA)**

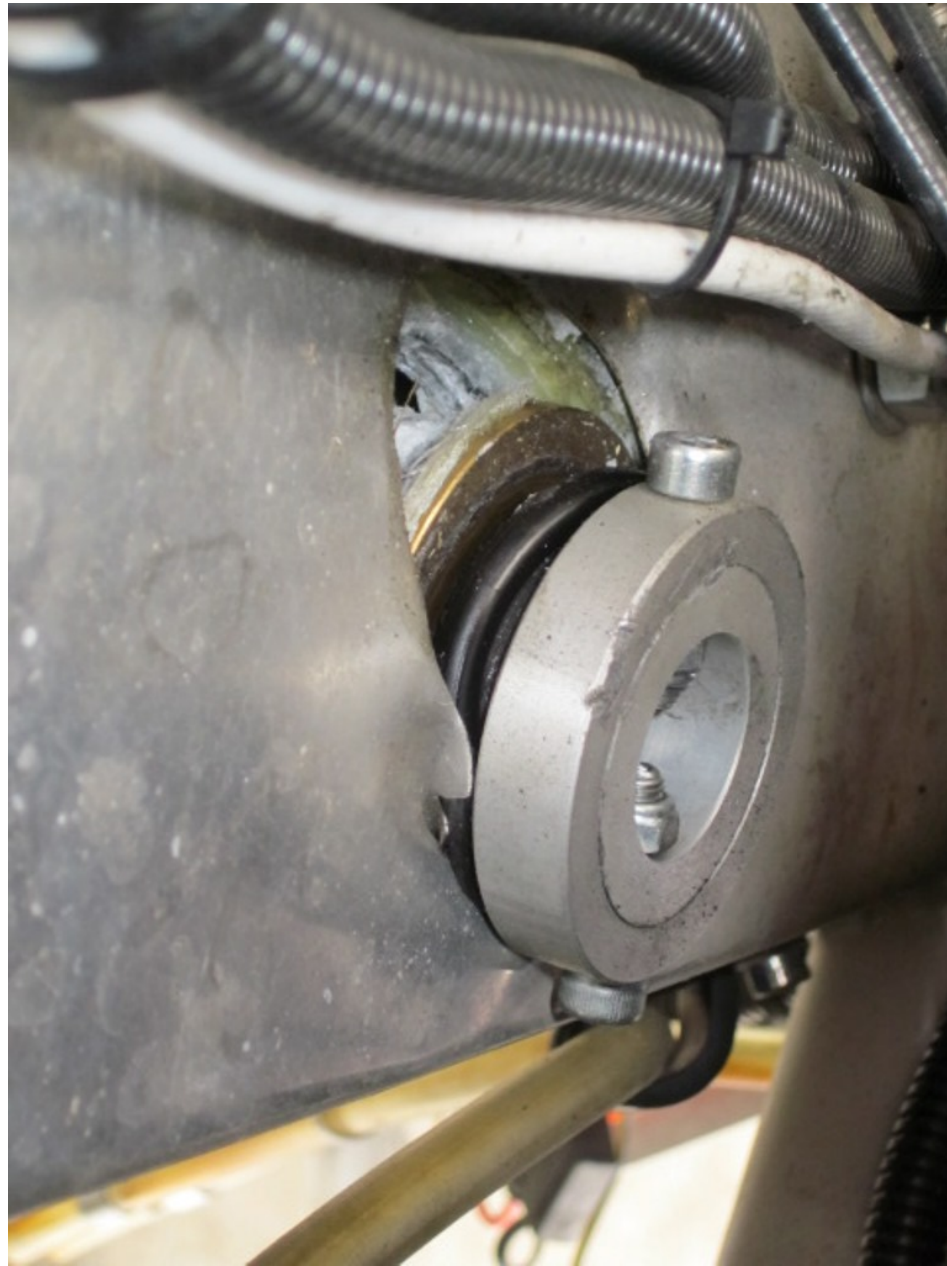
**Photo 2 – View of substantial damage to firewall (Courtesy of FAA)**

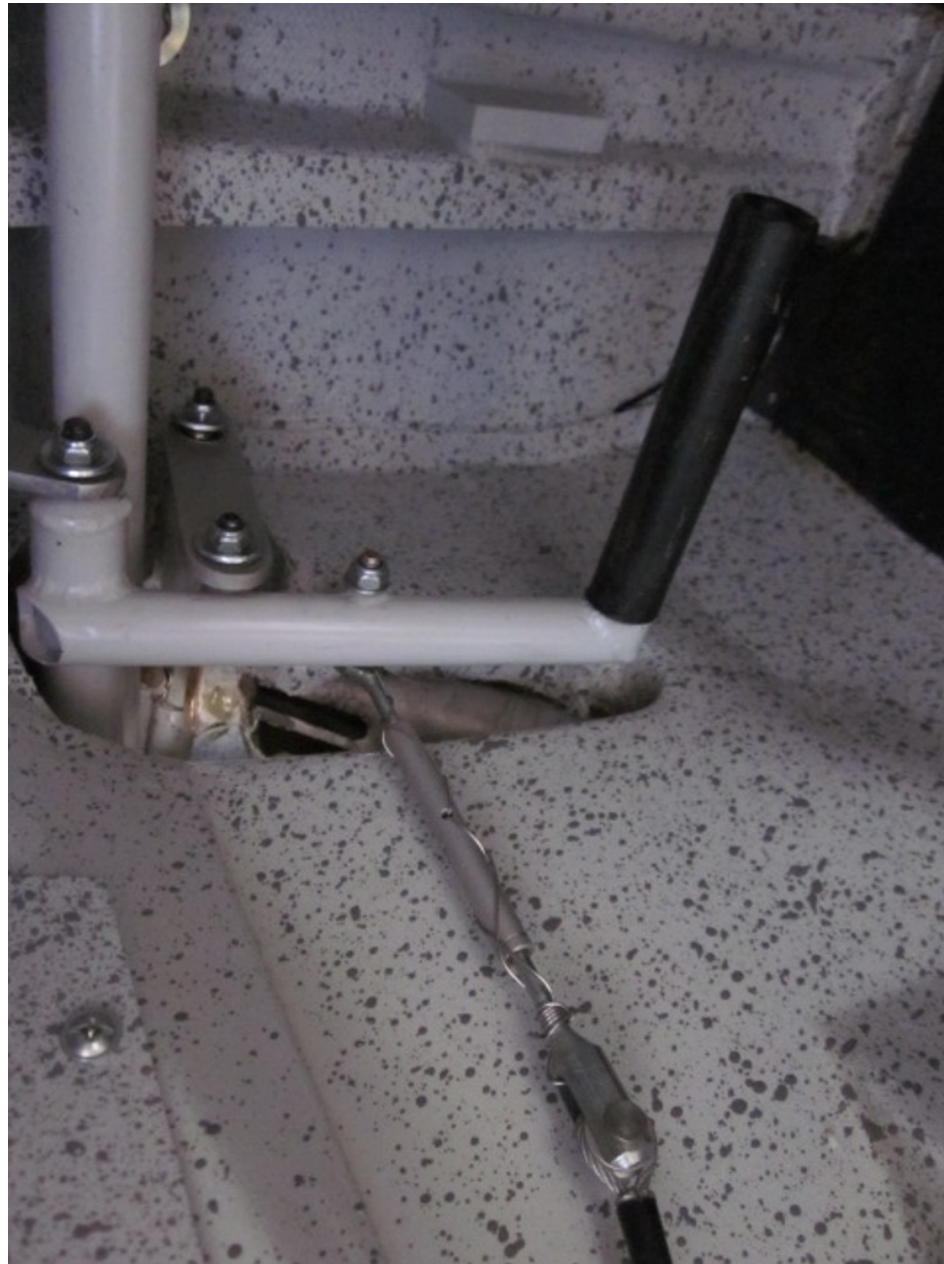
**Photo 3 – View of substantial damage to the cockpit floorboard (Courtesy of FAA)**
