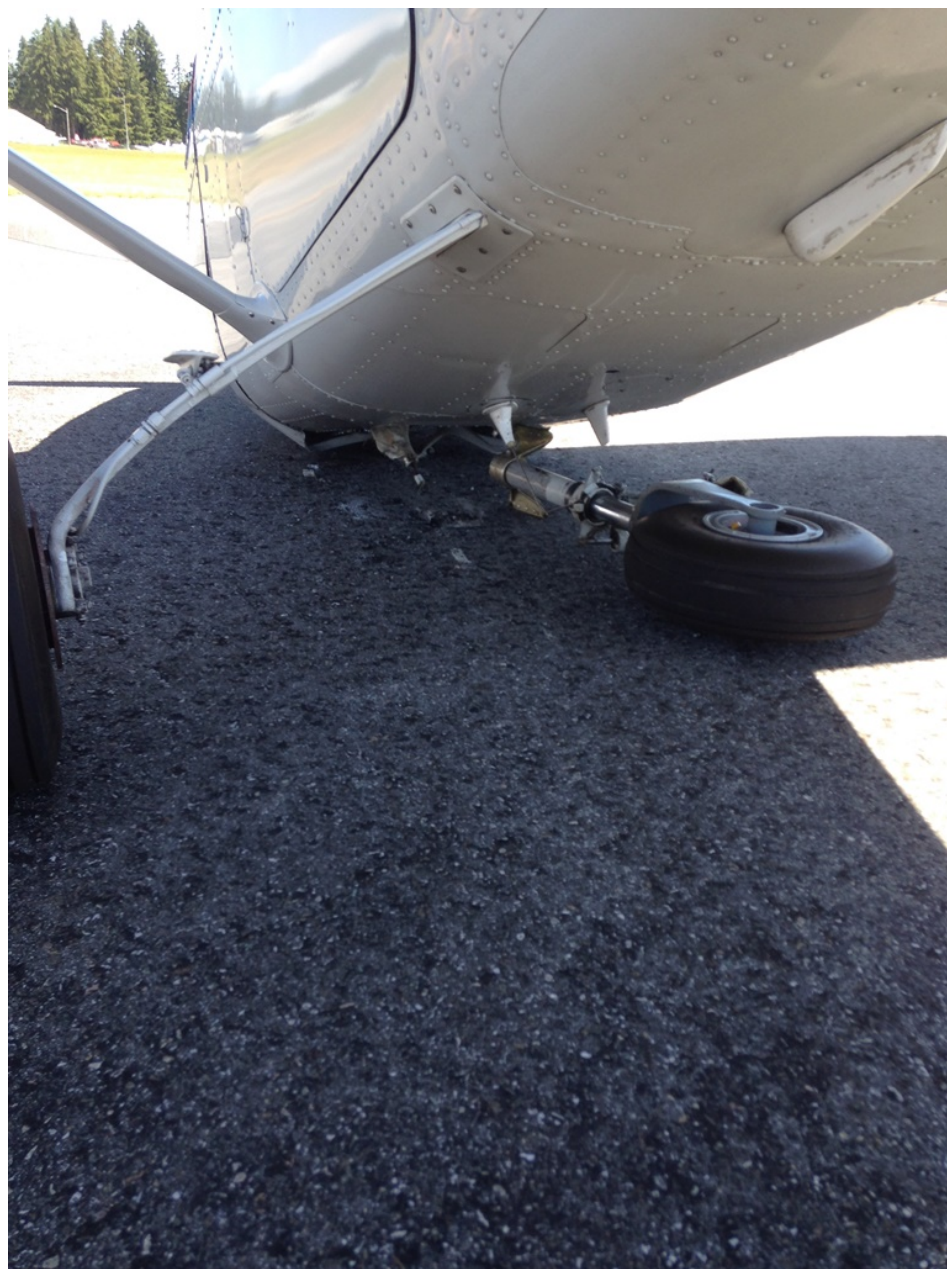
**Photo 3 – Collapsed nose gear strut assembly (Courtesy of FAA)**

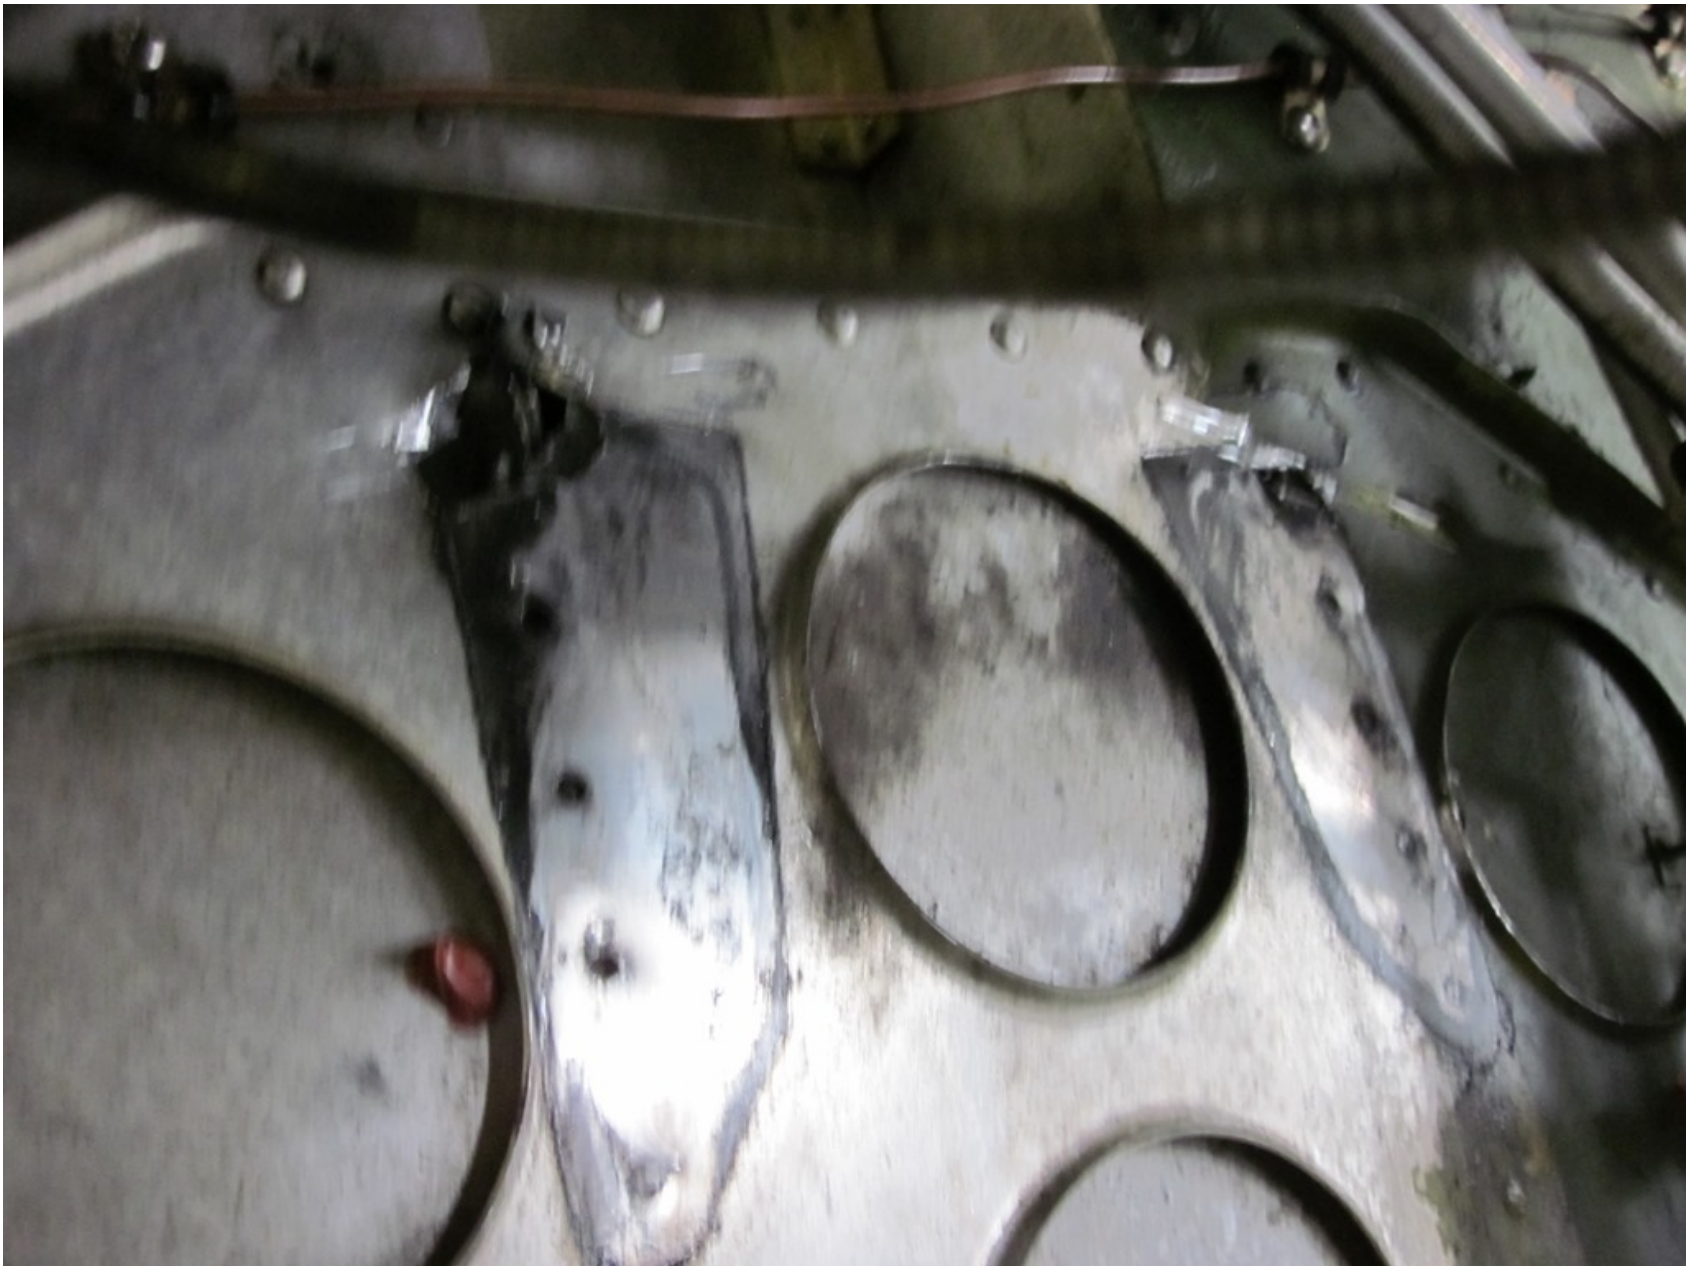
**Photo 4 – Damage to firewall (Courtesy of FAA)**

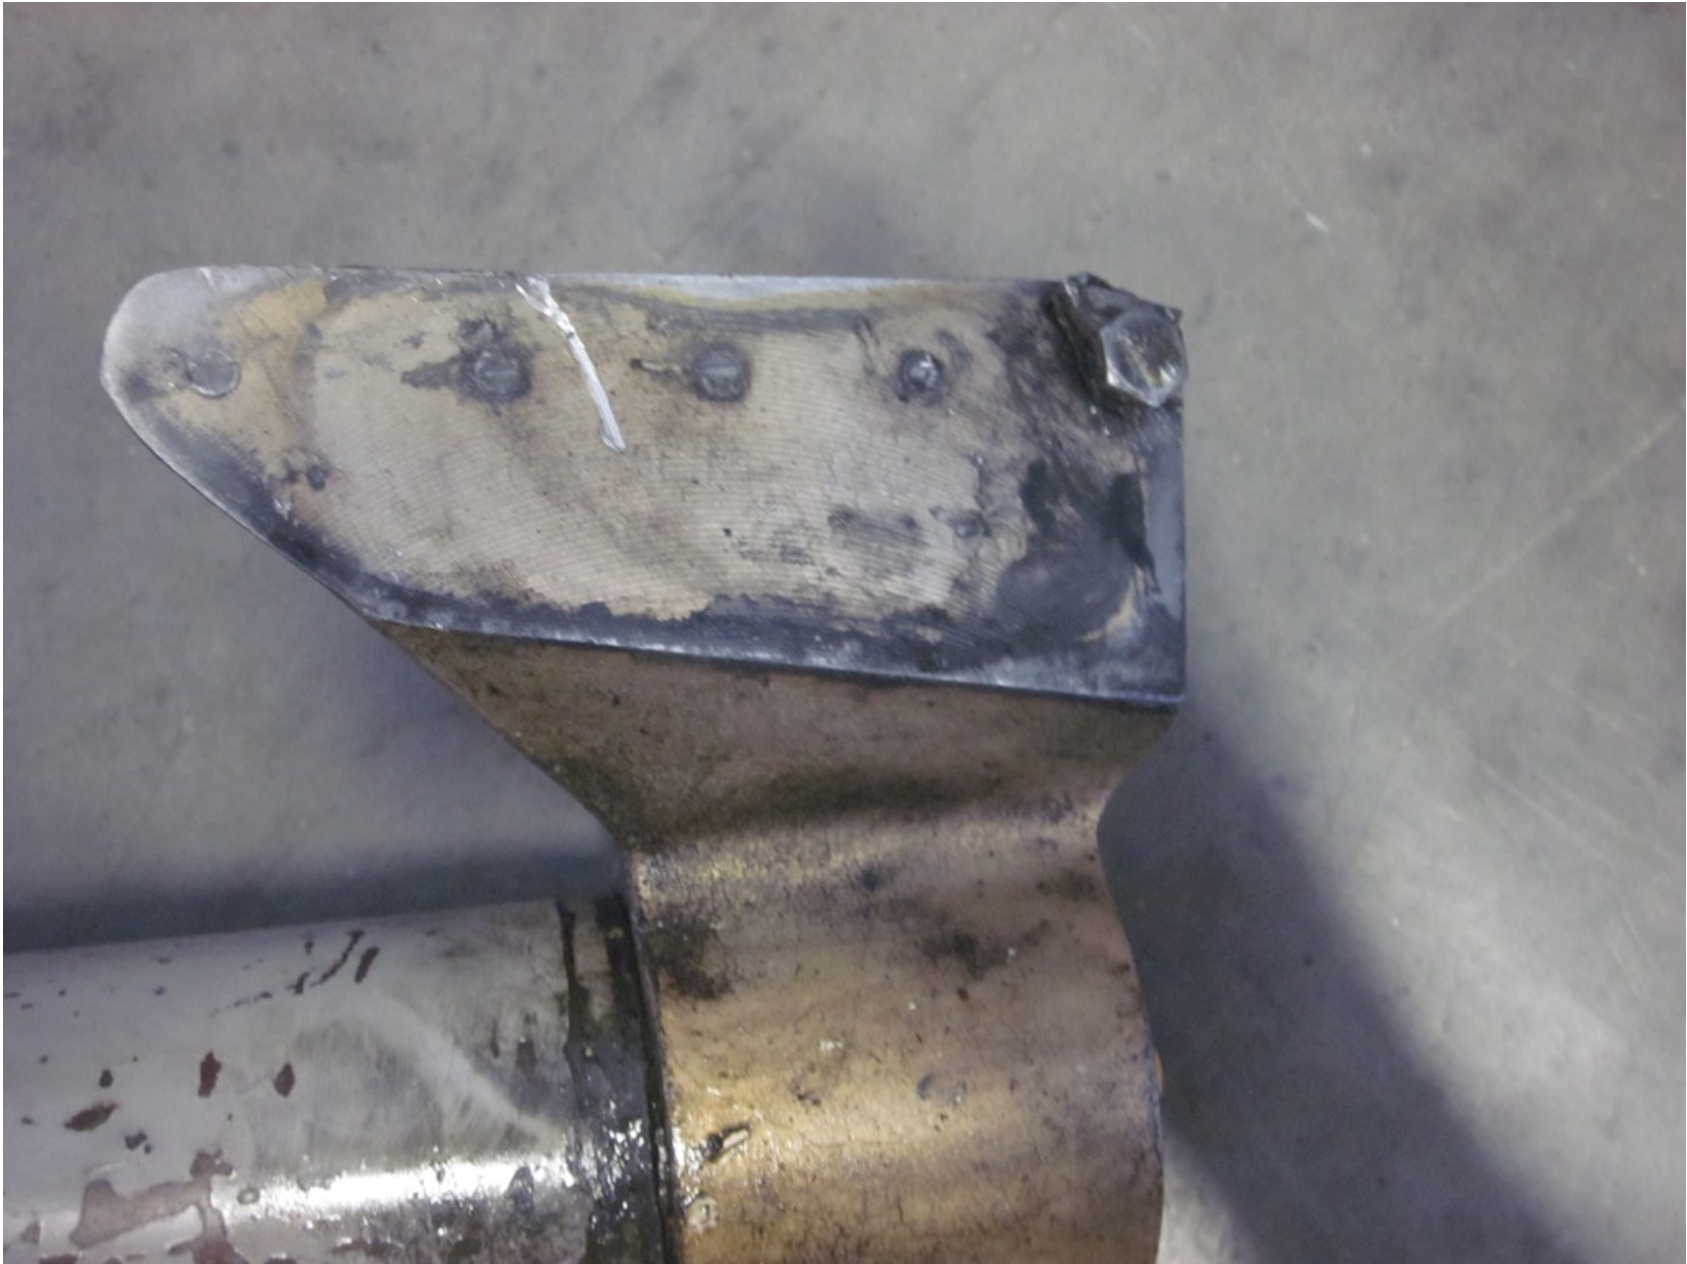
**Photo 5 – Failed upper forging (Courtesy of FAA)**

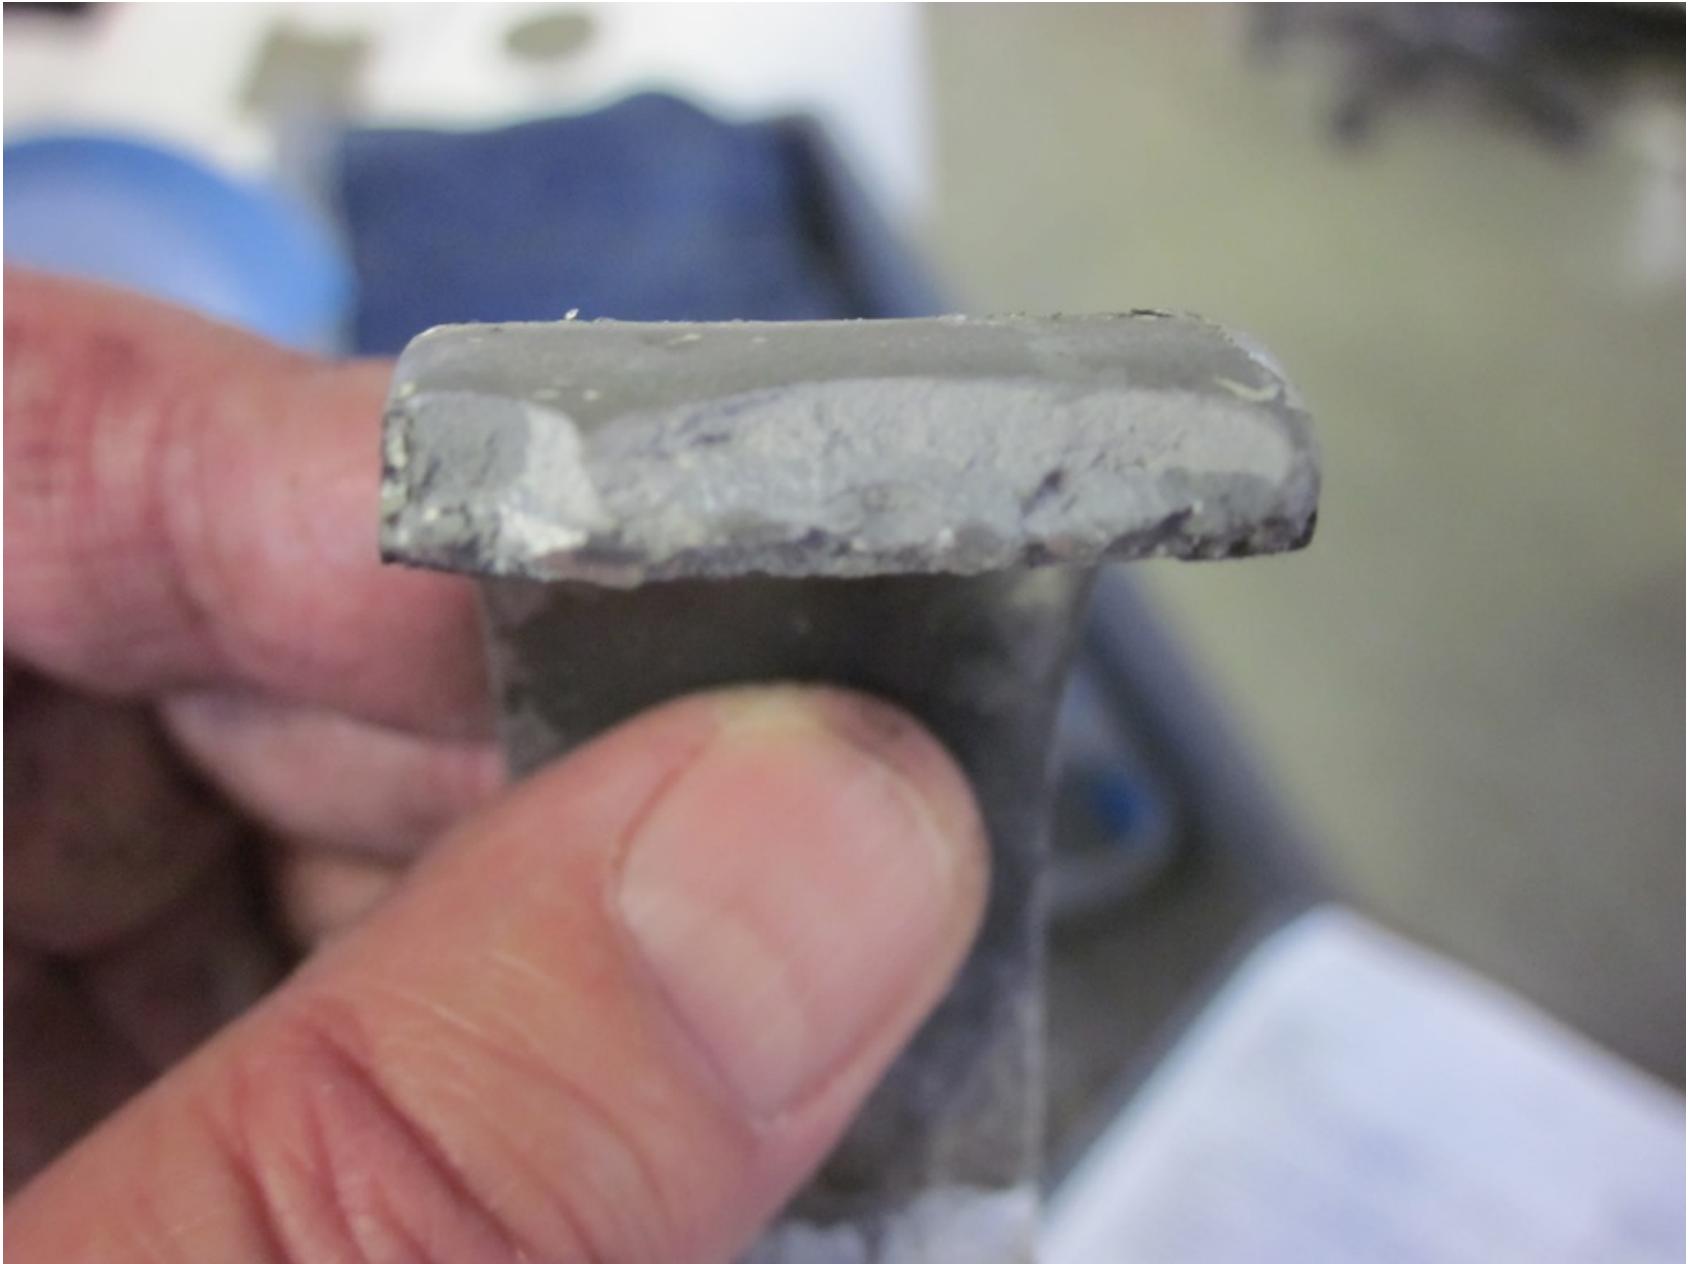
**Photo 7 – Failed lower forging clamp (Courtesy of FAA)**

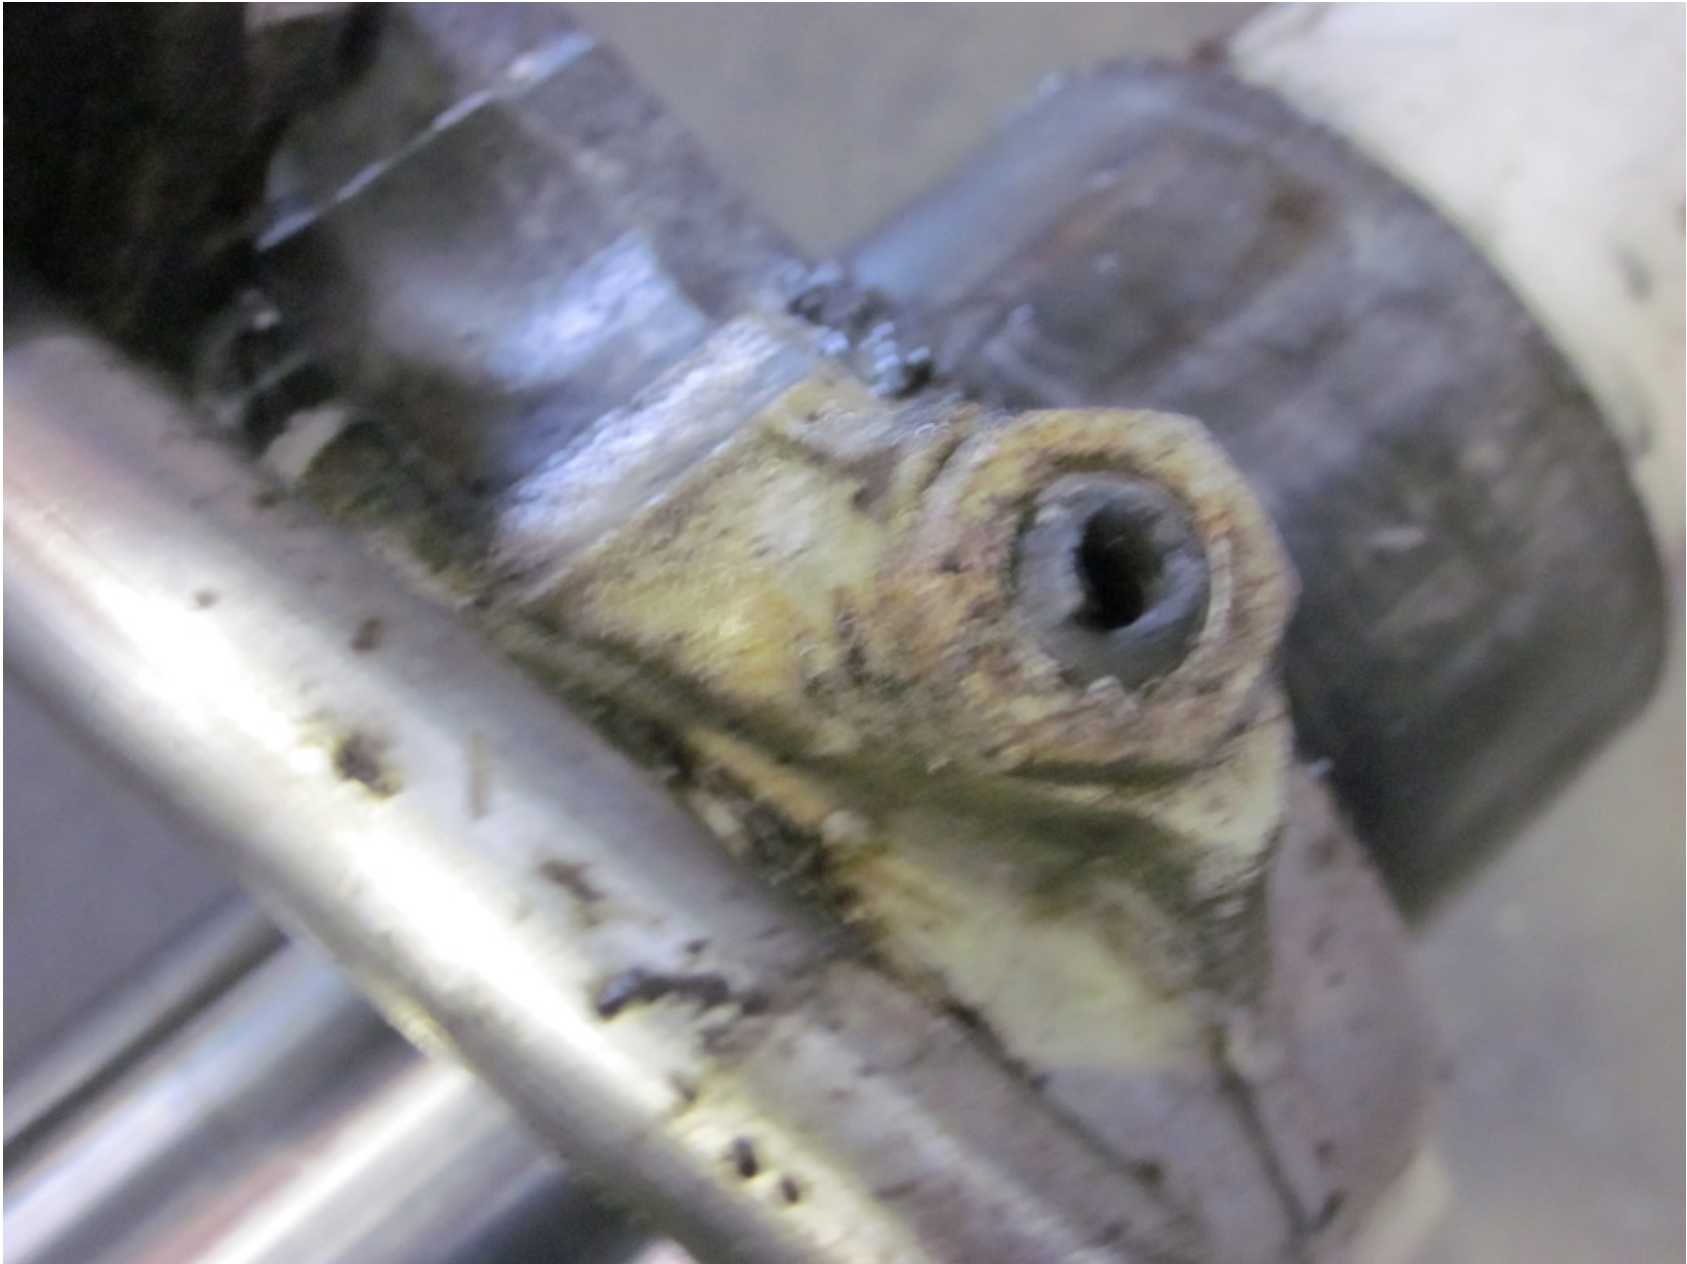
**Photo 8 – Failed steering rod end inside steering arm assembly (Courtesy of FAA)**

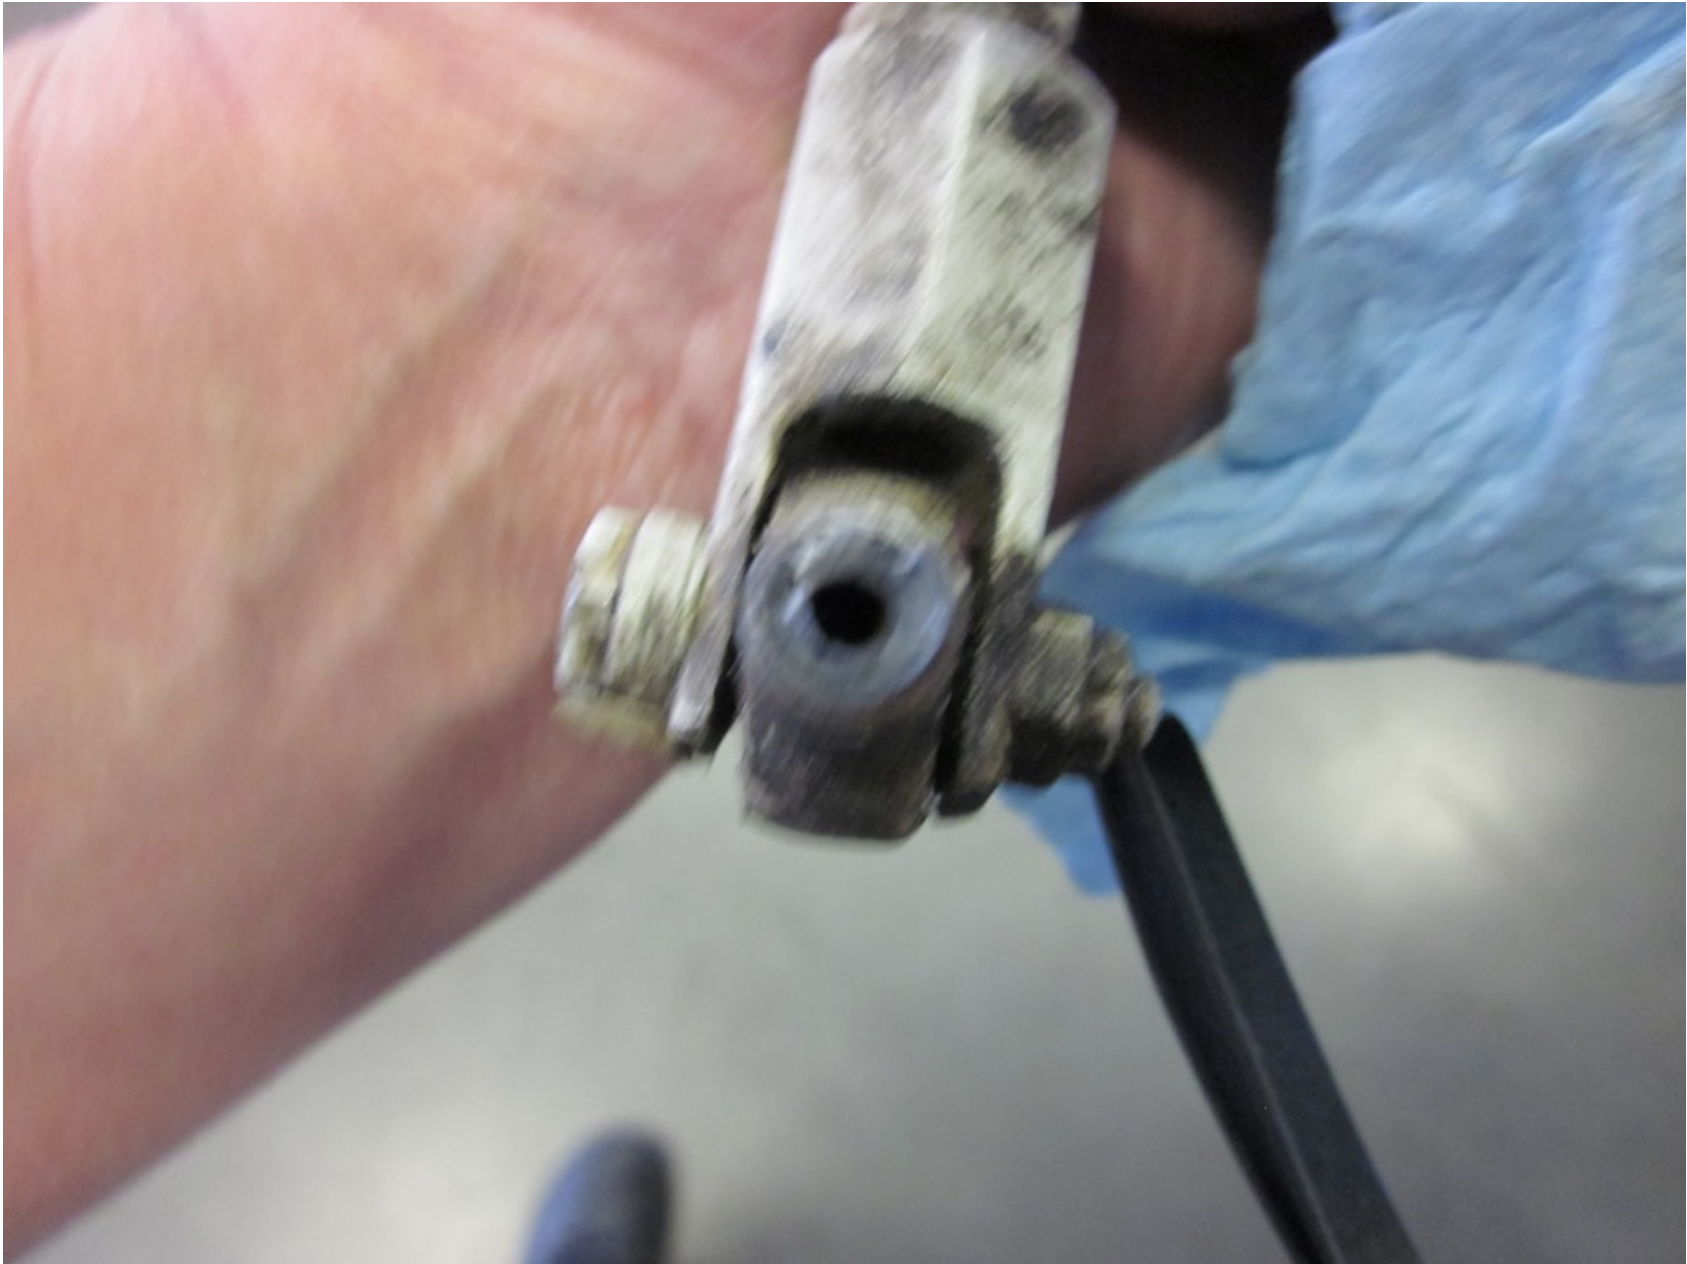
**Photo 9 – Failed steering rod end attached steering tube clevis (Courtesy of FAA)**

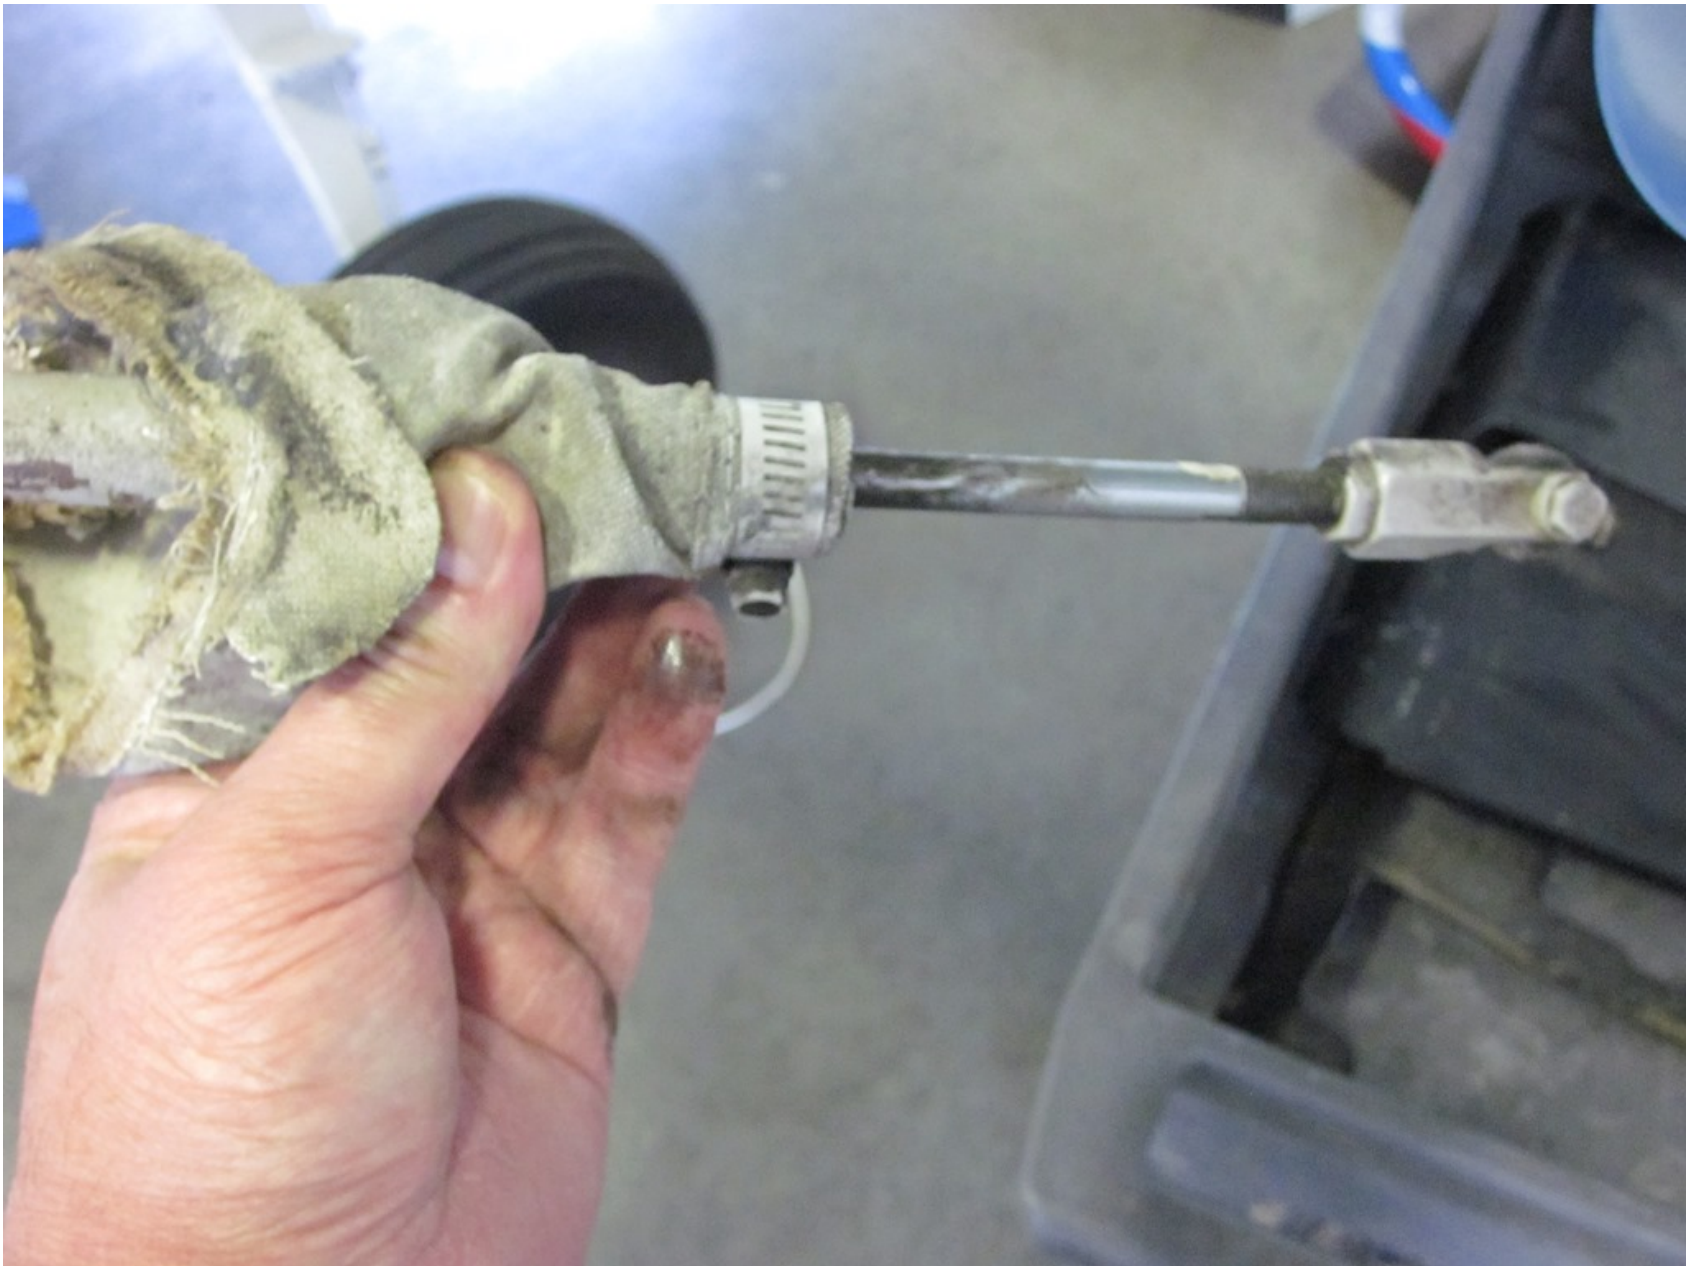
**Photo 10 – Failed steering bungee (Courtesy of FAA)**

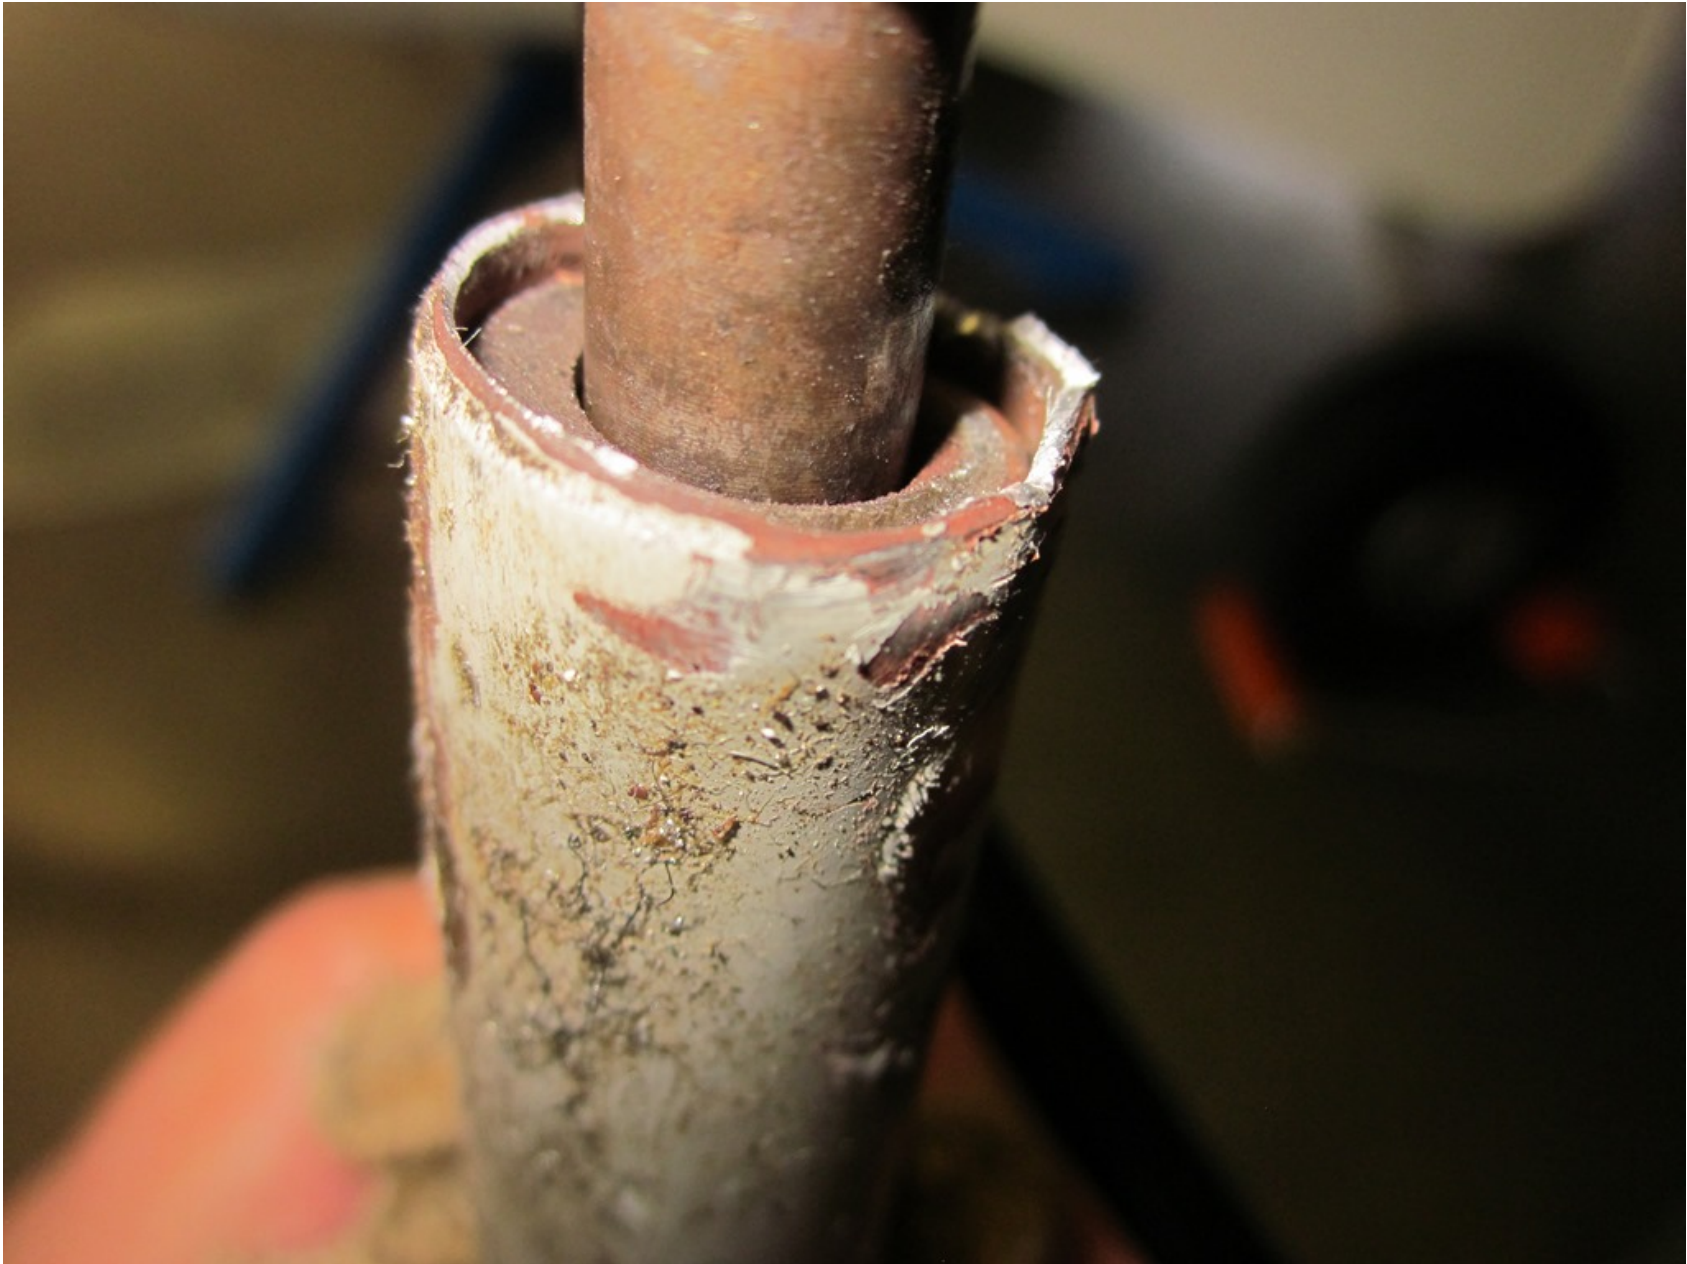
**Photo 11 – Steering bungee tube fracture surface (Courtesy of FAA)**

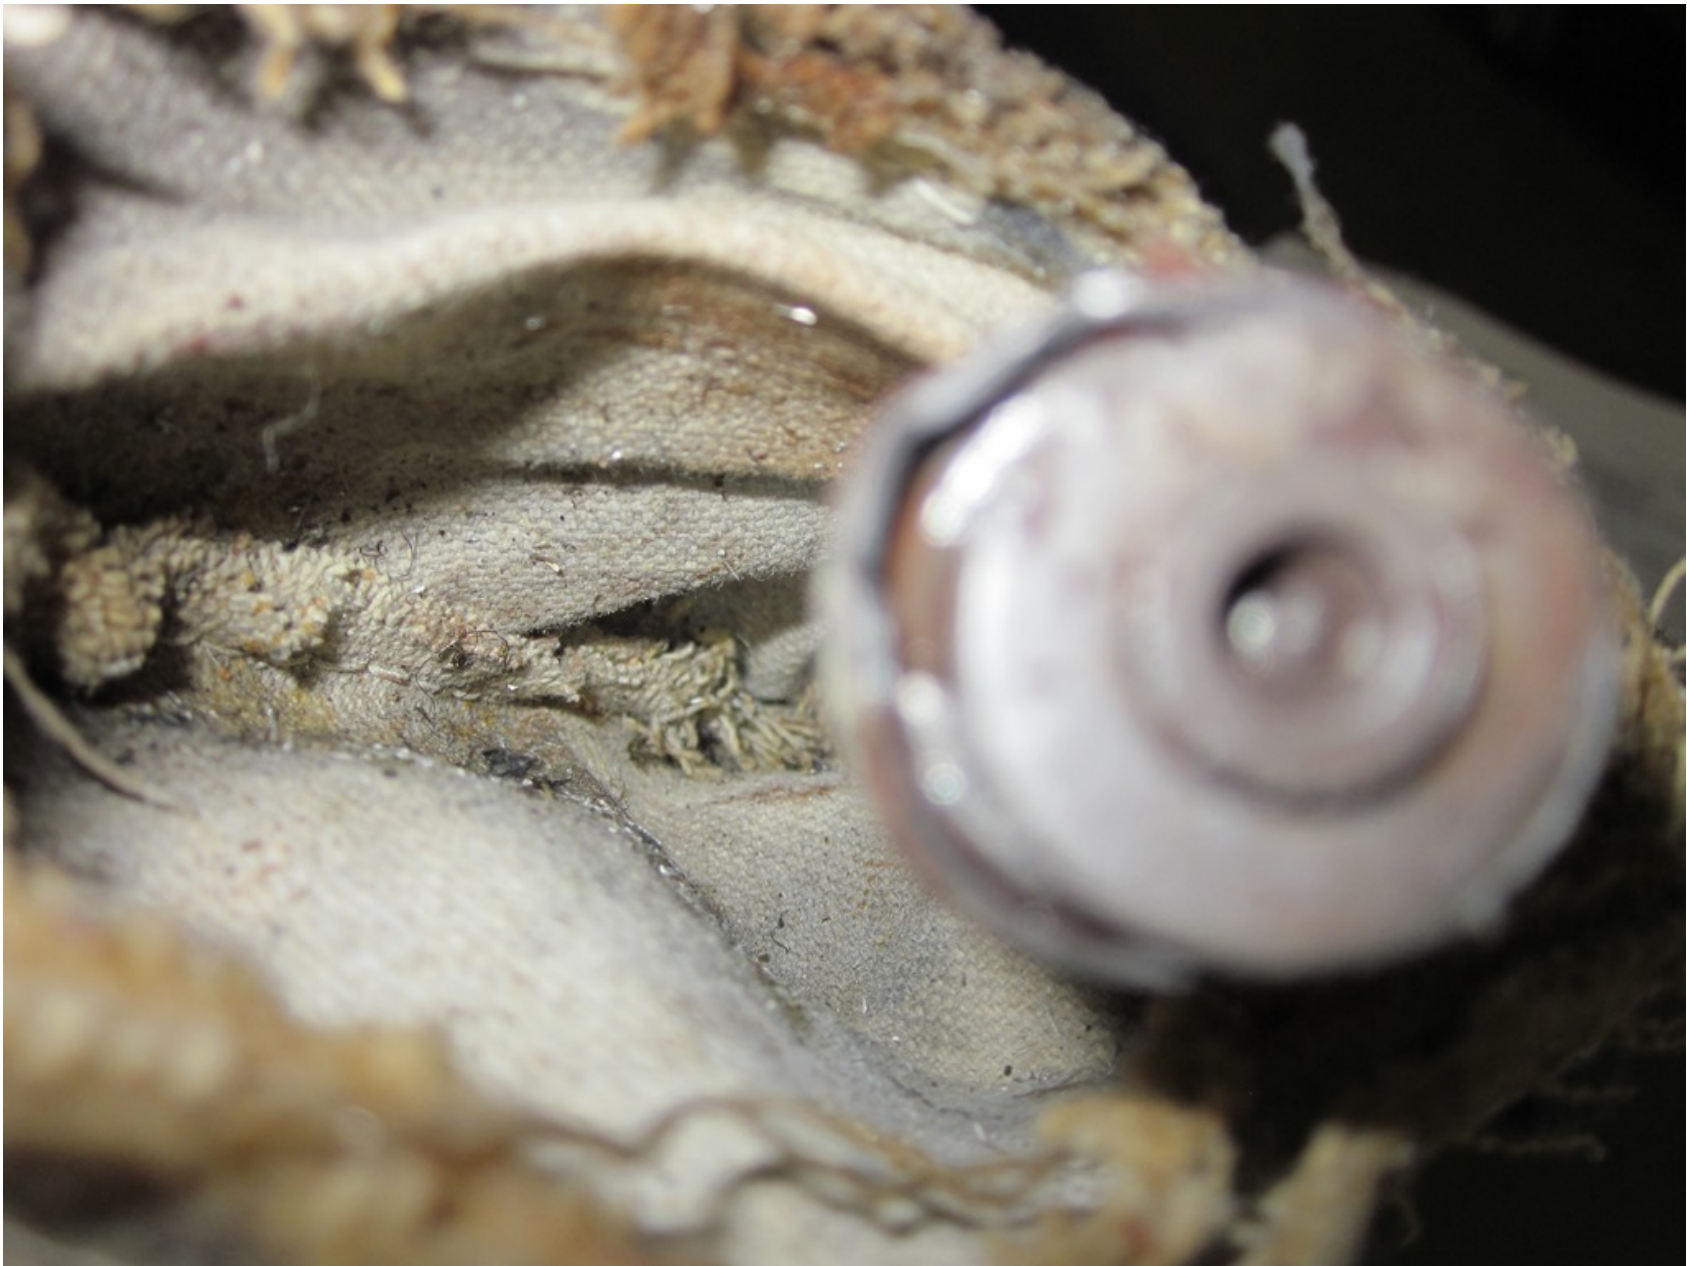
**Photo 12 – Aft end of steering bungee fracture surface (Courtesy of FAA)**

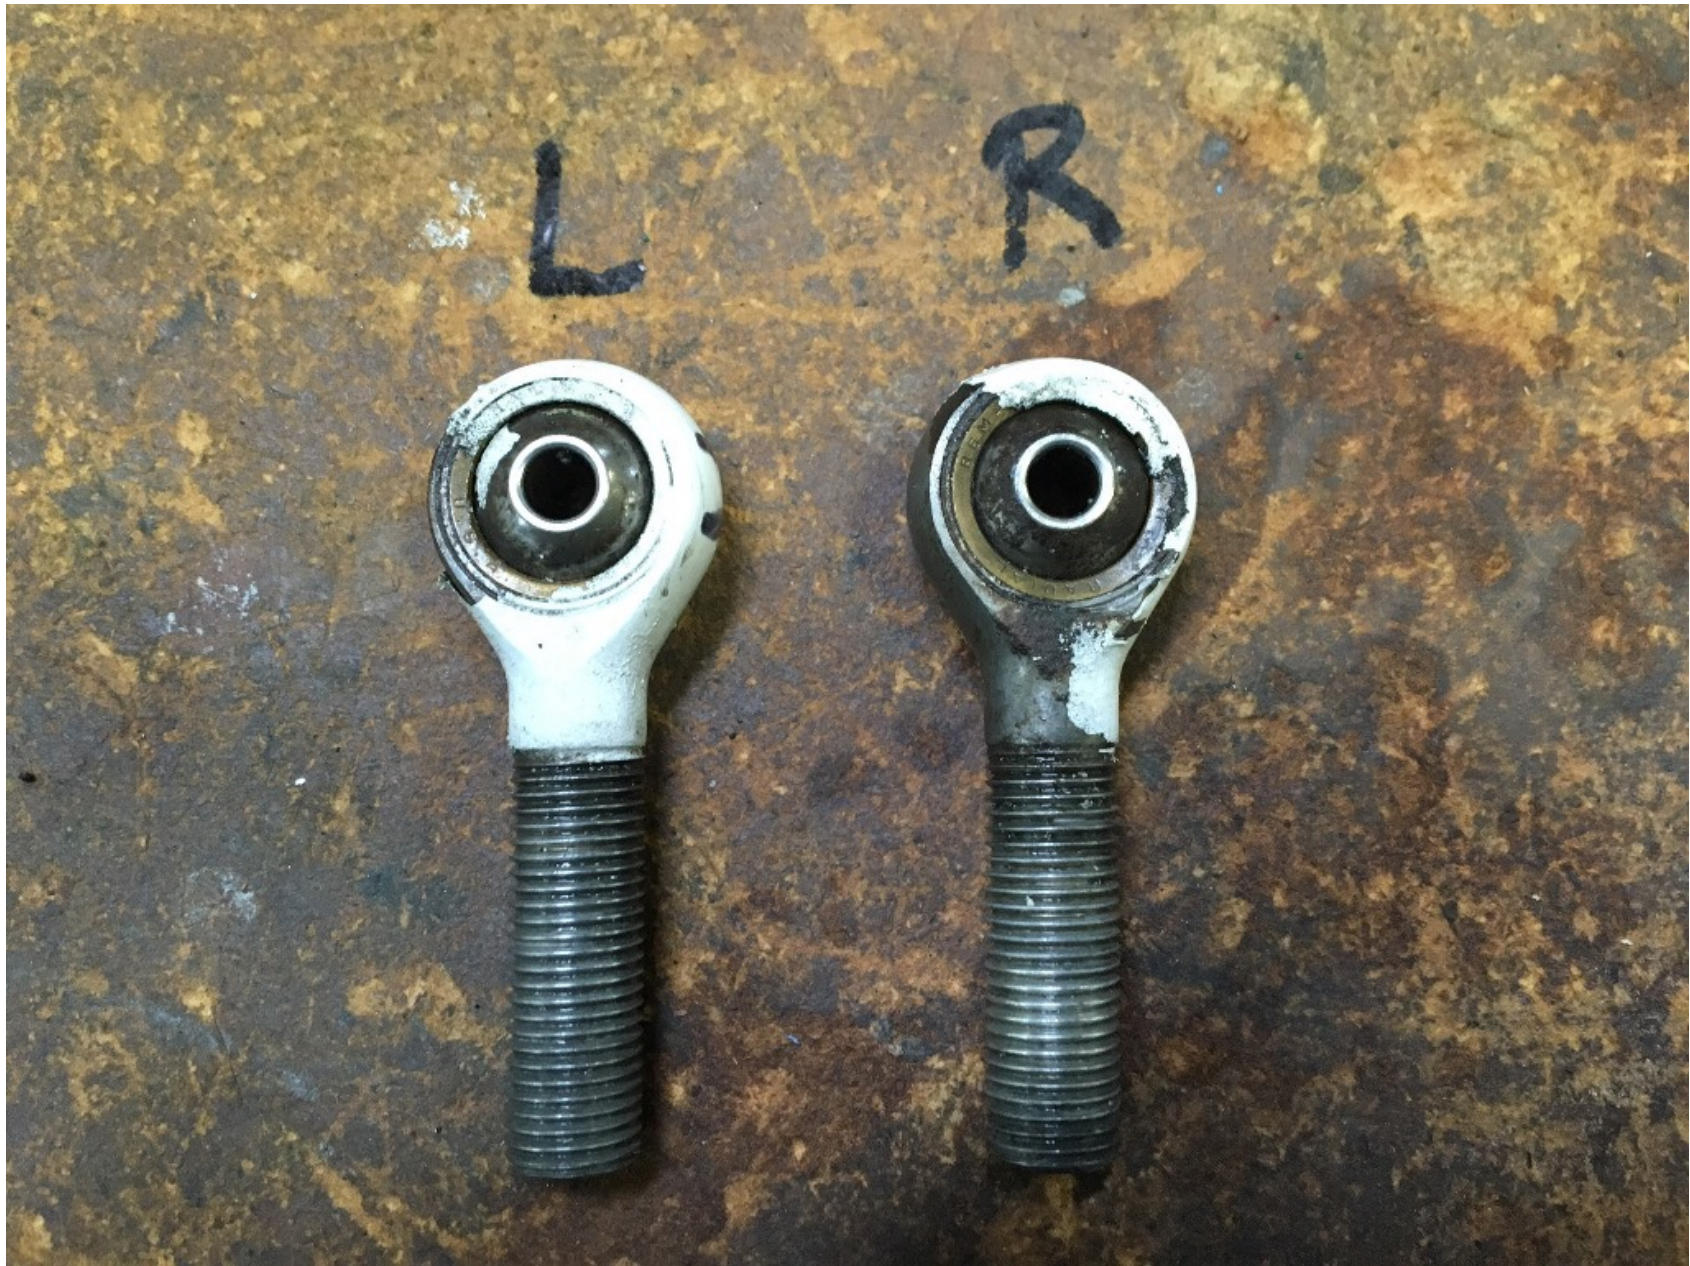
**Photo 13 -Steering rod ends from first non-accident C-172 with visible bending of right rod end (Courtesy of operator) □**

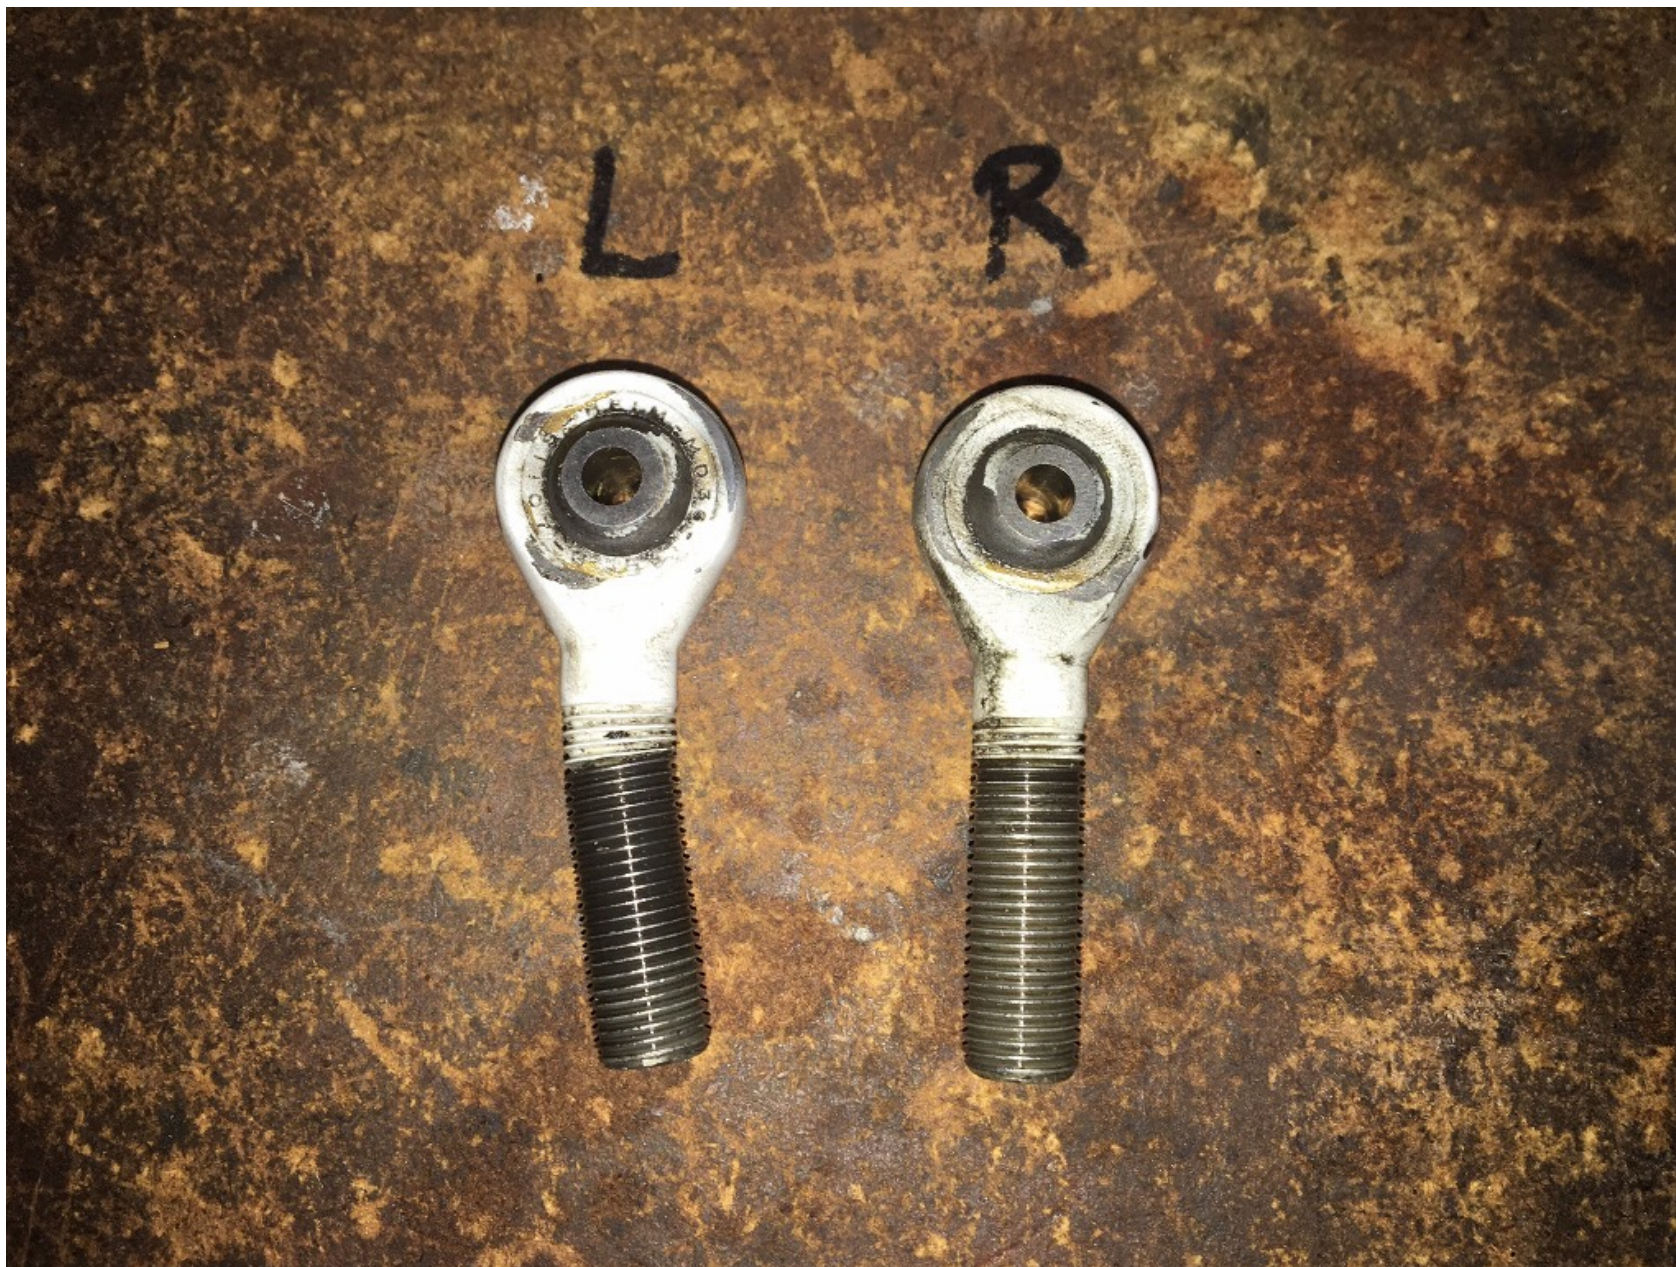
**Photo 14 – Steering rod ends from second non-accident C-172 with visible bending of left rod end (Courtesy of operator)**
